Assessment of Passenger Safety in Local Service PSVs

Final Report

Project Number 9/33/24

The Department of Environment,
Transport and the Regions (DETR)

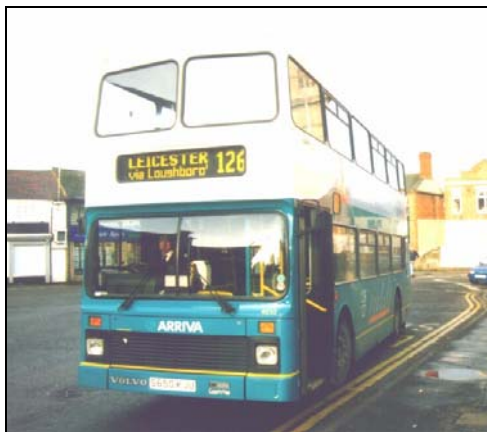
Bus number 1

Volvo Olympian chassis with an East Lancashire 'County Bus' body.

The high floor Olympian chassis necessitates the bus to have internal steps. This design also has a split entry steps. Once on board, the aisle is fairly flat with only a minimal slope.

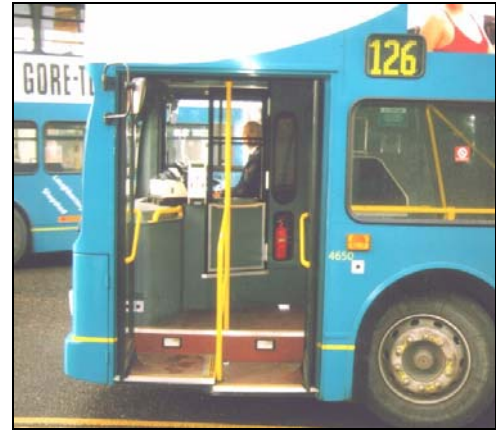
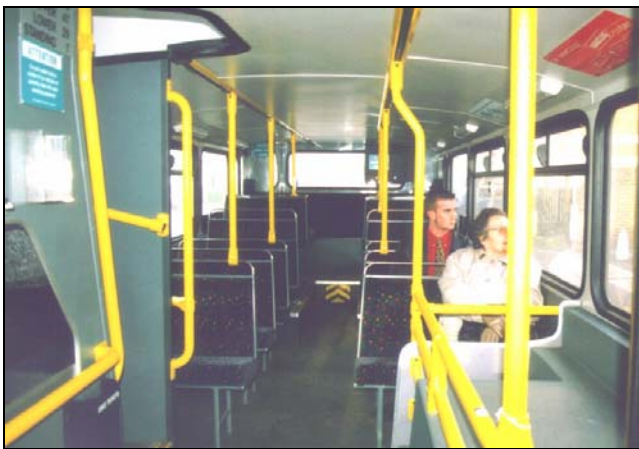
The internal environment shows yellow grabrails and the step towards the rear of the cabin. As this step drastically reduces headroom the operator has positioned a number of posters warning passengers to mind their head.

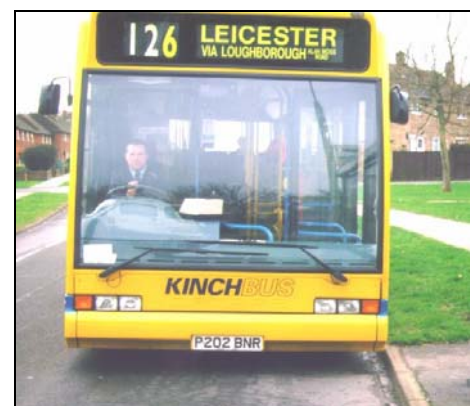
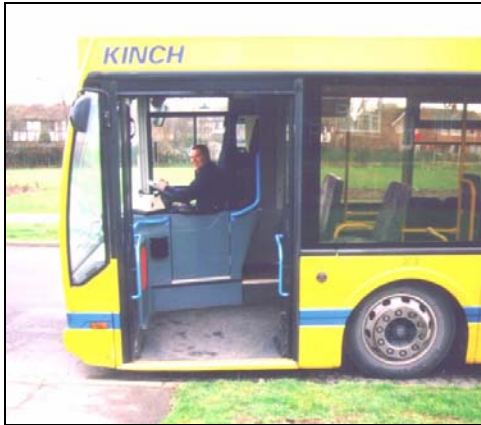
Bus number 2

The Optare 'Excel' is one of the new generation of low floor designs and this example is equipped to DPTAC guidelines.

The Excel has kneeling suspension and a wide open aspect to the entry area.

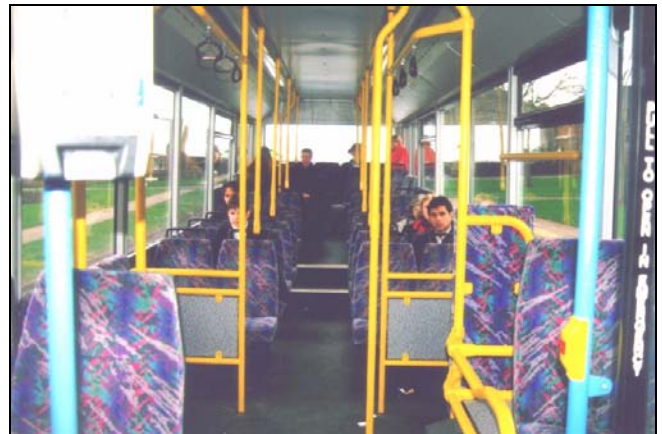
The wide aisle, individual seats, high roof and large windows give an impression of comfort which can affect passengers perception of their safety. Steps to the rear section were clearly marked with edge markers and the ceiling height in the rear section was more than adequate. The seats have a higher back than normal and have plastic coated grab rails positioned along the top.

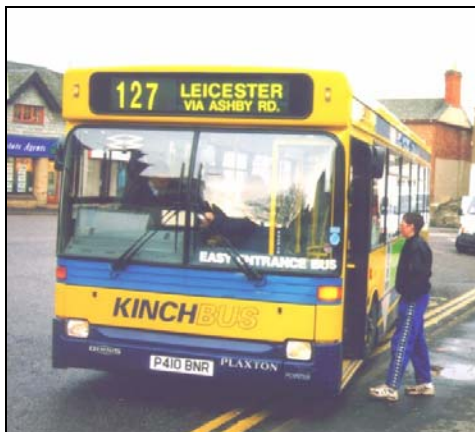
Bus number 3

Dennis chassis with the Plaxtons 'Pointer' body. This bus is a low floor design

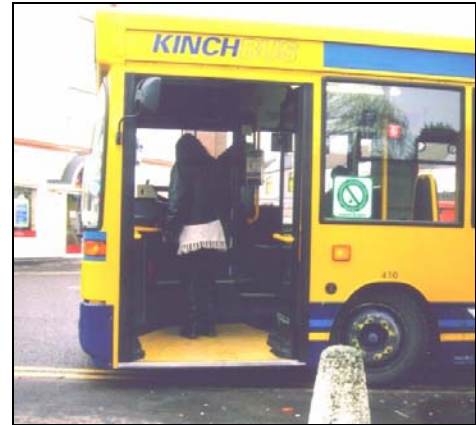
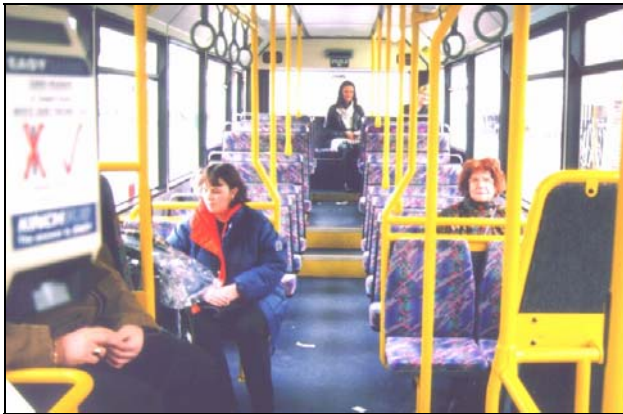
The pointer has a similar internal layout to the Optare Excel, with a wide entry area .

The internal design appears to be more compact than the Excel, and has overhead hand hold straps hung from the ceiling. This photograph

also shows an example of the protrusions within the aisle by the positioning to the left of the picture of an automatic card reader. The seats on this bus are of the basic bus type and feature stainless rails along the entire top.

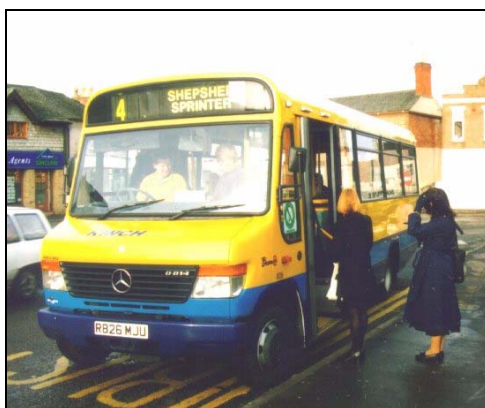
Bus number 4

Mercedes D814 with a Plaxtons 'Beaver2' body. For the trials both the Beaver and Beaver2 were used. The Beaver is a high floor midibus.

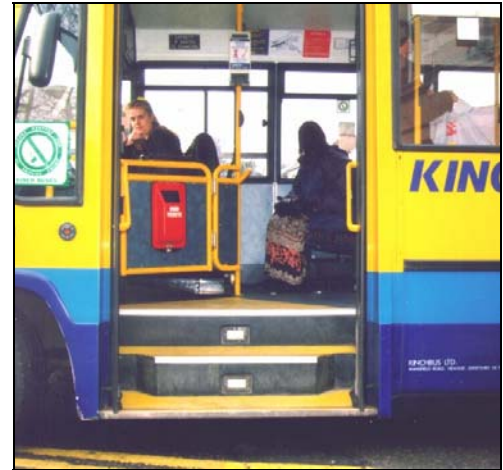
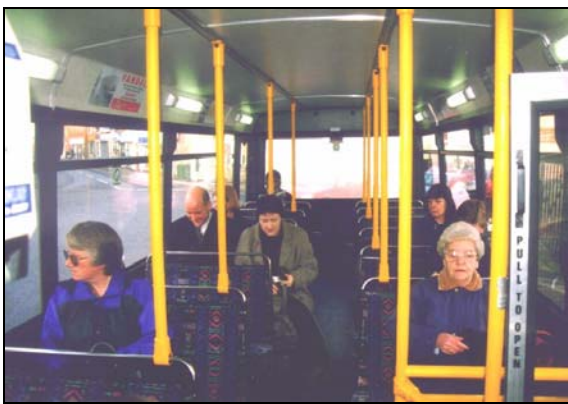
The Beaver has a wide door opening but has 2 internal steps once aboard. The handrails attached to the door help boarding and alighting but they tend to move with the door when they are used. The standing area at the side of the driver is also quite small and this example has a waste bin attached to the drivers door.

The internal floor on the Beaver is gently sloped from front to back and due to the short wheel base the ride at the rear is very bouncy. This example is fitted with basic bus seats which feature hand rails across the top of the entire seat.
