AIS 3+ HEAD INJURY MECHANISMS AND CRASH CHARACTERISTICS - A REVIEW OF AIRBAG DEPLOYED CRASHES

**Ruth Welsh, Steven Reed, Andrew Morris
VSRC, Loughborough University, UK**

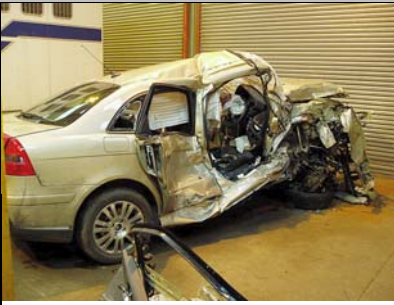
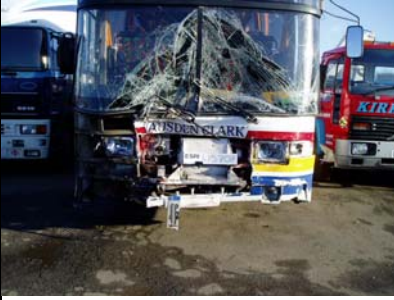
Case 1 - Fatal		
CDC	03RYAW4

Impact Object	Coach	
EES	43 km/h

Maximum Crush	460 mm	
Relevant lateral intrusion	300mm from base of window down to sill	
Belt Use	Belted	
Airbags	Hub - Activated Knee bolster - Activated Seat back thorax - Activated Curtain - Activated	
Occupant Age	57 years	
Occupant Gender	Male	
Head Injuries and sources

# Skull AIS 3 - External object		
Subdural bleed AIS 4 - External object		
Other injuries		
Multiple fractured ribs with hemothorax AIS 5		
Liver lacerations AIS 2		
Cause of Death		
Multiple injuries		
Comments		
<p>The head injuries are attributed to contact with an external object, there is evidence of hair and skin tissue at the base of window of the coach. Due to the nature of the impact the resultant deformation may give the impression of a higher energy impact than that calculated. The calculated value is believed to be representative. The side curtain has deployed. The side curtain would have been expected to have provided head protection to mitigate this kind of injury.</p>

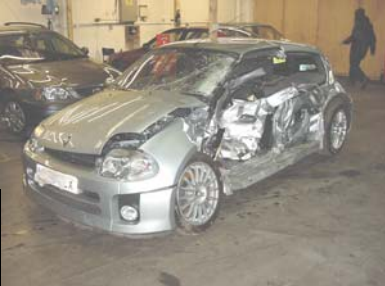
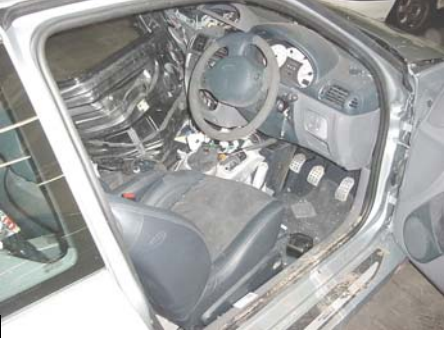
Case 2 - Fatal		
CDC	09LPEW4

Impact Object	Citroen Van	
EES	32 km/h

Maximum Crush	590 mm	
Relevant lateral intrusion	550 mm base window/mid door	
Belt Use	Belted	
Airbags	Facia - Not Activated Seat back head and thorax- Activated	
Occupant Age	20 years	
Occupant Gender	Male	
Head Injuries and sources

# Skull AIS 2 - External object		
Subarachnoid Hematoma AIS 3 - External object		
Cerebral Oedema AIS 3 - External object		
Other injuries		
# Ribs with Hemothorax AIS 4 , Diaphragm tear AIS3, Spleen injury AIS 2, # Pelvis AIS 2		
Cause of Death		
Multiple injuries		
Comments		
<p>The head injuries are attributed to contact with an external object, the striking vehicle. It is possible that the calculated EES value is a slight underestimate. The seat back head/thorax bag has deployed. The side bag would have been expected to have provided head protection to mitigate this kind of injury.</p>

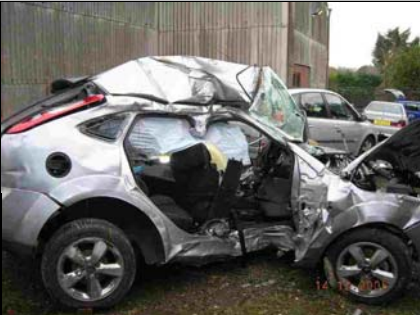
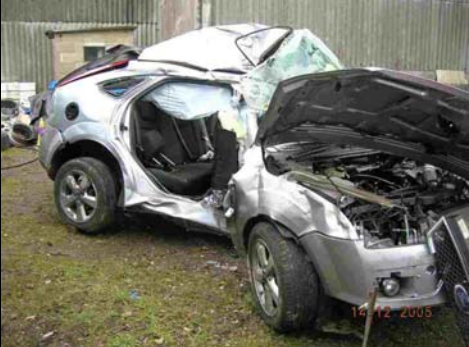
Case 3 - Fatal		
CDC	03RPAW5

Impact Object	Tree	
EES	n/k

Maximum Crush	910 mm	
Relevant lateral intrusion	550 mm at cant rail	
Belt Use	Belted	
Airbags	Hub - Not activated Seat back thorax - Not activated Curtain - Activated	
Occupant Age	47 years	
Occupant Gender	Male	
Head Injuries and sources		
Extensive regions of disruption to brain stem AIS 5 - B Pillar		
Extensive regions of disruption to the cerebellum AIS 3 - B Pillar		
Extensive regions of disruption to both cerebral hemispheres AIS 3 - B Pillar		
Complicated fracture base and vault of skull AIS 4 - B Pillar		
Other injuries

# Pelvis AIS 2, Liver Lacerations AIS 4, # Arm AIS 2		
Cause of Death		
Head Injuries		
Comments		
<p>Given the crush extent the crash severity is likely to be high but no reliable calculation could be made due to the nature of the damage. Though the head injuries have been attributed to the B pillar in this case, it is also likely that some external contact was made with the tree given the location of the impact and the perpendicular direction of force. The curtain might have been expected to offer better head protection.</p>

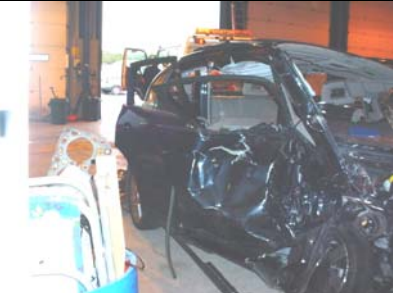
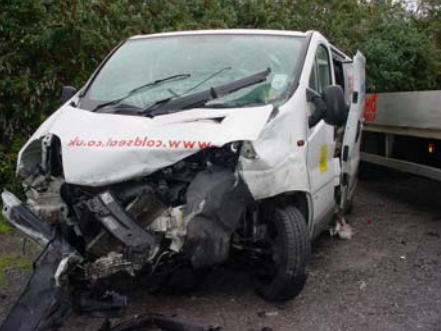
Case 4 - Fatal		
CDC	01RYAW3

Impact Object	Vauxhall Van	
EES	44 km/h

Maximum Crush	560 mm	
Relevant lateral intrusion	340 mm at base of door	
Belt Use	Belted	
Airbags	Hub - Activated Seat back thorax - Activated Curtain - Activated	
Occupant Age	73 years	
Occupant Gender	Male	
Head Injuries and sources		
Subdural haemorrhage AIS 4 - Own side nfs		
Subarachnoid haemorrhage AIS 3 - Own side nfs		
Brain swelling AIS 3 - Own side nfs		
Contusions in cortex AIS 3 - Own side nfs		
Other injuries

# leg, # thoracic spine, # ribs with hemothorax, lung contusions, ruptured atrium, liver and kidney lacerations		
Cause of Death		
Multiple injuries		
Comments		
<p>Due to the nature of the impact, the resultant deformation may give the impression of a higher energy impact than that calculated. The calculated value is however believed to be representative. This elderly occupant has received a fatal injury to the heart. Given the extent of the vehicle damage and the deployed side airbags, the head injuries are surprising.</p>

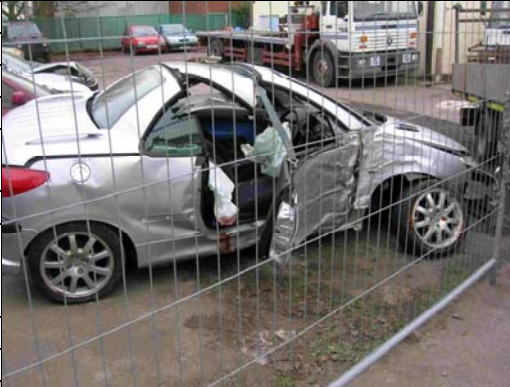
Case 5 - Fatal		
CDC	02RPAW3

Impact Object	Tree	
EES	33 km/h	
Maximum Crush	320 mm	
Relevant lateral intrusion	180 mm from cant rail down to mid door level	
Belt Use	Belted	
Airbags	Hub - Activated Seat back head and thorax - Activated	
Occupant Age	63 years	
Occupant Gender	Female	
Head Injuries and sources

# Base of skull AIS 3 - external contact with tree		
Subarachnoid haemorrhage AIS 3 - tree		
Intraventricular haemorrhage AIS 4 - tree		
Other injuries		
Pleural haemorrhage AIS 3		
Cause of Death		
Multiple injuries		
Comments		
The calculated EES is believed to be representative of the impact. This is a convertible. The side head airbag is relatively small. The non perpendicular impact could have resulted in occupant kinematics such that the head missed both the hub and the side airbag during the impact phase. If a larger airbag had been present then the contact with the tree may have been avoided.

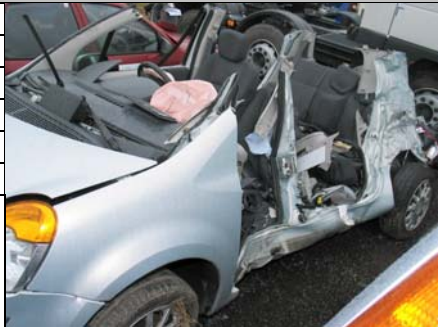
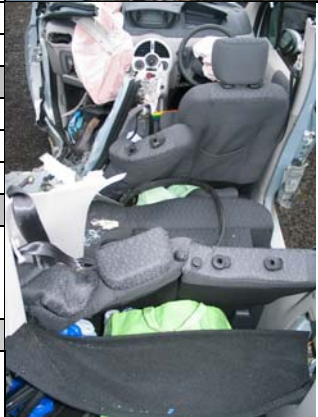
Case 6 - Fatal		
CDC	10LZAW5

Impact Object	Truck	
EES	Not Known	
Maximum Crush	380 mm	
Relevant lateral intrusion	710 mm at base of window	
Belt Use	Belted	
Airbags	Facia - Activated Seat back thorax - Activated Curtain - Activated	
Occupant Age	52 years	
Occupant Gender	Female	
Head Injuries and sources		
Basal # Skull AIS 3 - External object		
Blood present in meninges AIS 3 - External object		
Bone shards present in brain stem AIS 6 - External object		
Other injuries		
Multiple rib # with bilateral haemopneumothorax AIS 5, Atlanto-axial subluxation with severed spinal cord AIS 6, # spine AIS 2, Bilateral acetabulum #' & multiple pelvic #'s AIS 2		
Cause of Death		
Multiple injuries

Comments		
The head injuries are attributable to an external object (Truck) and the extensive intrusion into the vehicles nearside would support this. Considering the level of intrusion the curtain bag could have provided a level of protection although overloading may be a possibility

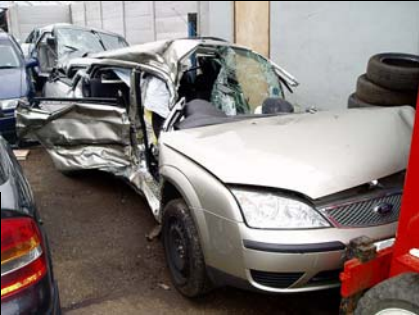
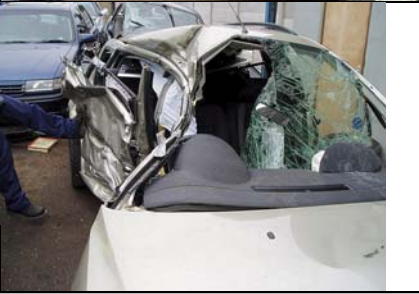
Case 7 - Serious		
CDC	01RYAW4

Impact Object	Truck	
EES	45 km/h

Maximum Crush	400 mm	
Relevant lateral intrusion	350 mm base of window / mid door	
Belt Use	Belted	
Airbags	Hub - Activated Seat back - Activated Curtain - Activated	
Occupant Age	28 years	
Occupant Gender	Male	
Head Injuries and sources

# Base of skull, CSF leak AIS 3 - External object		
Cerebral contusions AIS 3 - External object		
Subdural hematoma AIS 4 - External object		
Other injuries		
Internal chest injuries AIS 3		
Comments		
<p>Due to the nature of the impact the resultant deformation may give the impression of a higher energy impact than that calculated. The calculated value is believed to be representative. The head injuries are attributed to contact with an external object though no inspection was made of the truck. The side curtain has deployed. The side curtain would have been expected to have provided head protection to mitigate this kind of injury.</p>

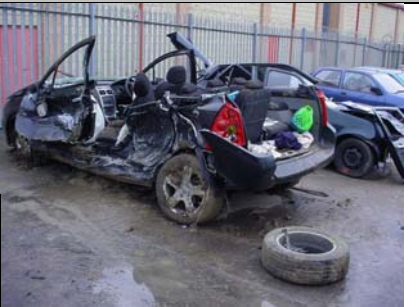
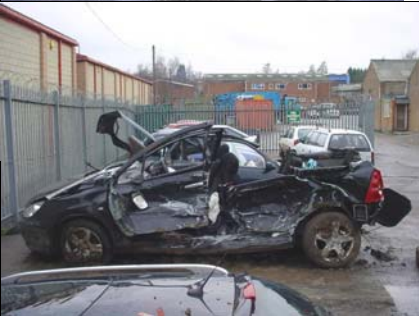
Case 8 - Serious		
CDC	09LPEW3

Impact Object	Car	
EES	35 km/h

Maximum Crush	400 mm	
Relevant lateral intrusion	200 mm at cant rail and mid door level	
Belt Use	No evidence of belt use	
Airbags	Facia - Activated Seat back thorax - Activated Curtain - Activated	
Occupant Age	16 years	
Occupant Gender	Male	
Head Injuries and sources		
Small brain hematoma AIS 3 - Own side/B pillar		
Other injuries		
None		
Comments		
<p>This vehicle has been substantially damaged by the emergency services giving the impression of a higher severity impact. The calculated EES is believed to be representative. The only injury to this occupant is the brain hematoma. The curtain would have been expected to mitigate this type of injury. There was no evidence of belt use. This was a perpendicular impact and therefore evidence of belt use is not necessarily expected.</p>

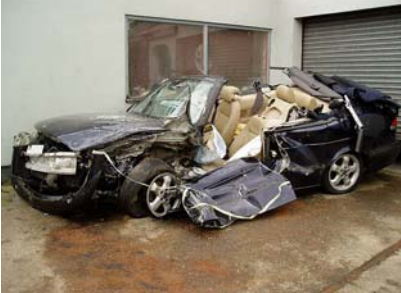
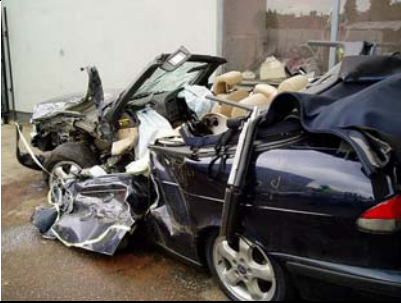
Case 9 - Serious		
CDC	11LYAW4

Impact Object	Transit Van	
EES	31 km/h

Maximum Crush	400 mm	
Relevant lateral intrusion	390 mm at base of door	
Belt Use	Belted	
Airbags	Facia - Activated Seat back head and thorax - Activated	
Occupant Age	66 years	
Occupant Gender	Female	
Head Injuries and sources		
Inter cerebral contusion AIS 3 - External object		
Subarachnoid haemorrhage AIS 3 - External object		
Other injuries		
AIS 2/3 injuries to the upper extremity, pelvis and lower extremity		
Comments		
<p>The nature of the collision was such that there was substantial soft structure damage (e.g. the wings) which gives the impression of a higher EES. The calculated EES is believed to be representative. This is a convertible. The side head airbag is relatively small. The non perpendicular impact could have resulted in occupant kinematics such that the head missed the side airbag during the impact phase.</p>

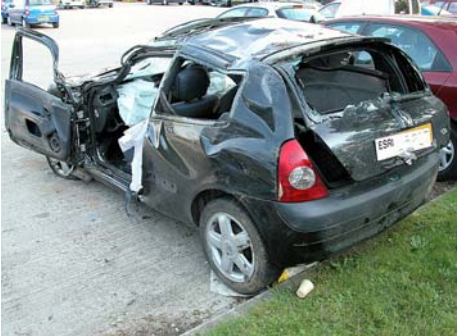
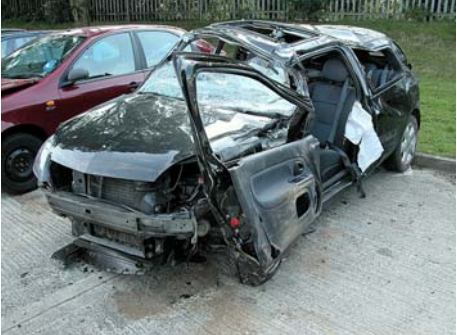
Case 10 - Serious		
CDC	00LDAW3

Impact Object	Ditch Side	
EES	U/K

Maximum Crush	7mm	
Belt Use	Belted	
Relevant lateral intrusion	Nil	
Airbags	Facia - Activated Seat back head and thorax - Activated	
Occupant Age	22 years	
Occupant Gender	Male	
Head Injuries and sources		
# Skull AIS 2 - Roof		
Mild R subarachnoid haemorrhage AIS 3 – Roof		
Loss of consciousness AIS 2 - Roof		
Other injuries		
Abrasion with swelling L forehead AIS 1		
Comments		
<p>The head injuries are attributable to a roof (internal cant rail area) contact due to the non horizontal impact with the ditch side. The seat back head and thorax bag has deployed and would be expected to mitigate these injuries.</p>
