“HUMBER BRIDGE – SUPPRESSING MAIN CABLE CORROSION BY MEANS OF DEHUMIDIFICATION”

C. Christodoulou¹, M. Bulmer¹, C. Cocksedge¹, D. Wilkinson¹, J. Cooper², P. Hill², S. Austin³, C. Goodier³

SUMMARY: The Humber Bridge officially opened in 1981 and carries 4 lanes of traffic across the Humber Estuary between Barton and Hessle to the west of Kingston-upon-Hull in East Yorkshire, England. When opened, it was the longest span suspension bridge in the world with a main span of 1410m but it currently ranks as the fifth longest span in the world. Humber Bridge Board (HBB) commissioned an internal inspection of the main cables following the discovery of extensive corrosion and broken wires in the main cables of two older suspension bridges in the UK. The main cable inspections revealed widespread, if generally light corrosion with localised pitting and a very small number of broken wires. Dehumidification of suspension bridge main cables is becoming standard practice not only in the UK but worldwide. This paper examines the installation of the Humber Bridge system, discusses the mechanics of atmospheric steel corrosion and explains how the cable dehumidification system will suppress future c

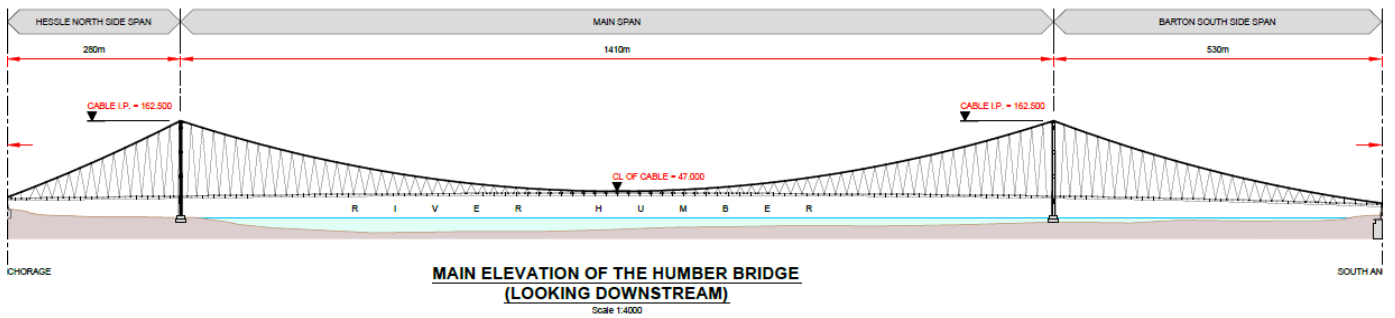
Figure 1: Elevation of the Humber Bridge

The Humber Bridge has an asymmetrical span arrangement and with a main span of 1410m it ranked as the longest single span bridge from its opening in 1981 until 1998. The north side span (Hessle side) has a length of 280m and the south side span (Barton side) a length of 530m. This brings the total length between anchorages to 2220m. **Error! Reference source not found.**, shows the elevation of the bridge and Figure 2 is a photograph taken during the installation of the cable dehumidification system, with one of the cable access gantries on the east main span cable.

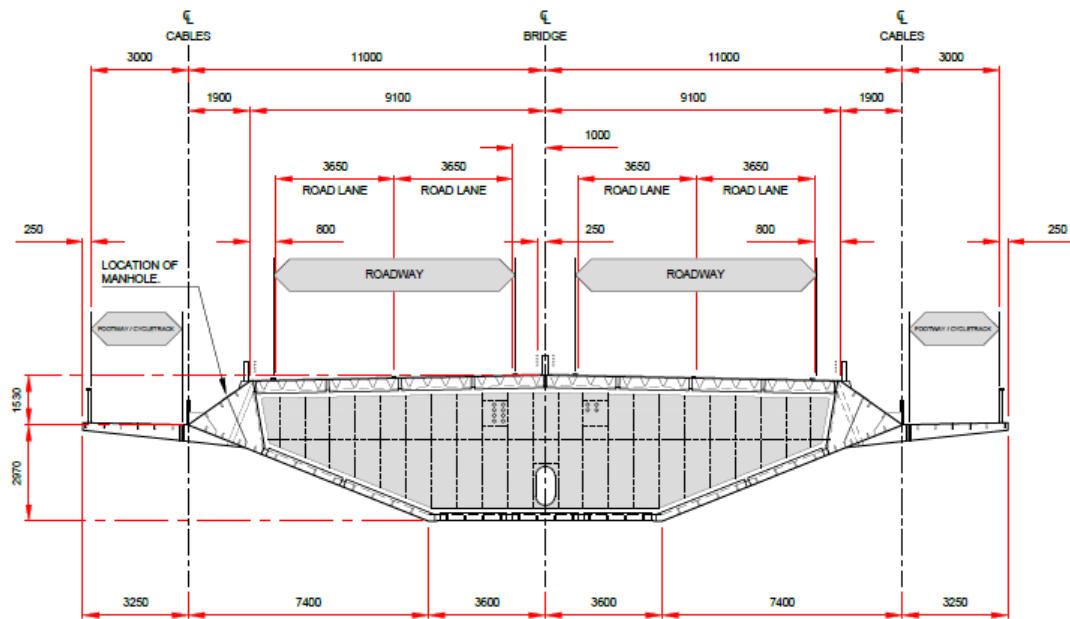
Figure 3: Typical deck box cross section

The deck of the bridge is an aerodynamically shaped continuously-welded trapezoidal closed box. The box is 4.5m deep and 22m wide and it carries a dual two lane carriageway, in addition to 3m wide footways supported by cantilever beams on both sides of the deck box. Figure 3, shows a typical cross section of the deck. The deck is supported by inclined hanger cables, spaced at approximately 18m.

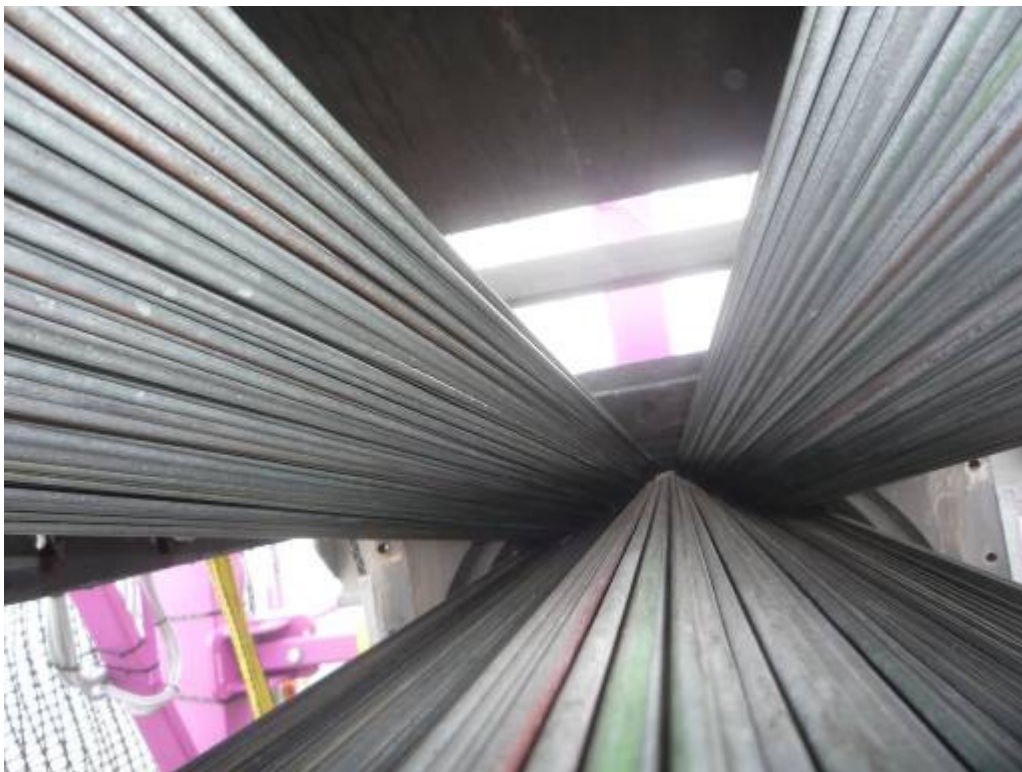
Figure 4: North (Hessle) side span main cable view

The main cables consist of 14948 high strength galvanised wires resulting in a cable diameter of approximately 680mm. The north side span is considerably shorter and steeper than the south side span and each north side span cable has an additional 800 wires to withstand the higher tension. Figure 4, illustrates a view of the main cable at the tower top where the additional 800 wires for the north (Hessle) side span can be seen splaying out.

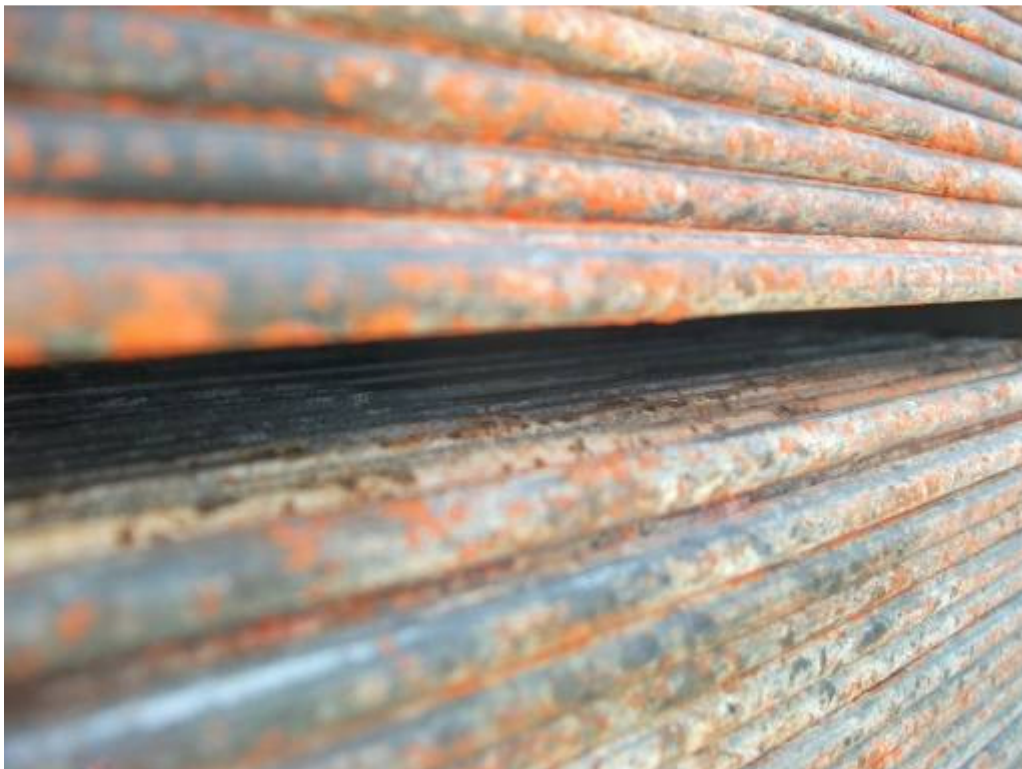
Figure 5: Corrosion condition of a section of the Humber Bridge main cable

The exposure conditions will largely dictate the corrosion intensity. In industrial areas, atmospheric pollution results in high levels of sulphur dioxide (SO_2) and nitrous oxides (NO_x). These pollutants can react with other molecules present in the atmospheres to form acids creating a highly corrosive environment. In marine environments salt particles are present in the air and they deposit on exposed metal surfaces based on the prevailing wind conditions. In the particular case of the Humber Bridge, both environments are present. Figure 5 illustrates the corrosion condition on a section of the Humber Bridge main cable. The rust pitting areas are evident on the outer wires.

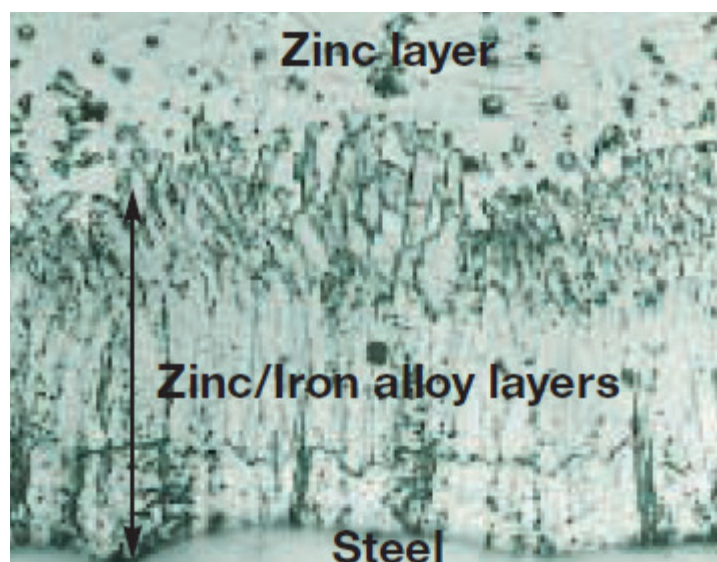
Figure 6: Cross-section through a typical hot-dip galvanised coating (Corus Construction Centre 2002)

Galvanising of steel is a commonly used technique to provide successful corrosion management (BS EN ISO 1461, Galvanizers Association). It involves the immersion of steel into a bath of molten zinc after it has gone through pickling and fluxing. The zinc will react with the steel and form zinc alloy and zinc layers. When the steel is removed from the bath the zinc will solidify forming a strong bond with the steel. This bond is superior to other forms of coatings due to its metallurgical nature. The process is quicker as opposed to traditional paintwork systems, provides a more reliable coverage without crevices and overall it is a more cost effective system. Figure 6, illustrates a typical cross-section of the hot-dip galvanised application.

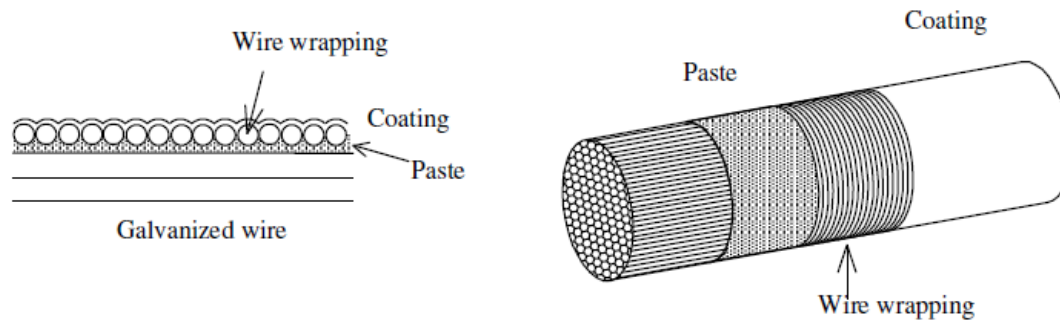
Figure 7: Cable corrosion protective system

The wires that make up the main cables on the Humber Bridge are hot-dip galvanized. During construction, a layer of red lead paste was applied to the external main cable wires to provide corrosion protection, in addition to a layer of circumferentially applied galvanised steel wrapping wire. A paint system was applied to the surface of the wrapping wire and maintenance painting has subsequently been carried out at intervals of approximately ten years to form a weather resistant coating. This corrosion protection system has been applied to the majority of suspension bridge cables worldwide. Figure 7 and Figure 8 illustrate this conventional protective system. It was envisaged until very recently that this approach would provide adequate corrosion protection for the design life of the bridge.

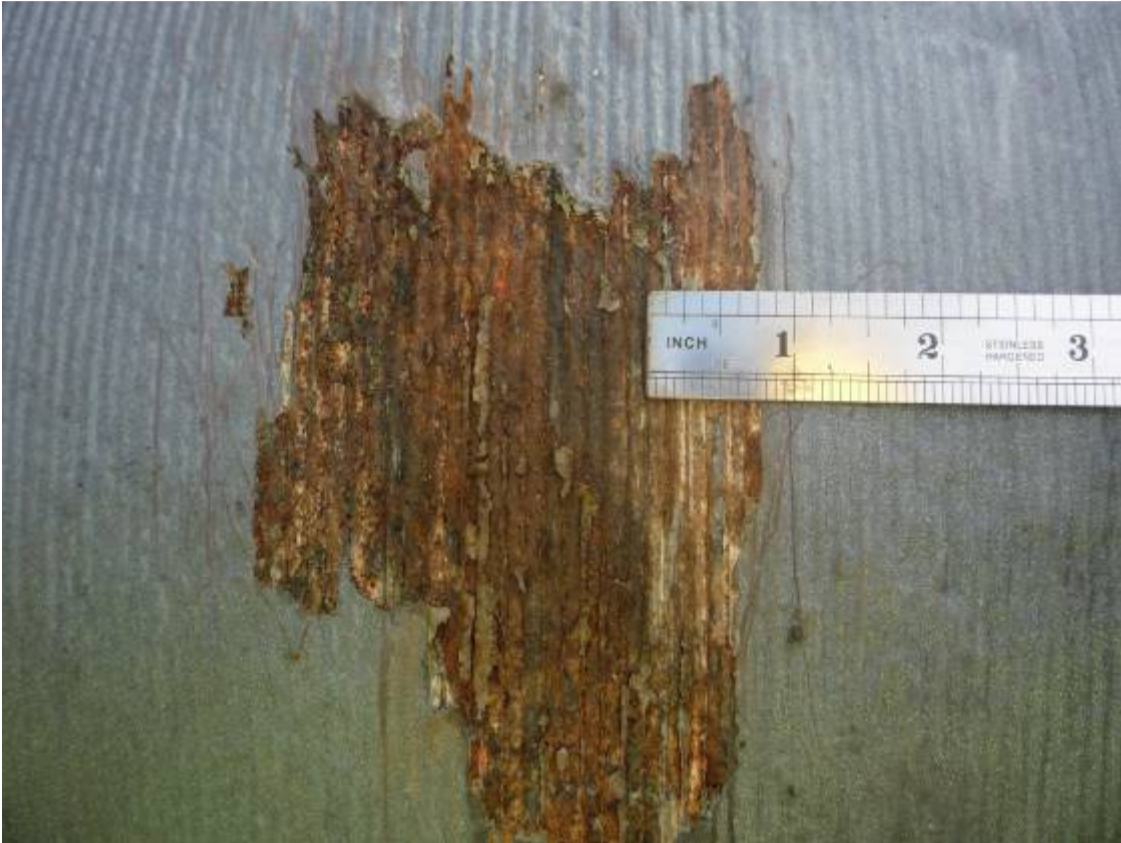
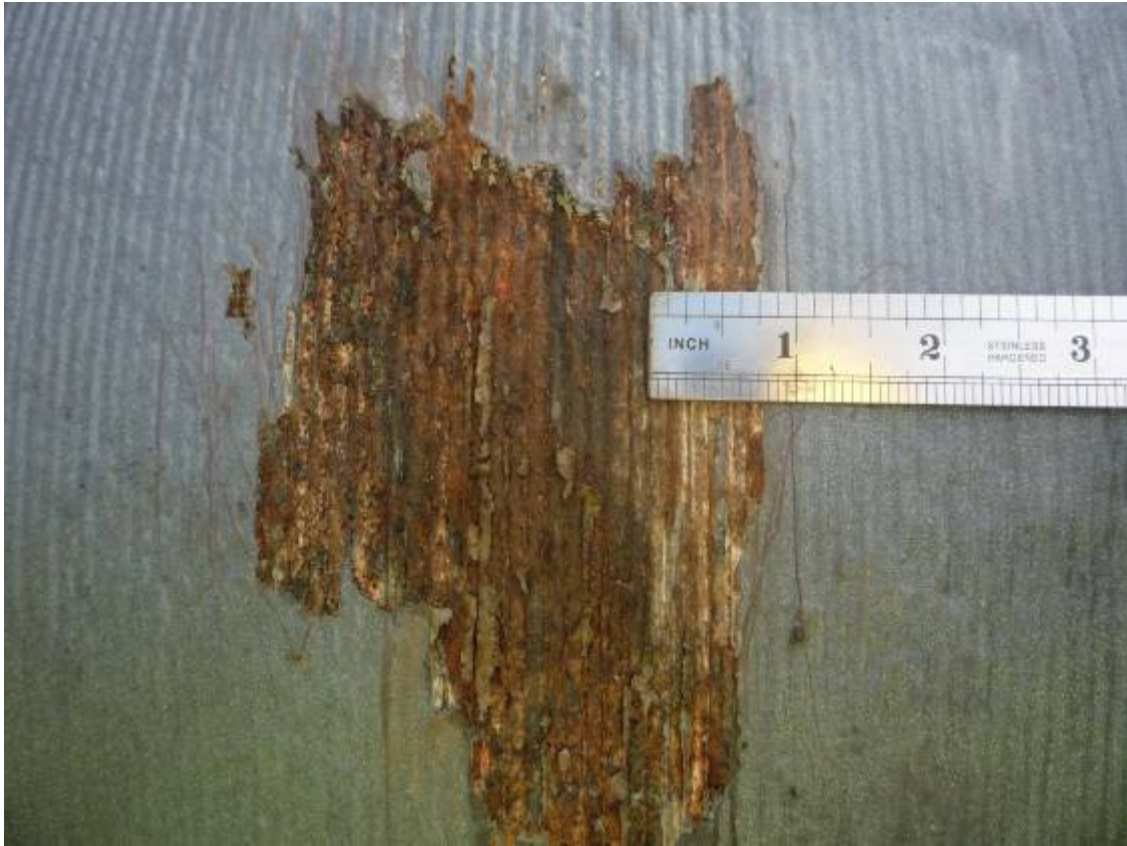
Figure 9: Typical outer skin corrosion damage

The main cable inspection on the Humber Bridge concluded that external surface corrosion was evident in various areas of the main cable. This was particularly pronounced at the mid main span locations where the slope of the cables diminishes and the cables are within the 'splash zone'. The internal main cable inspection revealed widespread corrosion although the number of broken wires was very low.

illustrates such an example where an area of actively corroding wrapping wire was uncovered. The bridge inspectors removed the protective paint coating locally as it appeared to be soft and bulging. It can be observed that corrosion activity has been quite intense as a result of contaminated water and moisture accumulating locally.

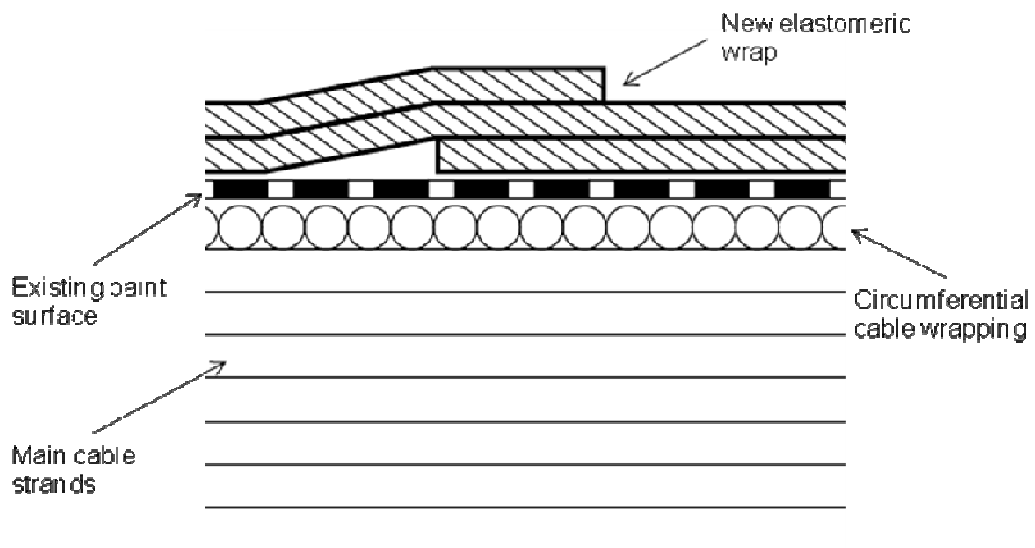
Figure 10: Typical elastomeric wrapping cross section

For the Humber Bridge main cable dehumidification system a proprietary elastomeric wrapping material was used to provide an air tight covering. The elastomeric material was laid circumferentially on the cable with specified overlaps. Figure 10, illustrates the elastomeric wrap laying procedure.

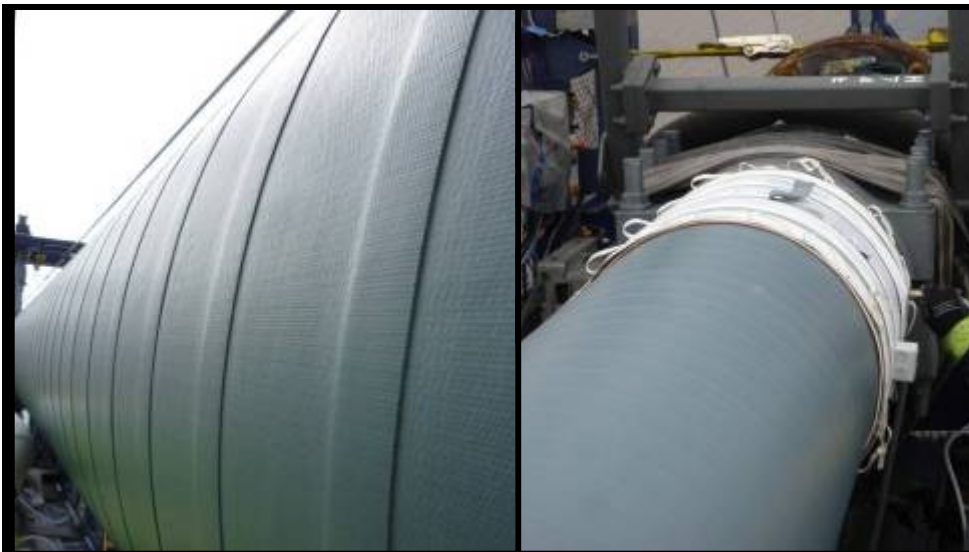
Figure 11: Elastomeric wrapping and heating process

Following application, the elastomeric wrap material was then heated by means of pneumatic heating blankets. The heating process causes the wrap to melt and creates a strong bond with the other layers, particularly at the overlap positions. Figure 11, shows the heating process with the pneumatic heating blankets and a close up of the finished elastomeric wrapping.

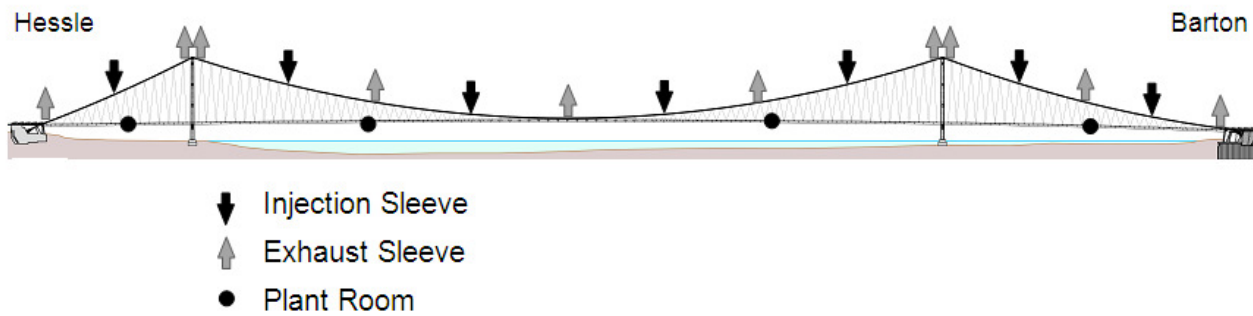
Figure 12: Dehumidification system layout

At pre-determined locations, injection and exhaust sleeves were installed (Figure 12). At these locations the circumferential wire wrapping and the red lead paste were removed and the cable was wedged open. Stainless steel manifolds or “sleeves” were then installed in order to inject air into the cables and exhaust air from the cables. The wedging of the cable was necessary in order to help the dry air penetrate into the voids at injection points and the exhaust air escape, thereby reducing humidity levels. Figure 13 shows an injection sleeve after installation, together with the associated housing for the continuous monitoring equipment.

The air for the dehumidification system is delivered via air pipes attached to the hangers from a number of plant rooms which are located within the steel deck box of the bridge (see Figure 12). The plant rooms draw in air from below the bridge deck box which is then dried by a desiccant wheel dehumidifier and exhausted into the plant room, which also acts as a plenum chamber. The dry air passes through a HEPA filter and is then delivered to the injection sleeves. The relative humidity of the injected air can be closely controlled. Initially the relative humidity of the dry air has been set at 10% within the plant rooms to accelerate the drying process but as the cables dry out this will be increased to reduce long term running costs whilst maintaining sufficiently low RH figures in the cables.

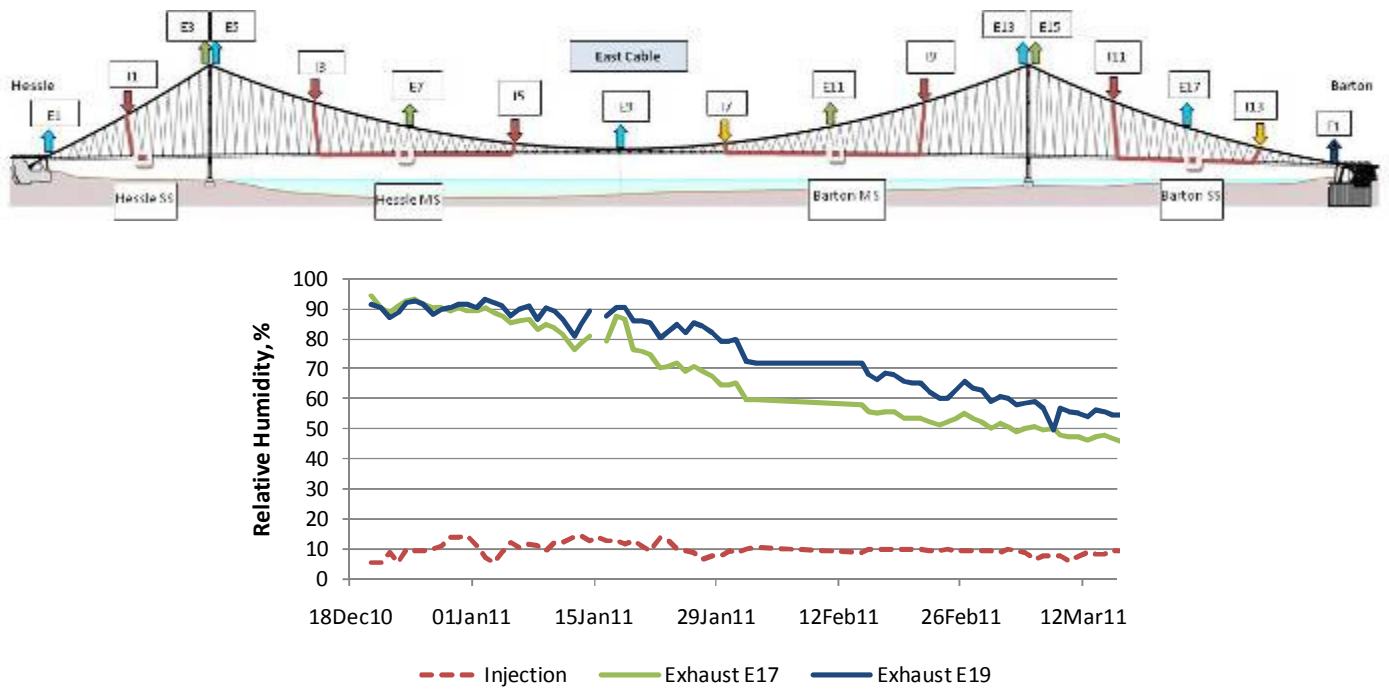
Figure 14: Initial monitoring data for relative humidity

The dehumidification system on the Humber Bridge became fully operational in December 2010. Since then dry air with only 10% RH is being delivered to the injection points. Figure 14 illustrates the data from the continuous monitoring system. It can be observed that after only 3 months of operation the RH within the cable has reduced significantly indicating the successful operation of the dehumidification system. It is anticipated that the long-term operation of the system will arrest the current corrosion activity. **Error! Reference source not found.**

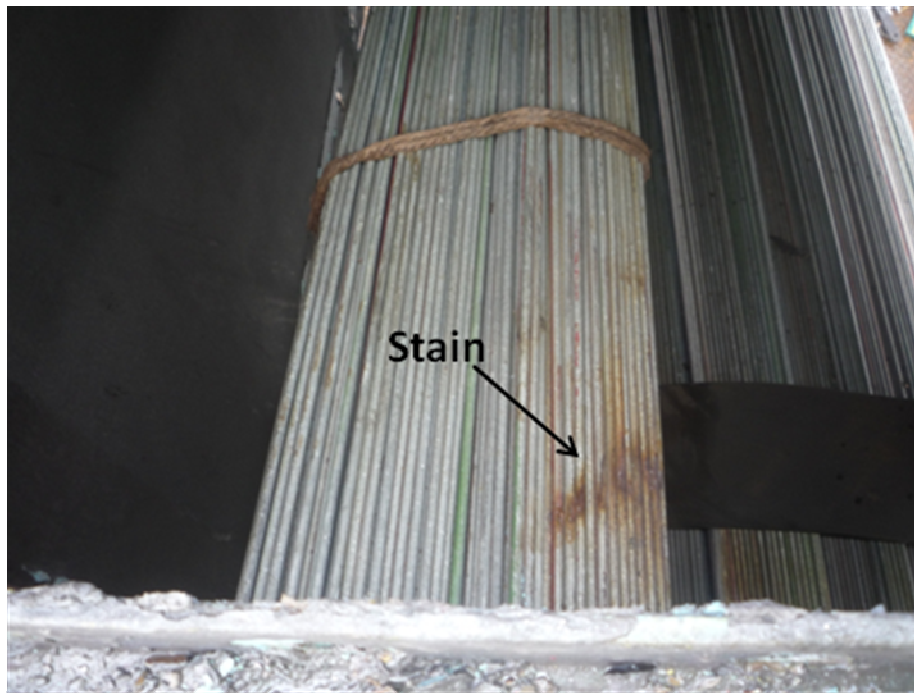
Figure 15: Condition of the main cable at the tower top

The condition of the individual wires was found to be excellent with no signs of corrosion. This can also be observed from Figure 15. However, a small area of staining was observed on top of the cable. Closer investigation of this area revealed that local pitting of the wires had not occurred and there was no observed loss of section. The source of this staining was water slowly leaking through the protective sleeve. This was also verified by evident cracking of the protective sleeve directly above the position where the staining was uncovered.

This finding was significant as it was the first time the condition of the cables had been verified since the dehumidification system was installed. It is presumed that the leakage of water through the sleeve occurred at some point after the installation of the dehumidification system. If this was not the case, then corrosion pitting should have been observed around the area. The dehumidification system on the tower tops was deemed to be successful in preventing corrosion and it had provided a protective environment despite water leakage. However, it is apparent that the water leakage was not heavy and this allowed rapid drying of the cable by the dehumidification system.
