Lloyd's Coppice Landslip study

Phase 1: design of site investigation programme

Prepared for Telford and Wrekin Council
by the British Geological Survey

Commissioned Research Report: CR/03/011N

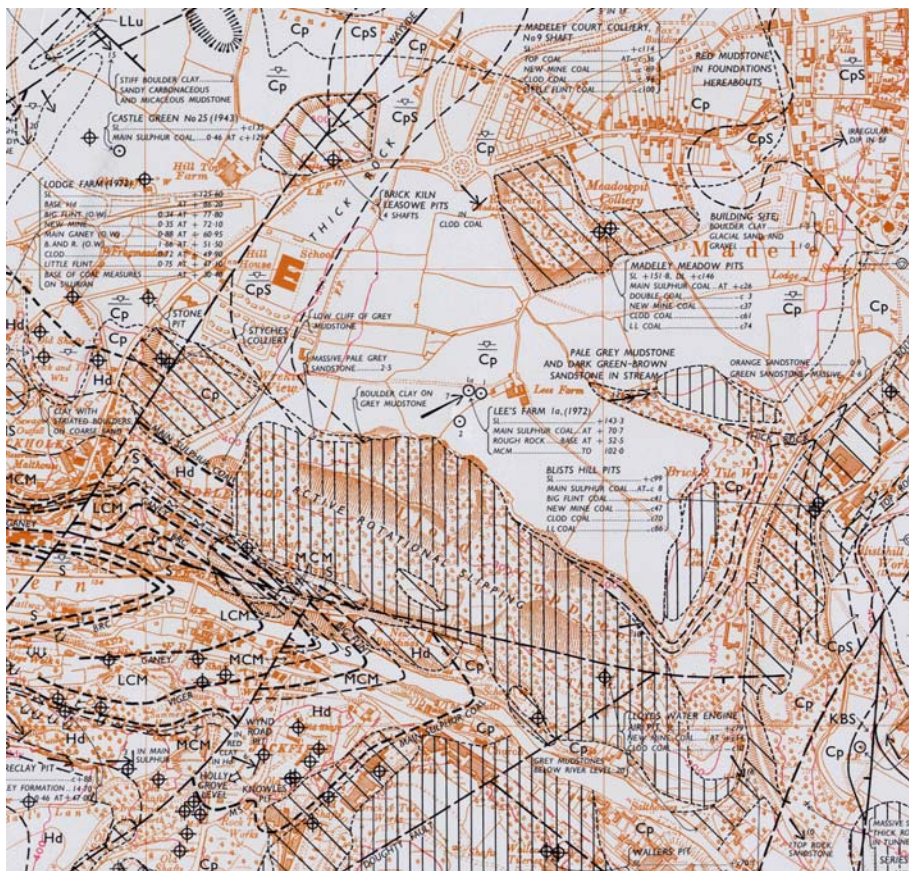
Figure 2 Geological setting:

- a) extract from 1:25 000 geological map b) extract from 1:10 560 geological map

The geological setting of Lloyd's Coppice is shown in Figure 2 and a generalised vertical section, taken from the published 1:25 000 Telford special sheet, shows the relationships between the mapped rock units (Figure 3).

Two distinct fault orientations are observed (Figure 2). North-east-trending faults dominate but east-south-east orientated structures are also important, particularly in respect of Lloyd's Coppice.
