## DYNAMIC IMPACT TESTING OF W152x13.4 (W6x9) STEEL POSTS ON A 2:1 SLOPE

# **DYNAMIC IMPACT TESTING OF W152x13.4 (W6x9) STEEL POSTS ON A 2:1 SLOPE**

MwRSF Research Report No. TRP-03-165-07

March 23, 2007

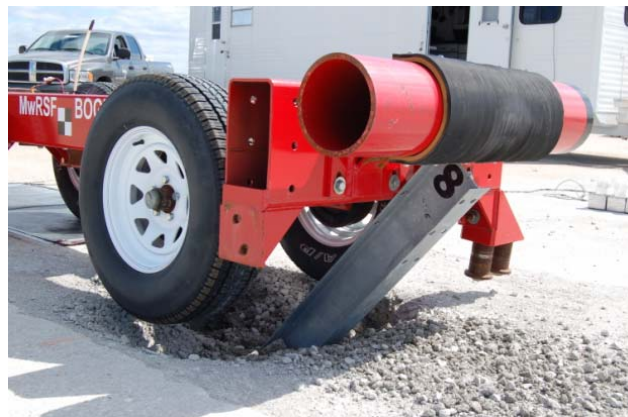
**Figure 1. Impacted Post Contacting Backslope of Testing Pit**

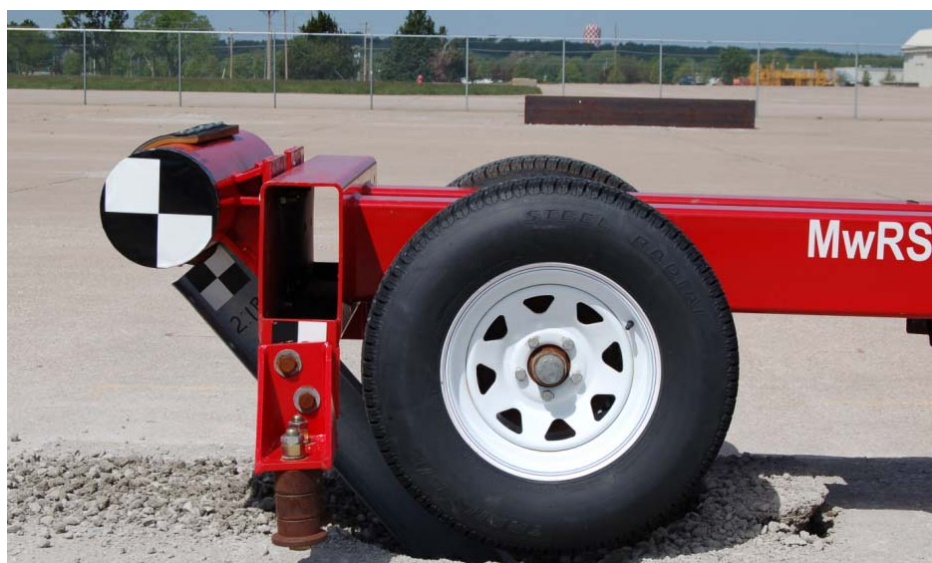
**Figure 3. Bogie and Test Setup**

A rigid-frame bogie was used to impact the posts. The bogie head was constructed of 203-mm (8-in.) diameter, 12.5-mm (0.5-in.) thick standard steel pipe, with 19-mm (0.75-in.) thick neoprene belting wrapped around the pipe to prevent local damage to the post from the impact. The impact head was bolted to the bogie vehicle, thus creating a rigid frame. The bogie with the impact head is shown in Figure 3. The weight of the bogie, with the addition of the mountable impact head, was 728 kg (1,605 lbs). The impact height was 632 mm (24.875 in.) above the ground. The target speed was either 24.14 km/h (15 mph), 27.39 km/h (17 mph), or 32.19 km/h (20 mph).

For test nos. MGS2-1B1 through MGS2-1B14 and test nos. MGS2-1B18 through MGS2-1B21, a pickup truck with a reverse cable tow system was used to propel the bogie. When the bogie reached the end of the guidance system, it was released from the tow cable, allowing it to be free rolling when it impacted the post. For test nos. MGS2-1B15 through MGS2-1B17, the bogie was pushed along a guardrail track. A remote braking system was installed on the bogie, thus allowing it to be safely brought to rest after the test.

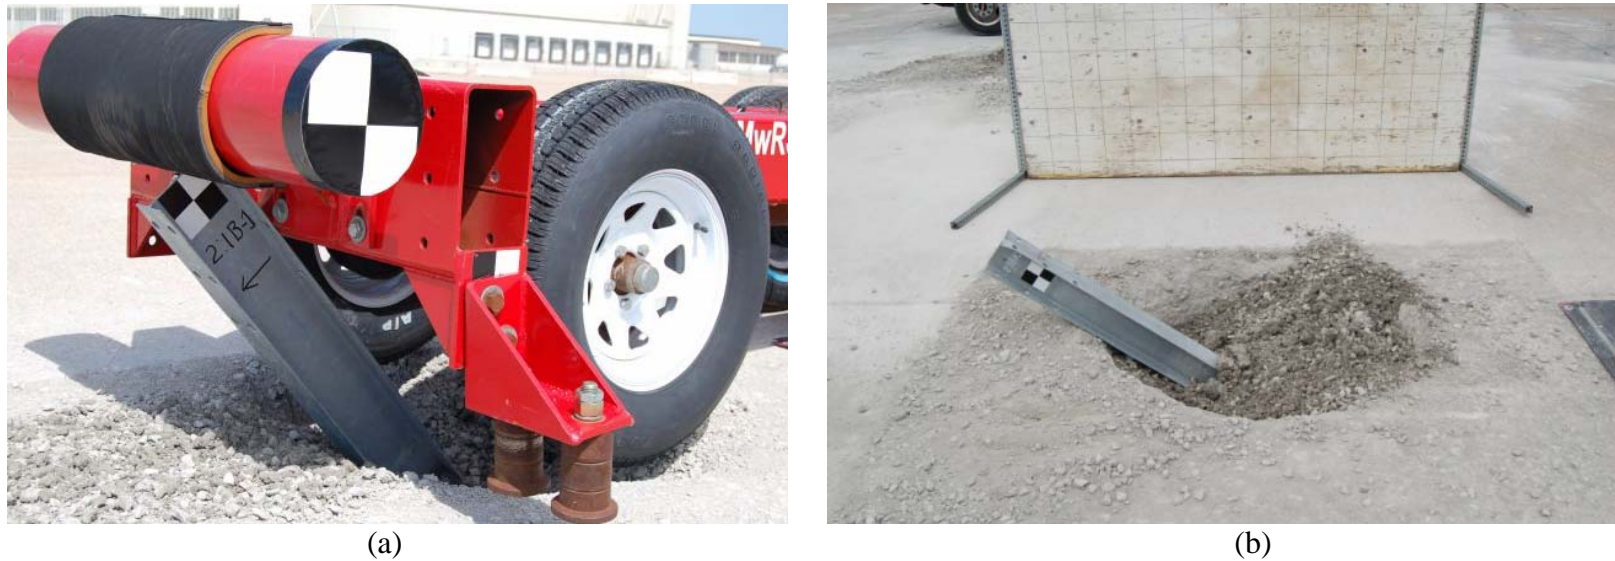
Figure 10. Post-Impact Image of (a) MGS2-1B1 and (b) MGS2-1B10

Two bogie tests were performed on 1,829-mm (6-ft) long posts at an embedment depth of 1,016 mm (40 in.). The test summaries for both of the tests are given in Table 3 and Figure 4. Force-displacement and energy-displacement curves are shown in Figure 8. The sequential photographs at regular time intervals are shown in Figure 9, while Figure 10 shows the posts in the soil after the impact test. The bogie test photographs and videos depict that soil failure was the primary mode of failure in both tests. The post rotated in the soil during the entire test period, and no post yielding took place. The force-displacement curves indicate the presence of a large inertial spike followed by a fairly uniform resisting force. The total energy dissipated in test MGS2-1B1 was almost twice the energy dissipated in test MGS2-1B10. This significant difference in energy dissipation between the two tests is believed to come from different soil compaction qualities.

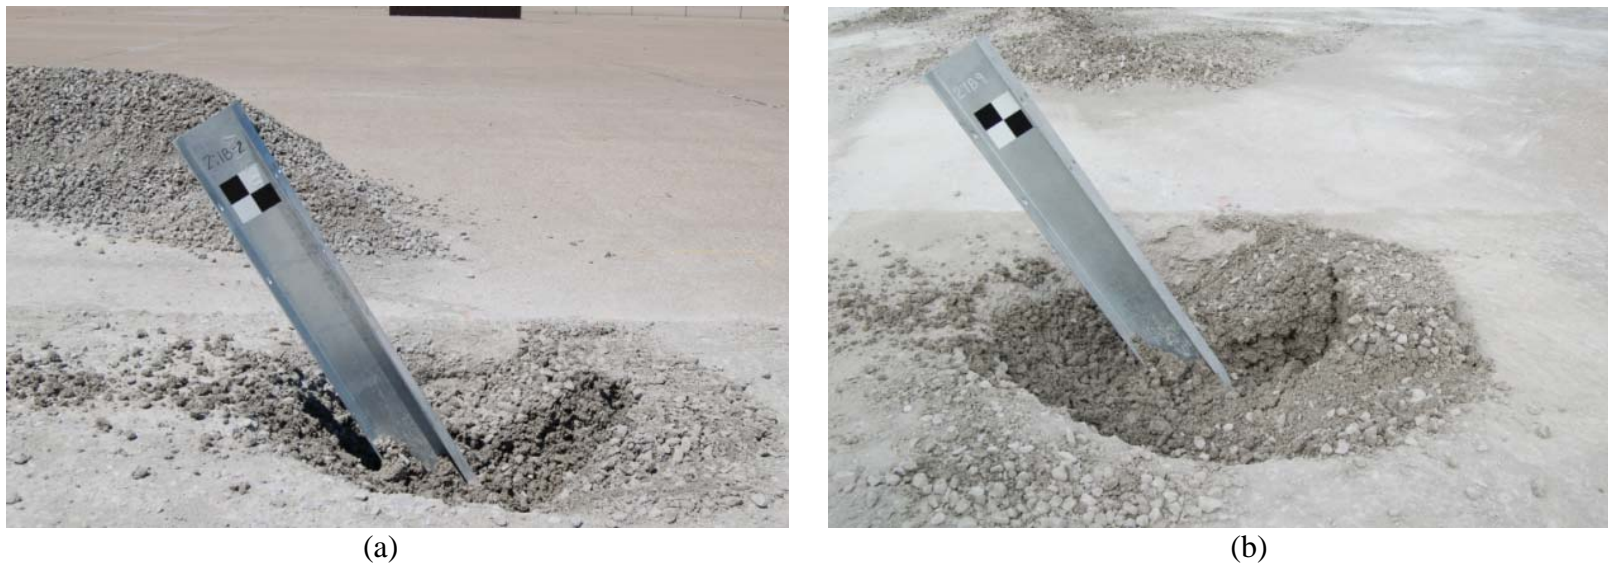
Figure 13. Post-Impact Image of (a) MGS2-1B2 and (b) MGS2-1B9

Two bogie tests were performed on 1,981-mm (6-ft 6-in.) long posts at an embedment depth of 1,168 mm (46 in.). The test summaries for both of the tests are given in Table 5 and Table 6. Force-displacement and energy-displacement curves are shown in Figure 11. The sequential photographs at regular time intervals are shown in Figure 12, while Figure 13 shows the posts in the soil after the impact test. For these tests, soil failure was the primary mode of failure. The post rotated in the soil during the entire test period, and no post yielding took place. When compared to the previous test results, the total energy dissipated in these tests were almost equal to one another, unlike that observed for MGS2-1B1 and MGS2-1B10.

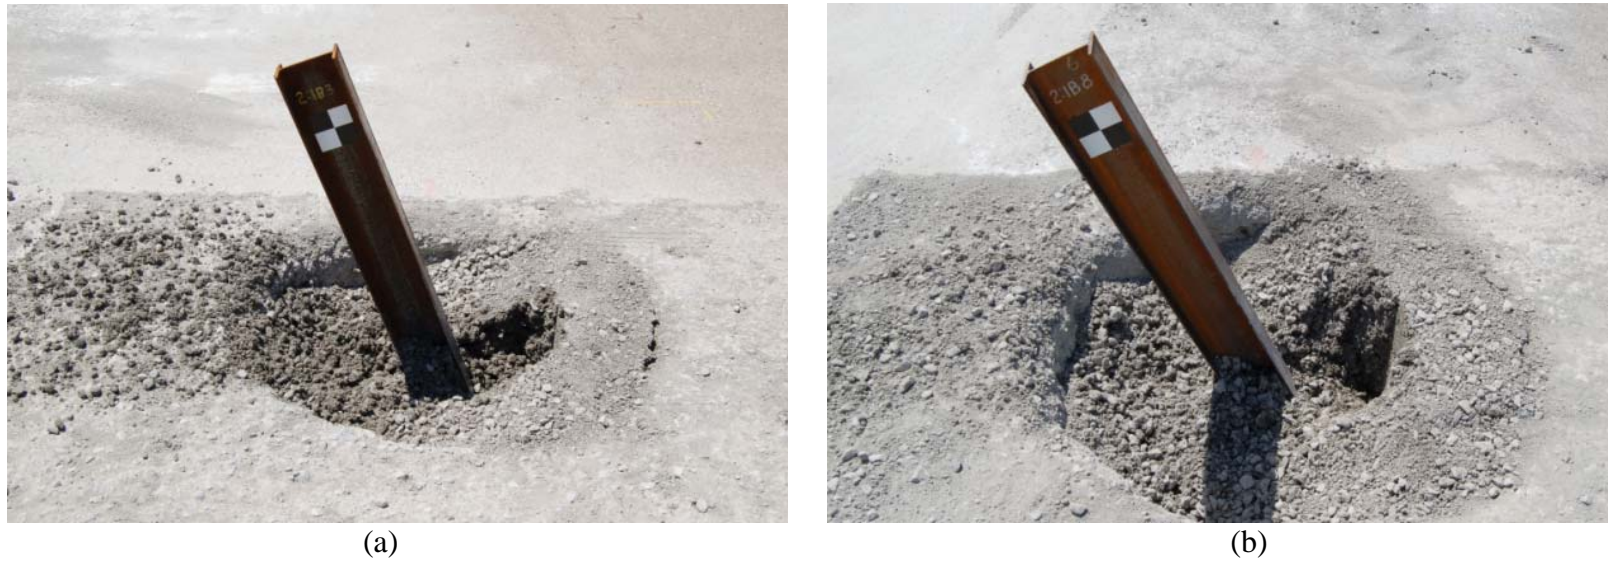
Figure 16. Post-Impact Image of (a) MGS2-1B3 and (b) MGS2-1B8

Two bogie tests were performed on 2,134-mm (7-ft) long posts at an embedment depth of 1,321 mm (52 in.). The test summaries for both of the tests are given in Table 7 and Table 8. Force-displacement and energy-displacement curves are shown in Figure 14. The sequential photographs at regular time intervals are shown in Figure 15, while Figure 16 shows the posts in the soil after the impact test. The primary mode of failure in both tests was soil failure. The post rotated in the soil during the entire test period, and no yielding of the post took place. The average force in test MGS2-1B3 was much higher than that in MGS2-1B8 but the energy values were almost equal.

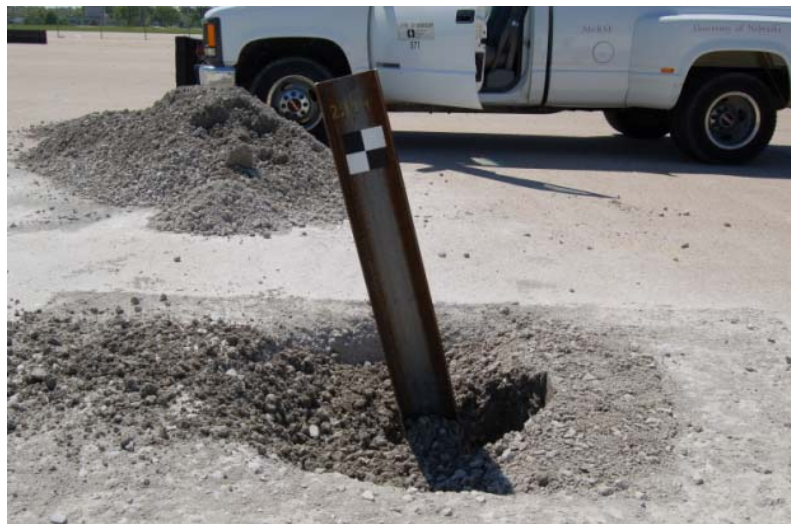
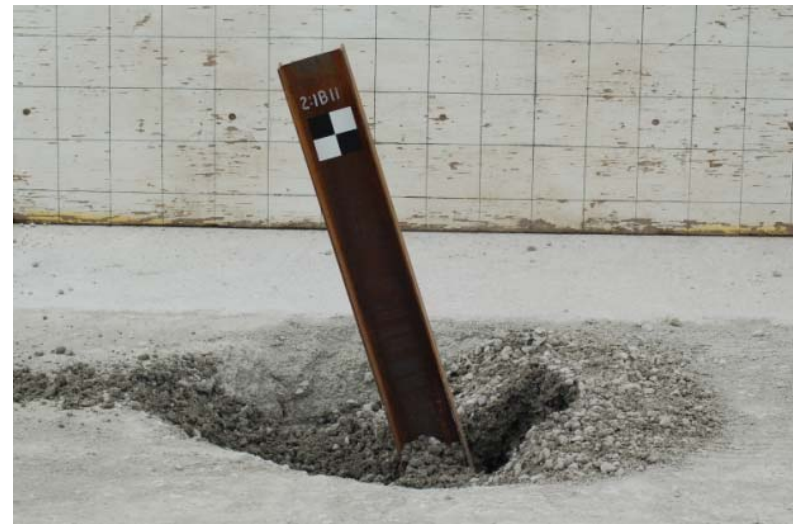
**Figure 19. Post-Impact Image of (a) MGS2-1B4 and (b) MGS2-1B11**

Two bogie tests were performed on 2,286-mm (7-ft 6-in.) long posts at an embedment depth of 1,473 mm (58 in.). The test summaries for both of the tests are given in Table 9 and Table 10. Force-displacement and energy-displacement curves are shown in Figure 17. The sequential photographs at regular time intervals are shown in Figure 18, while Figure 19 shows the posts in soil after the impact test. The primary mode of failure was soil failure. The post rotated in the soil and then pushed the bogie in a direction opposite to its initial motion. No visible deformation of the post was observed.

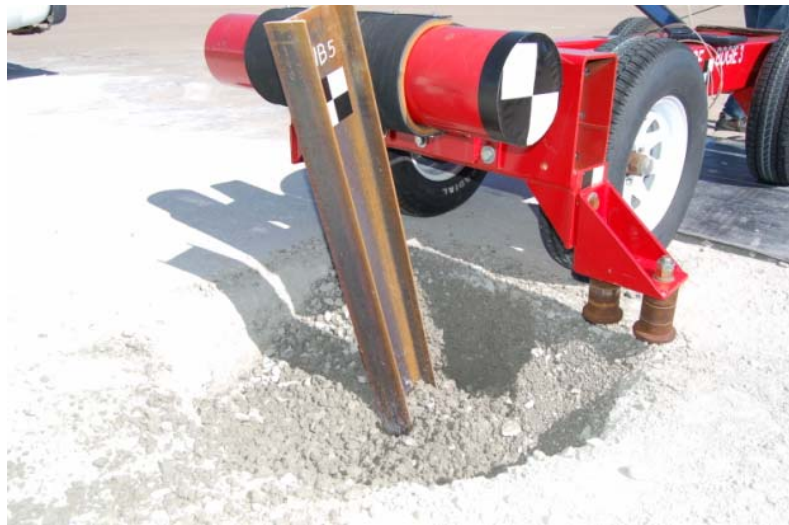
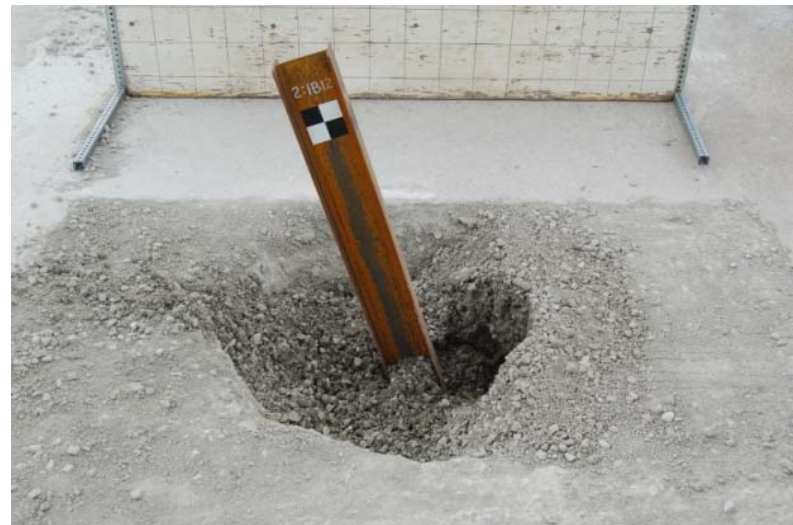
Figure 22. Post-Impact Image of (a) MGS2-1B5 and (b) MGS2-1B12

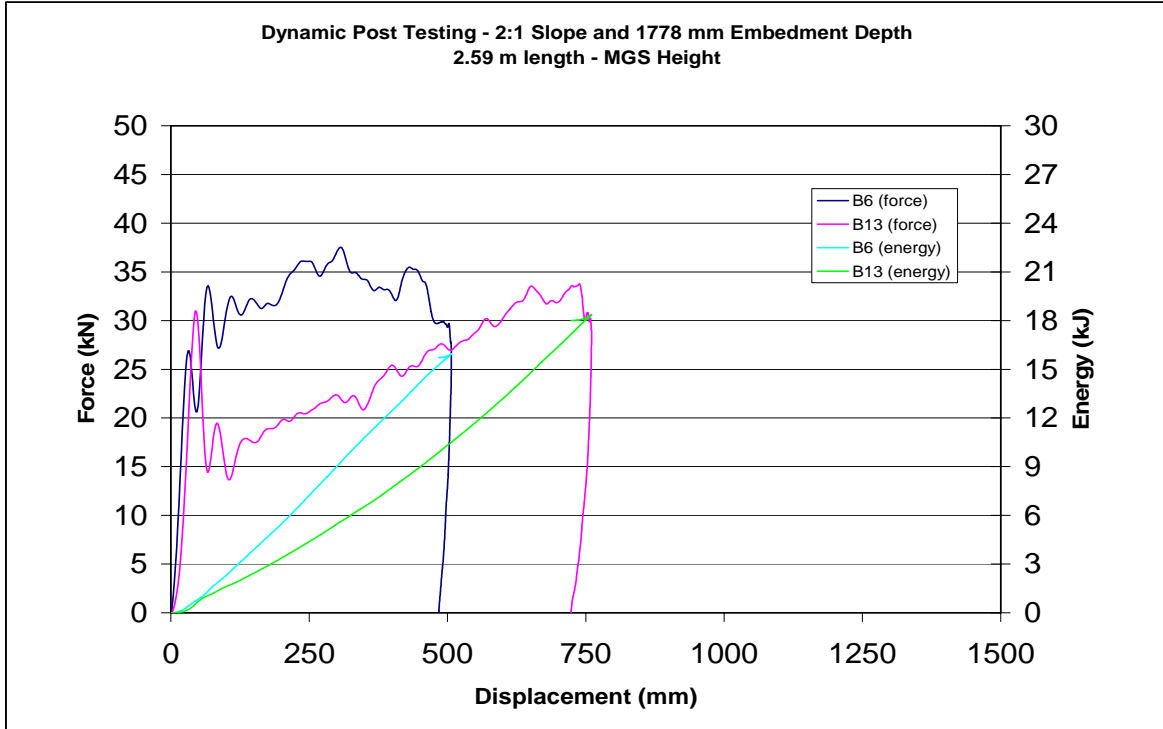
Two bogie tests were performed on 2,591-mm (8-ft 6-in.) long posts at an embedment depth of 1,778 mm (70 in.). The test summaries for both the tests are given in Table 13 and Table 14. Force-displacement and energy-displacement curves are shown in Figure 23. The sequential photographs at regular time intervals are shown in Figure 24, while Figure 25 shows the posts in soil after the impact test. Once again, the primary mode of failure was soil failure in both tests. The post rotated in the soil with slight deformation of the post in test no. MGS2-1B6 but no post deformation was observed in post test no. MGS2-1B13. The graph of the force-displacement curves revealed a significant difference in the magnitude of the average force in these two tests. The average force difference between these two tests at a displacement of 381 mm (15 in.) was approximately 12.1 kN (2.72 kips).

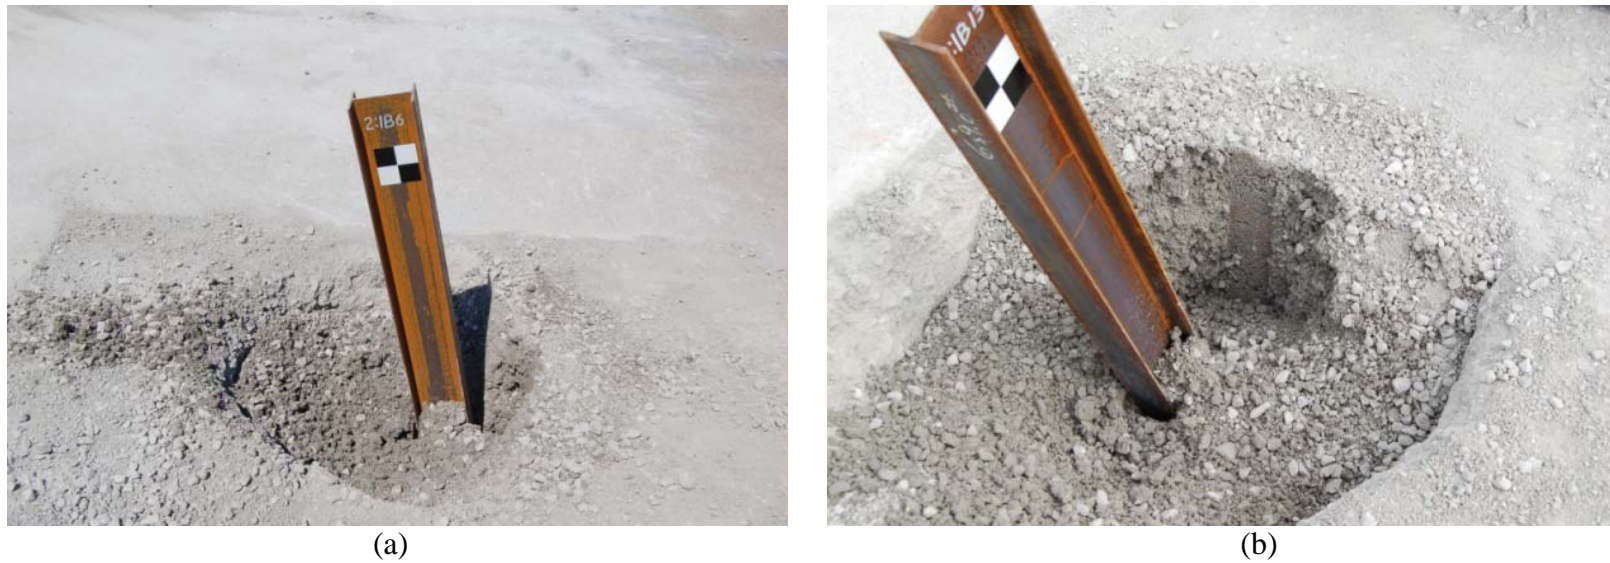
Figure 25. Post-Impact Image of (a) MGS2-1B6 and (b) MGS2-1B13

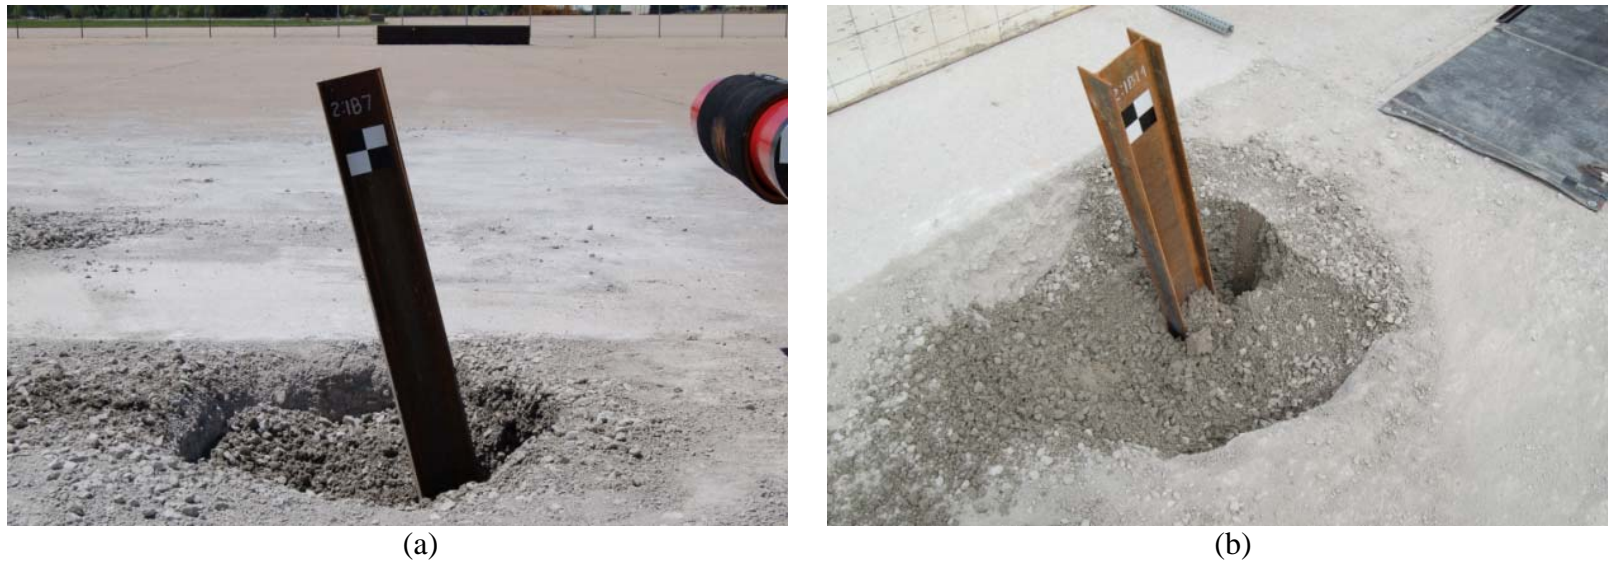
**Figure 28. Post-Impact Image of (a) MGS2-1B7 and (b) MGS2-1B14**

Two bogie tests were performed on 2,743-mm (9-ft) long posts at an embedment depth of 1,930 mm (76 in.). The test summaries for both the tests are given in Table 15 and Table 16. Force-displacement and energy-displacement curves are shown in Figure 26. The sequential photographs at regular time intervals are shown in Figure 27, while Figure 28 shows the posts in the soil after the impact test. The primary mode of failure was soil failure. As in the previous test series, the posts rotated in the soil with slight deformations in the web of both posts.

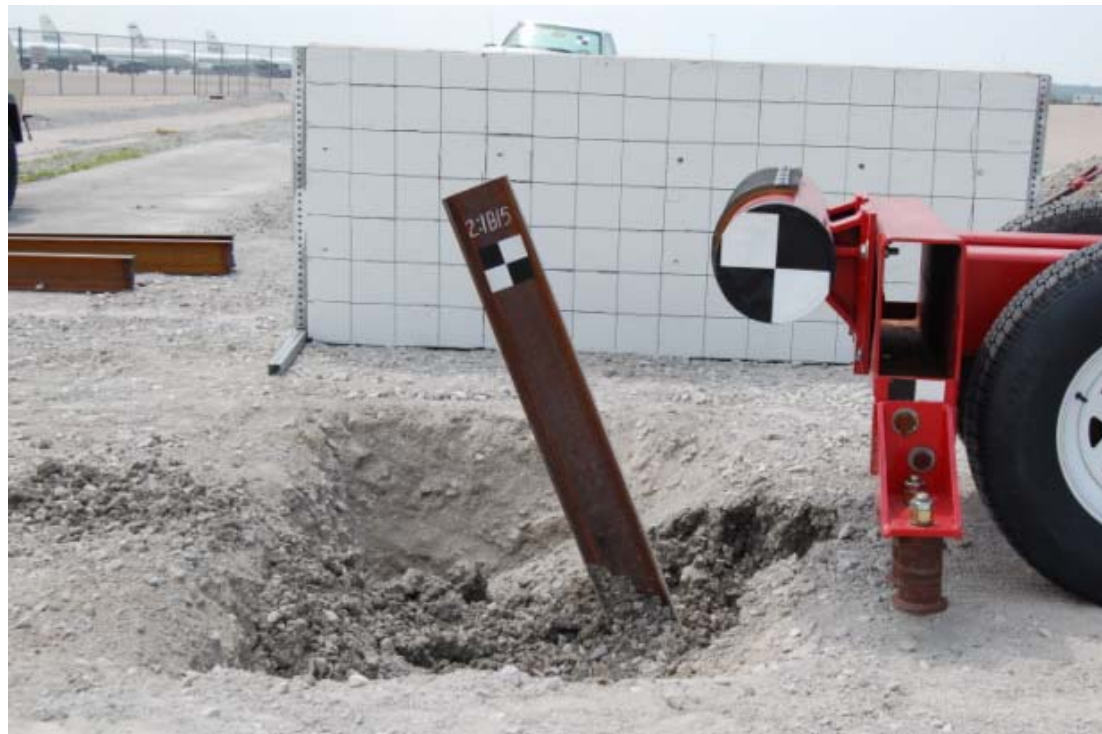
**Figure 31. Post-Impact Image of MGS2-1B15**

One bogie test was performed on a 2,438-mm (8-ft) long post at an embedment depth of 1,626 mm (64 in.) using the modified test setup shown in Figure 5. The test summary is given in Table 17 and Table 18. Force-displacement and energy-displacement curves are shown in Figure 29. The sequential photographs at regular time intervals are shown in Figure 30, while Figure 31 shows the post in the soil after the impact test. The primary mode of failure was soil failure. The post rotated in the soil during the entire test period, and no post deformation was observed.

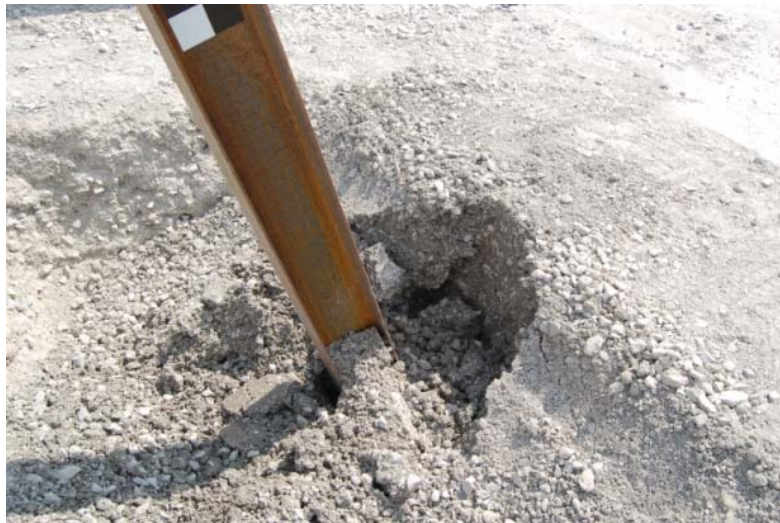
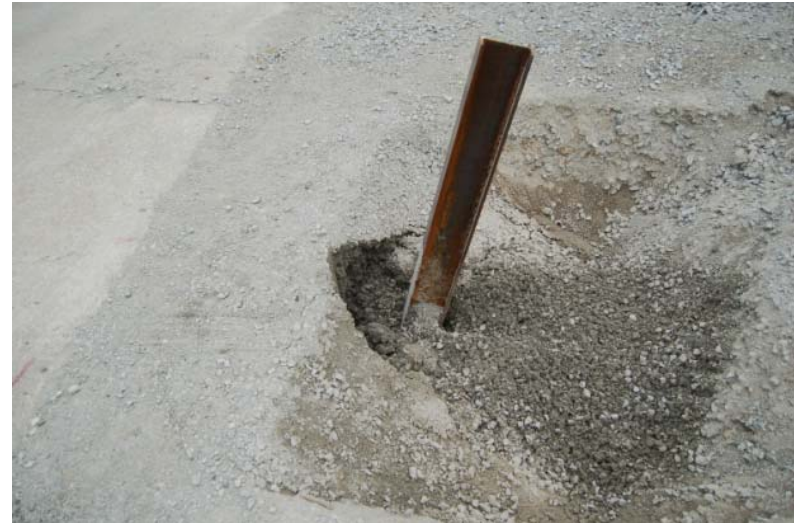
Figure 34. Post-Impact Image of (a) MGS2-1B16 and (b) MGS2-1B17

Two bogie tests were performed on 2,743-mm (9-ft) long posts at an embedment depth of 1,930 mm (76 in.) using the modified test setup shown in Figure 5. The test summaries for both the tests are given in Table 19 and Table 20. Force-displacement and energy-displacement curves are shown in Figure 32. The sequential photographs at regular time intervals are shown in Figure 33, while Figure 34 shows the posts in the soil after the impact test. Once again, the primary mode of failure was soil failure. The posts rotated in the soil during the entire test period without any post yielding.

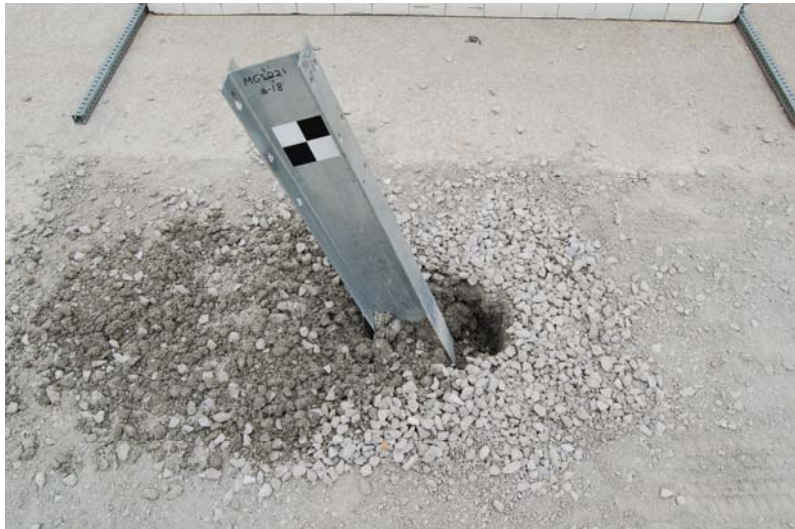
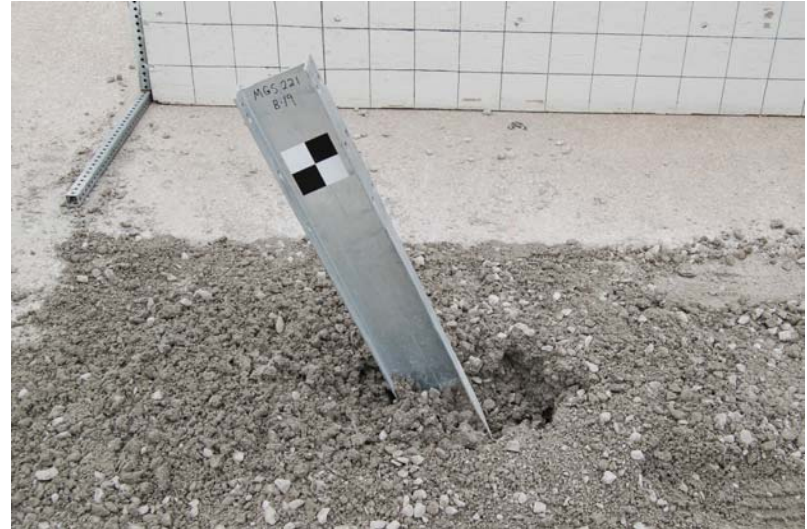
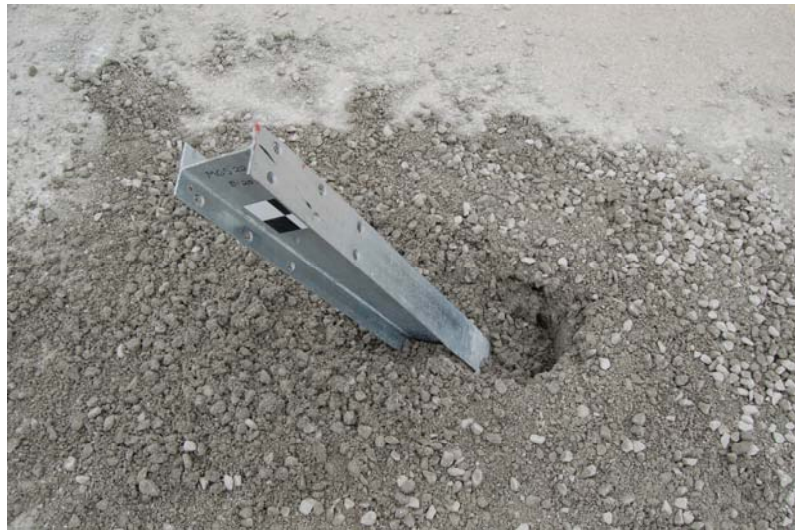
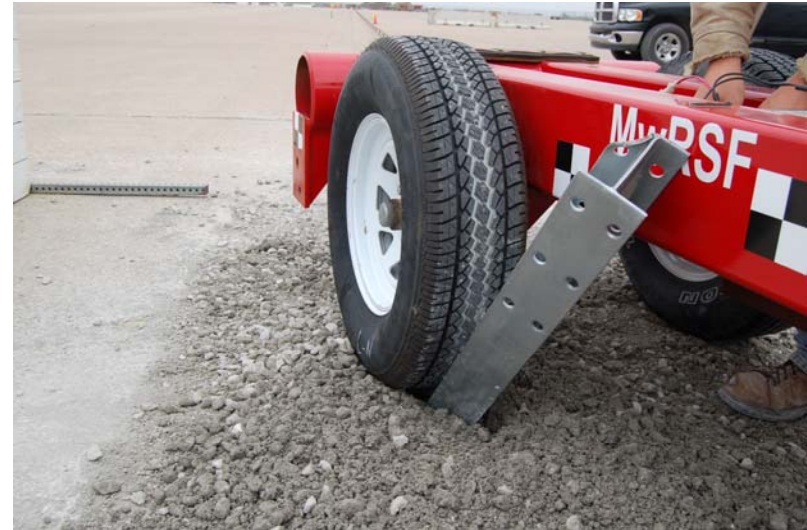
**Figure 38. Post-Impact Image of (a) MGS2-1B18, (b) MGS2-1B19, (c) MGS2-1B20, (d) MGS2-1B**

Four bogie tests were performed on 1,829-mm (6-ft) long posts at an embedment depth of 1,016-mm (40 in.) on level terrain. The test summaries for the four tests are given in Table 21 and Table 22. Force-displacement and energy-displacement curves are shown in Figure 35 and Figure 36. Test nos. MGS2-1B18 and MGS2-1B19 were plotted on the same graph, because both tests used a target impact speed of 24.14 km/h (15 mph). Test nos. MGS2-1B20 and MGS2-1B21 were plotted on a different graph, because both tests used a target impact speed of 32.19 km/h (20 mph). The sequential photographs at regular time intervals are shown in Figure 37, while Figure 38 shows the posts in soil after the impact test. The primary mode of failure in all of the tests was soil failure. The total energy was similar for MGS2-1B18 and MGS2-1B19, which had similar impact speeds and MGS2-1B20 and MGS2-1B21, which also had similar impact speeds. The average force of MGS2-1B18 was similar to MGS2-1B20, which had a different impact speed. Also, the average force of MGS2-1B19 was similar to that measured in MGS2-1B21, which also had a different impact speed. At 381-mm (15-in.) displacement, the average force for test nos. MGS2-1B18 and MGS2-1B19 was 26.04 kN (5.86 kips). At 381-mm (15-in.) displacement, the average force for test nos. MGS2-1B20 and MGS2-1B21 was 26.69 kN (6.00 kips). At 508-mm (20-in.) displacement, the average force for test nos. MGS2-1B18 and MGS2-1B19 was 28.72 kN (6.50 kips). At 508-mm (20-in.) displacement, the average force for test nos. MGS2-1B20 and MGS2-1B21 was 29.92 kN (6.72 kips).
