DEVELOPMENT AND EVALUATION OF A TIE-DOWN SYSTEM FOR THE REDESIGNED F-SHAPE CONCRETE TEMPORARY BARRIER

MwRSF Research Report No. TRP-03-134-03

August 22, 2003

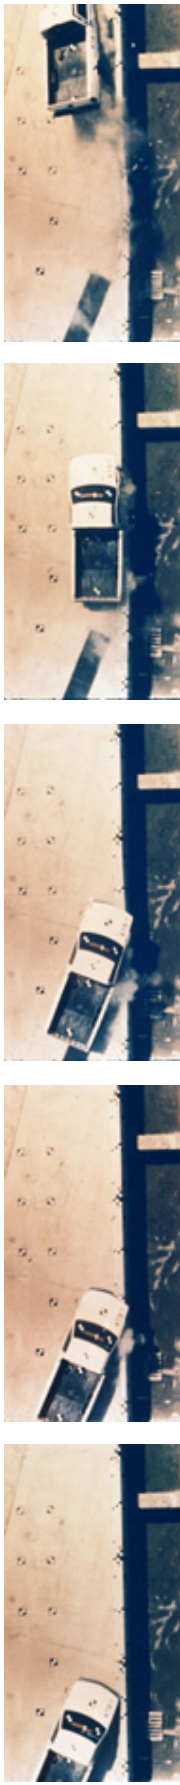
- Test Number KTB-1
- Date 7/31/02
- Appurtenance Kansas Temporary Barrier Tie Down System
- Total Length 62.23 m
- Placement 25 mm from concrete bridge deck edge

- Key Elements Nine 3,810-mm long Kansas Temporary Barriers
- Barrier Joint Pin Connections Seven 3,810-mm long Iowa F-Shape Temporary Barriers
- Tie-Down Anchors 32-mm diameter by 712-mm long A36 steel rod with 64x102x132-mm plate

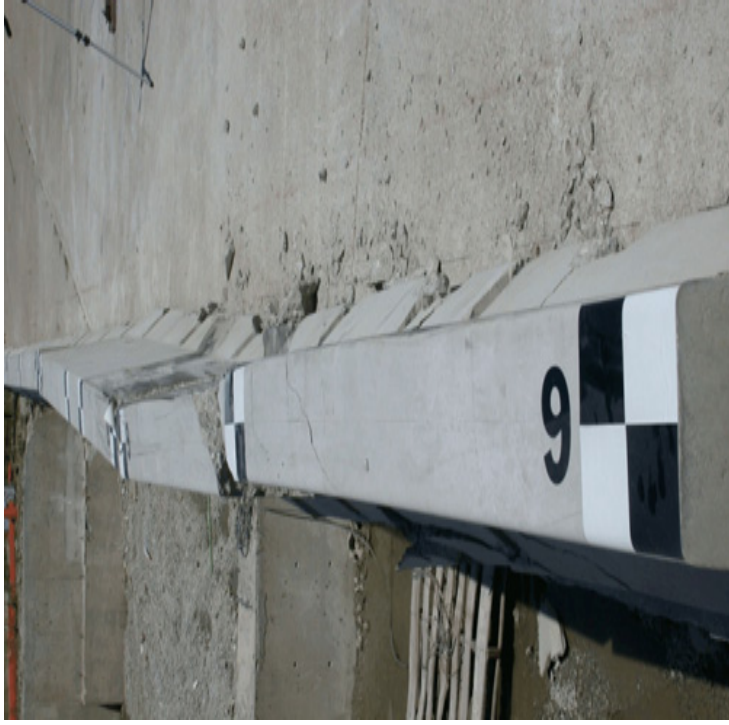
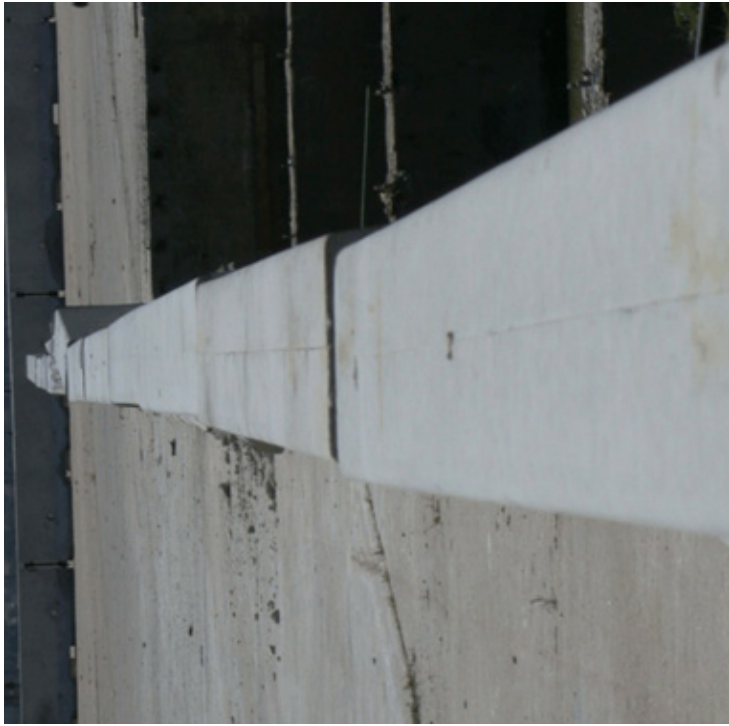
Figure 24. System Damage, Test KTB-1

Damage to the barrier was moderate, as shown in Figures 24 through 29. Barrier damage

consisted of contact marks on the front concrete face, spalling of the concrete, and concrete cracking and failure. The length of vehicle contact along the barrier was approximately 5.6 m (18.4 ft) which spanned from 1,651 mm (65 in.) upstream from the center of the joint between barrier nos. 8 and 9 to the upstream end of barrier no. 10.

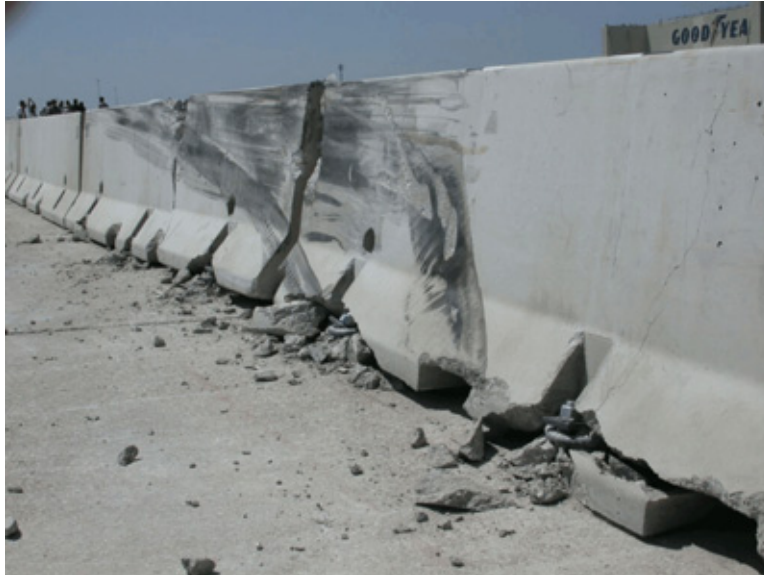
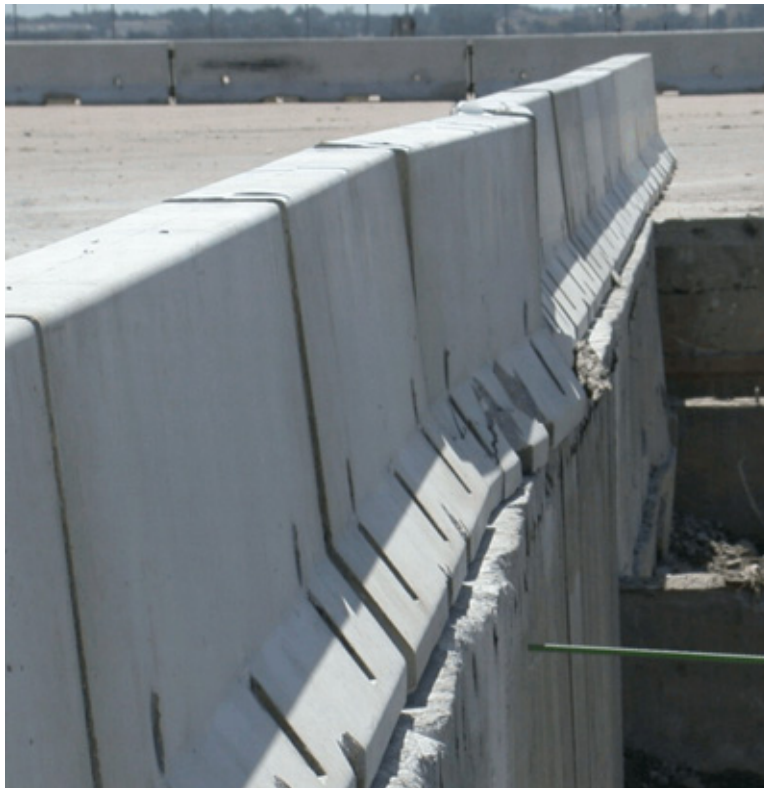
Figure 25. System Damage, Test KTB-1

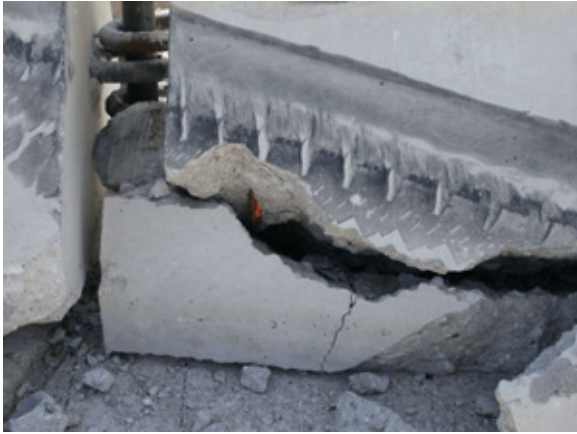
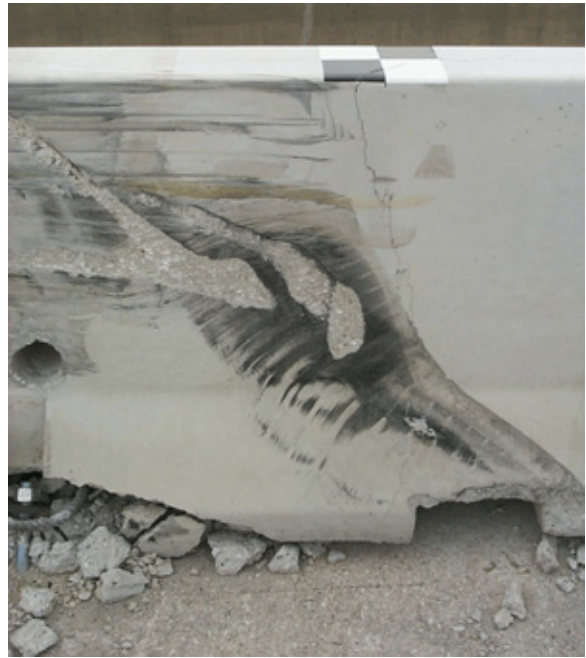
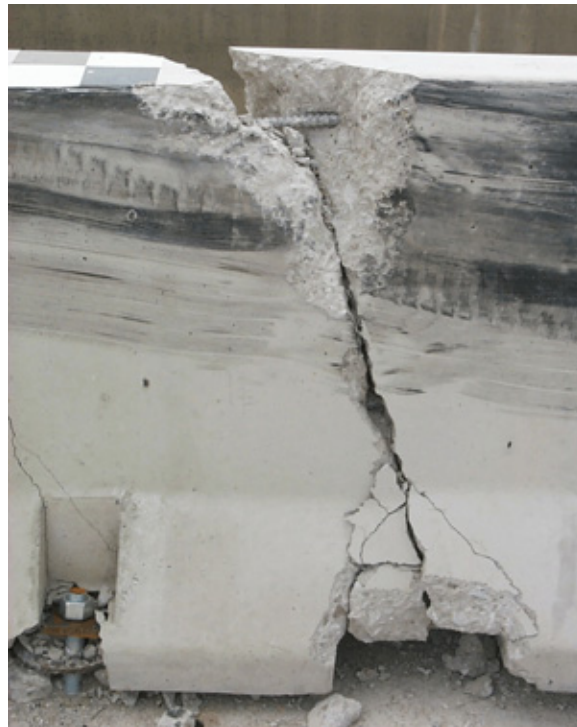
Figure 27. Barrier Nos. 8 and 9 Concrete Damage , Test KTB-1

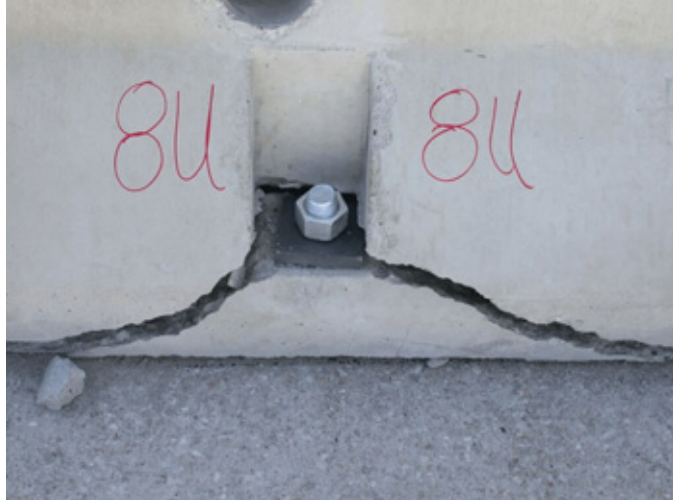
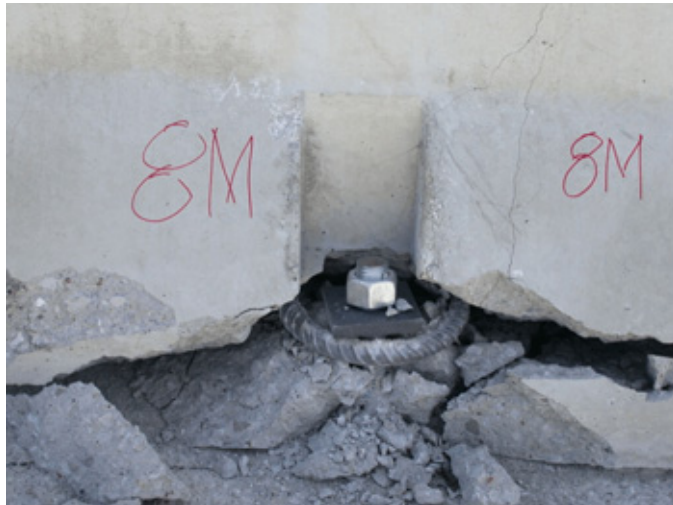
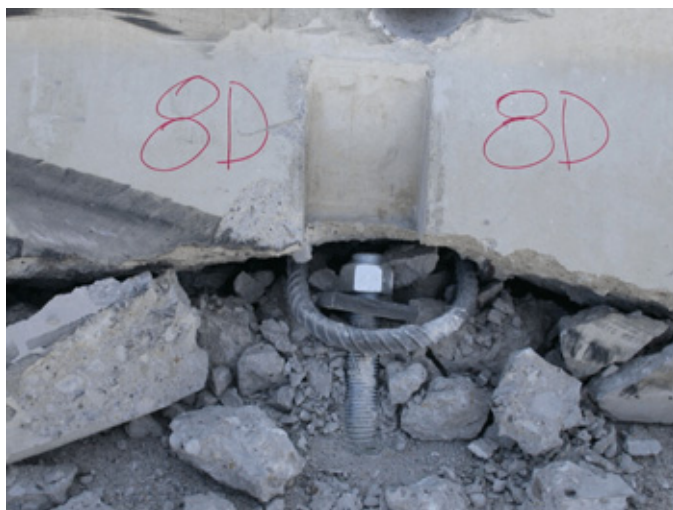
Figure 28. Barrier No. 8 Tie-Down Anchor Damage, Test KTB-1

Tire marks were visible on the front face of barrier nos. 8 and 9 and the upstream edge of barrier no. 10. Concrete failure was found at all of the tie-down anchors of barrier nos. 8 and 9, as shown in Figures 28 and 29. A 152-mm (6-in.) wide x 152-mm (6-in.) long x 89-mm (3.5-in.) deep piece of concrete was removed from the downstream end of barrier no. 8. Major concrete failure was found 457-mm (18-in.) upstream from the center of barrier no. 9 due to torsional loading. In addition, two larger cracks were found downstream from the center of barrier no. 9. Detailed sketches of the concrete failure and cracking of barrier nos. 8 and 9 are shown in Appendix E. The anchor dowels at the middle and downstream end of barrier no. 8 and the upstream end of barrier no. 9 were deformed. No major concrete spalling was found on the front face of barrier no. 9. Concrete deck failure did not occur at any of the anchor locations. No noticeable deformations were found on the connection pins nor the loops.

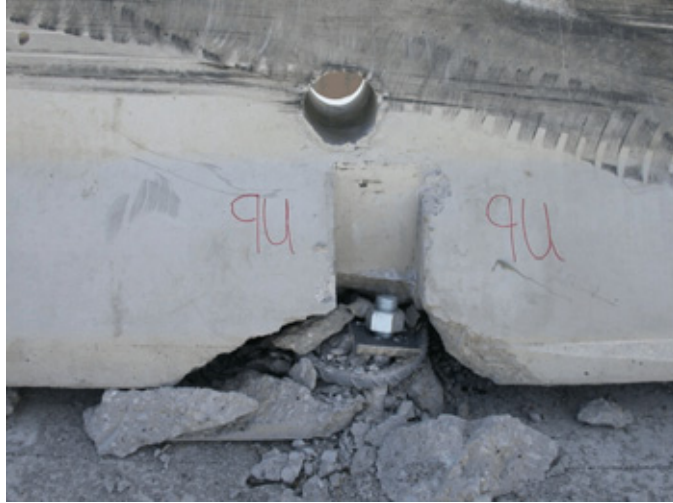
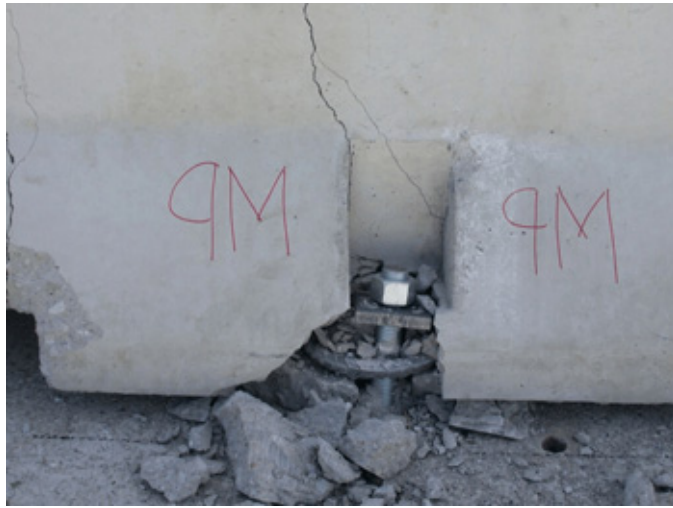
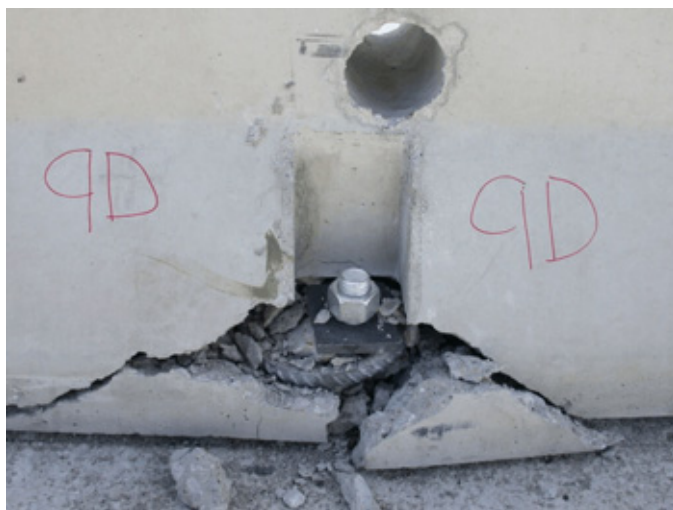
Figure 29. Barrier No. 9 Tie-Down Anchor Damage, Test KTB-1

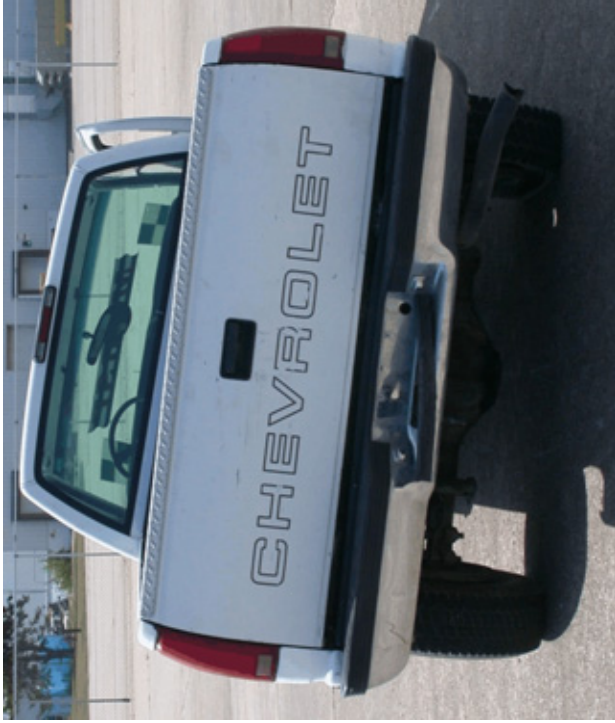
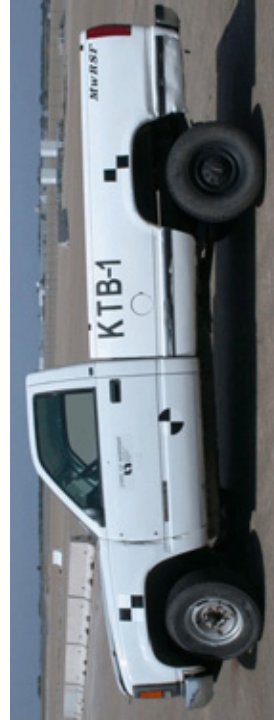
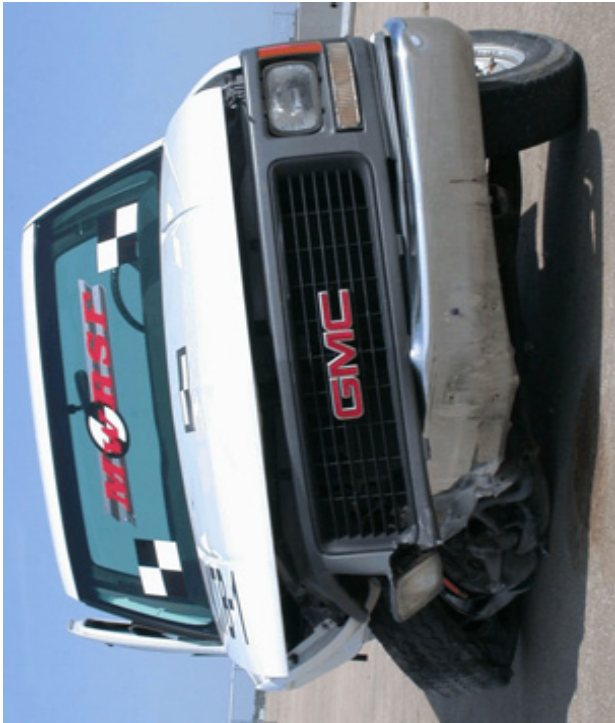
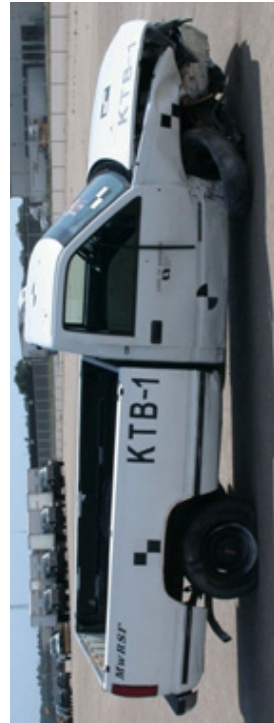
Figure 30. Vehicle Damage, Test KTB-1

Exterior vehicle damage was moderate, as shown in Figures 30 through 34. Damage was

concentrated on the right-front corner and right side of the vehicle where the impact occurred. The right-front corner of the vehicle was crushed inward and back, including the fender, bumper, and frame rail. A buckling point was found at the center of the front bumper with a minor tear near the right-front frame horn. Major frame damage was observed, including deformation to the right-side frame horn. The outer right-front tie-rod disengaged completely. The right-front tire disengaged from the rim, and the inner wall was torn. In addition, the right-front outer rim disengaged from the remainder of the hub and was severely deformed. Scuff marks were found on the right-rear wheel well, and the side wall of the right-rear tire encountered a 76-mm (3-in.) wide tear. The right-rear steel rim also received significant deformations and scrape marks. Minor scrapes and dents were also observed on the right-side door and the right side of the truck bed from the contact with the barriers. The top of the right-side door was jarred open with a 127 mm (5 in.) gap. Moreover, the door was jammed shut and could not be opened. The grill was broken and deformed around the right-side headlight assembly. The truck's box twisted and produced an inconsistent gap between the box and cab portions. The roof, the hood, the left side and rear of the vehicle, and all the window glass remained undamaged.

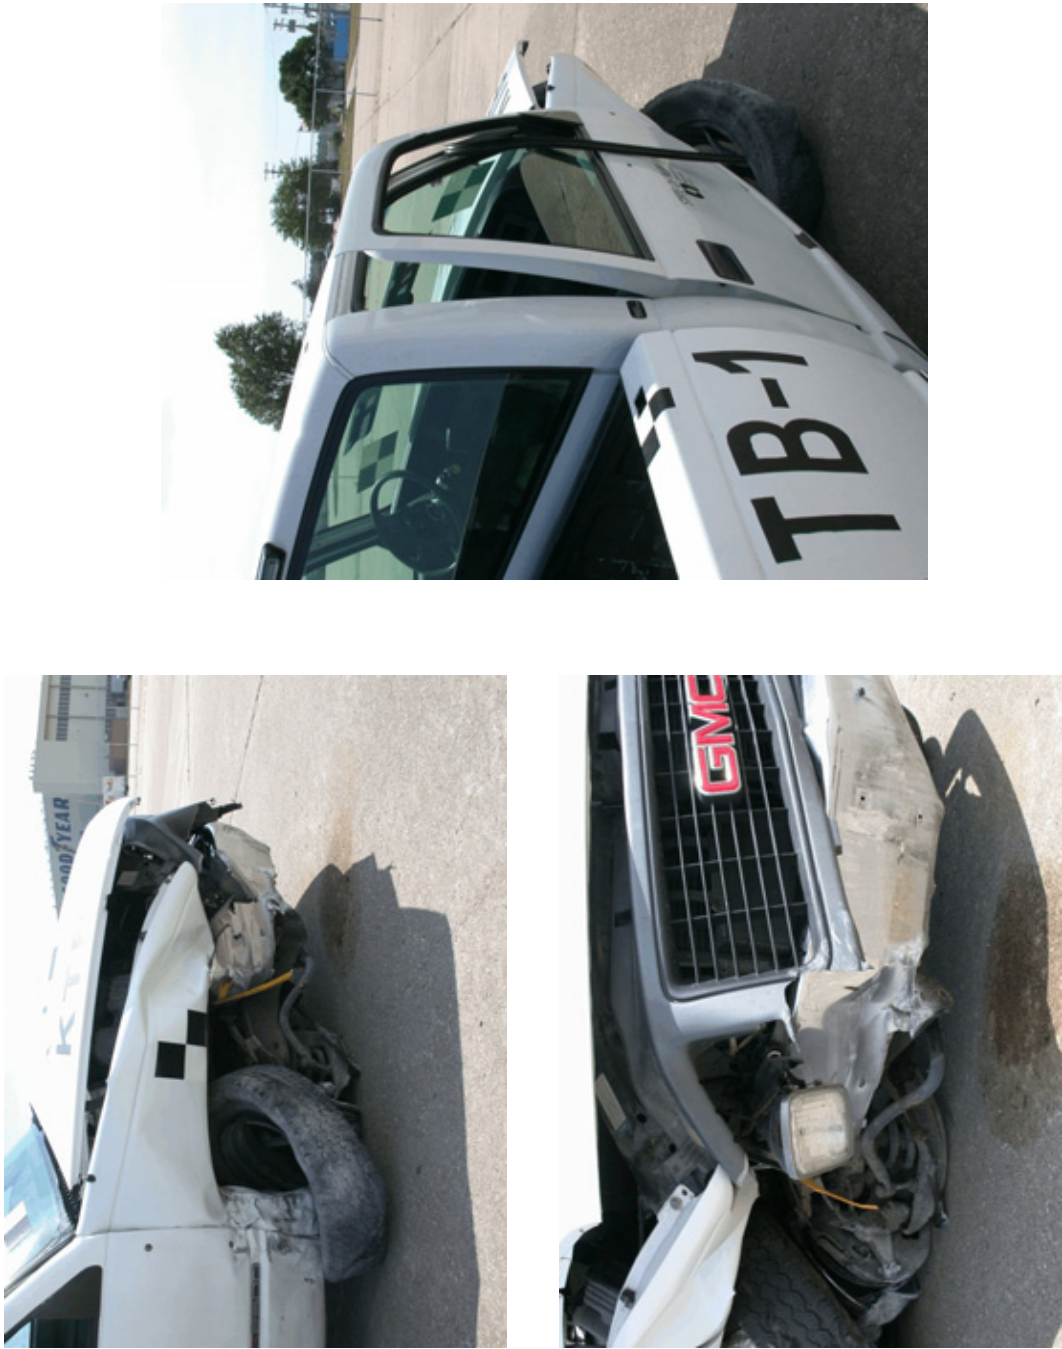
Figure 31. Vehicle Damage, Test KTB-1

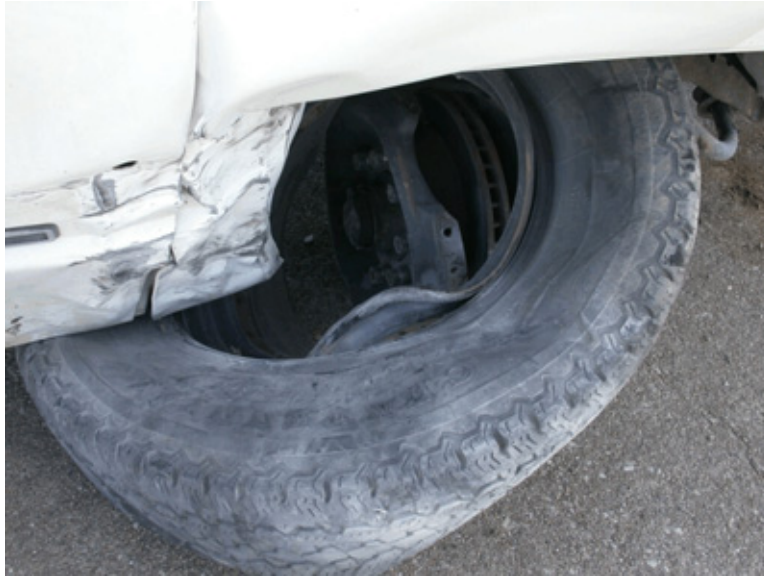
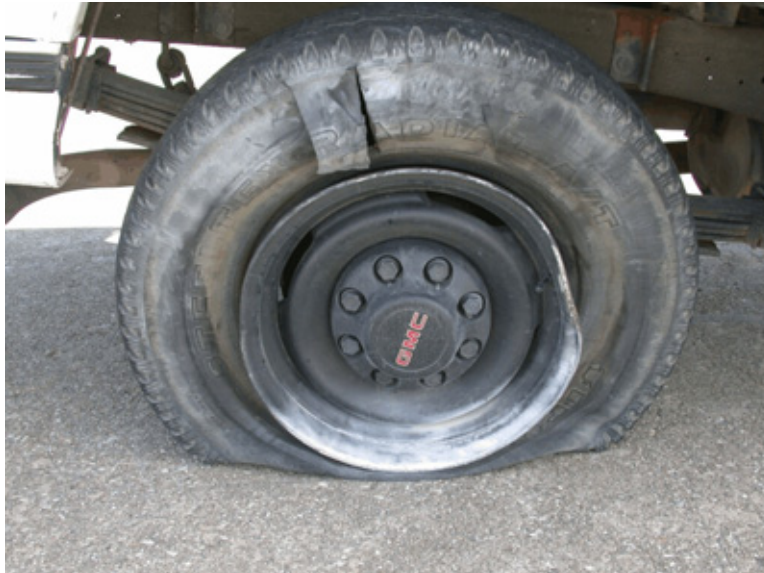
Figure 32. Right-Side Tire Damage, Test KTB-1

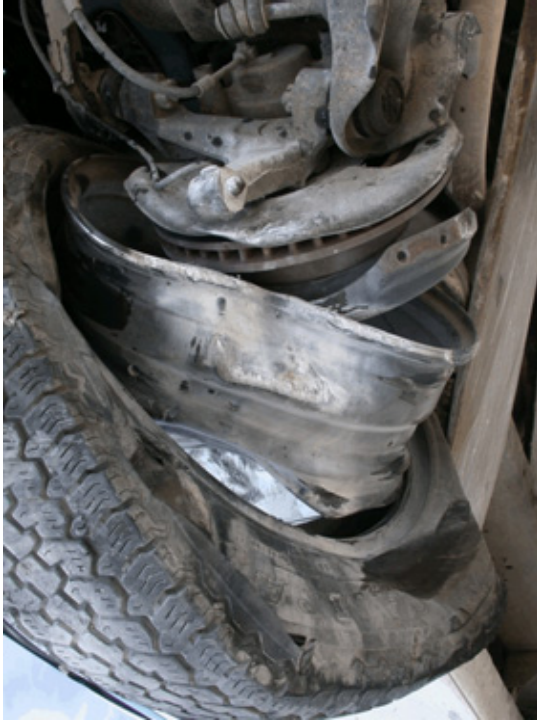
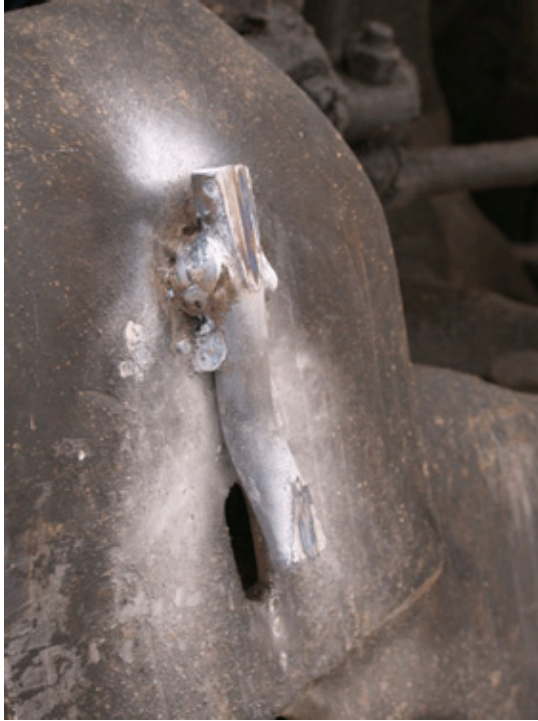
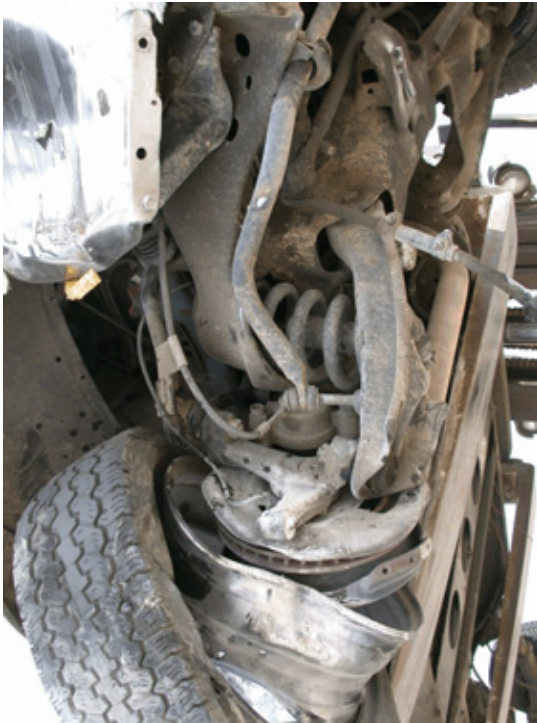
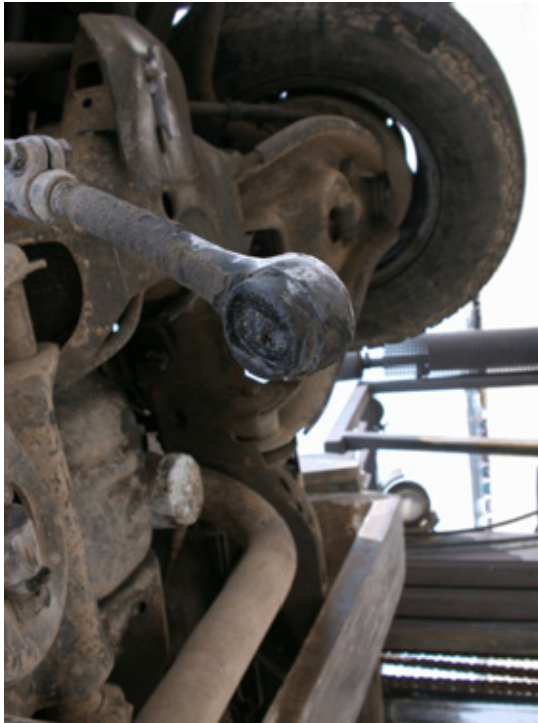
Figure 33. Vehicle Undercarriage Damage, Test KTB-1

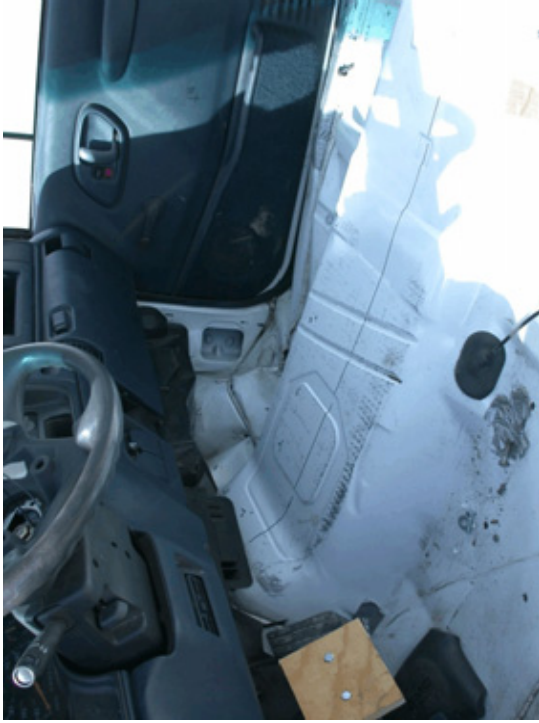
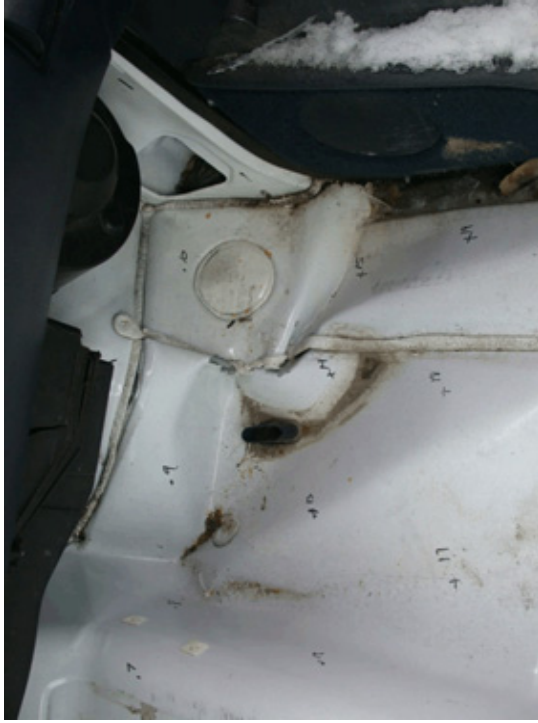
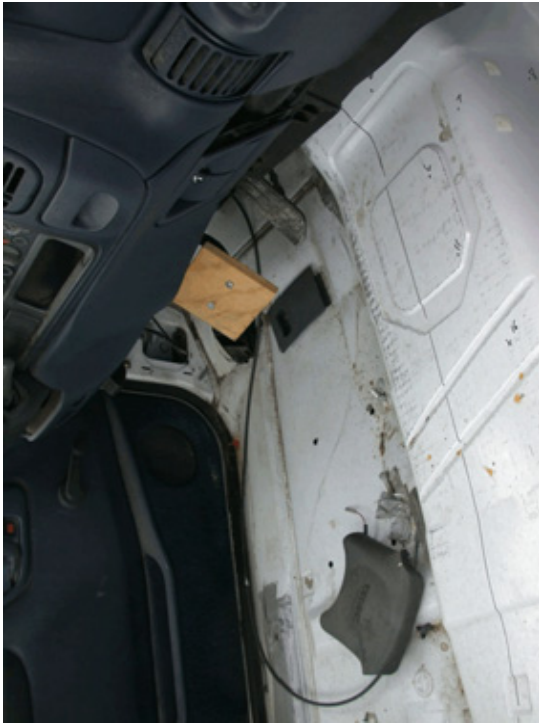
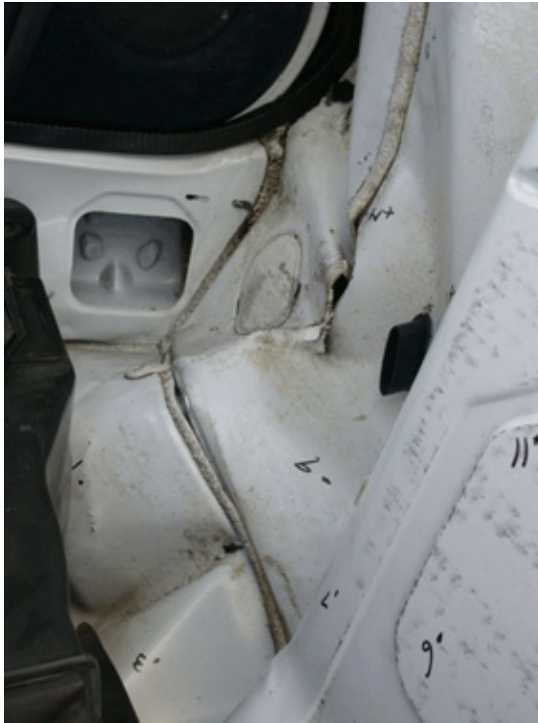
Figure 34. Occupant Compartment Damage, Test KTB-1

Moderate occupant compartment deformations occurred with deformations to the right-side floor pan and firewall, as shown in Figure 34. Occupant compartment deformations and the corresponding locations are provided in Appendix F. A maximum vertical deflection of 121 mm (4.75 in.) was found near the firewall at the center of the right side. Another significant vertical deflection of 76 mm (3 in.) was found near the center of the floor on the right side. Maximum longitudinal and lateral deflections of the floor pan were measured as 121 mm (4.75 in.) and 83 mm (3.25 in.), respectively. Maximum dash deflection was found to be approximately 25 mm (1 in.).

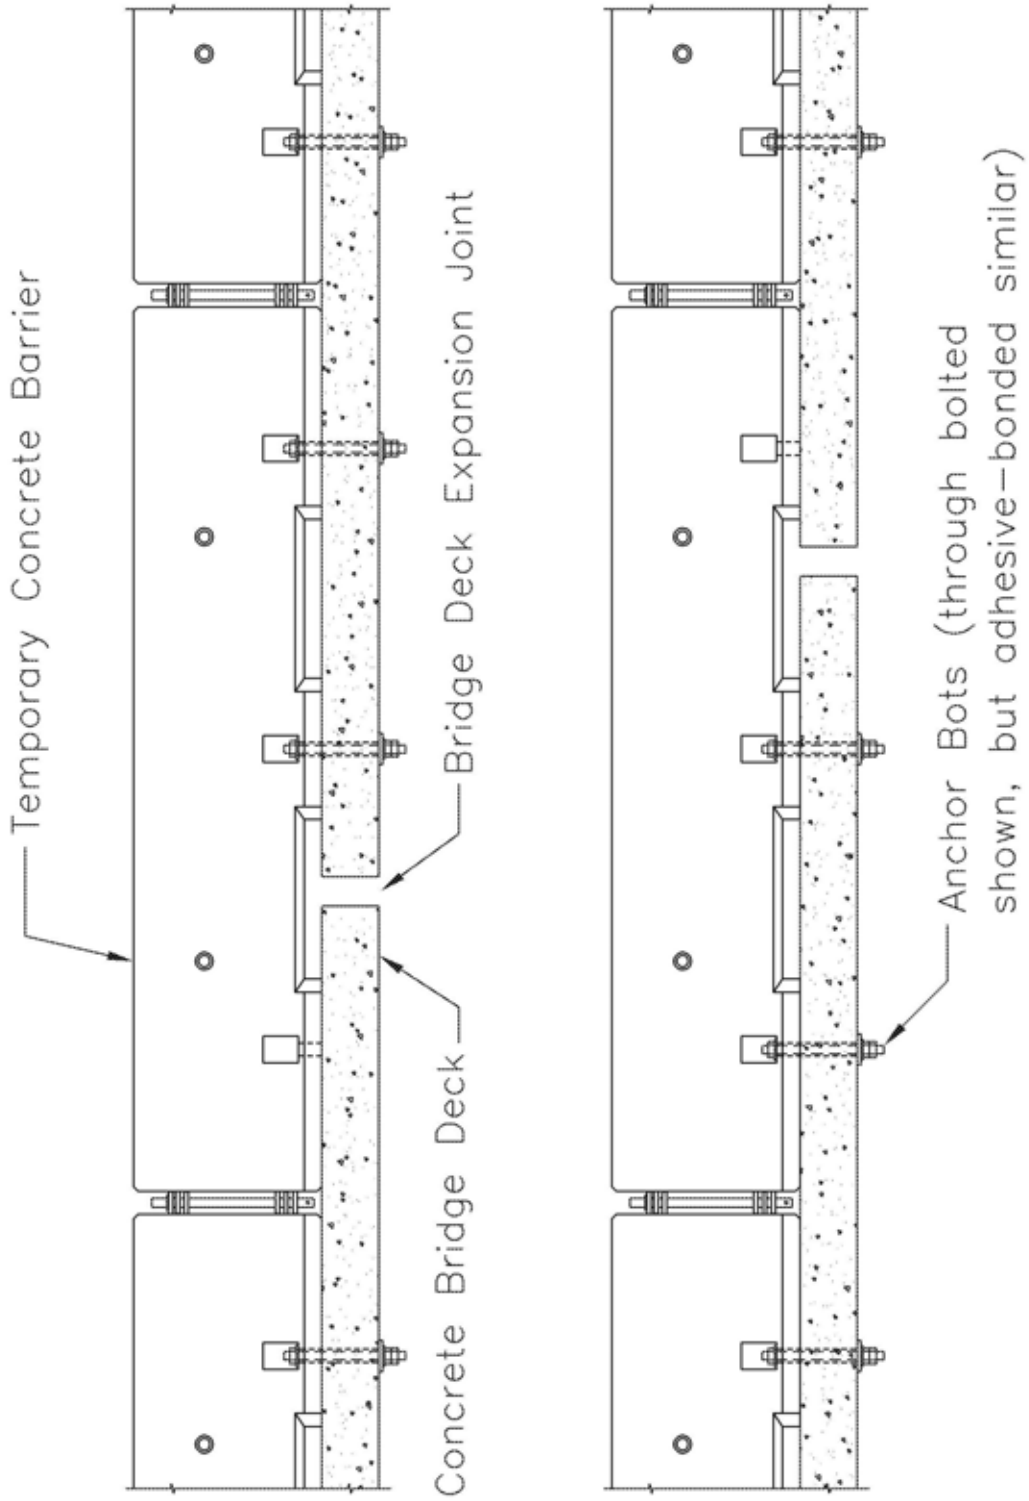
Figure 35. Treatment at Bridge Deck Thermal Expansion Joints

In some real-world applications, an expansion joint may fall between two anchor bolts within a single barrier unit. In this situation, omitting one anchor bolt is not believed to compromise the barrier performance. It is recommended that the one anchor bolt adjacent to the joint, as shown in Figure 35, should be left out of the barrier spanning the thermal expansion joint. It should be noted that the adjacent barrier units must each be installed with the standard three anchor bolts.

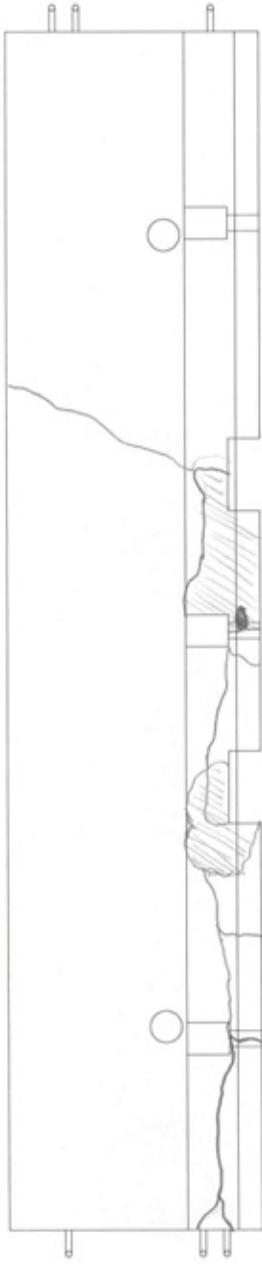
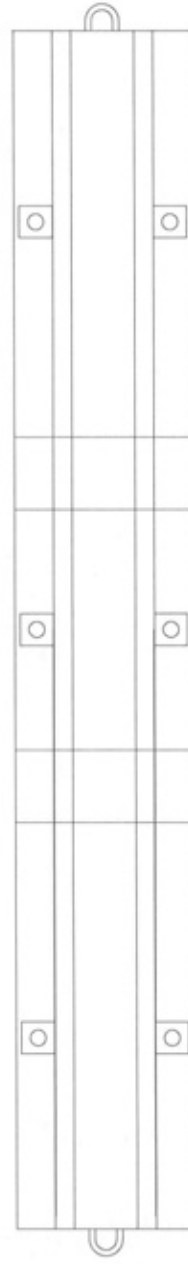
Major Barrier Damage; Barrier No. 8 - Back Face

Figure E-2. Concrete Damage – Back Face Barrier No. 8, Test KTB-1

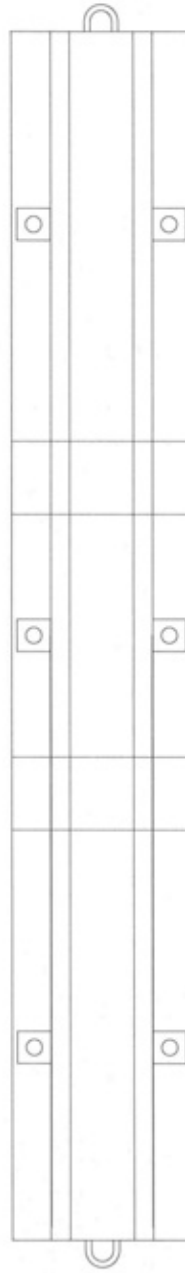
Major Barrier Damage: Barrier no 9 back face

Figure E-4. Concrete Damage – Back Face Barrier No. 9, Test KTb-1
