Modelling and analysis of possible displacements over the Mt. Peron niche

The Mt. Peron historical rock avalanche

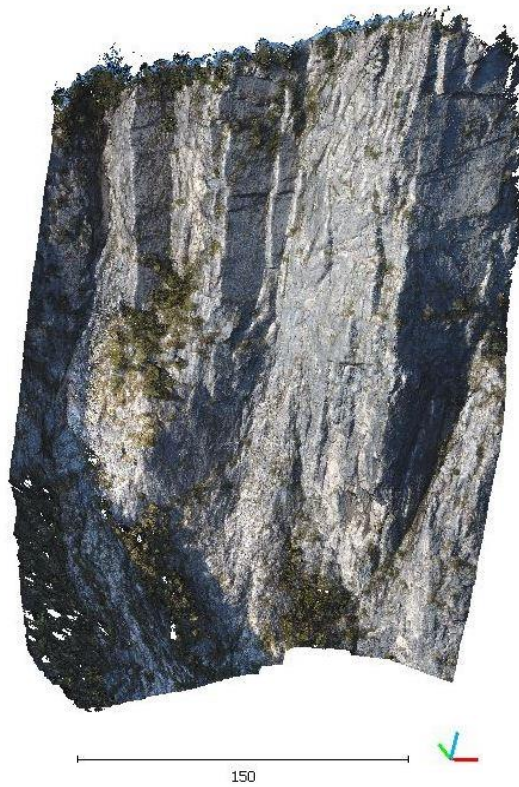
Fig. 2: Drone used during the surveys activities and points cloud generated using the acquired images.

For the 3-dimensional representation of the study area, a photogrammetric survey was performed taking 150 photos using a commercial drone/UAV (Unmanned Aerial Vehicle). From those images a points cloud (**Fig. 2**) and a triangular mesh have been built using the SfM (Structure from Motion) technique through the software Agisoft Photoscan[©].
