Behavior of Biaxially Loaded Slab-Column Connections with Shear Studs

by Eric M. Matzke, Rémy D. Lequesne, Gustavo J. Parra-Montesinos, and Carol K. Shield

ACI Structural Journal, V. 112, No. 3, May-June 2015.

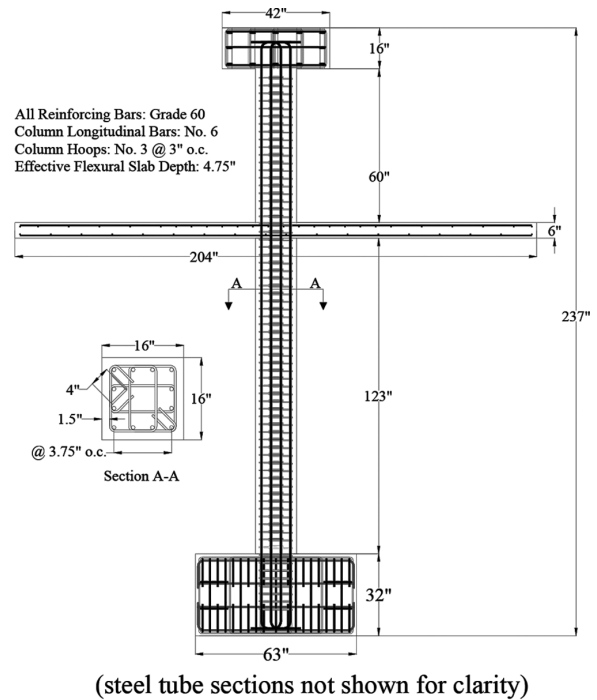
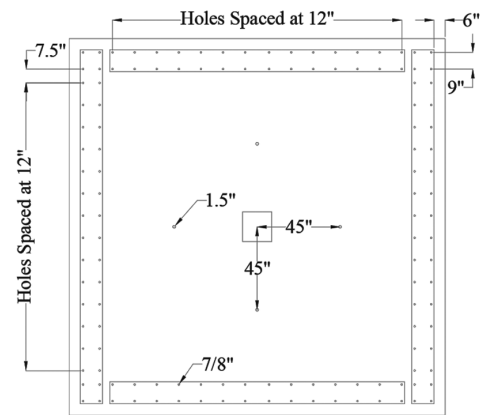
(a) Elevation view

(b) Plan view

Fig. 1—Typical geometry of specimens. (Note: 1 in. = 25.4 mm.)

Four nearly full-scale slab-column subassemblies with nominally identical geometry were tested under combined gravity loading and biaxial lateral displacements. Specimen design was based on a previous experimental investigation by Cheng et al. (2010). Elevation and plan views of the specimen are shown in Fig. 1. Each specimen consisted of a 17 ft (5.2 m) square, 6 in. (0.15 m) thick slab supported by a full-story 16 in. (0.41 m) square column with a clear height of 10 ft-3 in. (3.1 m). The column extended 5 ft (1.5 m) above the slab. The column base was anchored into a heavily reinforced concrete base block that was fixed to the laboratory floor. A top block was cast monolithically on top of the column for application of lateral displacements. A point of inflection was imposed at the top of the top block.

Column design—The column was designed to remain elastic except at the base. Twelve No. 6 (No. 19M) bars were used as longitudinal reinforcement, which represented a reinforcement ratio $\rho_g = 2.1\%$. Sufficient transverse reinforcement was provided to prevent any significant shear-related damage throughout the tests. Transverse reinforcement was uniformly spaced at 3 in. (76 mm) along the column height, with each layer of transverse reinforcement consisting of three No. 3 (No. 10M) closed hoops (four legs in each direction), as shown in Fig. 1(a).

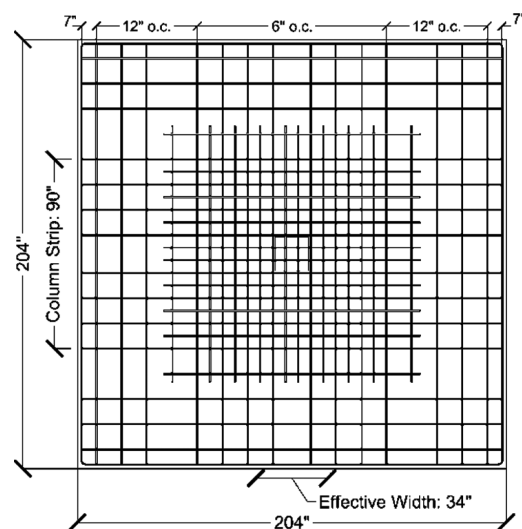
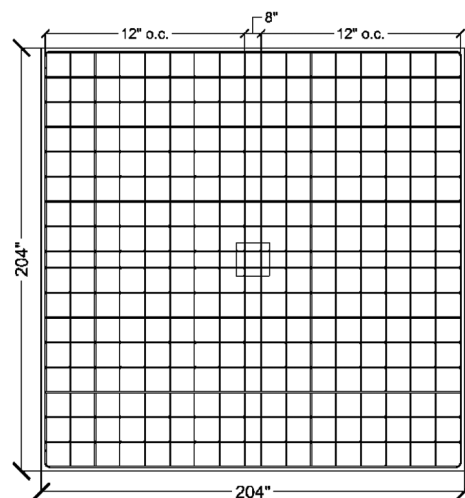
(a) Top layer of reinforcement

(b) Bottom layer of reinforcement

Fig. 2—Slab flexural reinforcement layouts. All bars are No. 4 (D13) Grade 60. (Note: 1 in. = 25.4 mm)

Design Method outlined in Section 13.6 of ACI 318-11. Reinforcement layouts, shown in Fig. 2, were nominally identical in each principal direction with an average effective depth d of 4.75 in. (0.12 m). Reinforcement in the column strip consisted of No. 4 (No. 13M) bars spaced at 6 in. (0.15 m), resulting in a tensile reinforcement ratio of 0.6% based on the slab overall thickness (0.7% based on the average effective slab depth). As shown in Fig. 2, two bottom bars in each direction passed continuously through the column core, as required in Section 13.3.8.5 of ACI 318-11.

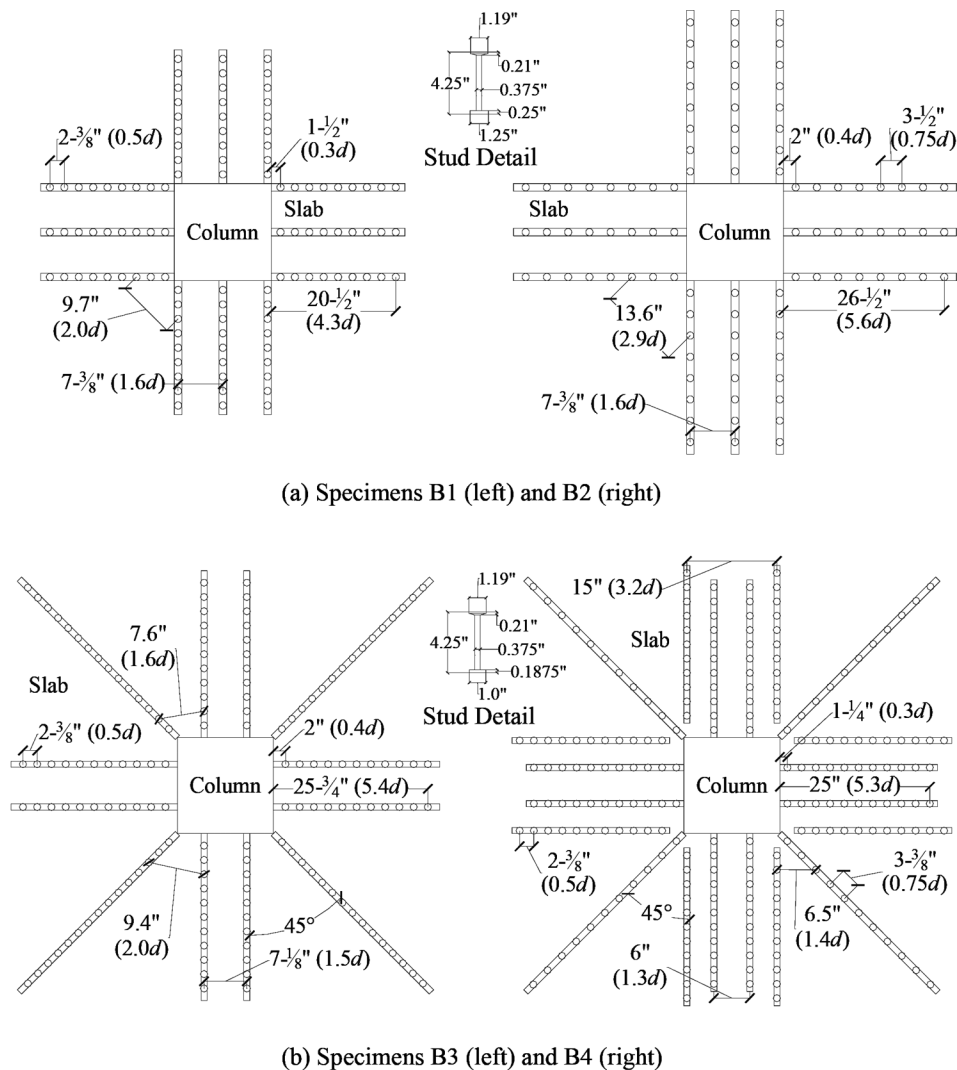
(a) Specimens B1 (left) and B2 (right)

(b) Specimens B3 (left) and B4 (right)

Fig. 3—Shear stud dimensions and layout. (Note: 1 in. = 25.4 mm.)

For design of the shear stud reinforcement (shown in Fig. 3), a yield strength of 55 ksi (410 MPa) was used. Stud rails for Specimens B1 and B2 were arranged in a cruciform pattern, with rails placed orthogonally to each column face. The shear design for the connection in Specimen B1 was based on the assumption of zero concrete contribution to shear capacity ($v_c = 0$), resulting in the layout shown in Fig. 3(a) with a shear stud spacing perpendicular to each column face of $0.5d$. Specimen B2 was reinforced with shear studs in a cruciform layout (Fig. 3(a)) proportioned such that $v_s = 3.5\sqrt{f'_c}$, psi ($0.29\sqrt{f'_c}$, MPa) extending over $4.4h$ from the column face, where h is the slab thickness. This shear reinforcement design satisfied the minimum amount required by Section 21.13.6 of ACI 318-11 if no shear stress or drift capacity check is performed. For this specimen, the shear stud spacing perpendicular to each column face was $0.75d$.

Specimen B3 was reinforced with the same number of stud rails at the same stud spacing as Specimen B1; however, four of the 12 stud rails were placed at the column corners, oriented at a 135-degree angle to the column faces (Fig. 3(b)). The other eight rails were placed perpendicular to the column faces (two per column face). The purpose of using this arrangement was to provide a more uniform shear stud spacing around the column and thereby increase the region of the connection reinforced in shear.

A total of 20 stud rail assemblies were used in the connection of Specimen B4 (Fig. 3(b)), which led to $v_s = 7.8\sqrt{f'_c}$, psi ($0.65\sqrt{f'_c}$, MPa). As in Specimen B3, one rail was placed at each column corner at a 135-degree angle to the faces of the column. To minimize interference with slab reinforcement, the stud spacing on these diagonally placed assemblies was increased by a factor of $\sqrt{2}$ so that the studs would lie on an orthogonal grid. This shear stud layout led to a lower maximum stud spacing in each peripheral row compared to that in Specimen B3.

Axial strain in the stud shanks was monitored in several shear studs in each specimen (the layout of studs is shown in Fig. 3). Beyond $1.5d$ from the column periphery, tensile strain readings in all instrumented shear studs never exceeded 0.0018, and were typically less than 0.001. Large increases in strain were observed in studs located in the first three peripheral lines during the cycles at 1.15% drift, likely indicating the formation of diagonal cracks. During subsequent cycles up to 1.85% drift, the peak strains in the first three rows of shear studs steadily increased. The fact that stud strains increased while the connection shear-stress demand remained relatively constant suggests an increase in the role played by shear reinforcement in resisting connection shear. The maximum measured stud strains in Specimens B1 and B2 were slightly lower than 0.003, except for one instrumented stud in Specimen B2, which exhibited a peak strain of 0.0045 during the 2.30% drift cycle. If shear studs with actual yield strength closer to the specified yield stress had been used, the shear studs may have yielded at lower drifts (the ratio of reported to specified yield strength exceeded 1.25 for Specimens B1 and B2).

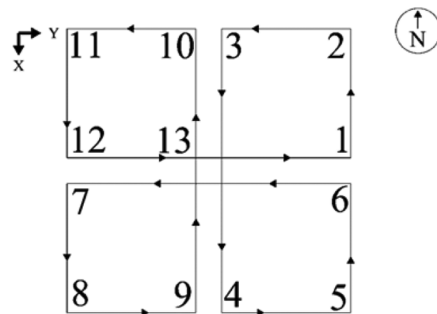
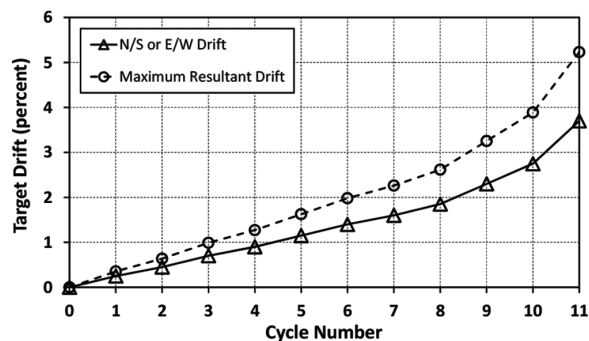
(a) Cloverleaf displacement followed for each drift cycle

(b) Target drifts for each loading cycle

Fig. 4—Loading pattern and target drifts.

Lateral displacements were applied to the top block through the crosshead. The displacement path for each drift cycle followed the cloverleaf pattern shown in Fig. 4(a). Target drifts for each cycle are shown in Fig. 4(b). These drifts represent total specimen drifts equal to the lateral displacement at the top of the column divided by the specimen height (17 ft-1 in. [5.21 m]). Drift values reported herein correspond to this total specimen drift. Lateral displacements at the level of the slab, however, were also measured in order to calculate “first-story” and “half second-story” drifts, which tended to be approximately 20% lower and 30% higher than the total specimen drift, respectively.

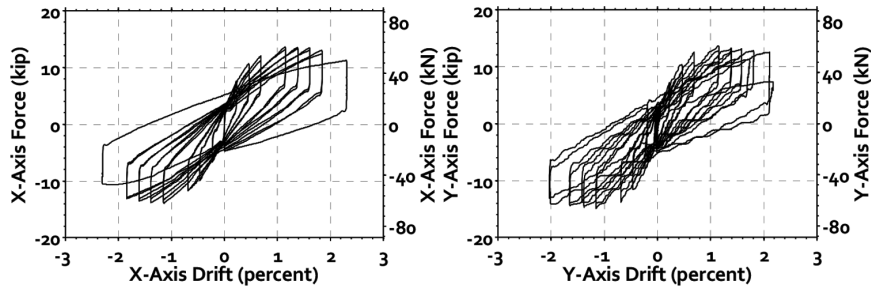
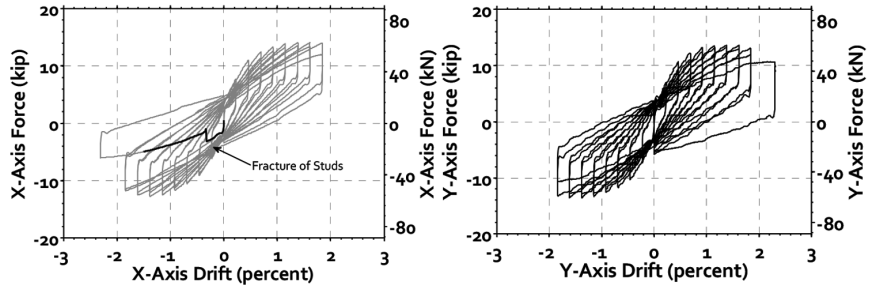
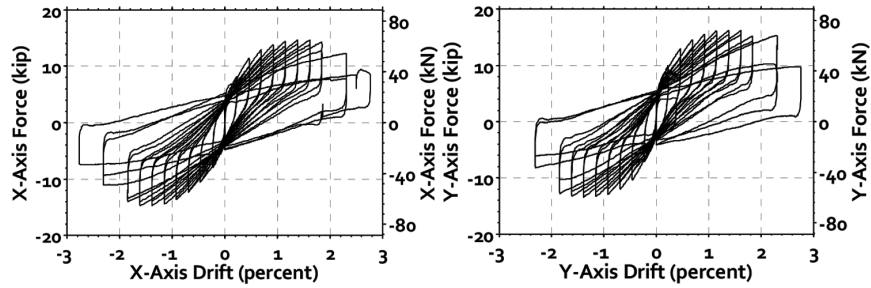
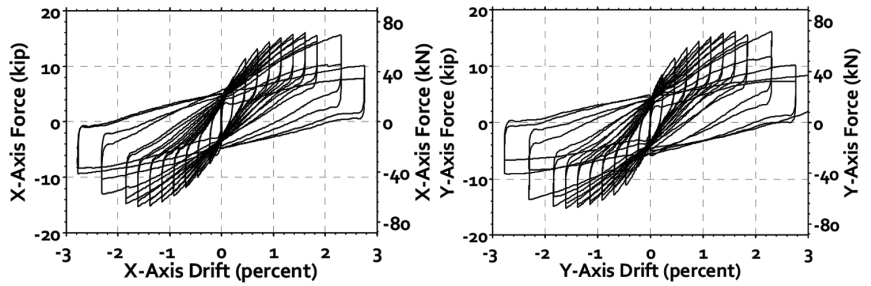
Fig. 5—Lateral force versus total specimen drift response.

The four specimens behaved similarly in response to initial application of gravity loads and to lateral displacements up to approximately 1.60% drift (Fig. 5). Gravity load application resulted in tensile strains ranging from 0.00035 to 0.0005 in the top mat of reinforcement approximately 2 in. (50 mm) from the column faces. However, these values do not account for initial strains resulting from the self-weight of the slab and fixtures, which were not measured. Linear variable differential transformer (LVDT) measurements indicated that strains large enough to cause cracking developed on the top and bottom surfaces of the slab within one slab

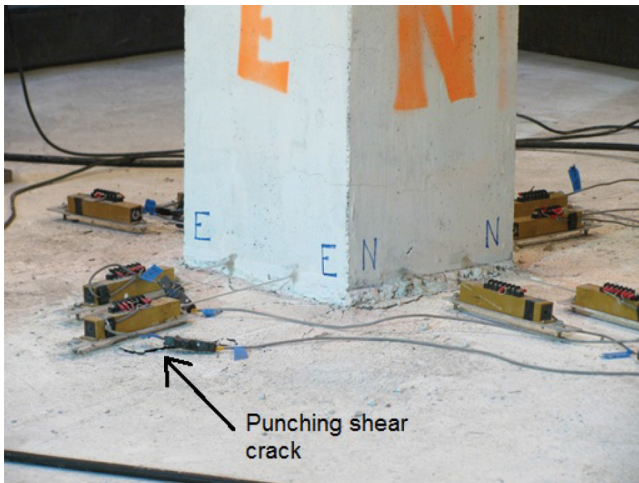
Fig. 6—Specimen B1 at Point 8 of 1.85% drift cycle, when first evidence of punching shear-related cracking was observed.

Specimen B1—The first punching shear-related crack in Specimen B1 (Fig. 6) was observed on the top face of the

slab east of the column during the 1.85% drift cycle at Point 8 in the cloverleaf load pattern. This crack, however, did not translate into any change in the overall hysteresis behavior of the specimen (Fig. 5(a)). When displaced to 2.30% drift, a loss of lateral load capacity occurred, as punching shear-related damage and severe concrete degradation was observed along the west, south, and east faces of the connection (refer to Fig. 7 for a photograph of this region taken after completion of test). The slab also dropped approximately 1 in. (25 mm) relative to its initial elevation on the

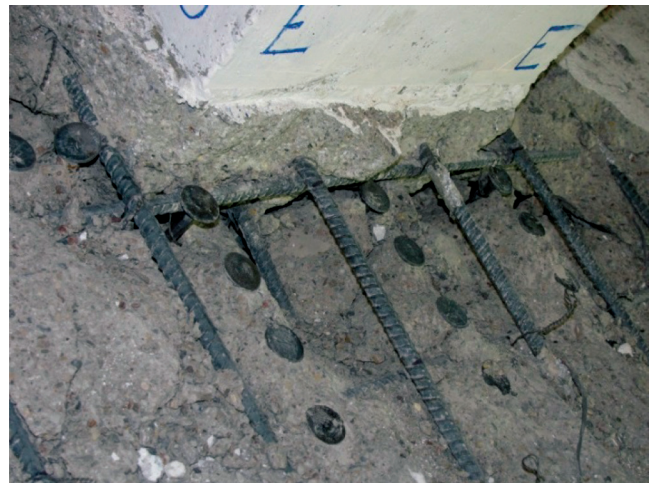
Fig. 7—Void in connection region, typical of damage at east, west, and south column faces of Specimen B1.

It is evident from visual observations during and after testing that the slab concrete was not well confined (Fig. 7 and 9). Rather than a well-confined core of concrete between the top and bottom mats of reinforcement, large, loose pieces of concrete and crushed “gravel-like” debris were found after the tests were completed. Furthermore, the concrete in the immediate vicinity of the headed studs was also not well confined. In some instances, a cylinder of concrete around the stud shank with a diameter smaller than the stud head remained intact after testing, indicating that it was either confined by or bonded to the stud. In other cases, the stud shank was exposed after testing, indicating that no concrete was effectively confined by the shear stud.

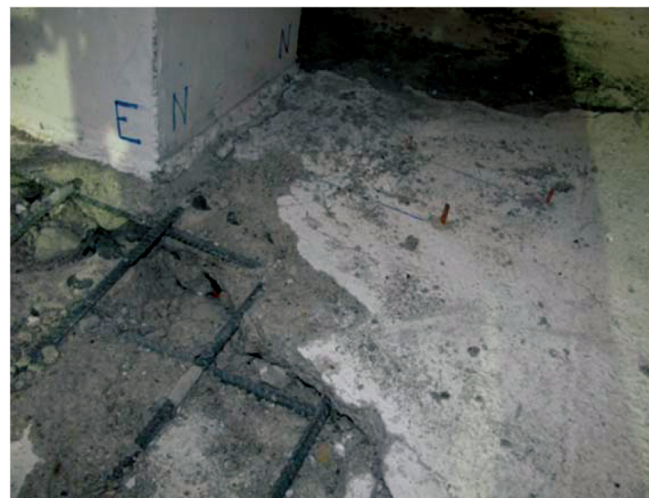
Fig. 8—Damage in slab north of column in Specimen B1.

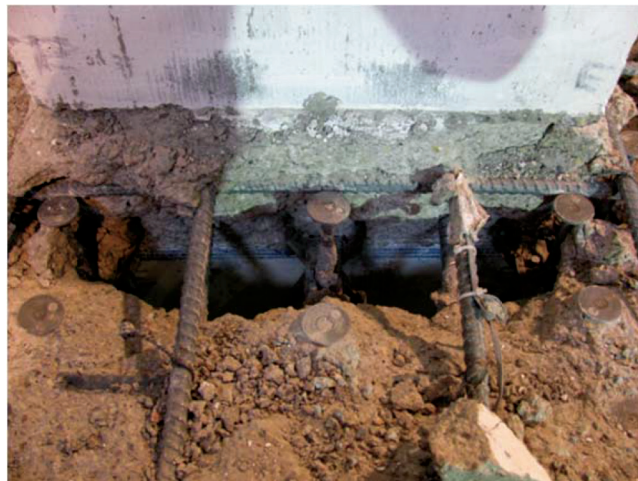
Fig. 9—East side of connection region in Specimen B2 after severely degraded concrete had been removed by hand.

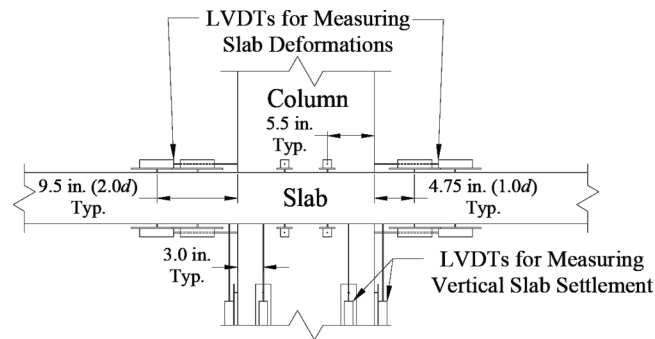
Fig. 10—Placement of linear variable differential transformers (LVDTs) at slab-column connection. (Note: 1 in. = 25.4 mm.)

Linear variable differential transformers (LVDTs) were fixed to the top and bottom of the slab at both d and $2d$ from each column face (Fig. 10) so that flexural rotations in the slab could be calculated. In general, all four specimens exhibited a similar behavior in terms of flexural rotations. Prior to evidence of slab punching, peak calculated flexural rotations were between 0.03 and 0.04 radians. Figure 11 shows the slab moment about the y-axis plotted versus rotations calculated d and $2d$ from the north column face of Specimen B2. The similarity between the two plots is typical of all four column faces in all four specimens and indicates that most or all inelastic flexural deformations concentrated within d from the column faces.

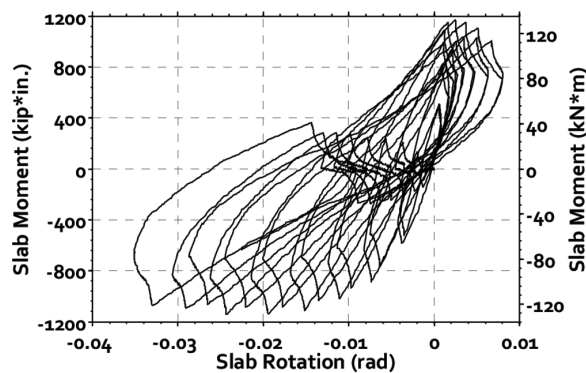
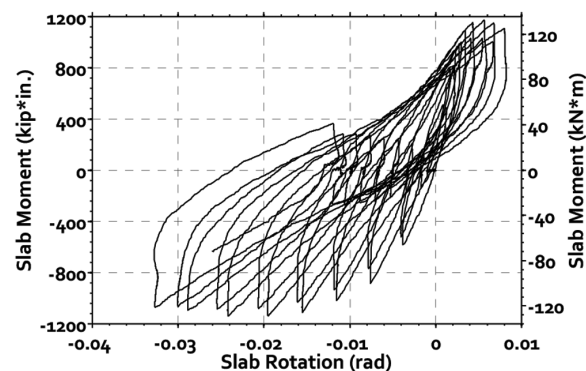
(a) Calculated at d from column face

(b) Calculated at $2d$ from column

Fig. 11—Slab moment transferred to the column about y-axis versus rotations in slab north of column in Specimen B2.

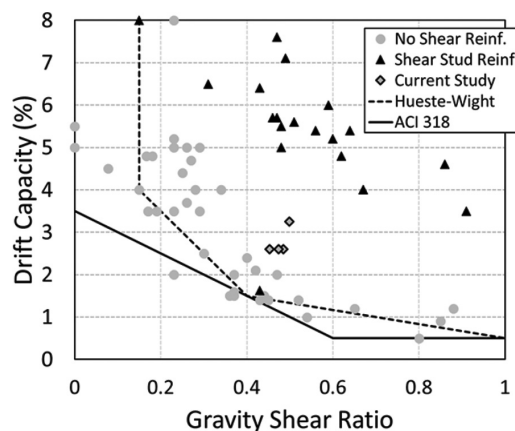
Fig. 12—Drift capacity versus gravity shear ratio for slab-column connection specimens.

failure. Drift capacity versus gravity shear ratio interaction for slab-column connections without shear reinforcement in ACI 318-11 and Hueste and Wight (1999) are also plotted in Fig. 12.
