STUDY OF THE INFLUENCE OF POST WELD HEAT TREATMENT (PWHT) ON THE SALT SPRAY CORROSION BEHAVIOUR OF 316L STEEL CLAD

Cladding process (Submerged Arc Welding - SAW)

Accelerated corrosion test

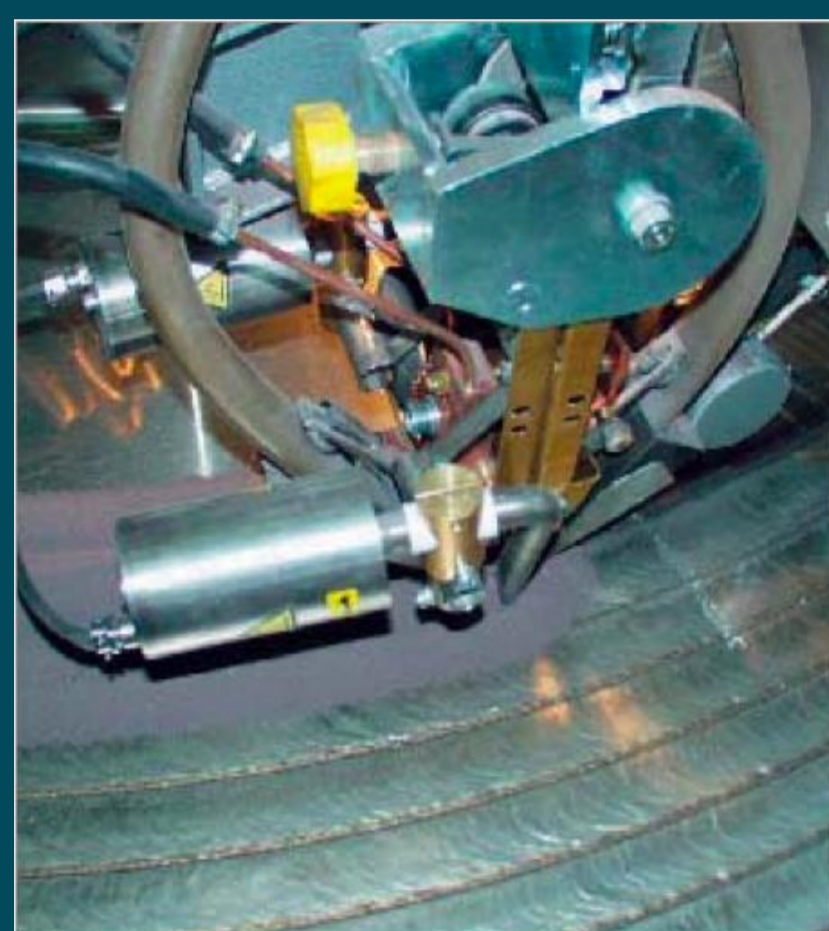
- **Base material:** ferritic steel P355 NH
- **1st layer:** austenitic stainless steel 309
- **2nd and 3rd layer:** austenitic stainless steel 316 L
- **Produced by** ARSOPI S.A., Portugal

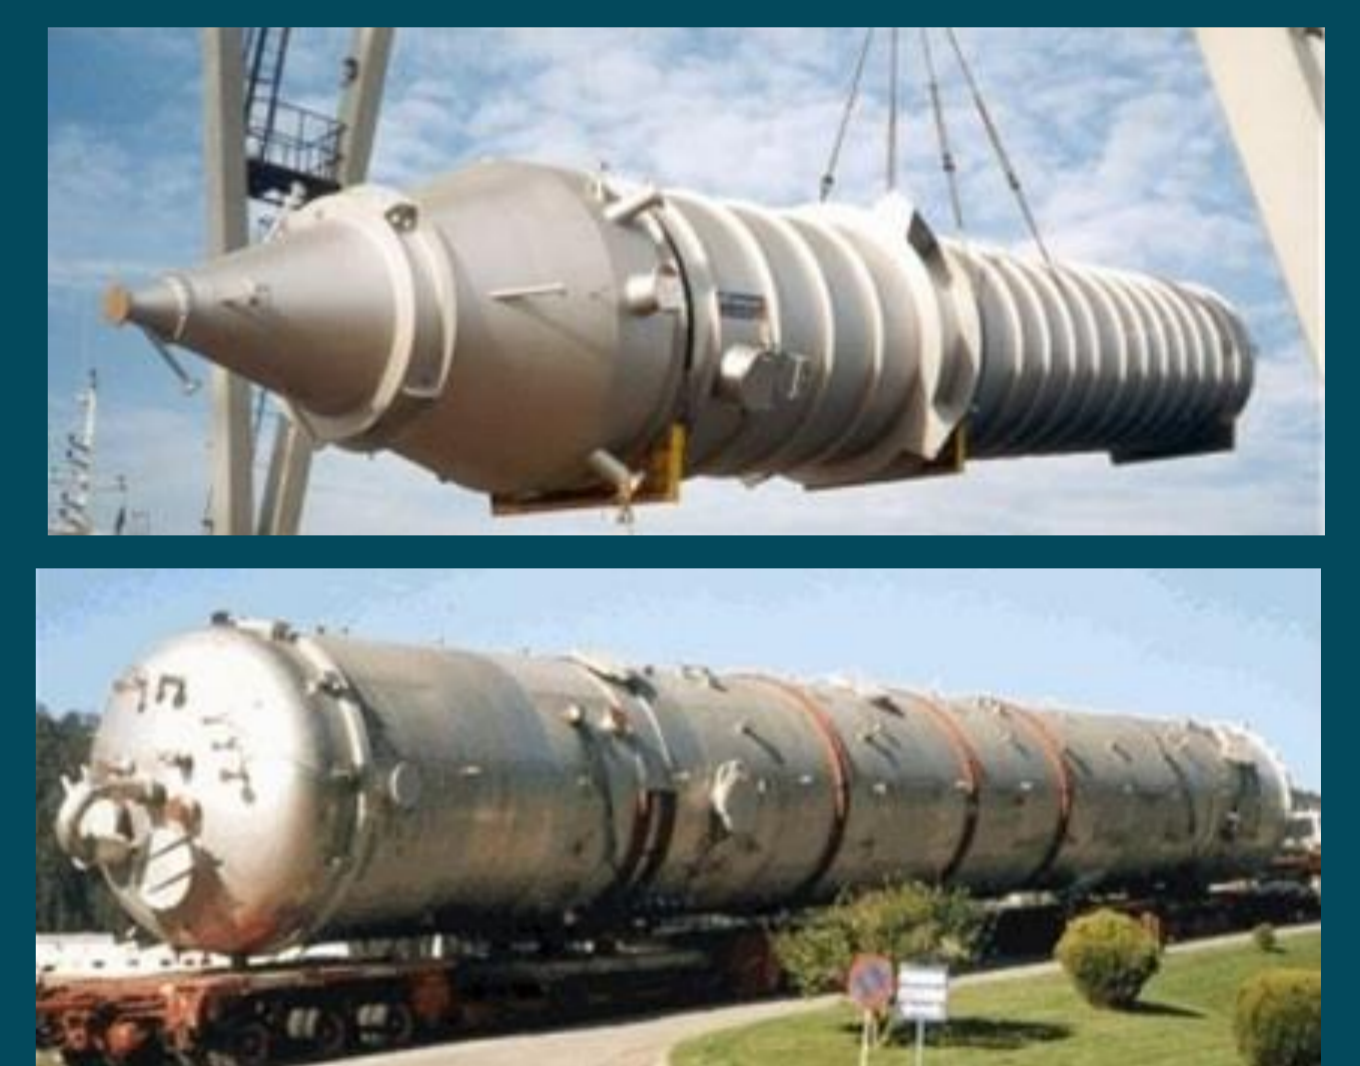
Process Equipment

ARSOPI S.A., Portugal

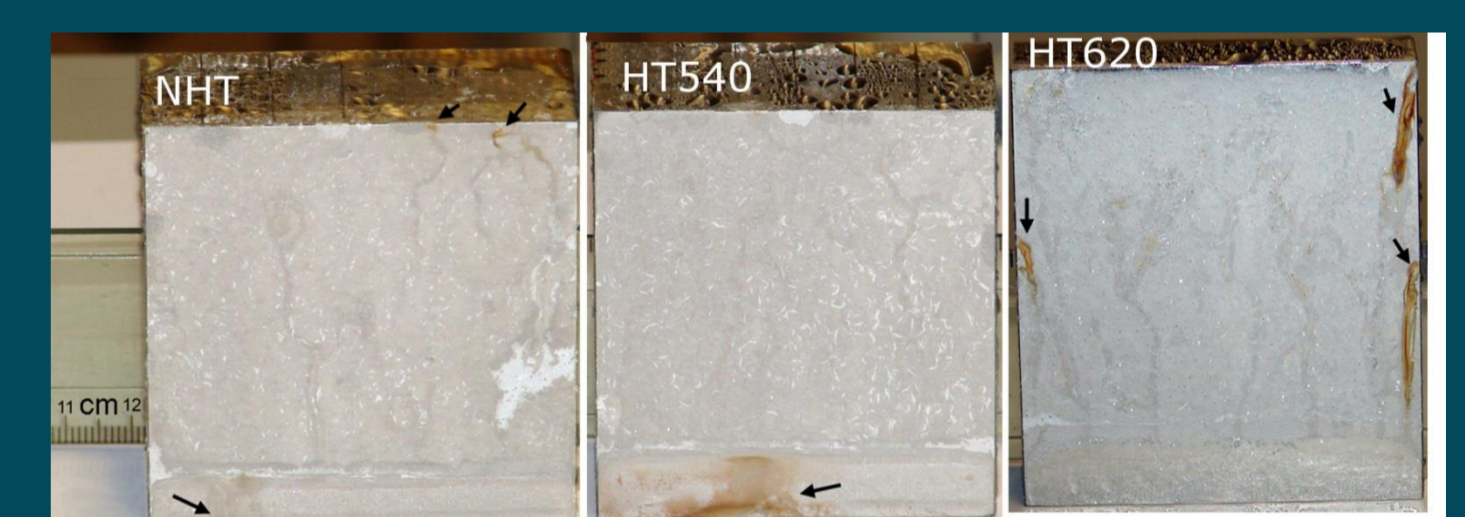
Test 2, after 24 h

TEST 2 was carried out using a solution of 5.0 ± 0.5 % NaCl, pH 6.5 and consisted of two phases:

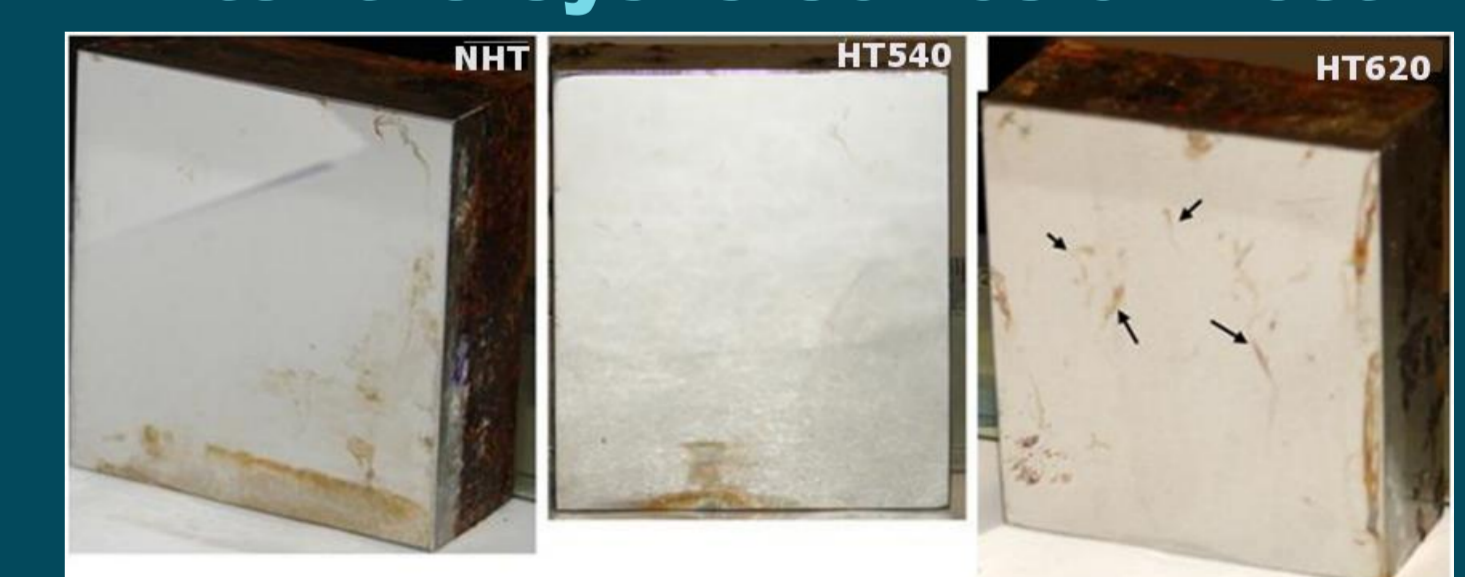
After the Cyclic Corrosion Test

(arrows indicate visible red corrosion areas)

In Test 2 after the first phase the sample surfaces presented a very small amount of localized red-brown rust. These results confirm that non-heat-treated and heat-treated materials possess good corrosion resistance under the tested conditions. However, in test 2 after CCT, the surface of HT620 presented significant localized corrosion, NHT showed some localized rust and HT540 insignificant change.

The results obtained confirm that PWHT at 620 °C deteriorates the corrosion behaviour of the material under CCT conditions. The partial transformation of residual δ -ferrite to σ (a Fe-Cr intermetallic) during the heat treatment produces Cr and Mo deficiency in regions adjacent to the σ phase. As a result, the passive film becomes weaker in those regions and leads to localized corrosion.
