Decorative renders simulating stone of middle 20th century in the region of Lisbon

Abstract

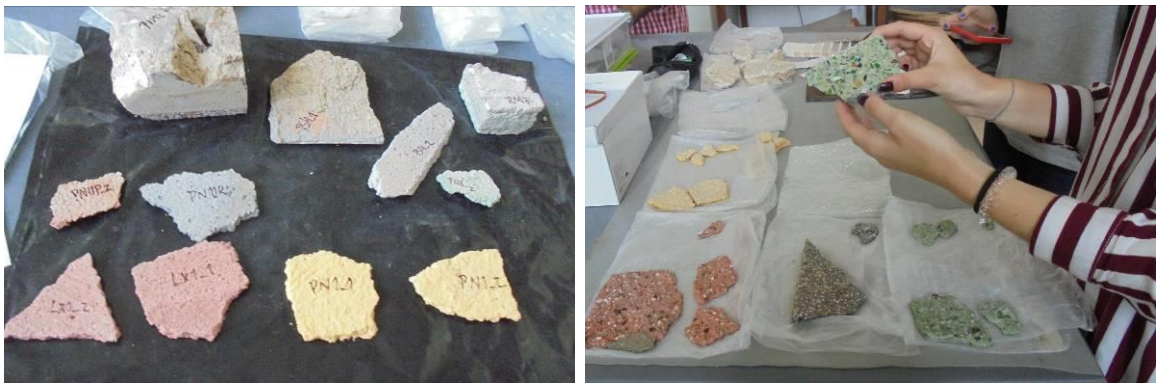
Figure 5. Samples of differently coloured *marmorites* collected

Samples of *marmorite* renders were collected in the districts of Lisbon, Santarém and Setúbal (within the region marked by the red circle in the map of Portugal mainland - Figure 4), in LNEC's main building, located in a heavy car and plane traffic, and in housing buildings mainly of the decades 1950-1960, with different colours. It should be noticed that the collection of samples was generally only allowed by the owners in the case of renders with anomalies and in limited quantity and dimensions. Such low quantities permitted chemical, mineralogical and microstructural tests, but in many cases were not enough for physical and mechanical testing (Figure 5).
