DURABILITY OF LIME BASED RENDERS: A REVIEW OF SOME DEGRADATION MECHANISMS AND ASSESSMENT TEST METHODS

Abstract

Keywords: Lime render; Degradation mechanism; Cracking; Loss of adhesion; Test method

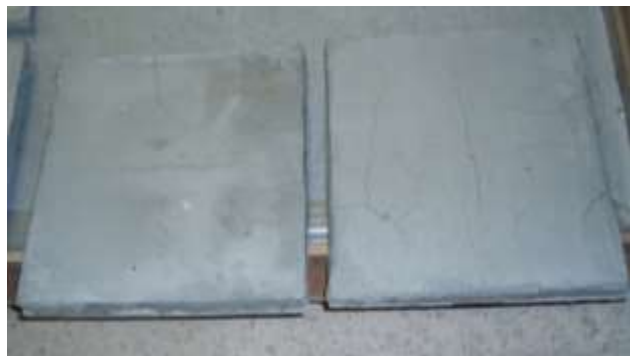
Figure 1 – Restrained shrinkage tests: a) Uniaxial test; b) Slab test

These methods [23,24,25] are based on the application of a mortar on a stiff substrate, such as a concrete slab, which simulates the wall that restrains shrinkage (Figure 1 b); the cracks formed are observed and several parameters are measured: time of opening of the first crack; pattern and area of cracking; number of cracks; maximum crack width, etc. These are the tests that better simulate the in-service conditions and they are easy to perform and do not need

complex equipment. They allow comparison between different materials, however, they are mainly qualitative, not permitting stress measurement.
