PARRACHA J.L., LIMA J., FREIRE M.T., FERREIRA M., FARIA P. Vernacular Earthen Buildings from Leiria, Portugal: Material characterization. *International Journal of Architectural Heritage*. Int. J. Architectural Heritage, <https://doi.org/10.1080/15583058.2019.1668986>

## **Vernacular Earthen Buildings from Leiria, Portugal - Material Characterization**

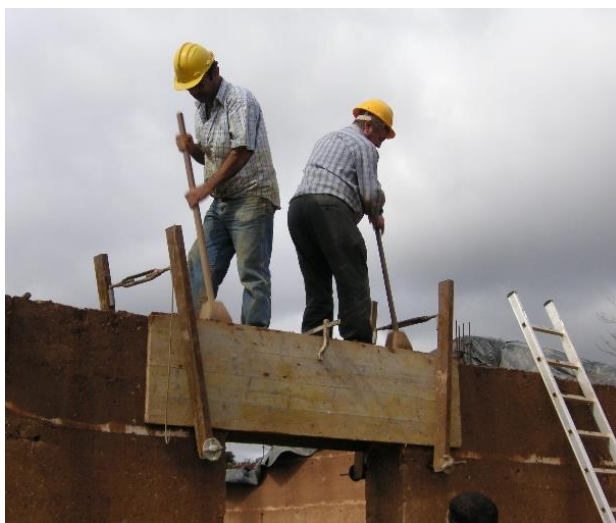
Figure 1 – Vernacular rammed earth formwork and manual compaction applied in a contemporary construction in Cercal, Alentejo, Portugal

complete filling, producing a rammed earth wall parcel or block. Afterwards, the formwork was immediately disassembled and assembled again to produce the adjacent rammed earth block - in the same wall level or in the upper level, if the lower level was complete. The joints between adjacent rammed earth blocks in the same level could be vertical or diagonal. Before starting to build the adjacent block, joint materials could be placed (although not essential), such as an air lime mortar layer or red ceramic or laminar stone pieces . This vernacular technique, with some occasional adaptations, is still used nowadays in Portugal (Figure 1).

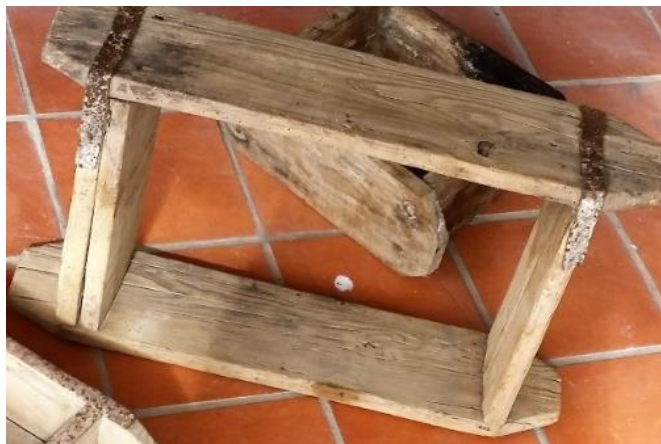
Figure 2. Wooden mold used for vernacular adobe production

For vernacular adobe production, traditional wooden molds (Figure 2) were filled with an earthen plastic mortar made with local earth, previously sieved to remove coarse stone particles. Leiria region is known for the production of pine wood. This wood was used for the production of both the adobe molds and the rammed earth formworks. The earth could be used either unstabilized or stabilized with the addition of air lime (if it had lack of clay), sand or plant fibres (if it was too clayey). The adobes were precast in advance, i.e., they were produced previously to the masonry construction to have time to dry. In comparison with rammed earth, a larger quantity of water was necessary to produce adobe and, later, the masonry layering mortar in order to build the adobe masonry wall. The masonry layering mortar could be similar to the adobe mortar

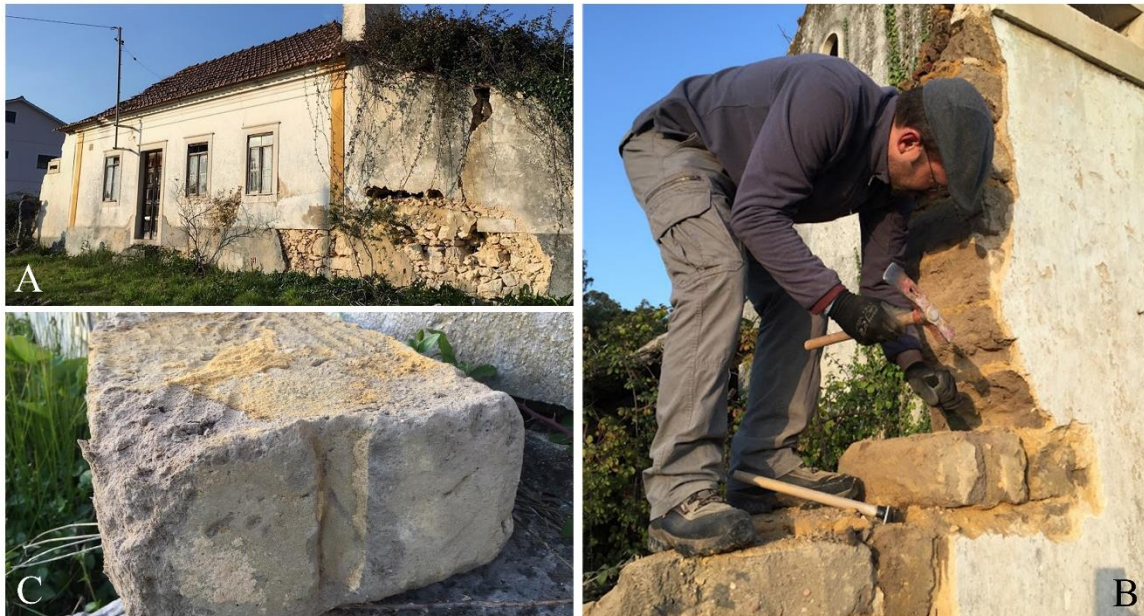
Figure 3. Adobe masonry dwelling from Leiria, Portugal (A); adobe samples being collected from a wall of the dwelling in A (B); detail of the adobe indentation (C)

- some construction specificities of these buildings, e.g. the existence of a vertical indentation in the adobe used for structural exterior walls (Figure 3);

The process of collection of the adobe samples is illustrated in Figure 3 as all adobes were collected from the buildings using a chisel and a hammer, trying to choose adobes that were protected and not directly exposed to weathering. With regards to rammed earth samples, a similar process was performed.

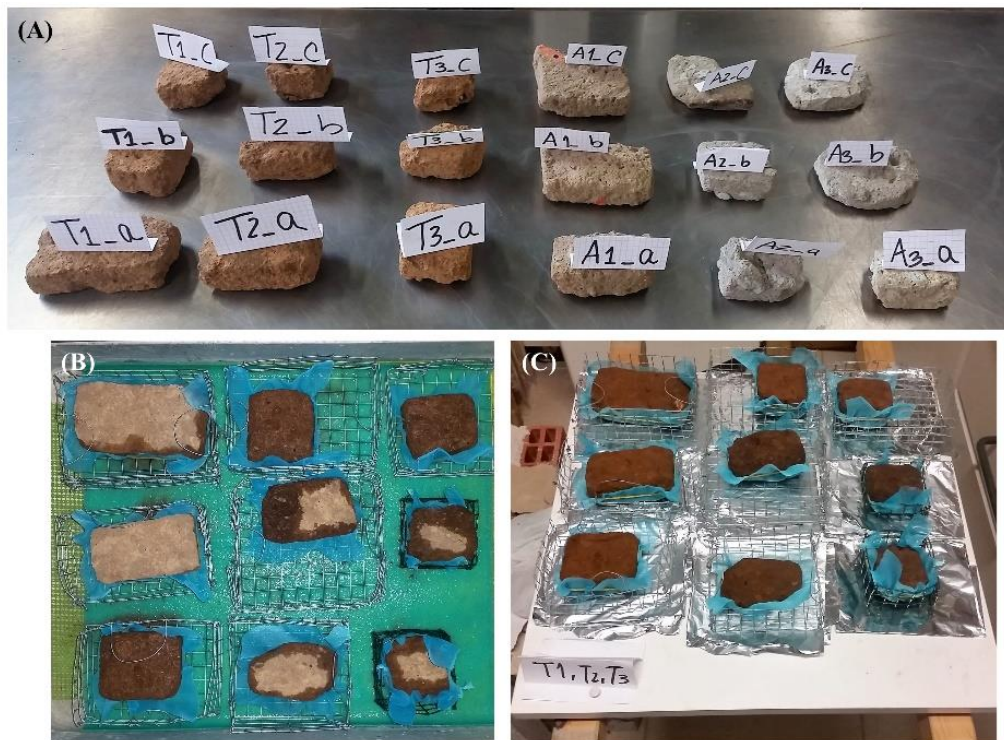
Figure 5. Samples of smaller dimensions (SSD) before the capillary absorption test (A); some samples during the capillarity test (B) and the drying test (C)

Capillary absorption and drying tests were conducted in a conditioned room (20±2°C and 65±5% RH) in samples that resulted from the cuts that have been made to produce the smaller samples for mechanical tests (Figure 5). Thus, the dimension of the samples was variable and CAD

After 48 hours of capillary absorption the samples were put to dry (Figure 5C) and weighted after determined periods of time. EN 16322 (2013) standard refers two distinct drying phases: DR1 – the first drying phase, calculated by the negative slope of the initial linear section of the drying curve plotted with time in abscissa; and DR2 – the second drying phase, calculated by the negative slope of the linear section of the drying curve plotted against the square root of time in abscissa.
