# Comparison of theoretical heat transfer model with results from experimental monitoring installed in a refurbishment with ventilated facade

**Belén Zurro García<sup>1</sup>, Beñat Arregi Goikolea<sup>2</sup>, José Manuel González Martín<sup>1</sup>, José L. Hernández García<sup>3</sup>**

**Abstract.** One of the main points to consider when a building is renovated is the improvement of its energy efficiency, minimizing the heat loss through the enclosures and its heating consumption. Under this scope idea a ventilated facade was designed and incorporated in an educational building located in the city of Burgos (Spain). The main objective of this document is a comparison between the theoretical model of heat transfer across the building envelope separating the environment and the interior space, and the heat intake through a linear regression model with installed experimental monitoring. For this it has been necessary to carry out an exhaustive study of the thermal transmission of each one of the materials that make up the thermal envelope of the building, as well as the linear thermal bridges that can be produced before and after the renovation. In addition, thanks to the monit

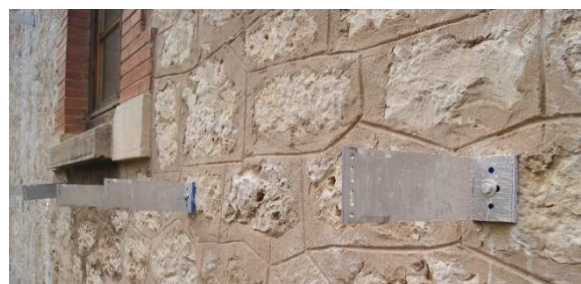
The renovation works of the building began with the redefinition of the facade, marking the position of the five rows of anchors to be placed on the external surface. Subsequently, and in the delimited position, the necessary L-shaped brackets were placed to support the vertical profiles.

**Figure 1.** Metal brackets for fixing vertical profiles.

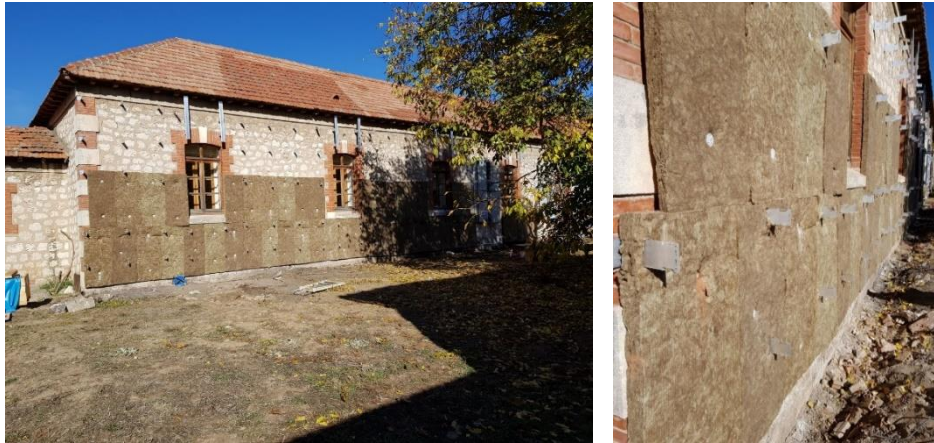
Thermal insulation was installed on the outside, consisting of two layers of mineral wool with thickness of 7,5 cm, making a total of 15 cm. These layers were fixed to the wall mechanically using fasteners.

**Figure 2.** Installation of thermal insulation.

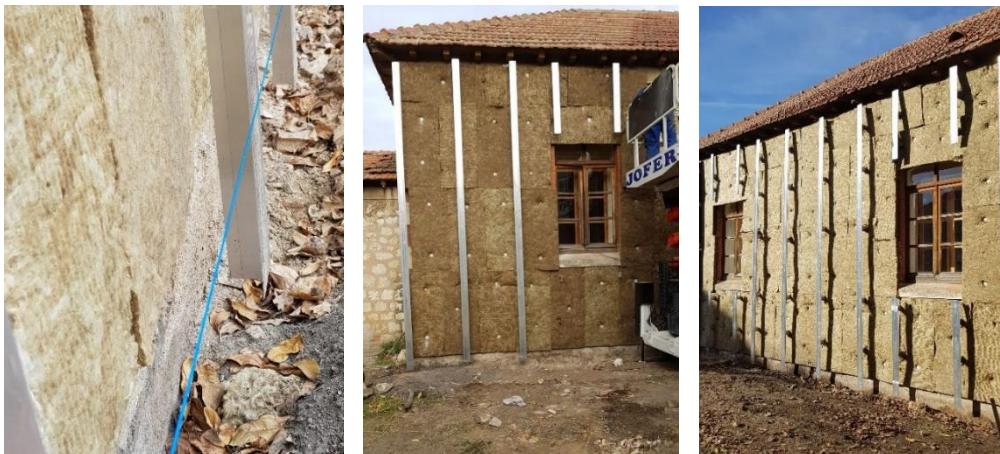
The next step in the execution of the renovation was the placement and plumb of the vertical profiles. These profiles were fixed to the previously installed brackets, firstly through their dovetail and later with screws.

**Figure 3.** Placement and plumb of the vertical profiles.

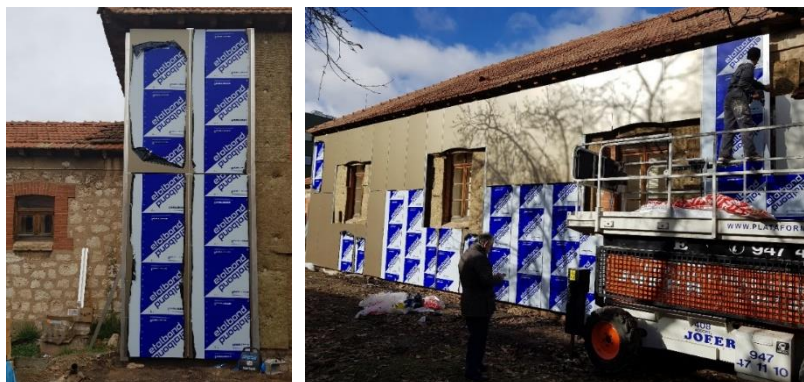
Finally, the final cladding of the façade, consisting of aluminum composite panels, was placed. Horizontal and vertical gaps with a width of 15 mm joint were left between the panels.

**Figure 4.** Final cladding placement.

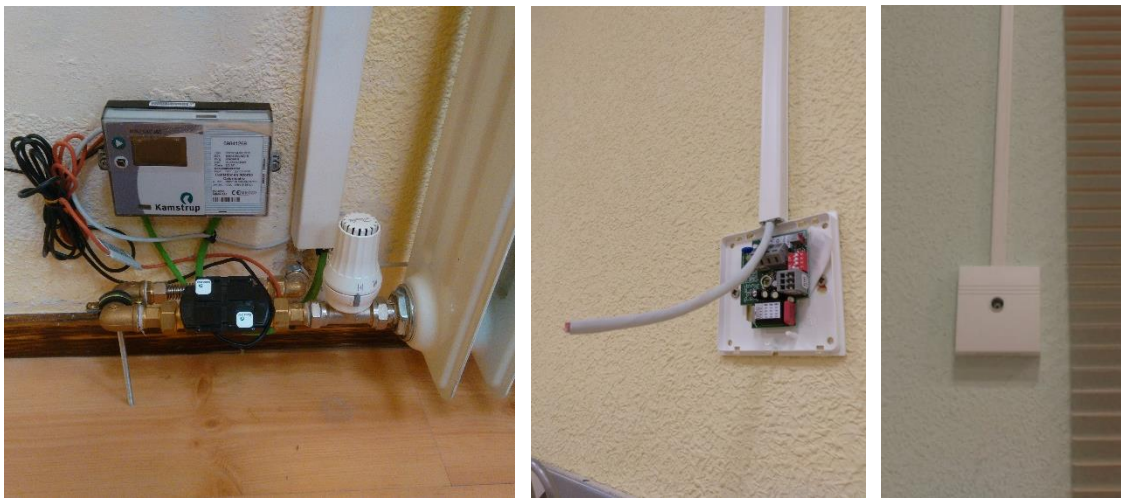
As mentioned, as part of the project, an advanced monitoring system was also installed, with multifunctional systems that monitor the environmental conditions both inside and outside. Among the data obtained are indoor and outdoor temperatures, relative humidity and CO<sub>2</sub> content [13], among others. The first of these is the most relevant for this study.

In addition, flow meters were also placed in the boilers for the control and regulation of the heating and the set point temperature.

**Figure 5.** Installed monitoring devices.

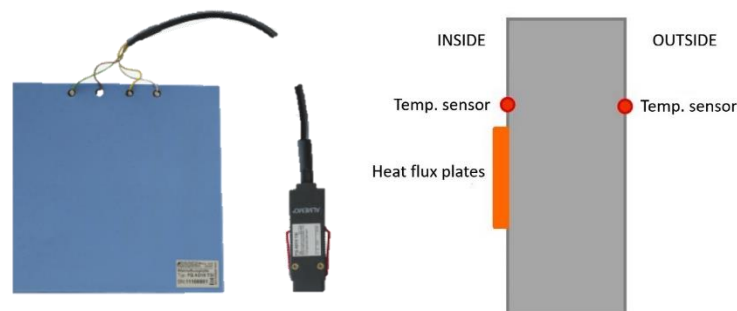
To complete the monitoring installed under the E2Vent project, for the realization of this analysis, a series of sensors has been installed on the north facade of the building, both in the renovated part and in the part that maintains the original state of the walls. Four temperature sensors have been placed, two on the inside of the wall and two on the outside, aligned with the previous ones. In addition, and considering that the purpose of this analysis is to check the heat flow in the enclosure, two heat flow meters are placed inside the classrooms.

**Figure 6.** Heat flow meter and position of the sensors.

The measuring devices have been placed on flat surfaces and away from encounters with other enclosures, that is, in areas where the values obtained are not affected by linear or point thermal bridges, following the indications of ISO 9869-1:2014 [6].

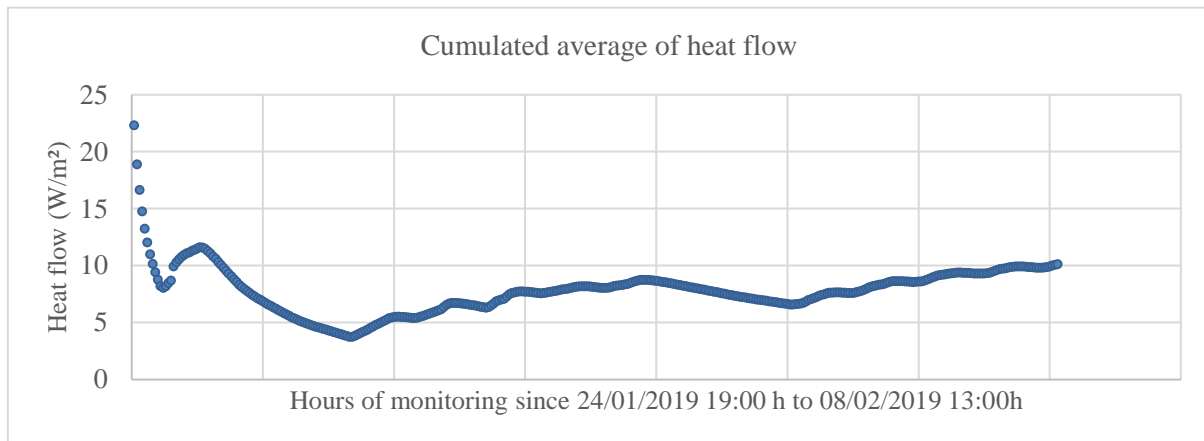
Once the data obtained from the sensors have been stored and studied, the hourly values of temperature ( $^{\circ}\text{C}$ ) and heat flow ( $\text{W}/\text{m}^2$ ) have been extracted and their cumulative average has been calculated. In such a way that the value of the average heat flow of the days in which the monitoring has taken place (from January 24 to February 8, 2019) has been obtained.

**Figure 7.** Cumulated average of heat flow.

On the other hand, from the data obtained after two weeks of monitoring, the resulting heat transfer coefficient in that same enclosure is  $192.6 \text{ W}/\text{K}$ .

As explained in the previous section, monitoring has also been carried out in the wall where no intervention was made in the E2Vent project, that is, the one that maintains its original state. Performing the same analysis as in the previous case, a heat transfer coefficient of  $268.1 \text{ W}/\text{K}$  is obtained.
