Phase II of tidal Marsh Restoration at Steedman Woods Reserve at York, Maine

Phase II of Tidal Marsh Restoration at Steedman Woods Reserve at York, Maine

Final report to:
Museums of Old York
207 York Street,
York, Maine

December 30, 2013

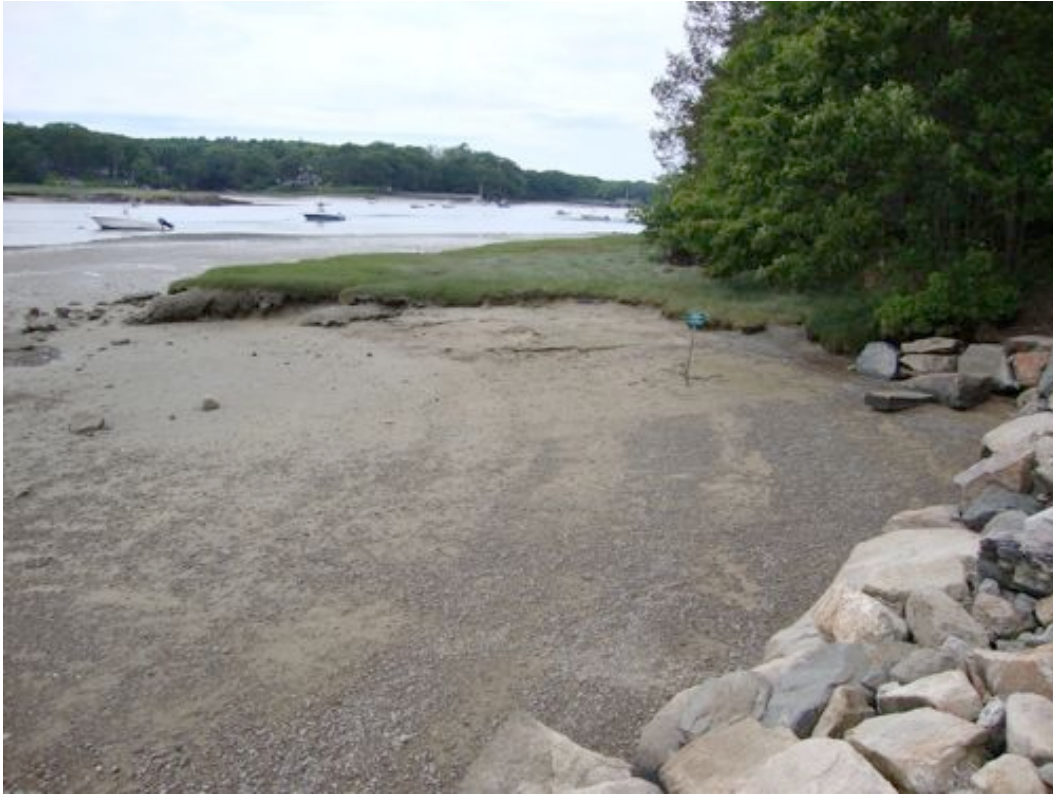
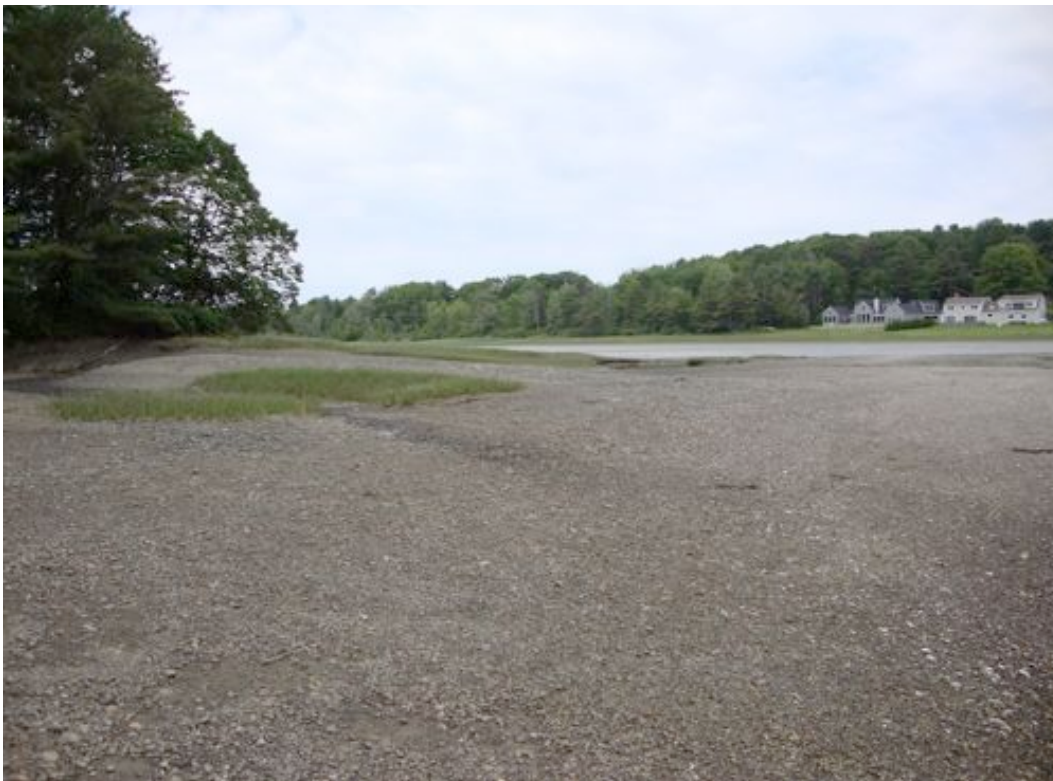
Figure 1. Eroded areas on the southern side of the Wiggley Bridge (top) and the northern side (bottom), before restoration.

South of the Wiggley Bridge (York River side) is a small tidally influenced area of shoreline, which is mostly devoid of marsh peat and contains no living vascular plants (Figure 1). Erosion from the York River is clearly evident, likely from daily boat traffic and storms. What little peat is found here is the remnant of marsh that has been eroded away. The sediments consist mainly of inorganic, sandy to gravelly areas that are wetter at lower elevations and steadily dry out up gradient. The salinity of the floodwaters is near seawater concentration, around 30 ppt.

North of the Bridge (Barrell Pond side), the area is comprised mostly of barren inorganic sediments with small islands of marsh and unvegetated pools (Figure 1). The sediments of the barren areas vary from silt to cobble (Figure 2). The sediment surface is also littered with common periwinkles and their shells. Very little organic matter is found here except in the marsh areas and at the higher elevations where terrestrial soil has been eroded down slope. Islands of existing marsh growing on thin peat deposits are mostly populated by stunted smooth cordgrass (*Spartina alterniflora*), with macroalgae mixed in. Although no motorboat traffic occurs on the Pond side, a strong current flowing under the bridge appears to contribute to erosion. Similar to the river side, the salinity of the floodwaters is also around 30 ppt.

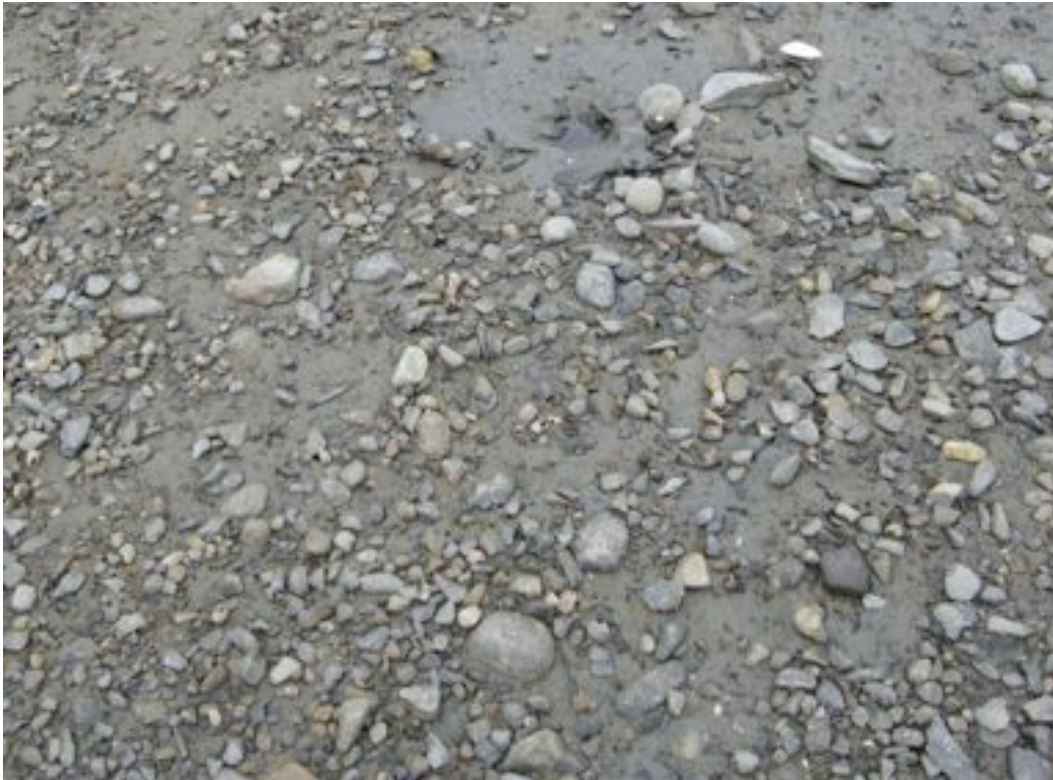
Figure 2. Silt to cobble substrate found in the northern area (Barrell Pond).

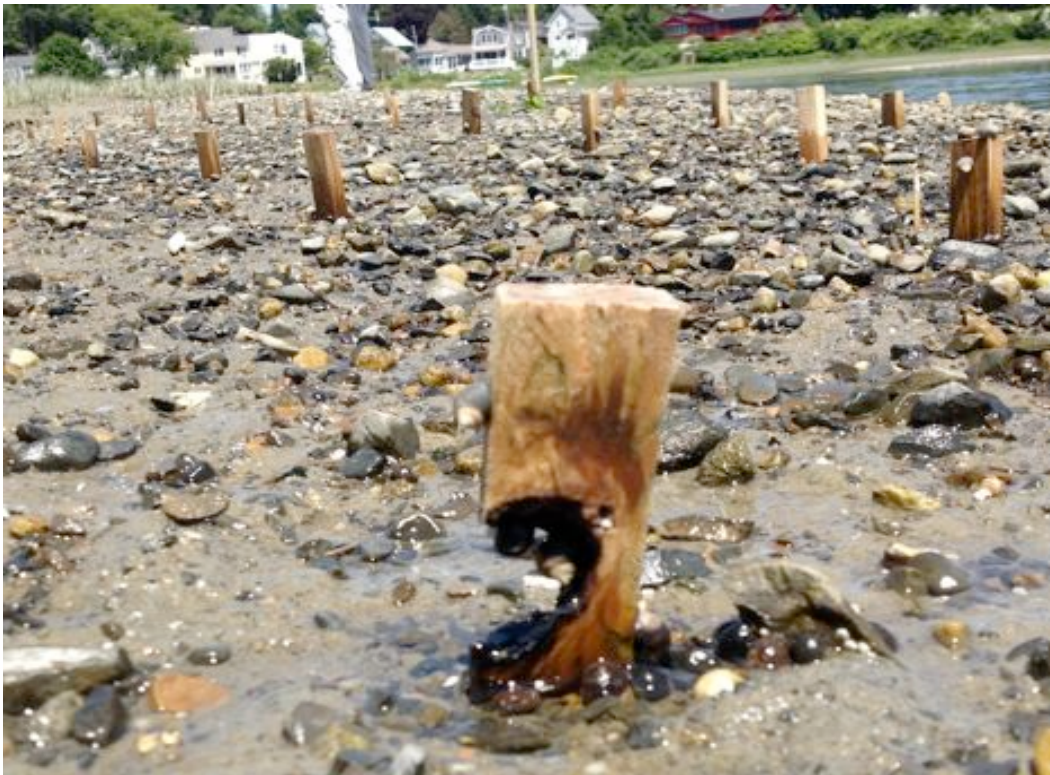
Figure 3. Wooden stakes used at restoration areas to protect plants.

In 2013, UNH scientists installed erosion control structures and transplanted halophytic species. Several rows of wooden stakes (1 by 1 inch) were pounded into the sediment across the entire area where marsh is desired. These 18-inch stakes were left protruding 2-4 inches above the soil surface (Figure 3). Stakes protect plants by reducing foot traffic, wave energy and erosion as

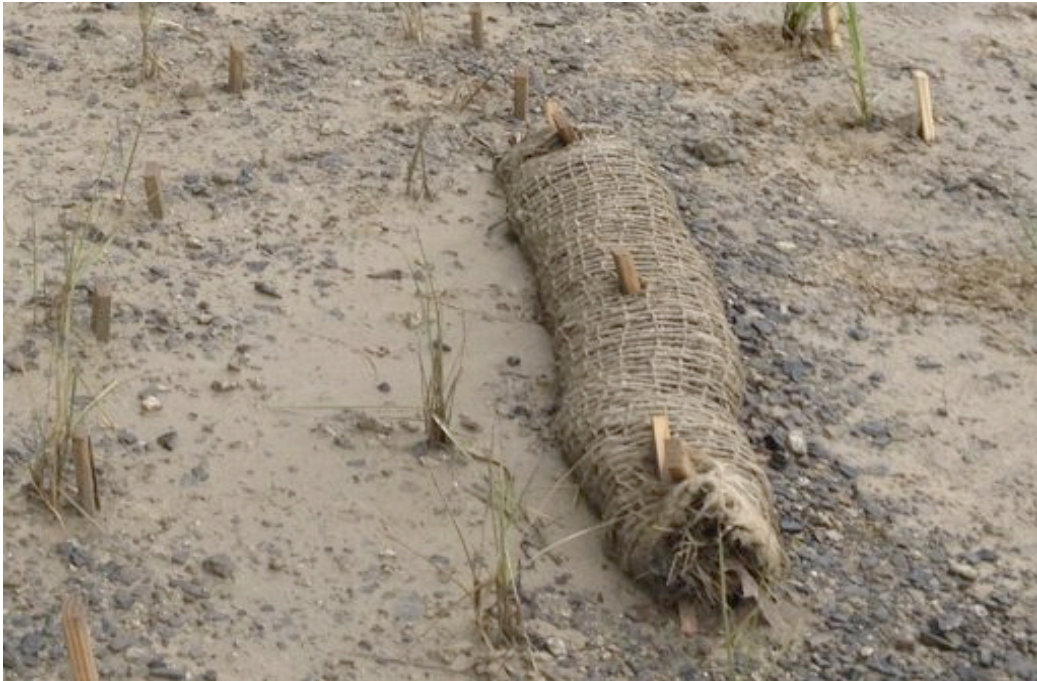
Figure 4. Wave baffle installed to reduce wave energy and erosion. Sand shoreward (left side) and lag deposit of pebbles (right side) of wave baffles.

well as preventing damage from sheet ice in the winter. In addition to stakes, wave baffles were constructed and deployed (Figure 4). The baffles were constructed of sheets of biodegradable fabric (jute), 4 feet wide, wrapped around wrack that washed up on the Barrell Pond shoreline. These baffles were then staked to the shore in rows. A total of 43 baffles were installed in 4 rows parallel to the shoreline. Lastly, a variety of boulders were moved from the lower intertidal zone and dug into the outer edge and within the planting area. The boulders protect the shoreline from waves caused from boating traffic and storms as well as ice floes in winter (Figure 5).

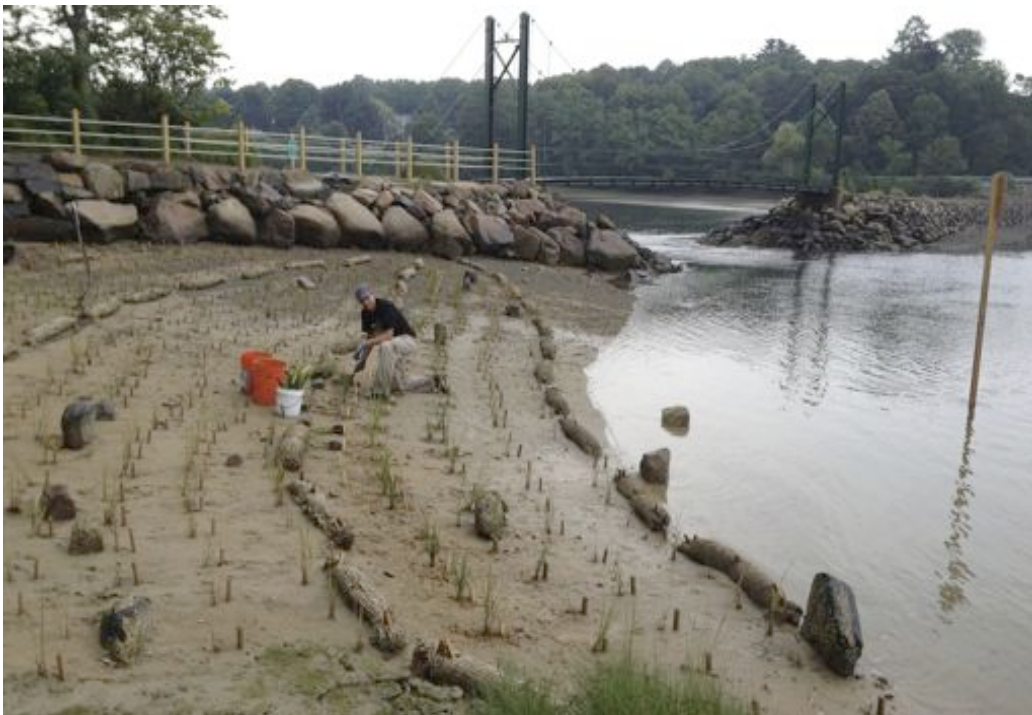
Figure 5. River planting site with biodegradable wave baffles and boulders.

The focus of Phase II was the south side of the point at Steedman Woods along the York River. In 2013, 905 planting units were installed behind approximately 700 stakes and 43 wave baffles. The wave baffles reduce wave energy and also help stabilize the site by catching sediment being eroded into the River. Observations of sediment erosion and movement toward the River seemed greatest following rainstorms that produced small eroding gullies (Figure 8). Significant amounts of sediment collected on the landward side of the wave baffles through the summer (Figure 4). To add another layer of protection from erosive forces, 14 boulders were moved up to the planted area of the shoreline where they help break up waves and currents (Figure 5).

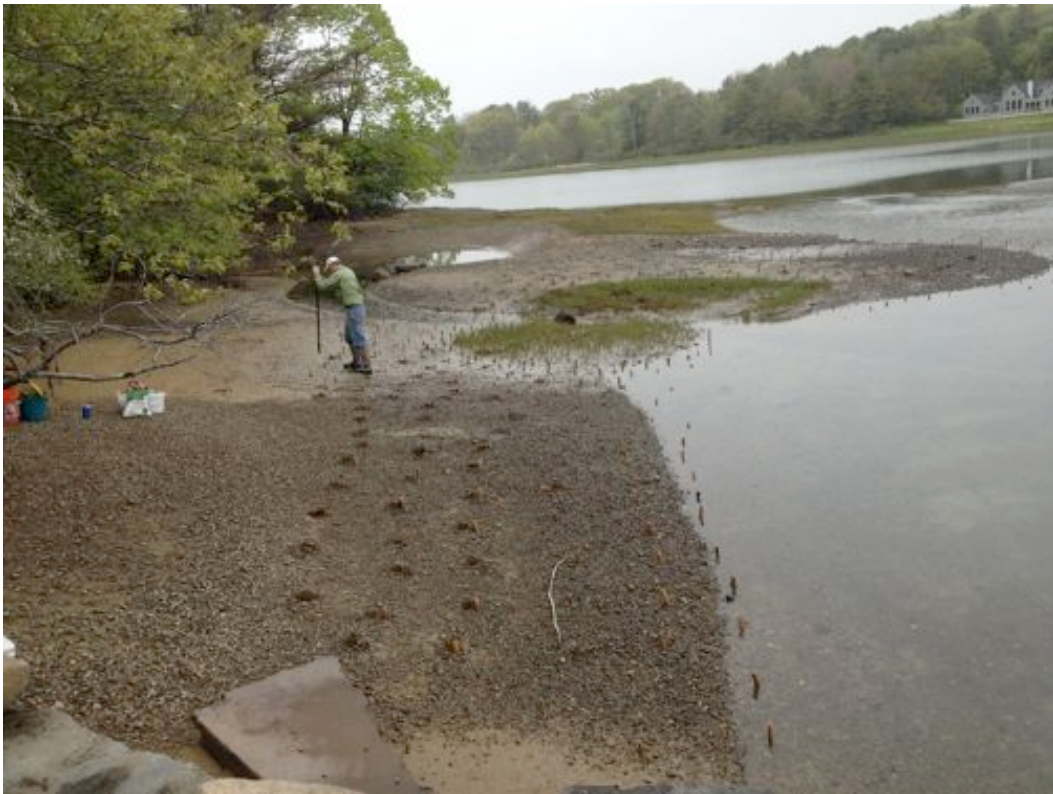
Figure 6. *Barrell Pond planting site with over 1200 stakes and 1100 plants.*

In 2012, the Barrell Pond side of the point was marked with signs landward and seaward, requesting people keep out of the restoration area. A substantial rope fence was erected along the trail from uplands to the Wiggley Bridge, further directing the public to stay on the trail and not use the shoreline. In addition to reducing human disturbance, over 1200 stakes and 790 salt marsh plants were installed over an area of 10,000 square feet, from the mean tide line up to and slightly over the mean high tide line (Figure 6). Due to the limited area above mean high tide, which was substantially shaded from overhanging trees, over 95% of the transplants utilized were smooth cordgrass. These were planted as bare root plugs landward (behind) wooden stakes. In the fall, 28 alkali grass plants growing in 3-inch diameter peat pots were planted behind wooden stakes at the upper edge of the site, but where shading was less prevalent.

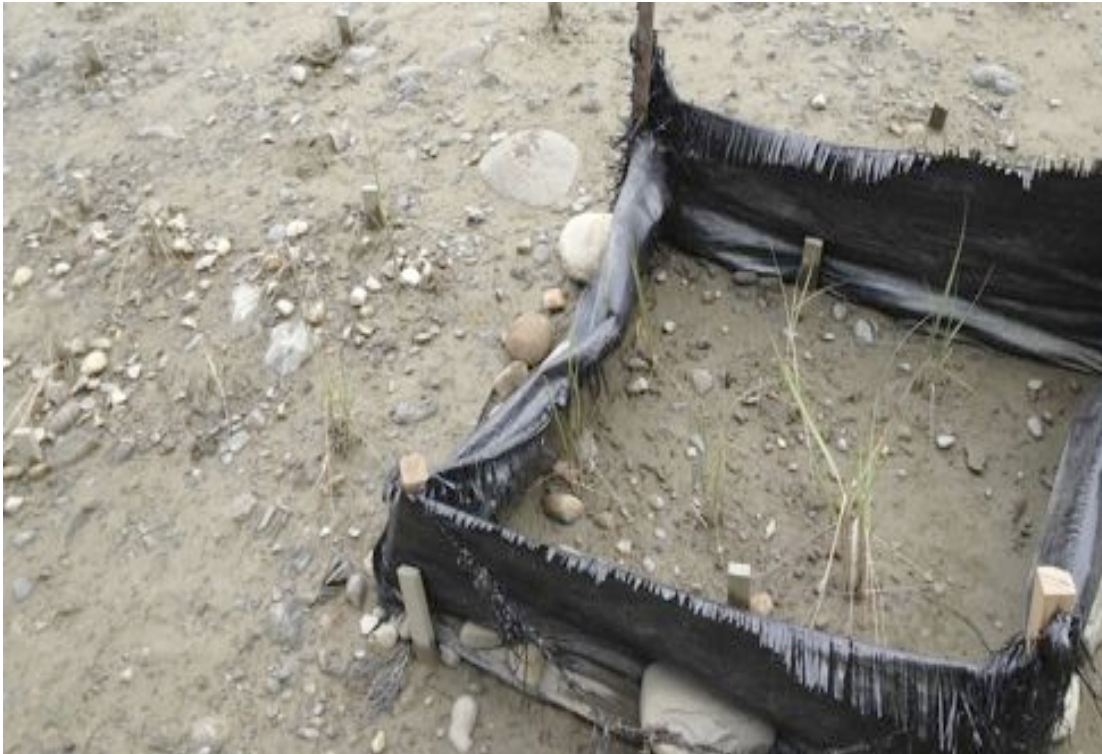
Figure 7. Periwinkle enclosure experiment showing 6 plugs of cordgrass planted inside and outside the sediment fencing. Snails were periodically monitored and removed from the enclosures.

On the Barrell Pond side of the bridge, smooth cordgrass plugs were planted within exclosures to determine if periwinkles were affecting the survival of grass transplants through grazing. Three exclosures, approximately 2 feet in height, were built with water permeable silt fencing to cover a 1 m² area in late June 2013. The design of the exclosures also protected the plants from wave and current exposure, so the impacts of snails could only be distinguished from exposure impacts through direct observation. Six smooth cordgrass plugs were transplanted in each exclosure and also adjacent to them as a control (Figure 7). Since there were 3 exclosures and paired controls, 36 total plugs were utilized for this experiment. Plants were evenly spaced (~12 inches) so that

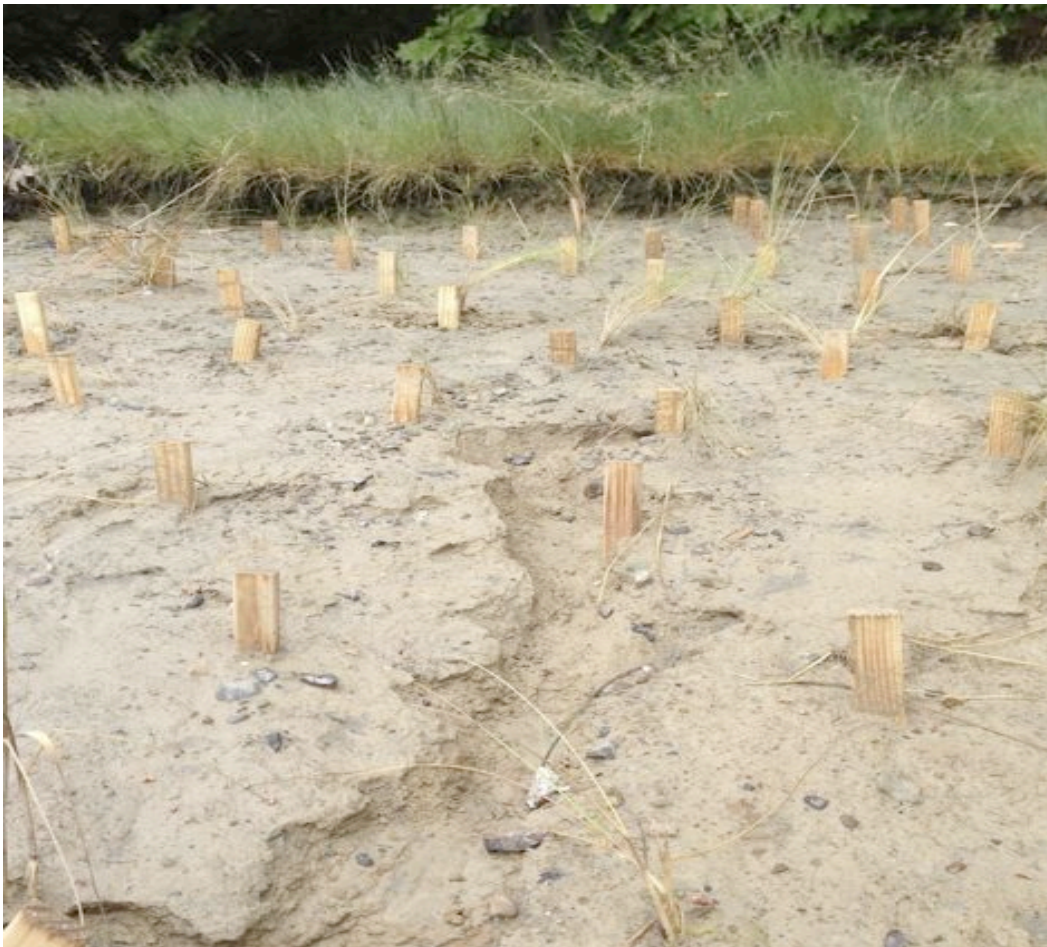
Figure 8. River planting site with erosion gully (center).

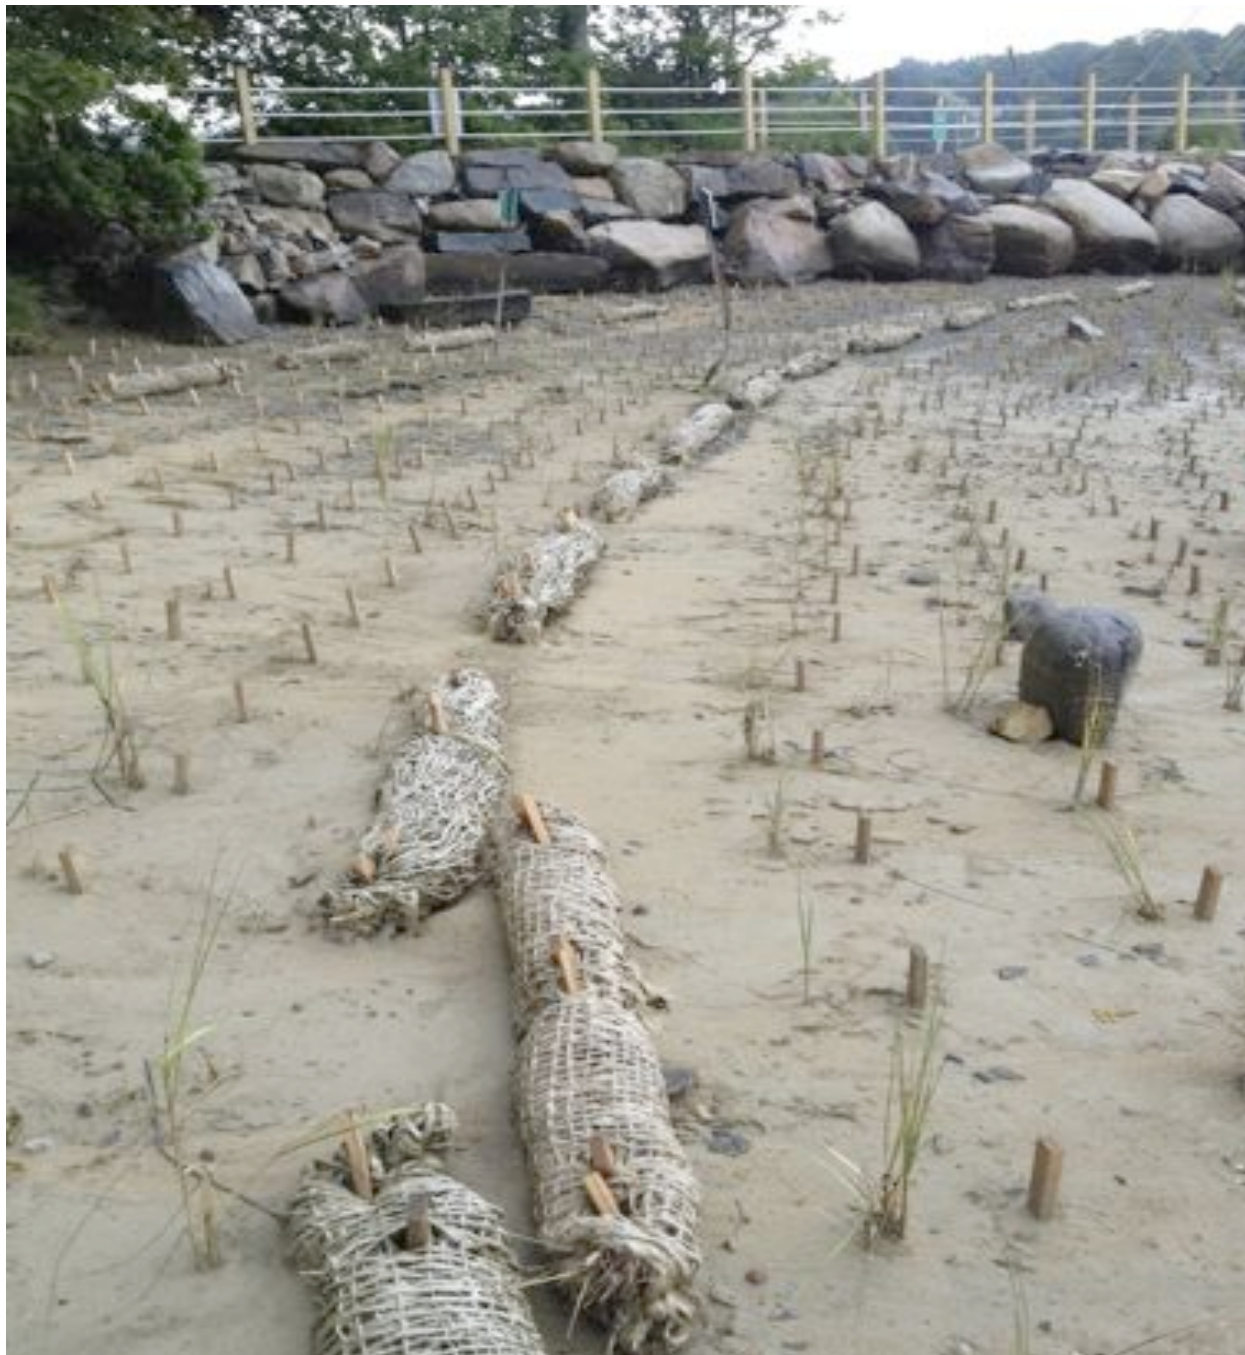
Figure 9. Plantings of smooth cordgrass on York River shoreline in July, 2013.

Of the 905 plants added to the site, 192 were alkali grass, 103 were salt hay and 610 were cordgrass. Casual observations showed few snails and very good survival through July (Figure 9).

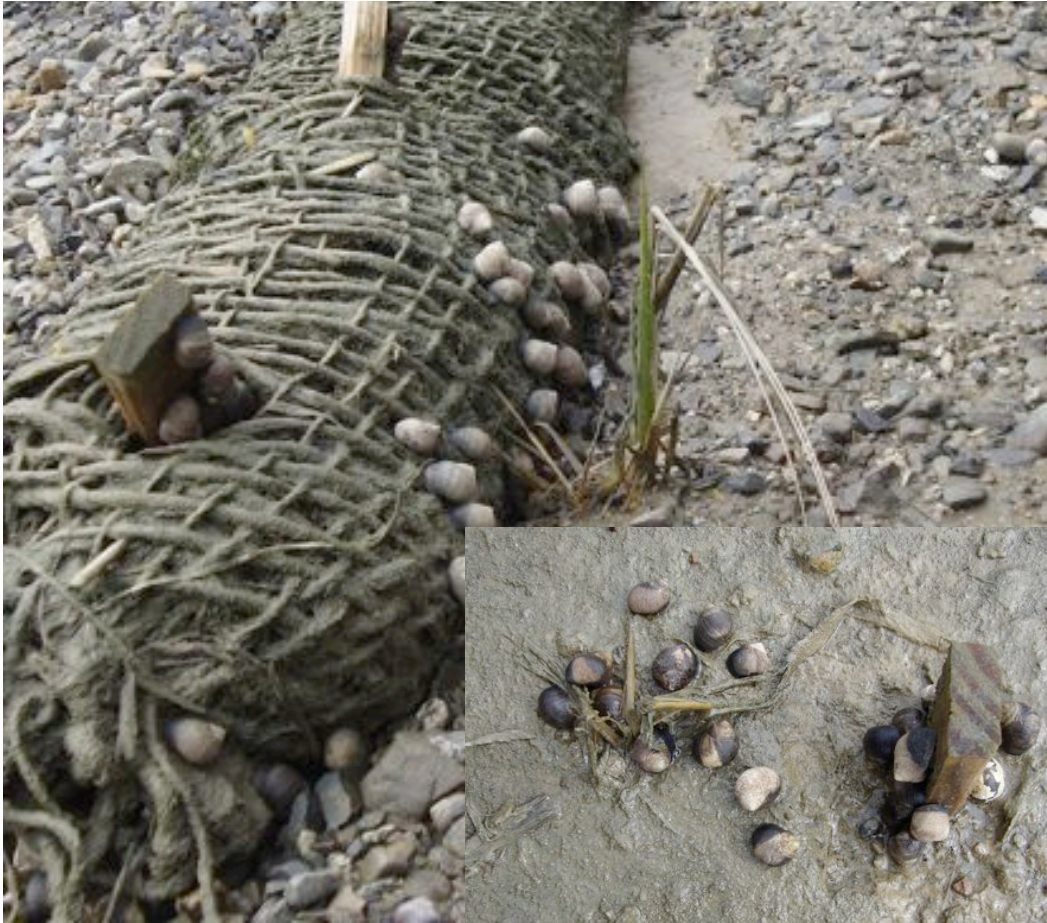
Over 500 snails were removed from the site when it was assessed in September; perhaps snail activity increased in late August and depressed plant survival rates. Figure 10 shows snails at the site and the inset shows the snails surrounding a grazed plant (classified as non-living). While we remain cautiously optimistic for the success of this site, common periwinkles seem to be a real threat (see discussion below) and snail populations will need to be controlled. Snails should be collected and removed from this site beginning in mid April until the threat from snail grazing is passed (early June), and then again in late August through September when snail populations rebound.

Figure 10. Snails return to planting sites in September and damage cordgrass shoots.

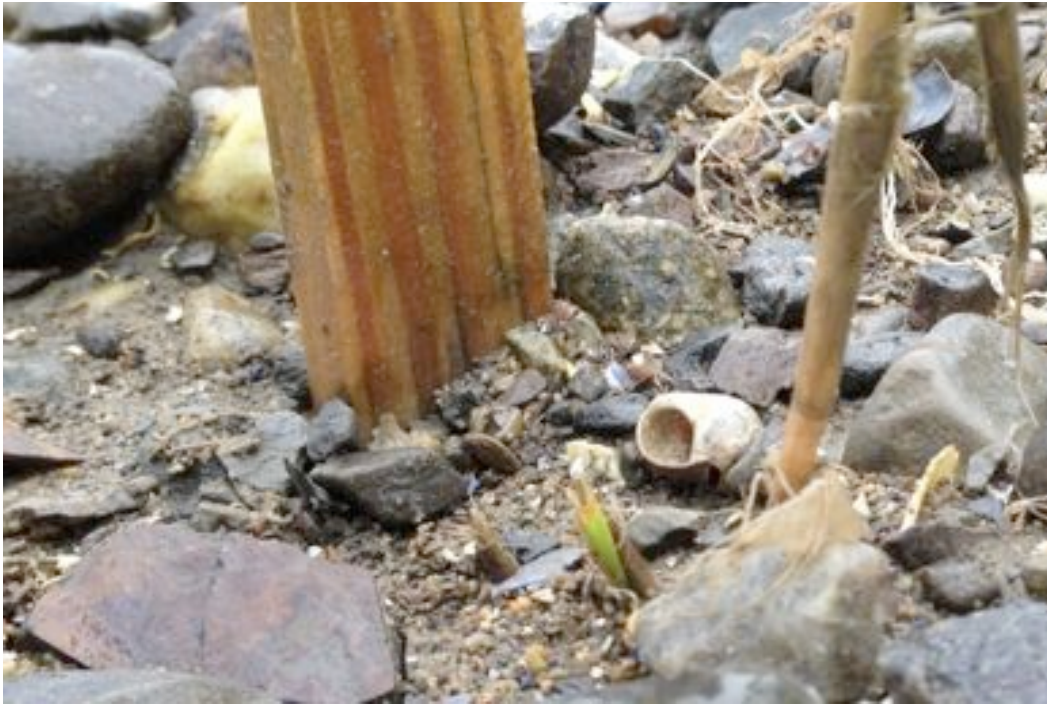
Almost 800 plants, the majority being cordgrass, were planted at this site in 2012 (Table 1). Very few of the cordgrass planted in 2012 survived. However, some green shoots did emerge from the 2012 plants, but most appeared to be grazed soon after emergence and did not last long into 2013 (Figure 11). Despite the presence of snails, some plants from 2012 did survive and grow along the upper elevations and adjacent to one of the intertidal pools (Figure 12).

Figure 11. Cordgrass emerging from 2012 planting unit in May, 2013. Note top of new shoot is already grazed.

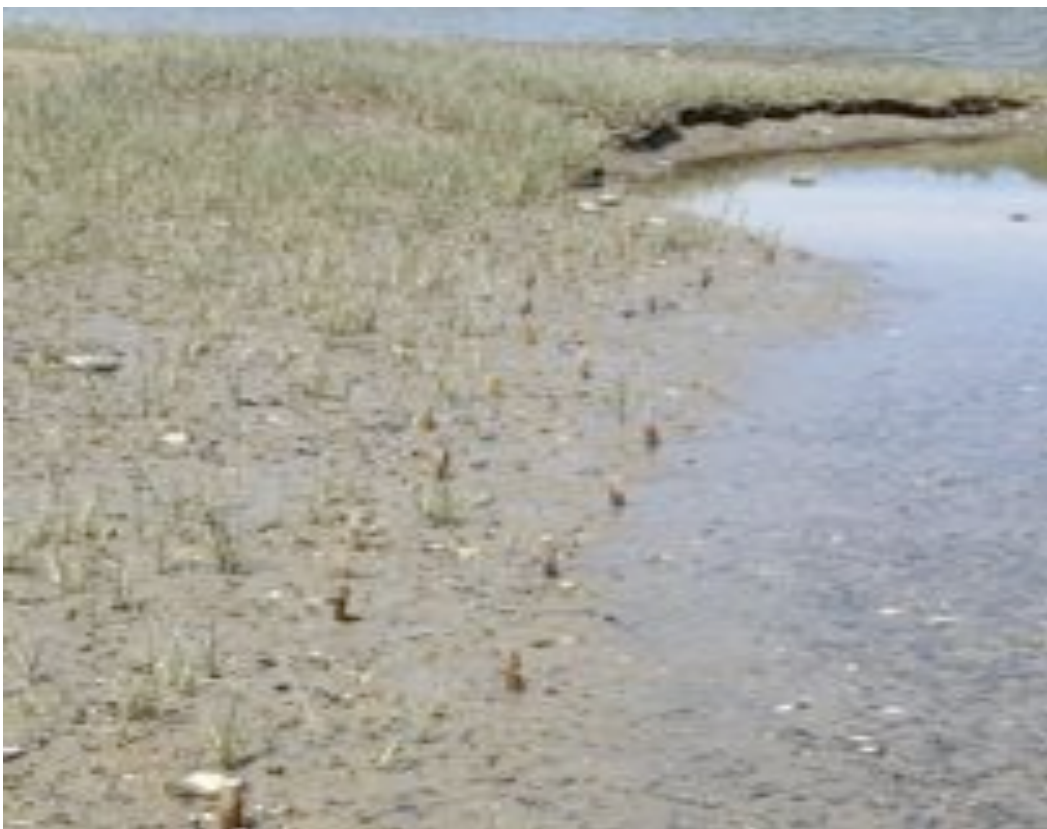
Figure 12. Cordgrass growing in summer 2013 among stakes established in 2012.

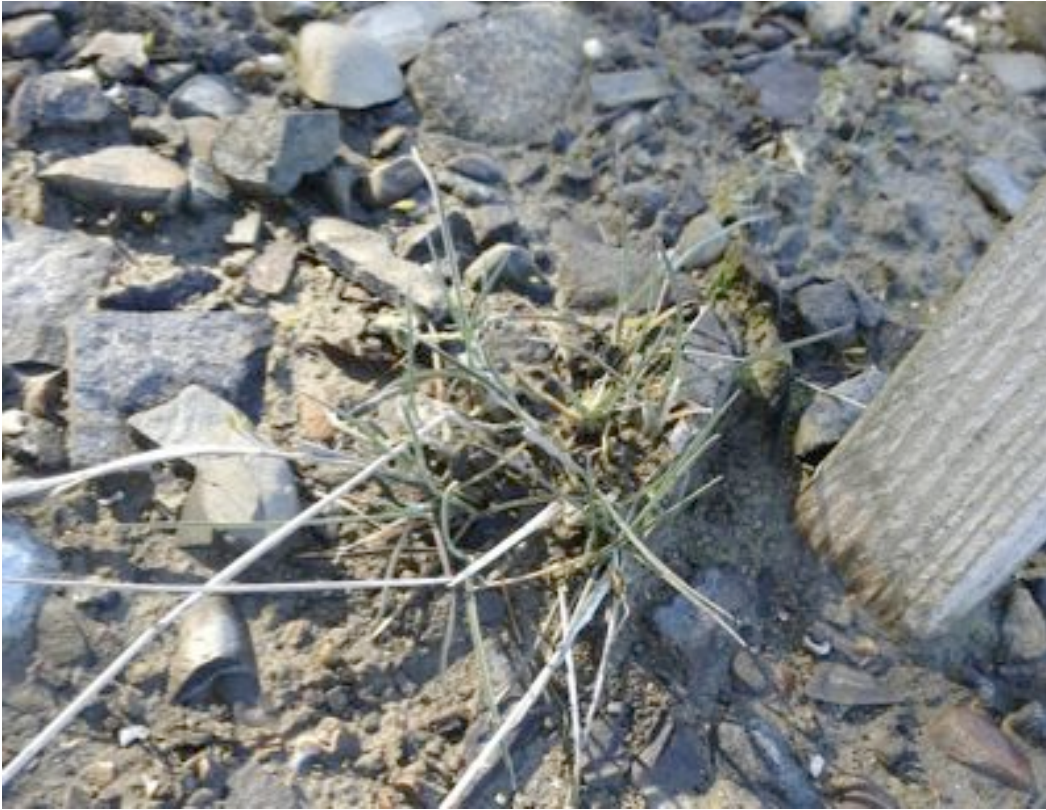
Figure 13. Alkali grass greening up in early spring. Photo taken April 24, 2013.

In May of 2013, over 200 alkali grass plants were added to upper elevations since many of the alkali grass planted in the fall survived the winter (79%; Figure 13). In addition, 225 smooth cordgrass plugs were planted in May 2013, generally at upper elevations of the planting site (Table 1). In all, a total of 1248 units were planted at this site (not counting the two experiments, which sum to an additional 50 planting units).

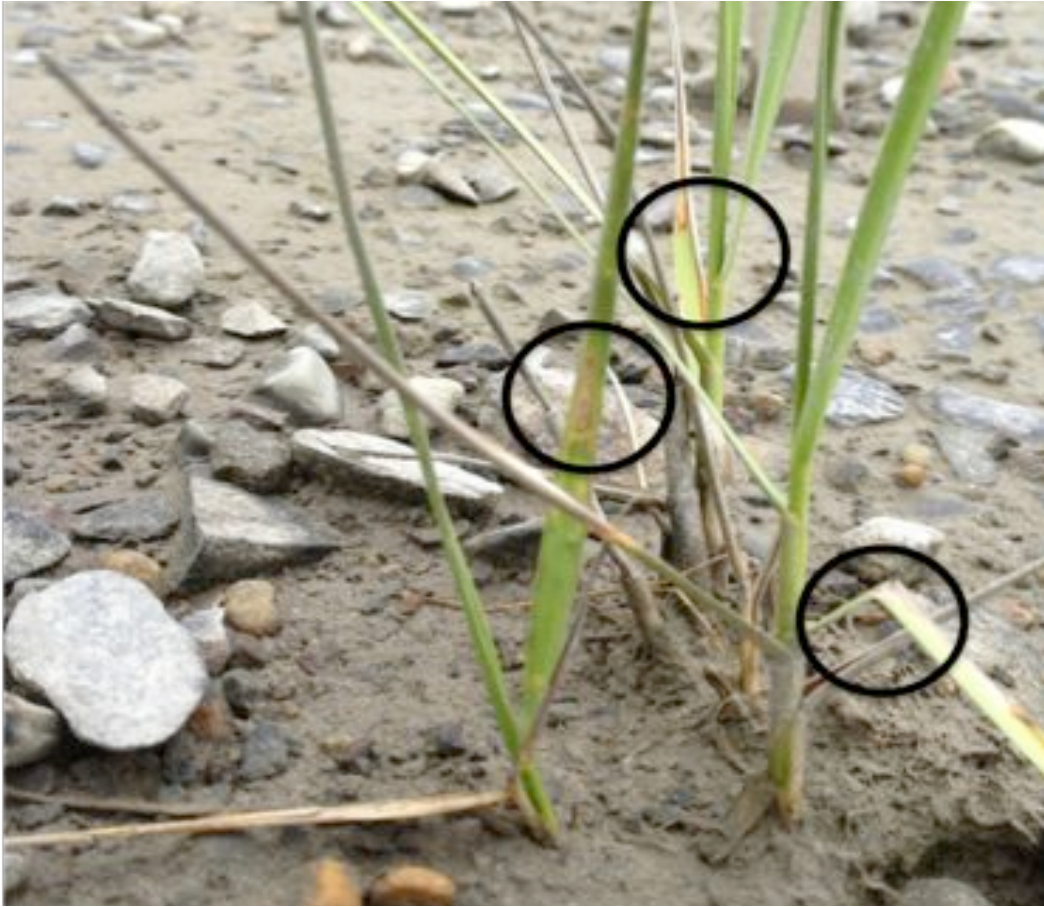
Figure 14. Visible signs of grazing are marked with circles and include lesions, dead leaf tips and cracked leaves.

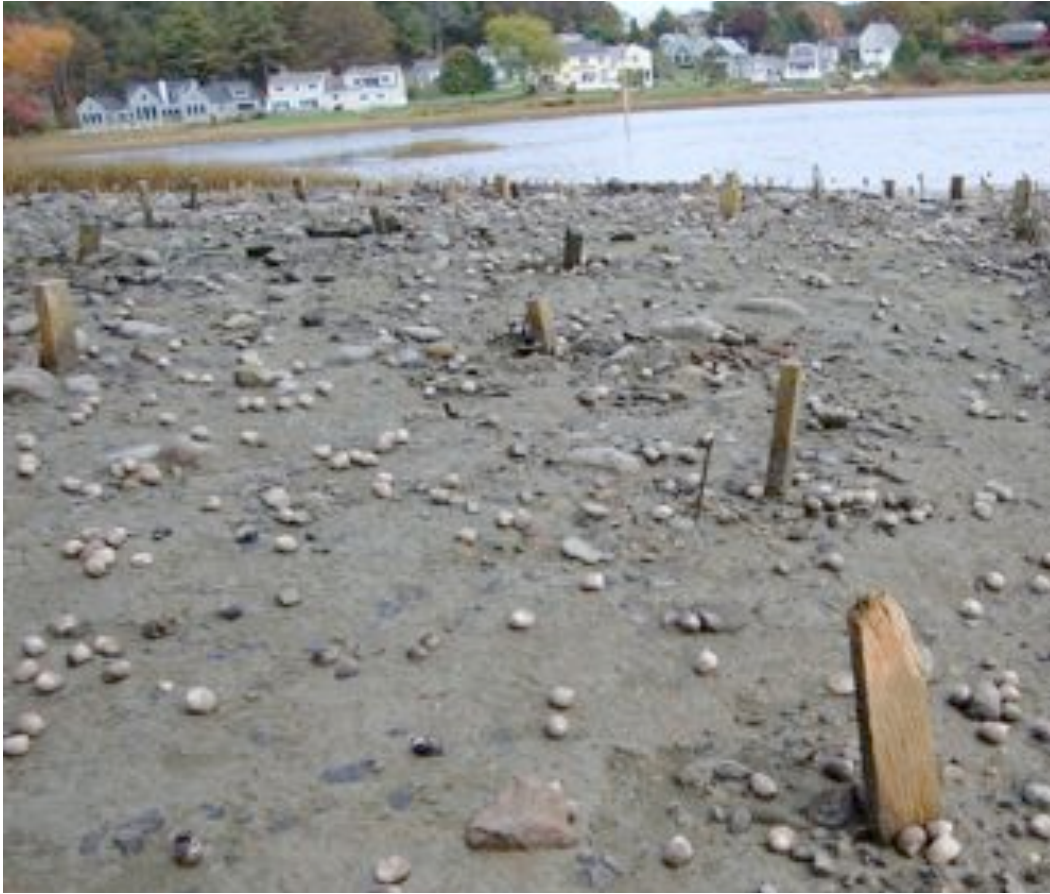
In response to the snail threat, over 14,000 of the common periwinkles were removed from the site between late May and early June. However, the snails appear to be replaced in a matter of days by an endless source of more snails. Volunteers removed more snails later in June and July, and at this point in the season the snail populations subsided, perhaps due to desiccation stress during hot summer days. Snails returned at high densities in September, as the weather cooled (Figure 16).

Figure 16. Snails have returned to planting site in Barrell Pond in fall, 2013.

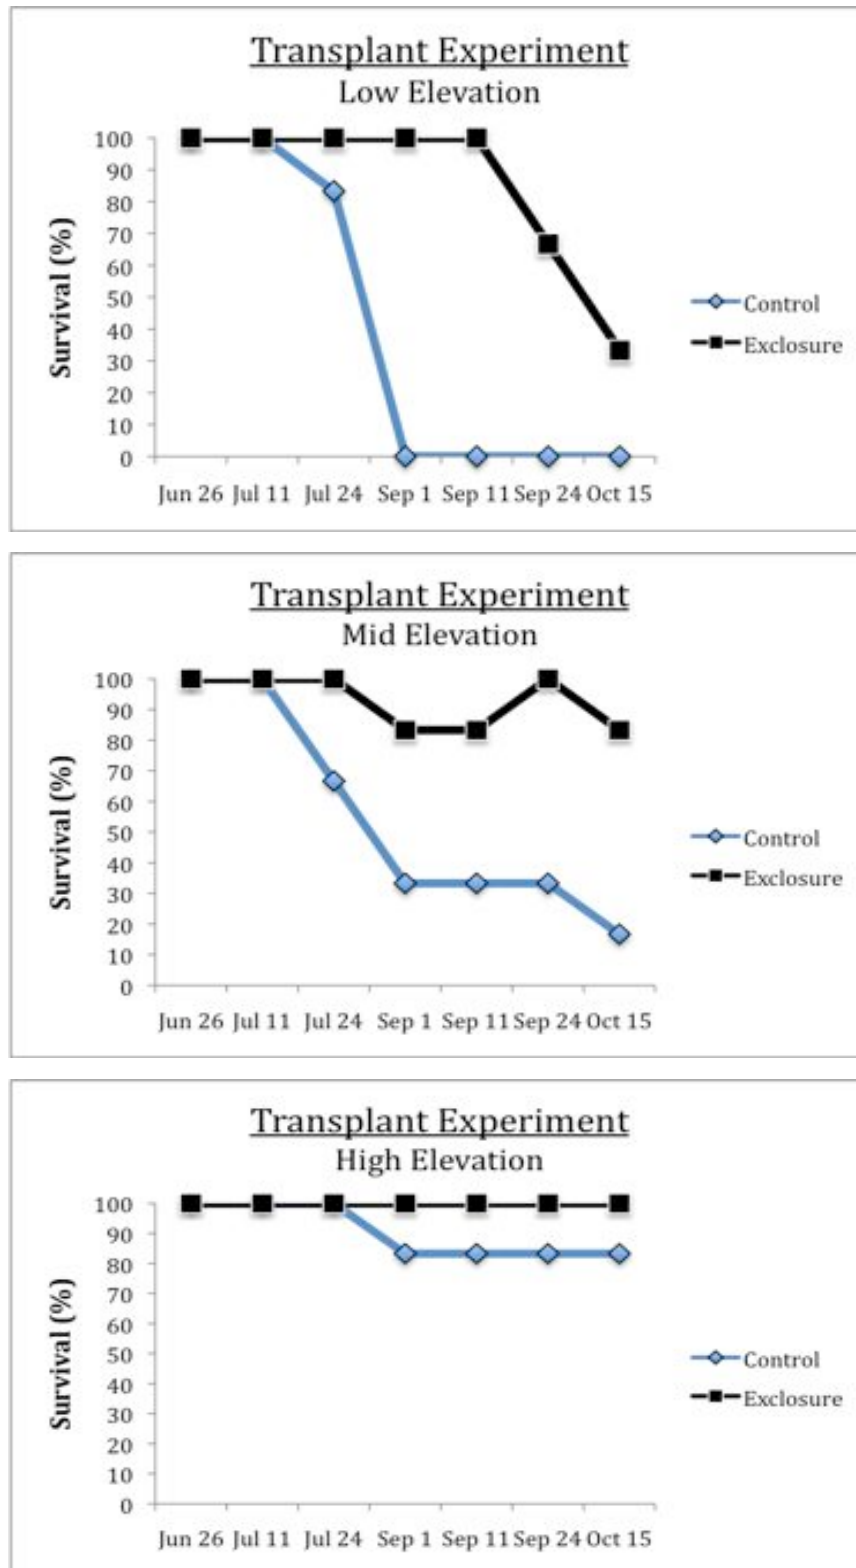
In June, an enclosure experiment was set up to test whether protecting plants by sediment fencing might help protect the plants from snails and physical exposure to waves and currents. Cordgrass plugs were planted within three enclosures and directly outside each enclosure for comparison (36 plants total). Enclosures kept out most snails through July, with about 10 snails distributed within the three enclosures on each of three return visits. In late July, we observed that all 18 plants were alive (15 were growing vigorously) within enclosures, but the outside control plots had three dead plants (Figure 17), with few appearing to be healthy. On our next visit on September 1st, snail densities had increased dramatically, and about 100 snails were found within each of the two lower elevation enclosures. By September, it was clear that plants at the highest elevation plot experienced less snail pressure. There were no snails found and all plants were alive in the enclosure, while five plants were still alive in the control. In comparison, 11 of the 12 plants were alive in the two lower enclosures, but only 2 of 12 plants survived outside the enclosures (Figure 17).

Figure 17. Survival of cordgrass planted June 26th within snail exclosures and adjacent to them (controls) at three elevations. Each plot was planted with six plugs of cordgrass.

An examination of the common periwinkle, *Littorina litorea*, along a rocky New England shoreline containing small sections of cordgrass-dominated salt marsh was carried out 30 years ago. The snail, considered exotic, grazed plant stems and rhizomes (new shoots), thereby limiting marsh expansion where snails were not removed (Bertness 1984). More recently, a team of researchers in Wells, Maine reexamined the role of the introduced snail (Tyrrell et al. 2008). They found *L. littorea* reduced biomass of cordgrass growing in stressful conditions but not in a marsh where physical conditions were benign. The difference was similar to the differences between the work of Silliman and Zieman (2001) and Kiehn and Morris (2009) and was in accord with our results on Barrell Pond: low-density marshes were more susceptible to damage from snails, especially at lower elevations (Figures 17 and 18).

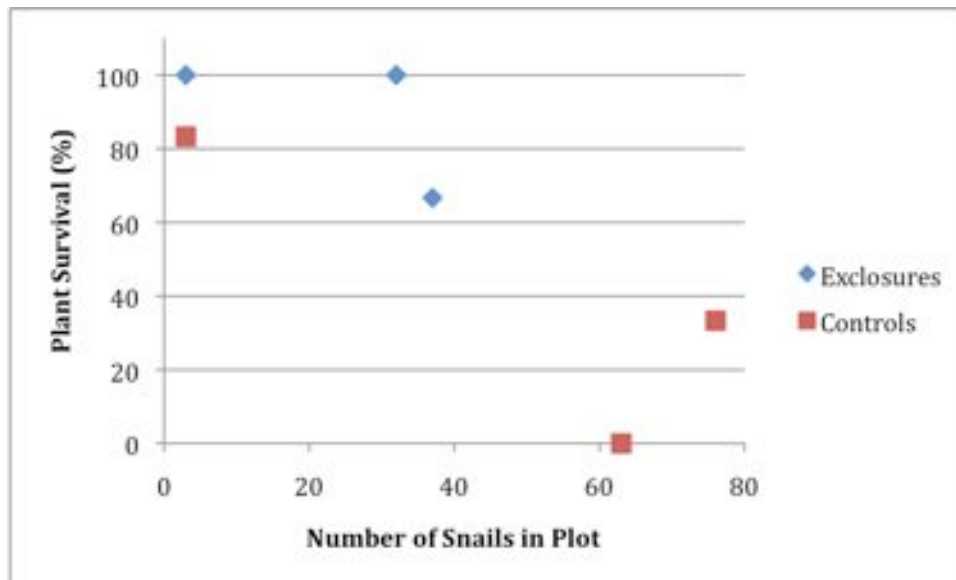
We began to count snails outside as well as inside the exclosures in September, and we found about half the snail numbers within exclosures (Table 2). Even though the snails returned and got into the exclosures, the reduced snail numbers were associated with better plant survival and health, and this trend continued until sampling ended October 15th (Figure 18).

Figure 18. Relationship between snails and cordgrass survival in exclosure experiment.
