### EXPERIMENTAL FIRE BEHAVIOUR OF PRECAST CFRP PRETENSIONED HPSCC SLABS

## EXPERIMENTAL FIRE BEHAVIOUR OF PRECAST CFRP PRETENSIONED HPSCC SLABS

**ABSTRACT:** Optimized concrete elements have been developed using high-performance, self-consolidating, fibre-reinforced concrete (HPSCC) reinforced with high-strength, lightweight, non-corroding pre-stressed carbon fibre reinforced plastic tendons. This new type of thin-walled precast carbon FRP (CFRP) pretensioned HPSCC slab has been used in building façades and is under consideration for a range of other applications in buildings. However, it is well known that the bond strength between both steel and FRP reinforcements and concrete deteriorates at elevated temperature, and that HPSCC has a comparatively high risk of heat-induced concrete spalling. Reductions in bond strength, the occurrence of heat-induced concrete spalling, and their impacts on the load-bearing capacity of precast CFRP pretensioned HPSCC slabs during fire are not well understood. This paper gives insights into the fire behaviour of precast CFRP pretensioned HPSCC slabs by evaluating the influence of concrete mixture, slab thickness and the presence of local reinfo

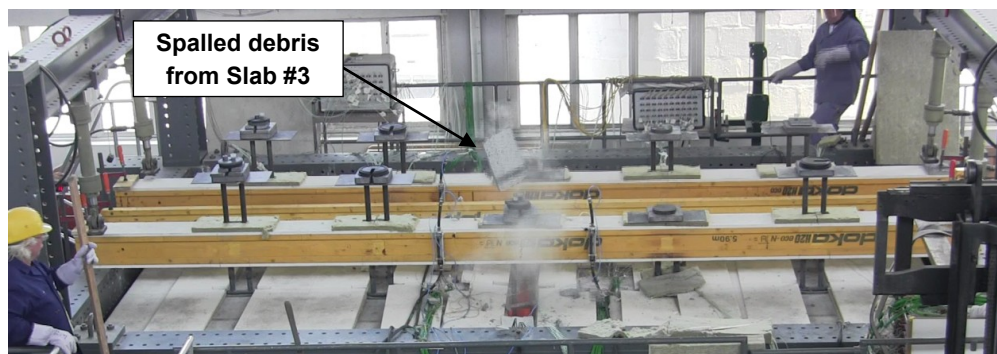
Failure of slabs #2 and #3, both cast from the same concrete batch (mix 342), was driven by the occurrence of a single explosive heat-induced concrete spalling event at minute 12 and 22, respectively (refer to Table 2). Immediately after spalling, the slabs failed suddenly. A snapshot from the video sequence recorded during testing shows the exact moment at which spalling occurred for Slab #3 (Figure

1) and shows the violence with which pieces of concrete were expelled from the furnace. Slab #2 suffered early failure at minute 12 due to a single explosive spalling event while Slab #1, which was virtually identical to Slab #2, failed due to loss of bond strength at minute 42 without significant spalling being observed (refer to Table 2). Whilst a full analysis of the reasons for this cannot be included in the current paper, through-thickness temperature measurements showed a more rapid temperature increase within Slab #2 compared with Slab #1 (both were 45 mm thick); this is thought to be associated with the occurrence of spalling and due to slight non-uniformity of thermal exposure within the furnace. Likewise, Slab #3, which also suffered from spalling, showed more rapid temperature increase at midspan.

**Fig. 1 – Testing Furnace, Explosive Spalling and Imminent Failure of Slab #3 at 22' 10''.**

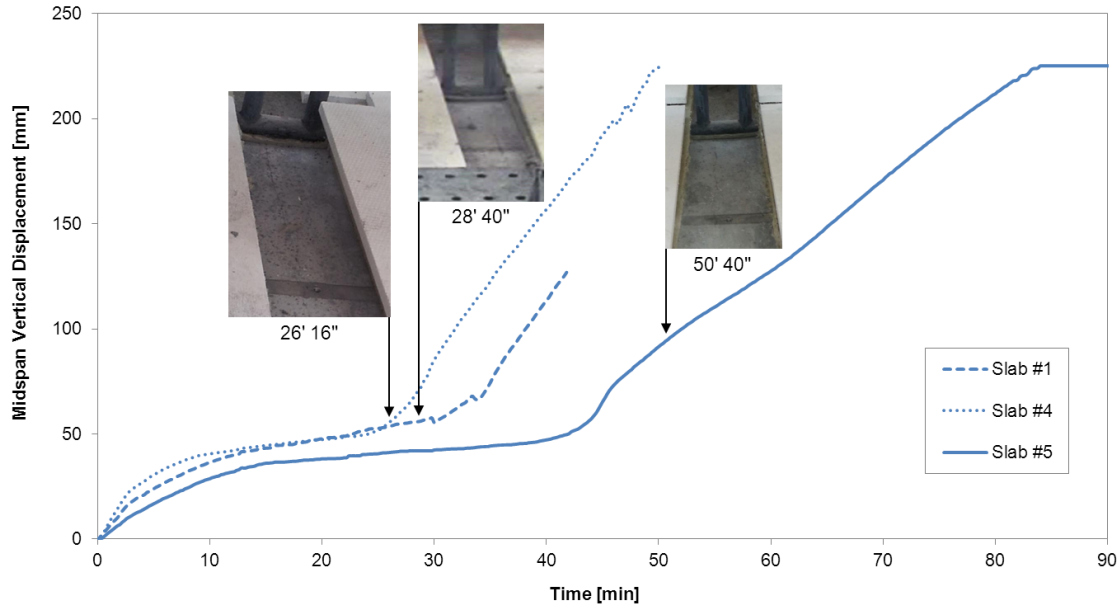
The failure mechanism of slabs #1, #4, and #5 was driven by loss of bond strength within the prestress transfer zone which resulted in structural failure at minute 42, 50, and 93, respectively (refer to Table 2). Loss of bond strength for CFRP prestressed HPSCC structural elements in fire resistance tests has previously been shown to be driven by thermo-mechanical bond degradation, thermo-mechanically induced longitudinal splitting cracks, or a combination of both (Terrasi et al., 2012). Figure 2 shows midspan deflection versus heating time for slabs which failed due loss of bond, as well as photographic evidence of the first observed longitudinal splitting cracks at the slabs' unexposed surfaces. Midspan deflection measurements showed an increase in the rate of deflection at the time when these splitting cracks were observed, as shown in Figure 2. The midspan deflection at an early stage of the test is governed by the well known thermal bowing of the test specimens, however the observed increase in the rate of midspan deflection appears to be linked to degradation of the bond strength and the observed splitting cracking.

To analyse the loss of bond strength and its influence on the failure mechanism observed for slabs #1, #4, and #5, the temperature at the lower edge of a central CFRP tendon measured at midspan and at 200 mm from the end of the slab (around the end of the unheated overhang) was measured. For all slabs an increase in the rate of midspan deflection was observed at the moment that the temperature at the lower edge of a central CFRP tendon was in the range of 300°C. The temperature at this moment 200 mm from the end of the slab was only around 70°C for the 45 mm thick slabs (slabs #1 and #4), and 120°C for the 60 mm thick slab (Slab #5). It is noteworthy that the thermocouples at the lower edge of the CFRP tendon measure the temperature of the concrete at the surface of the tendon rather than the temperature inside the tendon. At the moment that the first longitudinal splitting crack at the unexposed surface was observed, the temperature at the lower edge of a centre CFRP tendon was between 320-390°C. thermo-mechanical modelling is currently underway in an effort to understand the significance of these temperatures for splitting cracking.

**Fig. 2 – Midspan Deflection Measurements and Photographic Evidence of the First Observed Longitudinal Splitting Crack at the Unexposed Surface for Slabs #1, #4, and #5 (refer to Table 2).**

Slab #4 (45 mm thick) and Slab #5 (60 mm thick), both of which had CFRP grids in their prestress transfer zones, failed when midspan temperature at the lower edge of a centre CFRP tendon was about 600°C. Slab #1, which had no CFRP grids, failed when midspan temperature at the lower edge of a centre CFRP tendon was about 450°C. This indicates a possible increase in bond strength at elevated temperature provided by the presence of CFRP grids at the prestress transfer zones. Figure 3 shows a bottom view (i.e. view from inside the furnace) of Slab #4 at the moment of failure.

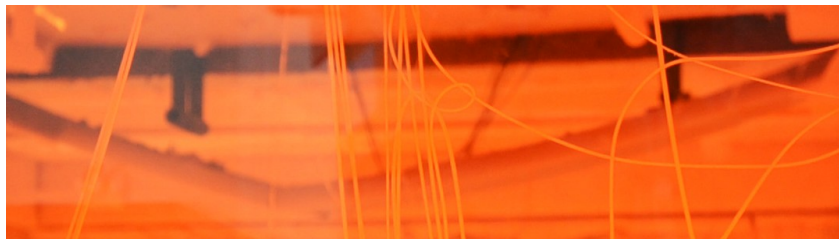
**Fig. 3 – Failure of Slab #4 at 50' 27\"/>**
