4D Monitoring of Active Sinkholes with a Terrestrial Laser Scanner (TLS): A Case Study in the Evaporite Karst of the Ebro Valley, NE Spain

Abstract: This work explores, for the first time, the application of a Terrestrial Laser Scanner (TLS) and a comparison of point clouds in the 4D monitoring of active sinkholes. The approach is tested in three highly-active sinkholes related to the dissolution of salt-bearing evaporites overlain by unconsolidated alluvium. The sinkholes are located in urbanized areas and have caused severe damage to critical infrastructure (flood-control dike, a major highway). The 3D displacement models derived from the comparison of point clouds with exceptionally high spatial resolution allow complex spatial and temporal subsidence patterns within one of the sinkholes to be resolved. Detected changes in the subsidence activity (e.g., sinkhole expansion, translation of the maximum subsidence zone, development of incipient secondary collapses) are related to potential controlling factors such as floods, water table changes or remedial measures. In contrast, with detailed mapping and high-precision leveling, the displacement models, covering a relatively short

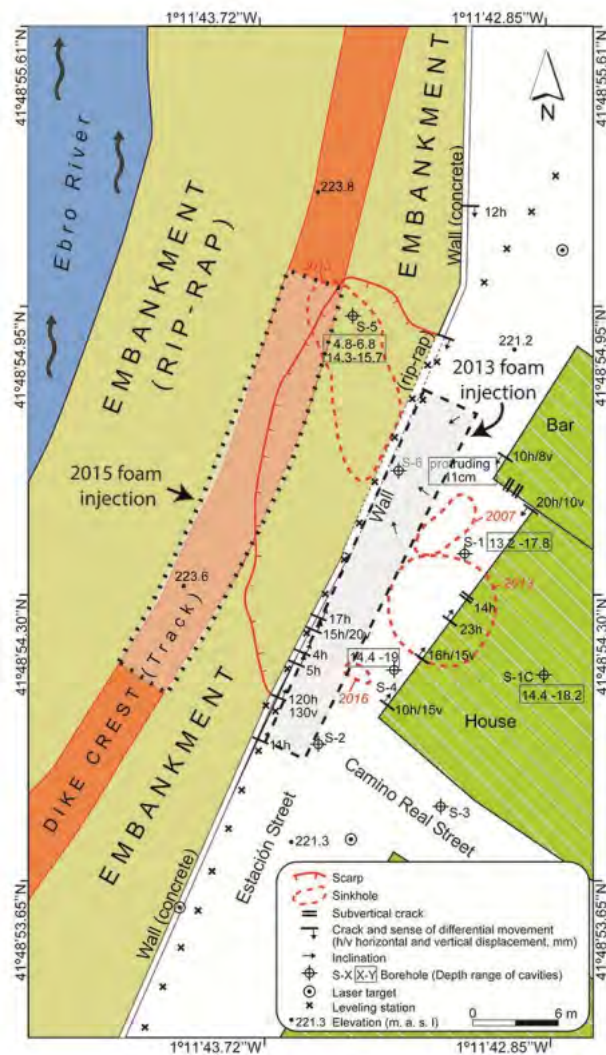
Figure 2. Detailed map of the Alcalá sinkhole produced in March 2016 showing the approximate locations of collapse events and remediation measures (compaction grouting with polyurethane foam), surface deformation features, positions of targets, leveling points and boreholes (numbers in parenthesis indicate the depth range of cavities).

The investigated sinkhole is located on the Western edge of Alcalá village, affecting the flood-control dike, the adjacent street (Estación Street) and two buildings: a bar and a house (Figures 2 and 3). In June 2007, a collapse sinkhole, 8 m across and 15 m deep, occurred in the street in front of the house. Since that event, the site has suffered from continuous subsidence as well as multiple collapse events (see their distribution in Figure 2) leading to a number of geotechnical investigations. A total of seven boreholes, 25–44 m deep, have been drilled in the site (Figure 2), indicating the following

stratigraphy in descending order: (1) An unconsolidated cover around 6–7 m thick, comprising an anthropogenic deposit up to 4.6 m thick, underlain by fluvial deposits; (2) a karstic residue consisting of 20 m of dark grey clays and marls with residual gypsum particles that grade downwards into the unaltered evaporitic bedrock; and (3) the Tertiary evaporitic bedrock, including gypsum, halite and glauberite beds [39]. The vertical distribution of water- and alluvium-filled cavities encountered in the boreholes is indicated in Figure 2. Borehole data reveal the presence of significant cavities beneath the investigated sinkhole and the surrounding zone, mostly concentrated at depths between 13 and 19 m, probably controlled by a salt unit (i.e., halite and/or glauberite). The water table at this site, located next to the river channel and underlain by pervious alluvium and cavernous bedrock, is controlled by the water level of the river. Elevation changes in the water table between low-discharge periods and floods may reach more than 5 m, and the sinkhole may eventually be affected by groundwater flooding. The spatial–temporal variations in the distribution and rate of subsidence in the sinkhole area may have been affected by the occurrence of collapse sinkholes—partial remediation measures carried out before and during the monitoring period—as well as by floods in the adjacent Ebro River. The main actions and events are listed chronologically below, together with the scans. The distribution of collapse events and remediation measures is shown in Figure 2:

1. June 2007: An elongated collapse sinkhole, 8 m long and 15 m deep, formed in the street, in front of the house. Anthropogenic infill and reactivation occurred in July 2007.

2. November 2013: A collapse sinkhole, 9 m across and 4 m deep, occurred on the Eastern flank of the dike.
3. November–December 2013: Shallow compaction grouting less than 8 m deep with polyurethane foam occurred along a 92 m² portion of the street at the foot of the dike and beneath the foundation of the house and the SW corner of the bar. Asphalt pavement was replaced by loose aggregate.

4. December 2013: A new collapse sinkhole formed at the front of the house (labelled as b in Figure 3B).
5. February–April 2015: The Ebro River flooded with a return period of less than 10 years. The water stage of the river was well above the street level. The river water flowed under pressure beneath and through the dike causing internal erosion and flooding of the sinkhole (Figure 3A). Scans were carried out in October 2014 and in April and October 2015.

The deformation features that developed on the ground surface and in human-built structures were mapped on March 2016, mainly to gain insight into the extent of the subsidence area (Figure 2). This map of surface deformation and structural damage indicates an elongated subsidence depression around 40 m long with an apparent N–S orientation. The area is affected by continuous sagging and embraces the multiple nested collapse sinkholes that have occurred since 2007. On the Western side, there was a conspicuous arcuate fissure-scarp, 10–20 cm high, affecting the crest and Eastern shoulder of the dike (Figure 3A). This surface rupture connected with the largest cracks that developed on the wall of the dike, showing horizontal and vertical separations higher than 10 cm. The wall also showed cracks related to its tilt towards the sinkhole center, 9.2 m and 3.2 m north and south of the main fissures, respectively. This suggests that the subsidence area along the dike comprises an inner sector, 28 m long, affected by more rapid subsidence, and an outer aureole with slow inward tilting. Surface evidence of deformation does not allow for identification of the edge of the subsidence area along its Eastern side due to the lack of adequate markers and the impossibility of accessing the house. The topographically lowest portion of the subsidence zone is located at the foot of the rip-rap wall around borehole S-6. The casing of the borehole protrudes 11 cm above the ground surface, providing a rough

measure of the amount of subsidence between 7 July 2015 (borehole installation) and 11 March 2016 (measurement) (Figures 2 and 3C).

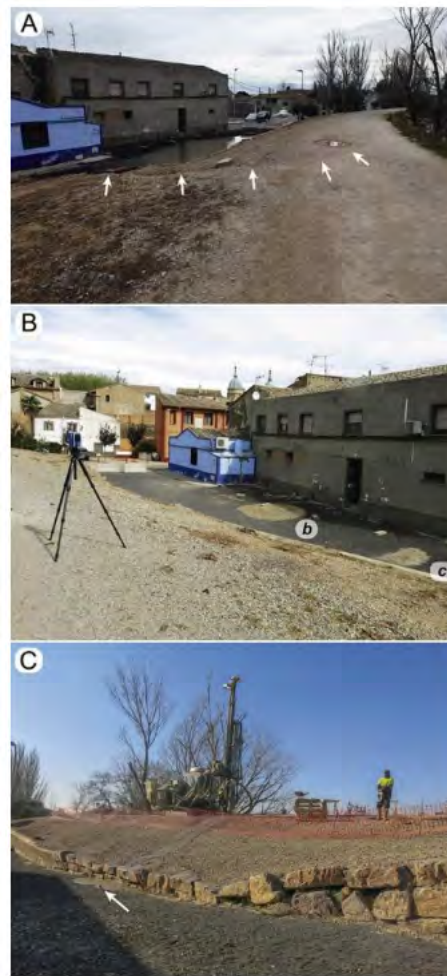
Figure 3. Images of the Alcalá sinkhole site taken at different dates. **(A)** Photograph taken on 2 March 2015, during the February–April Ebro River flood. The water stage in the river (right) is well above ground surface in the village, and water from the river flowed under pressure through and beneath the dike, flooding the sinkhole (left). The arrows point to an arcuate scarp-fissure developed in the dike. Note the cracking in the buildings. **(B)** Photograph taken on 5 October 2015, showing small collapse sinkholes (b and c) filled with lighter deposits. Note the cracking in the buildings. A laser scanner is to the left of the image. **(C)** Photograph taken on 1 December 2015 during the injection of polyurethane resin. The dike is affected by conspicuous sagging subsidence. The arrow points to borehole S-6, whose case protrudes above the ground surface.

6. November–December 2015: A new grouting program with polyurethane foam took place along a 30 m long section of the dike through drillholes 5–15 m deep (Figure 3C).

During the period from April 2015–October 2015, following the February–April flood and the associated water-table drop, the main subsidence area (sinkhole a) kept a similar shape (Figure 6B1). However, there was a clear acceleration of subsidence between sinkhole b and the outer wall of the dike (area labelled d in Figure 6B1). In this period, the frequency of the subsidence values recorded in the main subsidence area shows a bimodal histogram (Figure 6B3), defined by a main peak at -8.4 cm (-17 cm/year), higher than the previous one, and a secondary peak at -16 cm (-32.4 cm/year) corresponding to the area labelled as d. Maximum subsidence values reached as much as -20 cm (-40.5 cm/year) near collapse sinkhole b. Before October 2015, collapse sinkholes b and c were filled with aggregates, so that they displayed positive values in the model (Figure 3B).

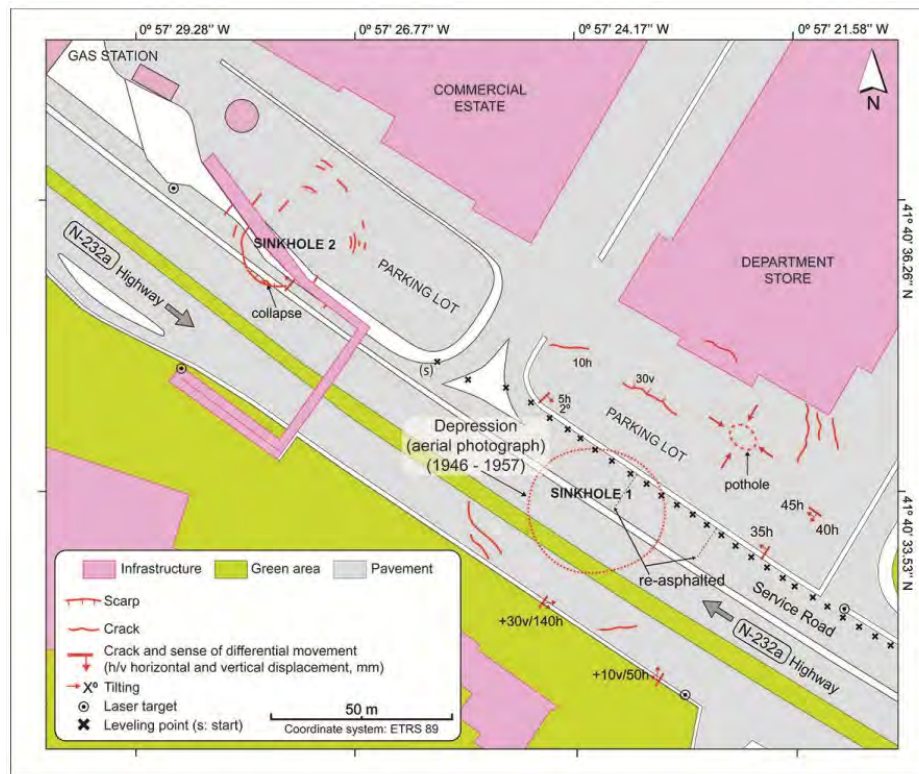
Figure 4. Map of the Logroño highway sinkholes. Surface evidence of deformation in sinkhole 1 (sinkhole in highway) and in sinkhole 2 (sinkhole in parking lot) were mapped in April 2016 and November 2011, respectively.

This site, located in the lowermost terrace of the Ebro River, includes two damaging sinkholes, here referred to as sinkholes 1 and 2 (Figure 4). Sinkhole 1 is a sub-circular buried sinkhole, around 110 m in diameter, that affects (1) both carriageways of the Logroño highway (N-232a); (2) the service road and a department store to the NE; and (3) a concrete wall on the SW flank of the highway [37,38]. The central and deeper part of the sinkhole can be recognised in grey-scale aerial photographs from 1945–1946 and 1957 as a sub-circular depression approximately 40 m across. Historical imagery reveal that this depression was filled sometime between 1957 and 1969. In the 1970s, a factory was built on the NE sector of the sinkhole, which was demolished in the late 1990s. At that time, the service road used to show a conspicuous sag related to rapid subsidence and poor maintenance (Figure 5A). The currently existing department store was built in 2001 (Figure 4). Nowadays, the Logroño highway and its service road are subject to re-asphalting works every one or two years. A map of this sinkhole

depicting the distribution of surface deformation features was produced in April 2016 (Figure 4). This map is rather limited due to frequent repair works but provides information on the minimum extent of the active subsidence area. Subsidence on the SW sector of the sinkhole was expressed as fresh arcuate cracks in the recent pavement of the highway, plus sagging and inward toppling in the concrete wall located along the edge of the highway. On the NE sector, a number of cracks with an overall arcuate geometry affect concrete walls, paved surfaces and the floor of the department store.

Sinkhole 2 is located on the NE side of the Logroño highway, beneath and next to the ramp of a pedestrian bridge built across the highway (Figures 4 and 5B). Historical imagery from Google Earth indicate that this sinkhole has been active since 2001 and has been repaired at least three times between that date and 2011. In September 2011, the sinkhole experienced a significant reactivation, damaging the service road up to the NE edge of the highway, a large diameter water-supply pipe and a portion of the parking of a car shop. The overall distribution of the fissures, scarps and small collapses mapped on November 2011 are depicted in Figure 4. These show a sub-circular depression with an approximate diameter of 40 m, with an inner sector around 27 m across, defined by more conspicuous ruptures which is affected by more rapid subsidence. After that event, the service pipe was rebuilt above the ground in order to detect any potential damage or leakage. The portion of the car shop affected by active subsidence was re-asphalted and fenced, showing rapidly evolving sagging subsidence and concentric fissures and scarps (Figure 5B). Several geotechnical boreholes drilled within or next to this sinkhole indicate the following stratigraphic succession, in descending order: (1) anthropogenic fill 3.5–4 m thick; (2) fluvial gravels 12–15.1 m thick; (3) karstic residue 19.7–35.4 m thick, consisting of grey marls with residual gypsum; and (4) fresh evaporitic bedrock at ≥ 25 m depth. The water table depth at this site typically varies between 5 and 9 m, with the highest levels recorded by the end of the summer season, since the recharge of the alluvial aquifer is mainly related to irrigation.

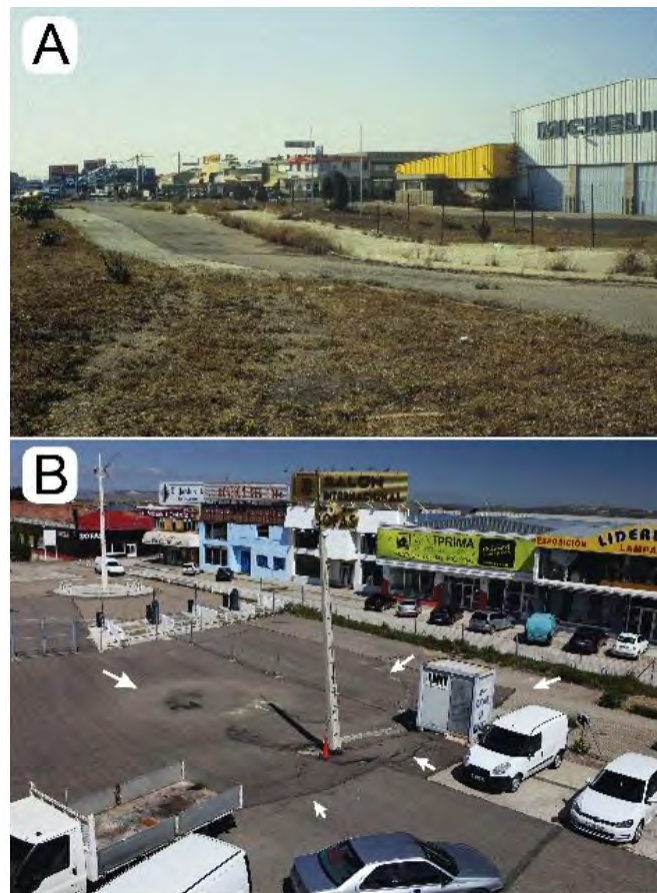
Figure 5. Images of the Logroño highway sinkholes. (A) Photograph taken on June 1996 at the NE sector of sinkhole 1 before the enlargement of the highway and the construction of the currently existing department store. Note the conspicuous sagging of the service road and the sidewalk. (B) Image of sinkhole 2 taken on April 2016 affecting a recently asphalted surface within a fenced area. The left arrow points to the deeper part of sinkhole and the arrows on the right mark the outermost cracks.

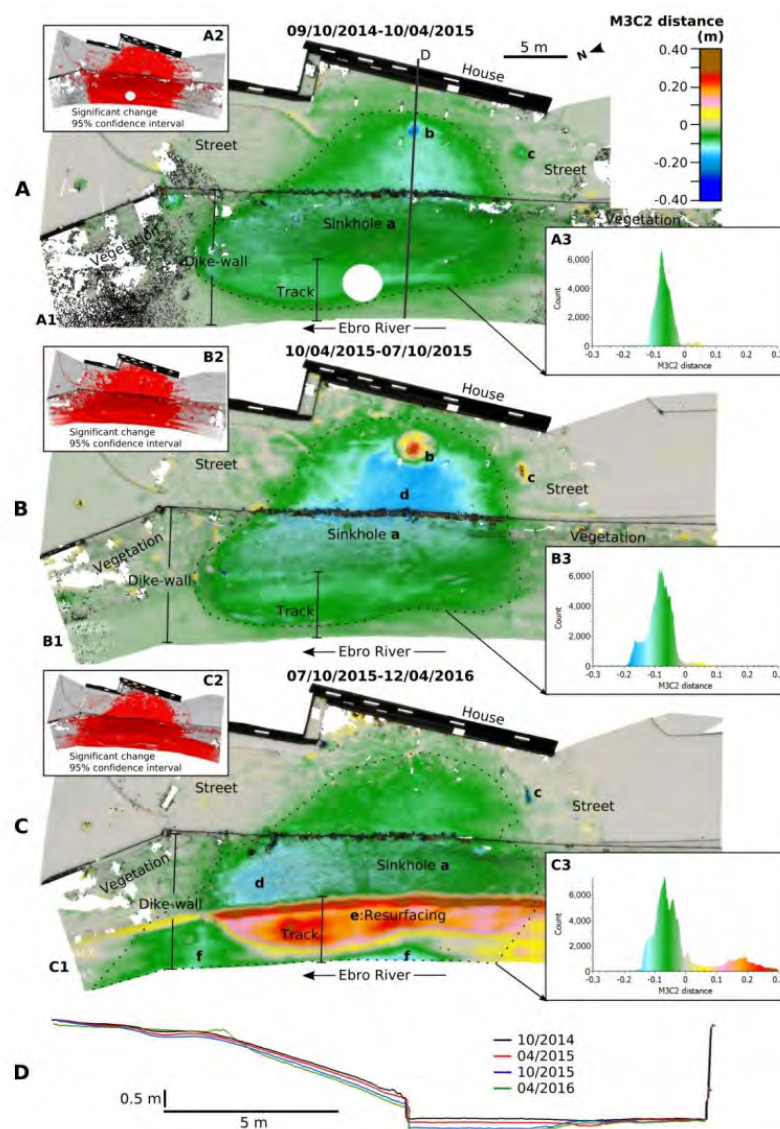
Figure 6. 4D monitoring of surface changes in the Alcalá sinkhole carried out between October 2014 and April 2016. (A) Changes from 09/10/2014 to 10/04/2015 (183 days). (B) Changes from 10/04/2015 to 07/10/2015 (180 days). (C) Changes from 07/10/2015 to 12/04/2016 (188 days). Surface-change frequency histograms are shown on the right of the displacement models. (D) Relative displacements along line D, depicted in image A.

In the Alcalá sinkhole, four 3D surveys were conducted on October 2014, April 2015, October 2015 and April 2016, covering a time span of 551 days (Table 1). In each survey, we carried out 15–21 scans of medium resolution (7–12 mm at a 10 m scanning distance) to cover an area of 1304 m². The resulting 3D point clouds displayed errors of 2–3 mm from the registration process and 1–2 mm from the referencing process using the B/W targets. The comparison of 3D point clouds allowed the accurate measurement of the deformation with a high spatial resolution (ca. 1 cm) in the portion of the sinkhole affected by greater subsidence.

The time lapse covered by the first comparison (October 2014 and April 2015) included the February–April 2015 Ebro River flood, during which water flowed through the dike, and the sinkhole was flooded by the water-table rise. The displacement model reveals an elongated subsidence area with a major axis of 26 m located on the Western sector along the dike, and a minor axis of 18 m on the Southern zone (sinkhole a in Figure 6A1). This subsidence area, which affects the dike and the street, and is embraced within the distribution of surface changes with a 95% confidence interval (Figure 6A2), can be considered the minimum extent of the zone affected by ground settlement. Surface displacement within this subsidence area shows a unimodal distribution with a main peak at -7.5 cm (-14.9 cm/year), and a maximum value of -25 cm (-49.8 cm/year) (Figure 6A3). The maximum subsidence was measured in a nested collapse sinkhole located in the street in front of the house (b in Figure 6A1). Changes were also detected outside the main subsidence area. To the south, there is a meter-sized collapse sinkhole with a maximum displacement of -18 cm (c in Figure 6A1). Around the main subsidence area, the model captured displacements of up to -1 cm at points, with a scattered pattern. The changes could be attributed to subsidence, but also to other changes unrelated to sinkhole activity, such as the movement of loose gravel in the street or the vegetation located on the dike.

Nonetheless, the overall distribution of these displacements, forming an aureole around the most active subsidence area, strongly suggests that they form part of the active sinkhole.

In the last period analysed (October 2015–April 2016), which included the shallow polyurethane grouting program carried out along the dike, the subsidence area (sinkhole a) expanded significantly to the west and north, mainly in the dike (areas labelled as f in Figure 6C1). Additionally, the area affected by the greatest subsidence translated completely from the street to the dike (area labelled d in Figure 6C1). The frequency of the displacement values of the 3D model in the main subsidence area showed a polymodal distribution with peaks at -4.3 cm (-8.3 cm/year), -6.8 cm (-13.2 cm/year) and -12.2 cm (23.7 cm/year) (Figure 6C3). The maximum subsidence occurred in the dike (area d in Figure 6C1), affecting the outer shoulder, and probably also the track on the dike crest. However, this latter zone showed apparent upward displacement due to the accumulation of a man-made fill in the subsidence zone, developed at the foot of an arcuate scarp (area e in Figures 6C1 and 3A). The nested collapse sinkhole b seems to have been inactive during this period. In contrast, collapse sinkhole c was reactivated after the previous fillings. The elongated geometry of this sinkhole, with an orientation parallel to the edge of the main subsidence zone, suggests that it may be related to ravelling of surficial deposits through an extensional fissure developed in the marginal zone of the main sinkhole.

A 3D comparison of the point clouds also allowed the detection of deformation affecting vertical structures, such as the house located to the east. The deformation of the house façade progressively increased from October 2014 to April 2016. In the last comparison (October 2015–April 2016), more than half of the façade was affected by movements ranging from -0.6 to -5 cm. In fact, the house had to be demolished in July 2016.

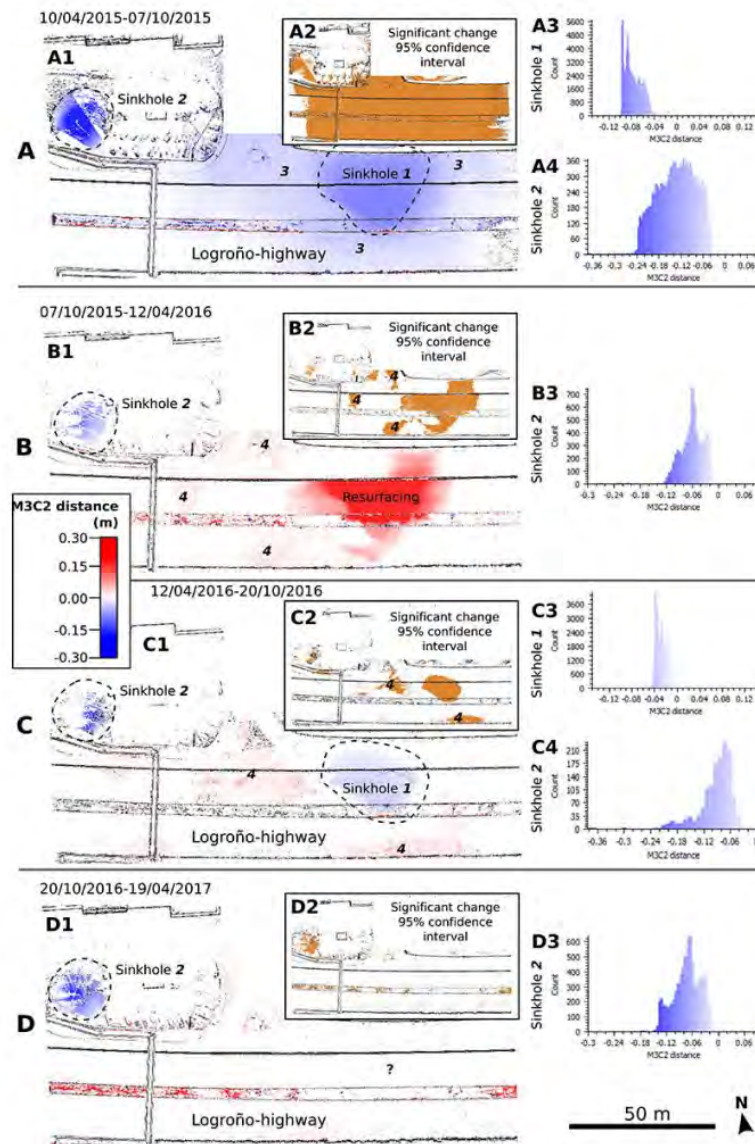
Figure 7. 4D monitoring of surface changes in the Logroño highway sinkhole, carried out between April 2015 and April 2017. (A) Changes from 10/04/2015 to 07/10/2015 (180 days). (B) Changes from 07/10/2015 to 12/04/2016 (188 days). (C) Changes from 12/04/2016 to 20/10/2016 (191 days). (D) Changes from 20/10/2016 to 19/04/2017 (181 days). Surface-change frequency histograms are shown on the right of the displacement models.

The comparison between the 3D point clouds from April 2015 and October 2015 revealed two active sinkholes (Figure 7A1). Sinkhole 1, mainly affecting the Logroño highway, showed a high inner subsidence area, characterised by a complex polymodal displacement distribution between -4 and -10 cm (-8.1 and -20.2 cm/year) (Figure 7A3), with the highest mode at -9 cm (-18.1 cm/year). This inner high-subsidence sector of sinkhole 1 is surrounded by an ill-defined aureole (labelled as 3 in Figure 7A1) with a mean subsidence of -4 cm (-8.1 cm/year). Sinkhole 2, located in a non-accessible fenced plot, north of the highway, could not be scanned completely. Nonetheless, it showed the greatest

subsidence (Figure 7A4), mainly ranging between -2 and -25 cm (-4 and -50.4 cm/year), with the main mode at -12 cm (-24.2 cm/year). Subsidence in both sinkholes was measured with a 95% level of confidence, although the data do not allow precise mapping of the sinkhole edges (Figure 7A2).

Between October 2015 and April 2016, the central sector of sinkhole 1 was filled and re-paved, displaying positive distance values in the comparison model (Figure 7B1). Sinkhole 2 showed subsidence activity, but with a lower rate and different pattern than in the previous period. Subsidence values showed a trimodal distribution, ranging between -2 and -13 cm (-3.9 and -25.2 cm/year), with the main mode at -6 cm (-11.6 cm/year) (Figure 7B3). This comparison also showed other significant positive distance changes with scattered distribution (labelled 4 in Figure 7B1,B2), which can be ascribed to scanning errors, discussed in the next section.

The subsequent comparison (April 2016–October 2016) also showed positive distance changes attributable to scanning errors (labelled 4 in Figure 7C1,C2). Nonetheless, the model captured negative changes related to subsidence in both sinkholes. Subsidence in sinkhole 2 ranged between -2 and -24 cm (-3.8 and -45.9 cm/year) (Figure 7C1), with a main mode of -7 cm (-13.4 cm/year) (Figure 7C3). Subsidence values in sinkhole 1, with the highest mode at -4 cm (-7.6 cm/year) (Figure 7C4) were lower than those measured during the first period.

Perhaps surprisingly, the M3C2 displacement model of the period from October 2016–April 2017 did not capture subsidence activity in sinkhole 1 (Figure 7D1). Although the model showed values of -1 to -1.6 cm (-1.9 to 3 cm/year) for this sinkhole, the high referencing error involved in this comparison model (Table 1) did not allow the detection of significant changes with a 95% confidence interval (Figure 7D2). Conversely, the rapid subsidence in sinkhole 2 allowed the measurement of negative, vertical displacement, displaying a similar trimodal distribution to that observed during the period October 2015–April 2016 (Figure 7D3), concentrated between -1 and -13 cm (-1.9 to -24.7 cm/year), with the main mode at -7 cm (-13.3 cm/year).
