Identifying the boundaries of sinkholes and subsidence areas via trenching and establishing setback distances

Francisco Gutiérrez, Mario Zarroca, Rogelio Linares, Carles Roqué, Domingo Carbonel, Jesús Guerrero, James P. McCalpin, Xavier Comas, Anthony H. Cooper

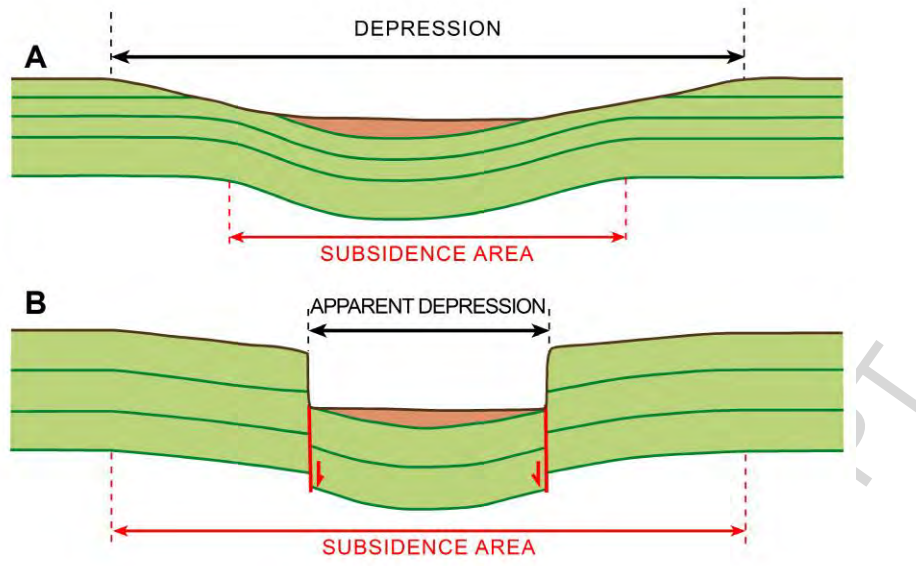
Fig. 1

Over the last few decades, sinkhole hazards and their associated risks have increased dramatically in many inhabited areas (e.g., Waltham et al., 2005; Gutiérrez et al., 2014). Despite the advances in our understanding of sinkholes revealed by the rapidly increasing scientific production, commonly there is no efficient transfer of knowledge and needs between scientists, technicians and decision-makers. This frequently leads to improper planning and risk management, resulting in significant economic losses (Gutiérrez, 2016 and references therein). Nonetheless, there is an emerging trend in many karst regions to incorporate sinkhole hazards in land-use planning (e.g., Farrant and Cooper, 2008). An essential step for risk mitigation in sinkhole areas is the construction of comprehensive and accurate cartographic sinkhole inventories. These maps and their data allow the identification of the areas affected by subsidence and delineation of the most hazardous sectors. Preventive planning is probably the safest mitigation strategy, which is typically implemented through regulations that exclude sinkholes and their vicinity from development and various anthropogenic activities. The effective application of this “hazard avoidance” measure requires: (1) the identification of all the existing sinkholes; (2) precise mapping of the edges of the sinkholes and the underlying subsidence structures; and (3) the definition of an adequate setback distance from the sinkhole edge. Mapping the boundaries of sinkholes and the areas affected by subsidence is frequently a challenging task and may have a high degree of uncertainty due to the following reasons: (1) the geomorphic expression of sinkholes is commonly obliterated or subdued by anthropogenic filling and natural depositional and erosional processes; (2) some depressions may have an uncertain origin and may be related to non-karstic processes (artificial excavation, aeolian deflation); (3) the actual area affected by subsidence may be smaller than the topographic depressions due to recession of the edges by erosion and the consequent expansion of the topographic basin (e.g., Fabregat et al., 2017) (**Fig. 1A**); and (4) the area affected by ground settlement may be much larger than the apparent size of the sinkhole mapped on the basis of surface evidence (e.g., Pueyo-Anchuela et al., 2013; Carbonel et al., 2014). This underestimation of the sinkhole size is frequently related to subtle subsidence at the sinkhole margins with little topographic expression, a situation common in complex sagging and collapse sinkholes (**Fig. 1B**).

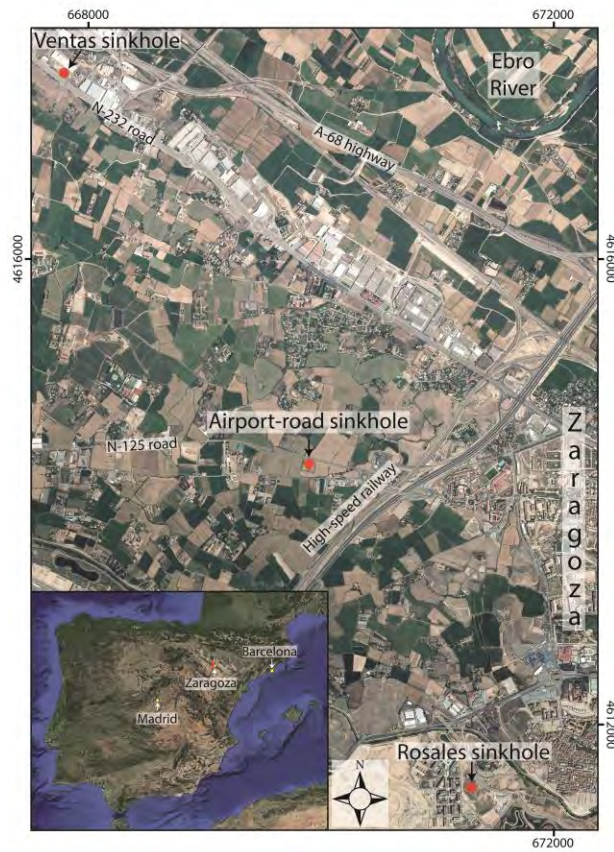
Fig. 2

Figure 2. Geographic location of the investigated sinkholes in the mantled evaporate karst of the Ebro River valley, NE Spain. The Ventas and Airport-road sinkholes are located next and beneath the N-232 and N-125 roads. The Rosales sinkhole is situated in an area under urbanization in the SW sector of Zaragoza city (Images from the Instituto Geográfico Nacional).

subsidence rates, timing of subsidence events and recurrence (Carbonel et al., 2014; Fabragat et al., 2017; Sevil et al., 2017). The aim of this paper is to illustrate, through the application of the trenching method (1) the significant mismatch that may exist between the actual boundaries of the areas affected by subsidence in sinkholes and the edges of the corresponding topographic depressions; (2) the practicality of the trenching technique for accurately and unambiguously locating the boundaries of the unstable areas affected by ground subsidence, in comparison with other methods like surface mapping or shallow geophysics (GPR, ERI); (3) the value of information that can be extracted from trenches relevant to hazard analysis, in combination with geochronological data and retrodeformation analyses. This work also discusses some of the criteria that may be considered for the establishment of setback distances around sinkholes. These concepts and approaches, relevant to sinkhole hazard assessment and risk management, are explored through the investigation of three buried sinkholes located in urban and suburban areas located on the mantled evaporite karst of the Ebro River valley, in and around the city of Zaragoza, NE Spain (**Fig. 2**).

The study area is located in middle reach of the Ebro River valley, in Zaragoza city and its surroundings, NE Spain (**Fig. 2**). From the geological perspective, the area is situated in the central part of the Ebro Cenozoic Basin. The bedrock corresponds to the horizontally-lying Zaragoza Gypsum Formation. This is an Oligo-Miocene evaporitic succession more than 850 m thick deposited in playa-lake systems (Quirantes, 1978; Salvany et al., 2007). In the subsurface, the non-weathered evaporitic formation consists of anhydrite ( $\text{CaSO}_4$ ), halite ( $\text{NaCl}$ ) and glauberite ( $\text{Na}_2\text{Ca}[\text{SO}_4]_2$ ) with interbedded shale and marl layers. In outcrops, the weathered zone of the evaporitic formation displays secondary gypsum ( $\text{Ca}[\text{SO}_4] \cdot 2\text{H}_2\text{O}$ ) related to the hydration of anhydrite and the incongruent dissolution of glauberite (Salvany et al., 2007). Recent borehole data reveal the presence of thick high-solubility halite and glauberite units at limited depth beneath the Quaternary alluvium (terraces, pediments). The rapid karstification of these salts plays an instrumental role in the development of dissolution-induced subsidence phenomena in the area (e.g., Guerrero et al., 2013; Gutiérrez et al., 2015). Data on the hydrogeological functioning of the karstic-alluvial aquifer system can be found in Acero et al. (2015).

This sinkhole is located at the right margin of the Ebro River valley, on the second terrace above the floodplain, which is perched 25-30 m with respect to the river channel (Galve et al., 2009) (**Fig. 2**). Currently, the sinkhole lies south and beneath the airport road (N-125) and causes progressive sagging in the infrastructure, which is built on an embankment (**Fig. 3**). The sinkhole is clearly identifiable in aerial photographs from 1946 (1:43,500 scale) and 1956 (1:32,500) as a funnel-shaped depression showing a well-defined edge with an E-W oriented ellipsoidal geometry 60 m long and 42 m wide. The sinkhole was filled between 1956 and 1970. Images from 1970, 2007 and 2017 capture re-asphalted sections of the road 20, 65, and 170 m long, respectively (**Fig. 3**). The area was surveyed with the aim of identifying surface evidence of deformation, including: (1) a sag in the road pavement with vaguely-defined edges and the deepest sector situated next to the central sector of the adjacent square-shaped plot of land; (2) a tilted pole of a power line; and (3) a tilted tree on the NW corner of the plot of land (**Fig. 3**).

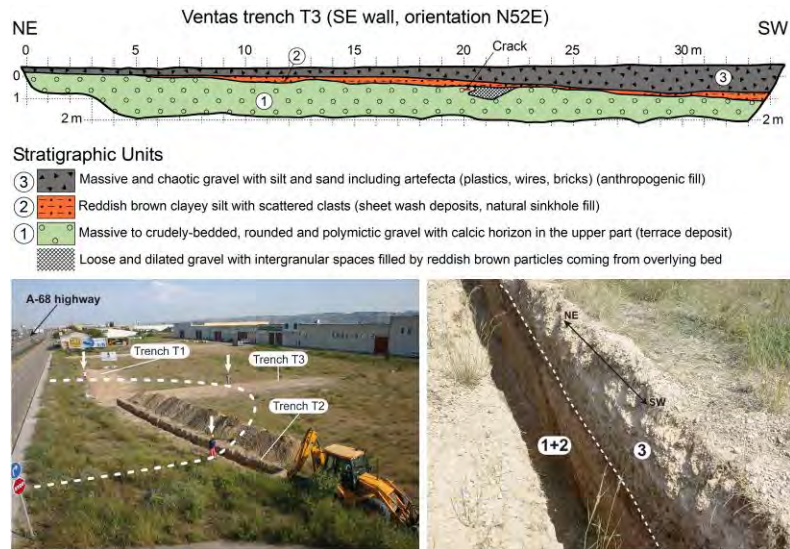
Fig. 13

filled by anthropogenic deposits, is situated on the northeastern side and beneath the A-68 highway, in a plot of land susceptible for industrial development (**Fig. 13**). The previously existing depression was recognised in a detailed topographic map from 1969 produced at a scale of 1:2000 with contour interval of 1 m (cartographic data of Zaragoza Municipality). In this map the depression is depicted with a dashed contour as a semicircular basin around 50 m across adjacent to the NE side of the old A-68 road. Nowadays, the site shows a flat topography and the overlying human-built structure does not show any evidence of deformation attributable to sinkhole-related subsidence (**Fig. 13**).

The buried Ventas sinkhole was investigated through three radial trenches (Fig. 13). The integration of the data gathered from the trenches allowed us to confirm that the depression mapped from old topographic maps was not an anthropogenic feature, but a shallow sagging sinkhole with basin structure, as defined by centripetal dips. The trenches were used to precisely locate the boundary of the subsidence area at three points and map the edge by interpolation. Here, the limit of the area affected by subsidence was also identified by a change in the attitude of the pre-sinkhole sediments, from horizontal to dipping, and thickenings or pinch outs in the sinkhole-fill deposits.
