Gucunski, N., Slabaugh, G.G., Wang, Z., Fang, T. & Maher, A. (2008). Impact echo data from bridge deck testing: Visualization and interpretation. *Transportation Research Record*(2050), pp. 111-121. doi: 10.3141/2050-11

VISUALIZATION AND INTERPRETATION OF IMPACT ECHO DATA FROM BRIDGE DECK TESTING

Paper submitted for presentation in TRB 87th annual meeting and publication in Journal of Transportation Research Board, Transportation Research Record.

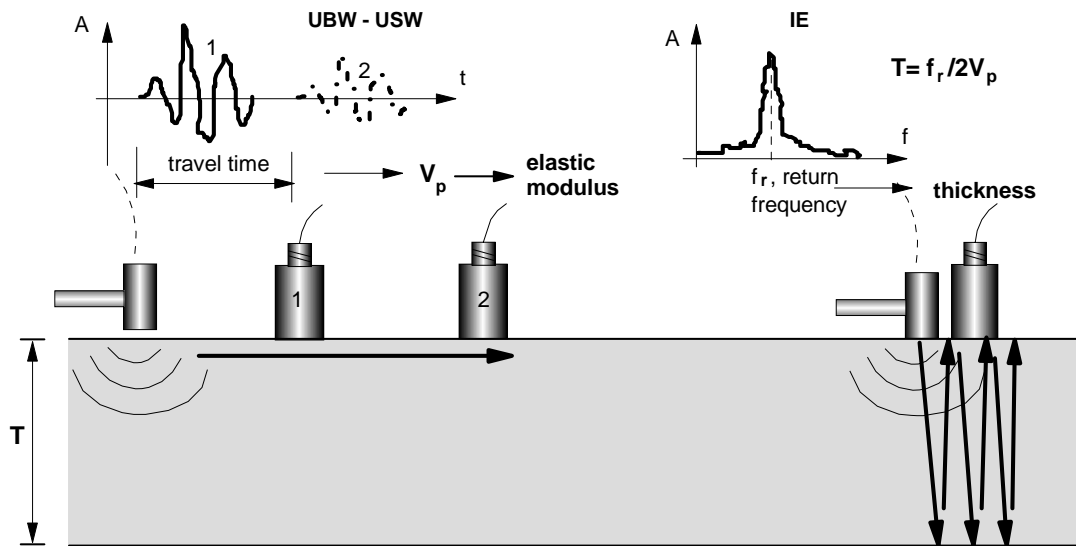
Application of UBW, USW and IE techniques in the evaluation of a bridge deck is illustrated in Figure 1. In the first part of the evaluation, the UBW and USW tests are conducted using an impact source and two receivers. The UBW technique is used to measure the velocity of propagation of compression (P) waves. By measuring the travel time of the P-wave between two receivers, the P-wave velocity (V_p) is calculated. Because it is often difficult to identify P-wave arrivals in an automated way, a more reliable procedure to estimate the P-wave velocity is through a measurement of the surface (Rayleigh or R) wave velocity using the USW test. The USW test is identical to the SASW test (7,8), except that the frequency range of interest is limited to a narrow high frequency range where the velocity of the surface wave (phase velocity) does not vary significantly with frequency (9). Variation in the phase velocity would be an indication of variation of material properties (elastic moduli) with depth. Once the R-wave velocity is determined, it can be well correlated to both compression and shear (S) wave velocities, and thus to the Young's and shear moduli. In the second part of the evaluation, the IE test is conducted using an impact source and a single nearby receiver. Because of a significant contrast in rigidity of concrete and air, the elastic wave is practically entirely reflected off the bottom of the deck back to the deck surface. The frequency of the reflection, called return frequency, can be identified in the response spectrum of the recorded signal. Finally, the depth of the reflector, in this case the deck thickness, can be obtained from the return frequency and the previously determined P-wave velocity, as illustrated in Figure 1.

FIGURE 1 Measurement of bridge deck elastic modulus and thickness by UBW and IE methods.

While the primary objective of IE testing is to determine dominant reflectors, according to the relationship described in Figure 1, a unique thickness or depth of the reflector can be correlated to every component of the frequency spectrum. This is illustrated in Figure 2 by a frequency spectrum, and the corresponding thickness spectrum. The thickness spectrum enables simple data interpretation, because positions of the dominant and secondary peaks describe clearly the pattern of energy partitioning, and thus the degree of delamination. Spectra for a set of points along a single test line can be combined to form spectral surfaces. As shown in the same figure, frequency spectra for one test line on a bridge deck are combined to form a frequency spectral surface and are converted into a corresponding thickness spectral surface. The following observations, regarding the advantages of the two surface types, can be made when linear scales are used for both frequencies and depths. The frequency spectral surface

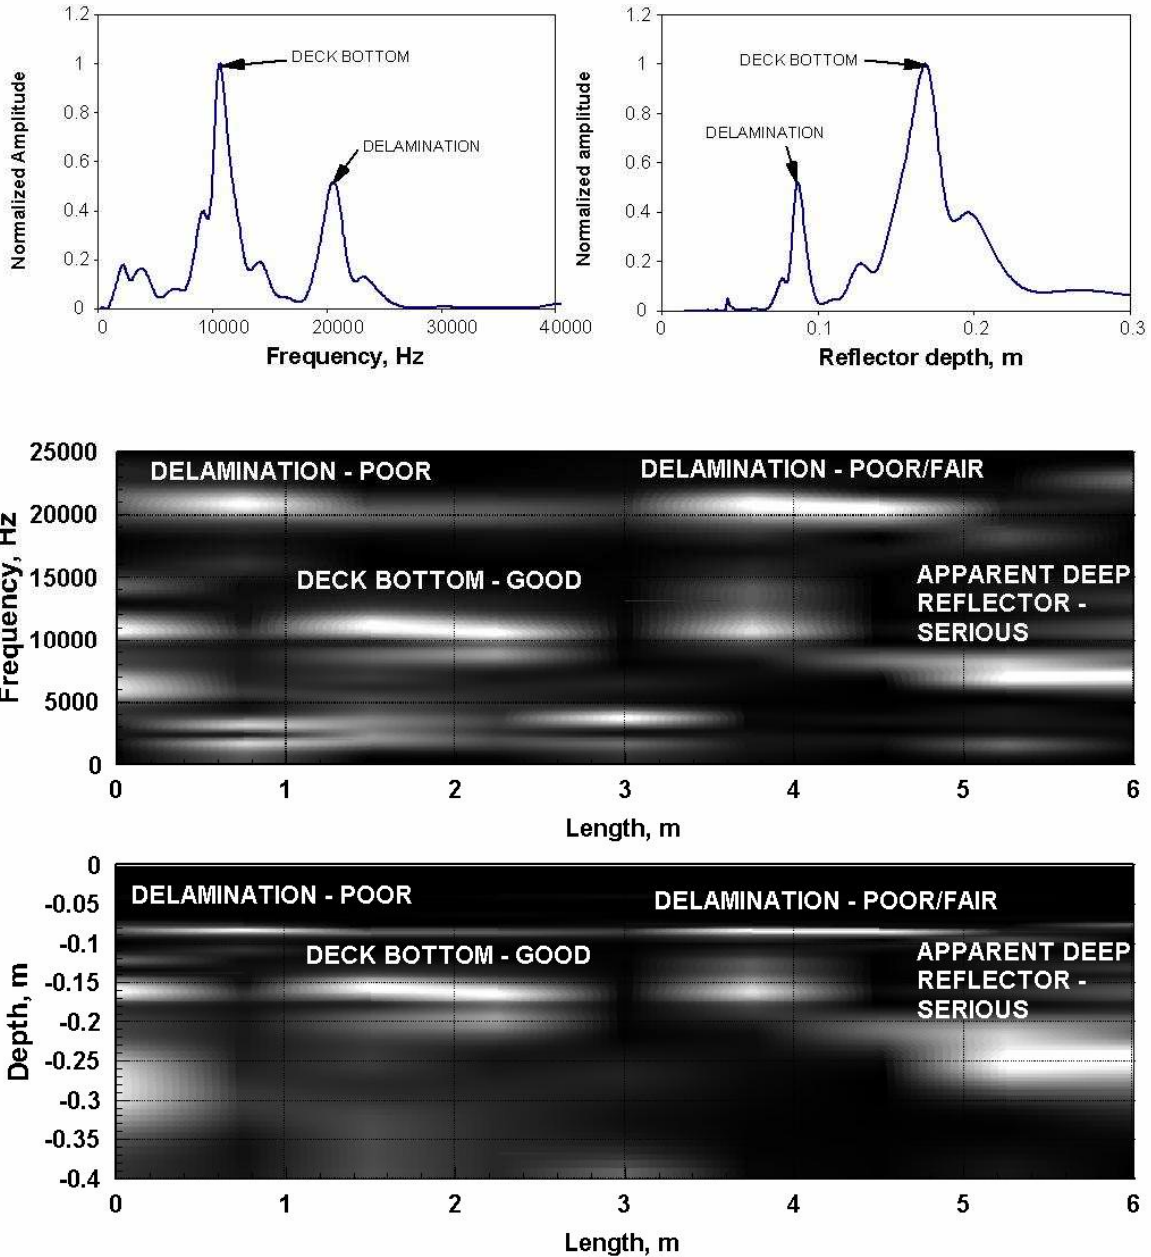
emphasizes presence of shallow delaminations, while the thickness spectrum emphasizes presence of apparent deep reflectors, deck zones in a serious condition that will be discussed in the following section (10). Because the thickness spectral surface represents a more natural choice for data viewing, a properly selected nonlinear depth scale can provide a well-balanced image for identification of all detected reflectors.

FIGURE 2 Frequency and thickness spectra and spectral surfaces.

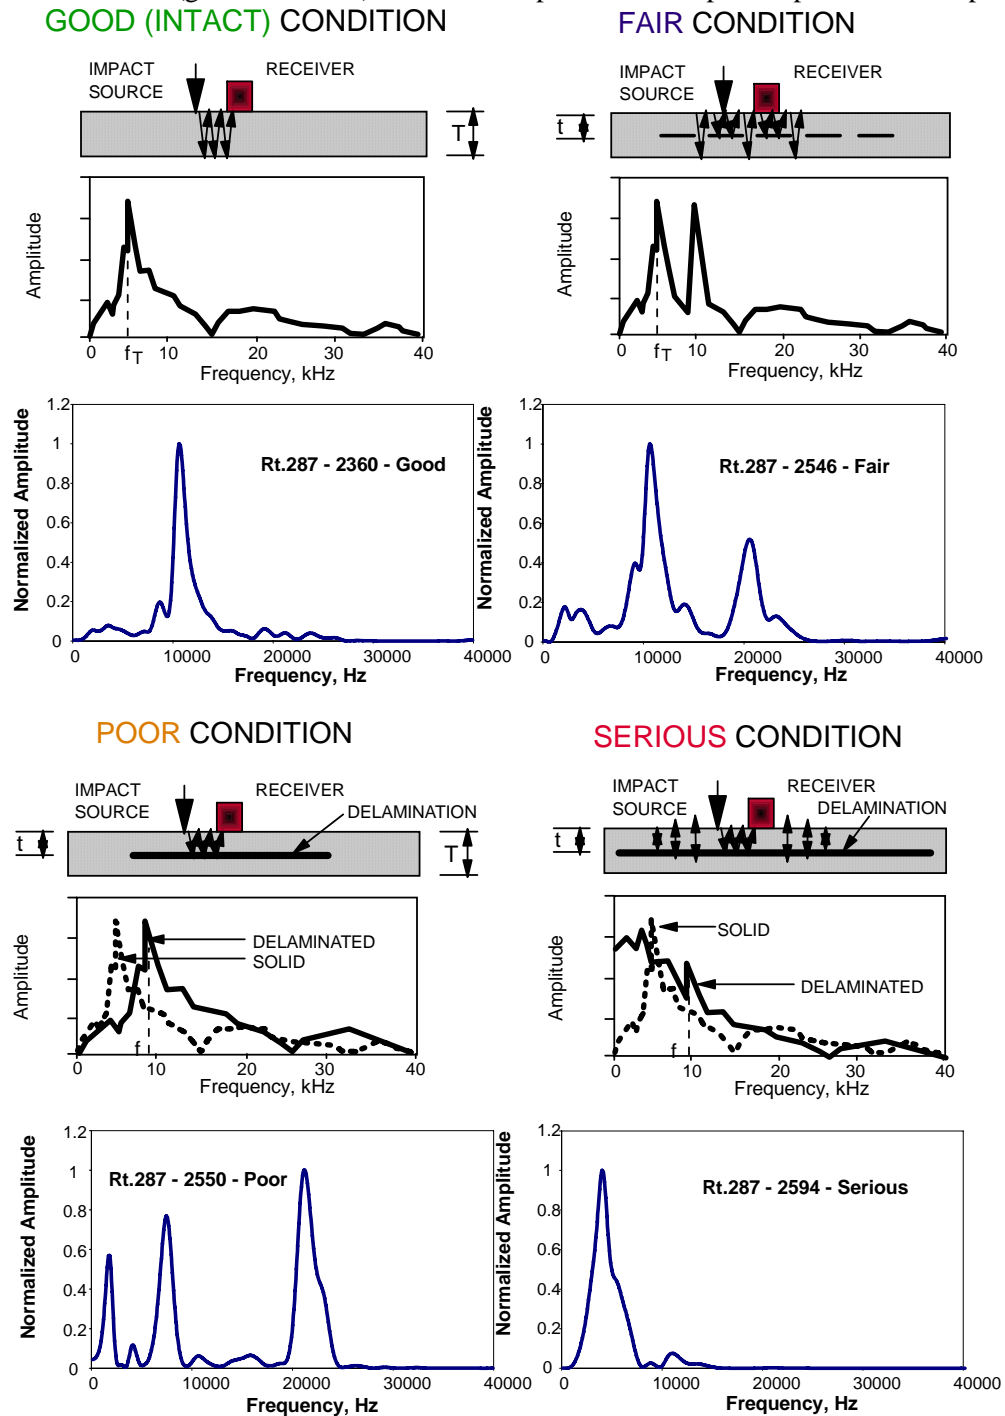
In the case of a delaminated deck, reflections of the P-wave occur at shallower depths, causing a shift in the response spectrum towards higher frequencies. Depending on the extent and continuity of the delamination, the partitioning of energy of elastic waves may vary and different grades can be assigned to

that particular section of a deck as a part of the condition assessment process. This is illustrated in Figure 3. In the case of a sound deck (good condition), a distinctive peak in the response spectrum corresponding

FIGURE 3 Grades for various degrees of deck delamination.

to the full depth of the deck, can be observed. This is illustrated by two spectra under the schematic of the bridge deck. The upper spectrum in the figure represents a schematic of the expected spectrum, while the lower spectrum is taken from actual field testing. Initial delamination (fair condition) is described as occasional separations between the two deck zones. It can be identified through the presence of two

distinct peaks, indicating energy partitioning from two dominant wave propagation patterns. The first peak corresponds to reflections from the bottom of the deck, while the second corresponds to reflections from the delamination. Progressed delamination (poor condition) is characterized by a single peak at a frequency corresponding to a reflector depth that is shallower than the deck thickness, indicating that little or no energy is being propagated towards the bottom of the deck. Finally, in a very severe case of a wide delamination (serious condition), the dominant response of the deck to an impact is characterized by a low frequency response of flexural mode oscillations of the upper delaminated portion of the deck. This response is almost always in the audible frequency range, unlike response of the deck in the fair and poor condition that may be in the ultrasonic range. Because it is significantly lower than the return frequency for the deck bottom, it produces an apparent reflector depth that is larger than the deck thickness.

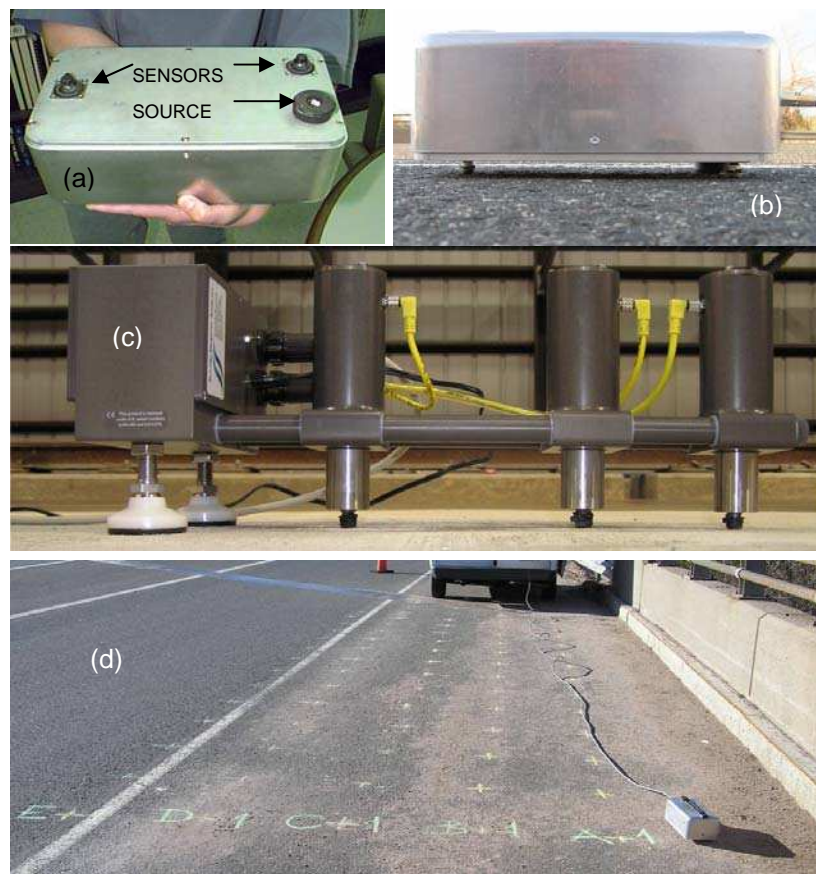
IE is commonly implemented in deck evaluations by conducting point testing on a grid of selected spacing. The testing is conducted using impact echo devices, which in some case integrate other ultrasonic seismic methods. One of such devices is PSPA with has a sole purpose of evaluation of surface pavement layers and bridge decks. The device integrates all three previously described ultrasonic techniques (UBW, USW, IE). The core of the PSPA system is a sensor box (Figure 4a), a box containing a solenoid type impact hammer and two high frequency accelerometers, 7.5 and 21.5 cm away from the hammer. All controls and data acquisition are in a computer that is connected by a serial cable to the sensor box. A new design of the PSPA (Figure 4c) has all data acquisition and control elements are a part of the unit. Field evaluation of bridge decks is typically done on grids of 0.6x0.6 m to 0.9x0.9 m (Figure

FIGURE 4 Older and newer versions of PSPA sensor box (a and c), and field implementation (b and d).

4d). Testing using the PSPA is simple and for a single point takes less than 30 seconds. The sensor box is placed at the test point (Figure 4c), a series of impacts (6-10) of 50 μ s duration are applied and acceleration histories are recorded. The testing is fairly insensitive to traffic induced vibrations because of the high frequency range used—typically between 2 and 30 kHz.

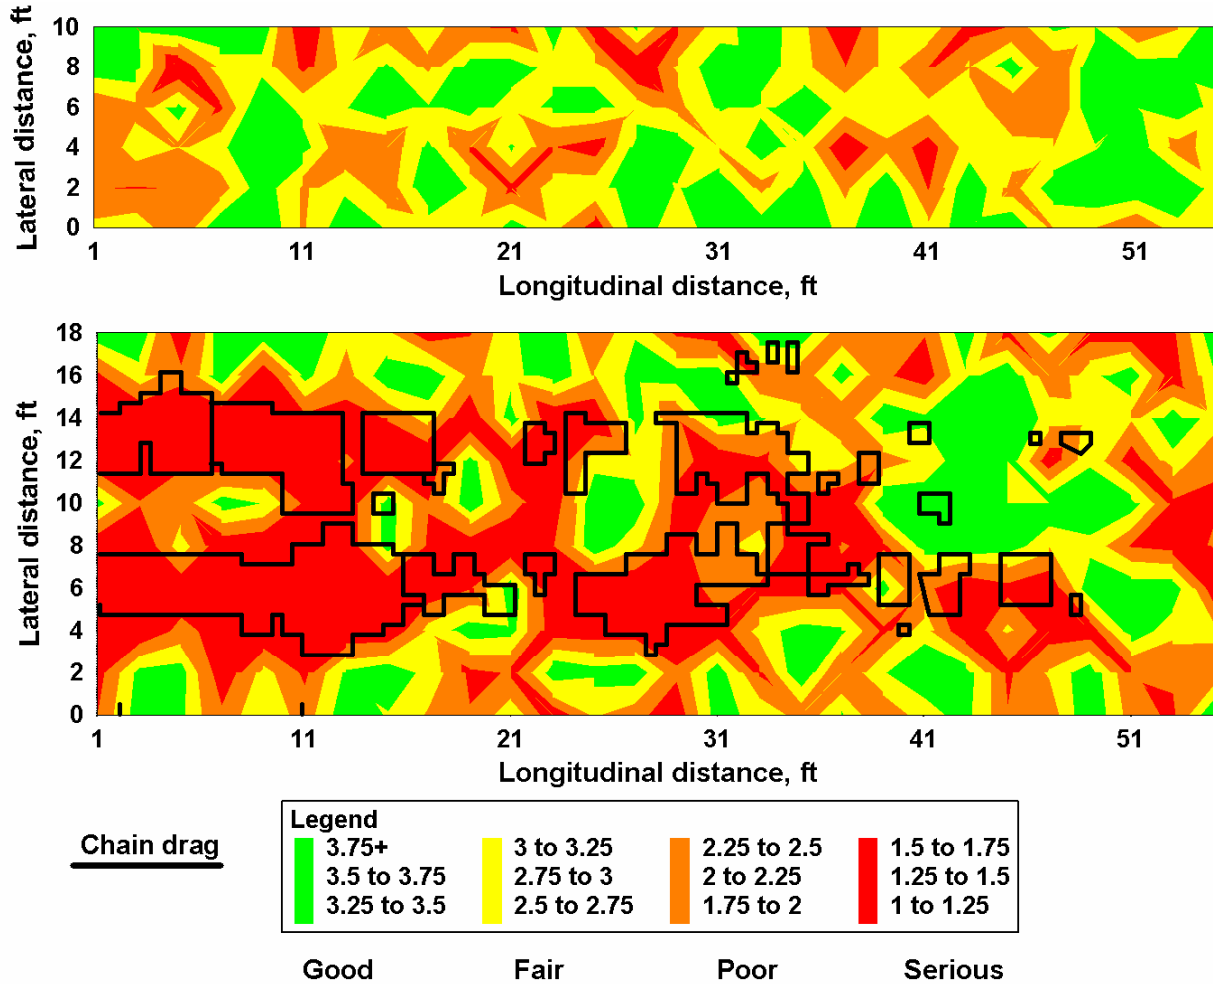
FIGURE 5 Condition assessment maps for Carter Creek Bridge (top) and Van Buren Bridge (bottom).

PSPA testing results are commonly described in terms of shear and Young’s moduli (or P- and S-wave velocity) distributions, and condition assessment distributions (with respect to the degree of delamination). This is illustrated by conditions maps for sections of two bridges in Virginia, Carter Creek and Van Buren bridges (Figure 5). As can be observed in the upper condition assessment plot for the Carter Creek bridge, the deck is in a good condition and only smaller zones of initial and progressed delamination, and minor zones of a deck in a serious condition, can be identified. On the other hand, the bottom condition assessment plot for Van Buren bridge deck illustrates a deck in a significantly deteriorated condition. Zones of all previously described conditions (grades) can be identified in the condition assessment plot. Since the deck was also evaluated by chain dragging, the PSPA results were compared to those of the chain drag. The comparison points to similarity of the two approaches in detection of areas with progressed delamination (poor to serious condition). The ability of the chain drag to identify zones in a serious condition can be explained by the fact that the frequency response in such cases is in the audible range. On the other hand, the most of the zones identified by the PSPA as zones of initial delamination (fair to poor grades) were not detected by the chain drag. This ability to detect signs

of initial delamination represents a significant advantage of the PSPA device (seismic ultrasonic testing) over the chain drag approach. It allows more accurate definition of boundaries of delaminated zones, better prediction of delamination progression, and leads to better assessment and timing for implementation of rehabilitation measures.

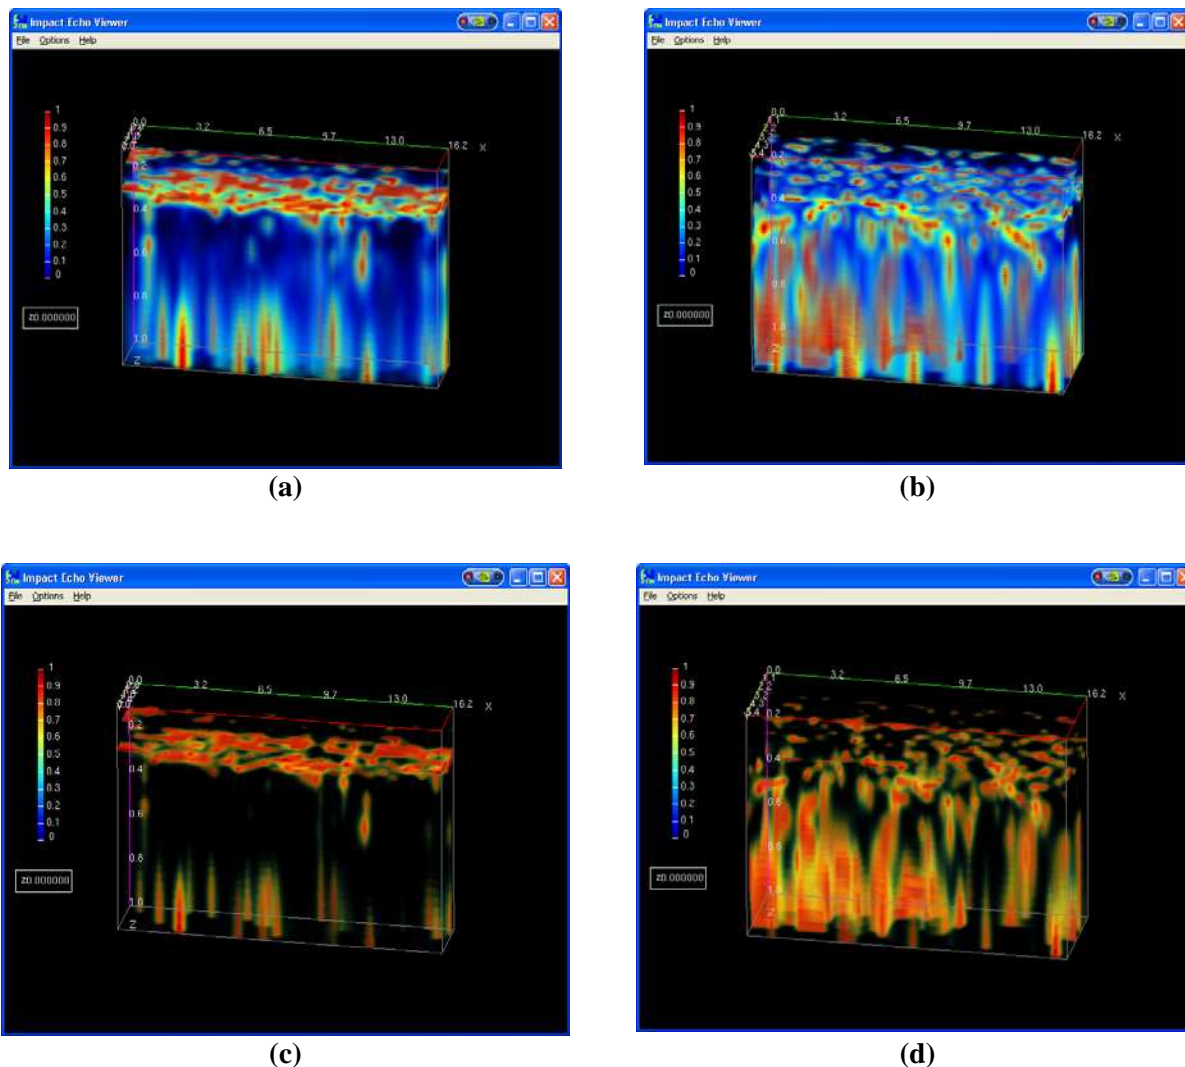
FIGURE 6 Interactive visualization of IE data. Carter Creek Bridge (a) (c), Van Buren Bridge (b) and (d).

A 3D visualization platform for IE data was developed. The platform is written in C++ for Microsoft Windows, and depicted in Figures 6a and 6b for Carter Creek and Van Buren bridge decks. The IE data consists of a reflection value, normalized in the range [0, 1], and sampled on a discrete 3D grid of voxels. Using OpenGL, the data is rendered as a series of texture-mapped planes that slice through the volume, where the reflection strength is used as an index into a colormap look-up table that consists of red, green, blue, and alpha (transparency) values. The user can rotate and shift the camera position, enlarge or shrink the volume and observe the data from different viewing positions and angles. Additionally, as shown in Figures 6c and 6d, the user can interactively adjust the transparency so that weaker reflectors become more transparent, allowing better visualization of the strong reflectors. Similar to the observations in the previous section, in the visualizations provided in Figure 6 it can be noticed that the Carter Creek Bridge, visualized in 6a and 6c is in reasonably good condition. The primary reflections are coming from the bottom of the deck. In contrast, the Van Buren Bridge, visualized in Figures 6b and 6d, has a large number of reflections throughout the volume, indicating a highly deteriorated condition. Data presented in 3D viewer can be inspected as vertical and horizontal cross sections or slices, as illustrated in Figure 7.

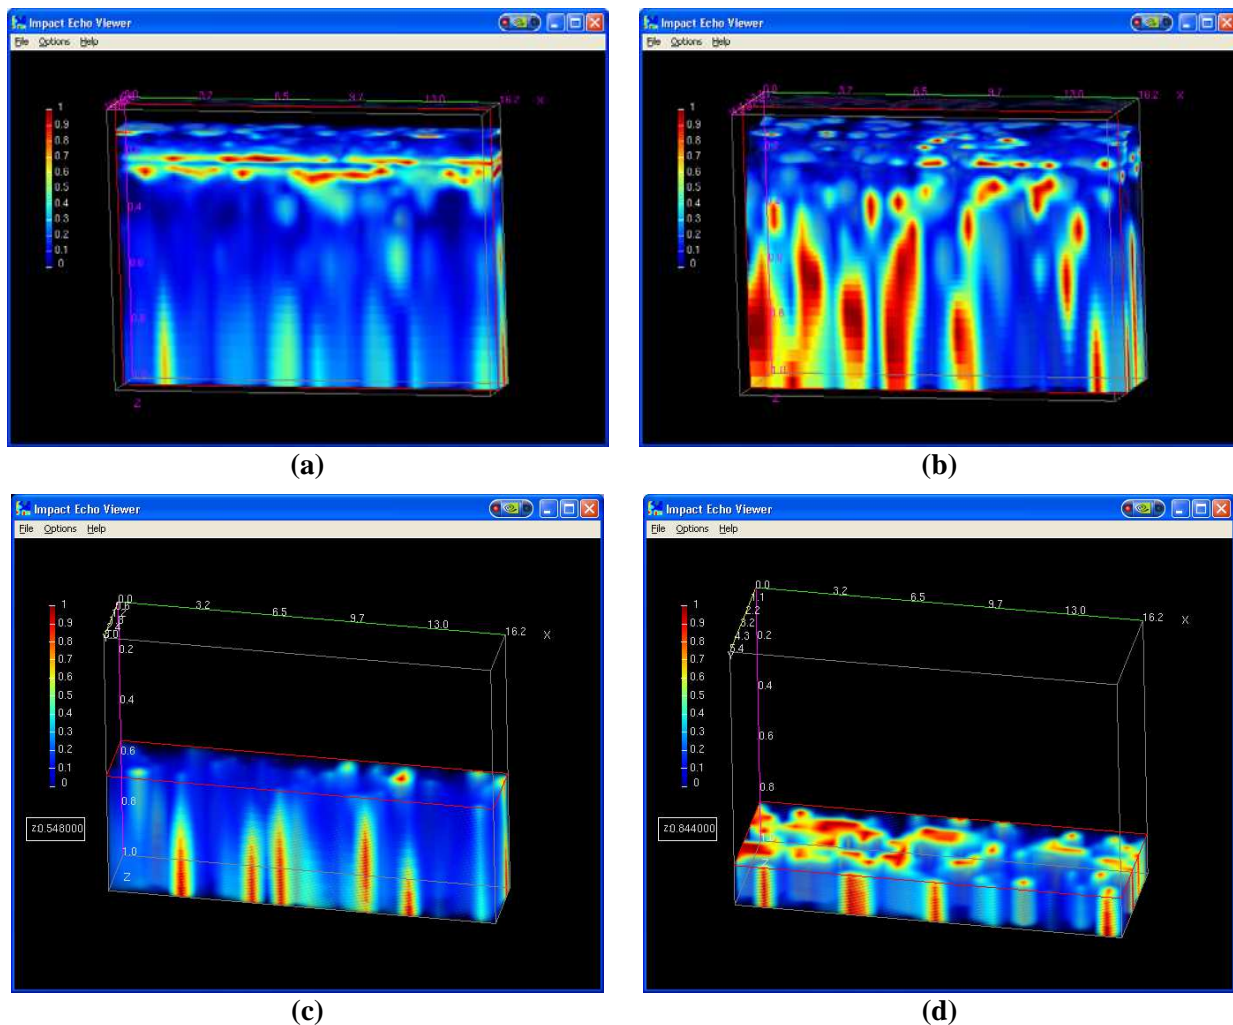
FIGURE 7 Vertical (top row) and horizontal (bottom row) cross-sections through the data. Left: Carter Creek Bridge (vertical section for $y=1.6$ m (a) and horizontal for $z=0.54$ m (c)), Right: Van Buren Bridge (vertical section for $y=3.5$ m (b) and horizontal for $z=0.84$ m (d)).

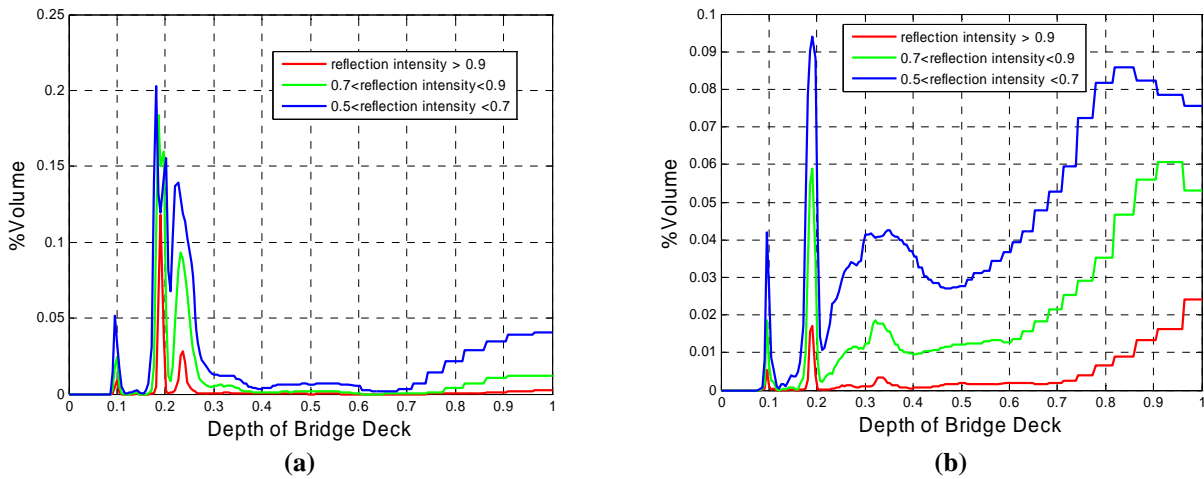
To locate the depth of the strongest reflectors, which could be indicators of defects in a bridge deck, it is very useful to study the relationship between the reflection intensity and depth of the bridge deck. In Figure 8a, strongest reflections appear around a depth equal to about 0.2 m, which corresponds to the bottom of the deck. This phenomenon indicates that the deck is in good condition, consistent with the previous observation and analysis. However, in Figure 8b, strong reflections appear throughout the deck, particularly in the lower regions (close to a 1 m depth) of the deck, indicating presence of flexural oscillations of the upper portion of the deck and thus serious condition.

FIGURE 8 Percent Volume for Various Reflection Intensities vs. Depth. Carter Creek (a), Van Buren (b).

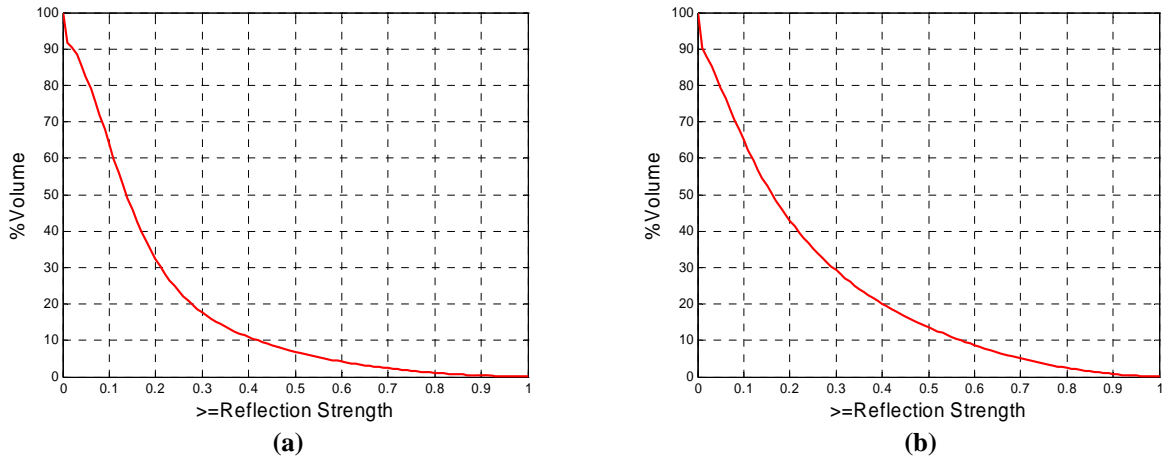
We also examined the cumulative distribution of reflection intensities, shown as Fig. 9. Specifically, these graphs plot the percentage of the IE reflectivity that is greater than or equal to a specific reflection strength. From this figure, it is obvious that strong reflectors at depths deeper than the bottom of the deck are existing in the Van Buren (b) are more than those in the Carter Creek Bridge (a). This is considered to be a sign that the former bridge deck is in a worse condition. Quantitatively, this can be presented in terms of the areas under the curve, which for Carter Creek is 1909.8 and Van Buren Bridge 2376.6.

FIGURE 9 Cumulative Distribution of Reflection Intensity. Carter Creek Bridge (a) and Van Buren Bridge (b).

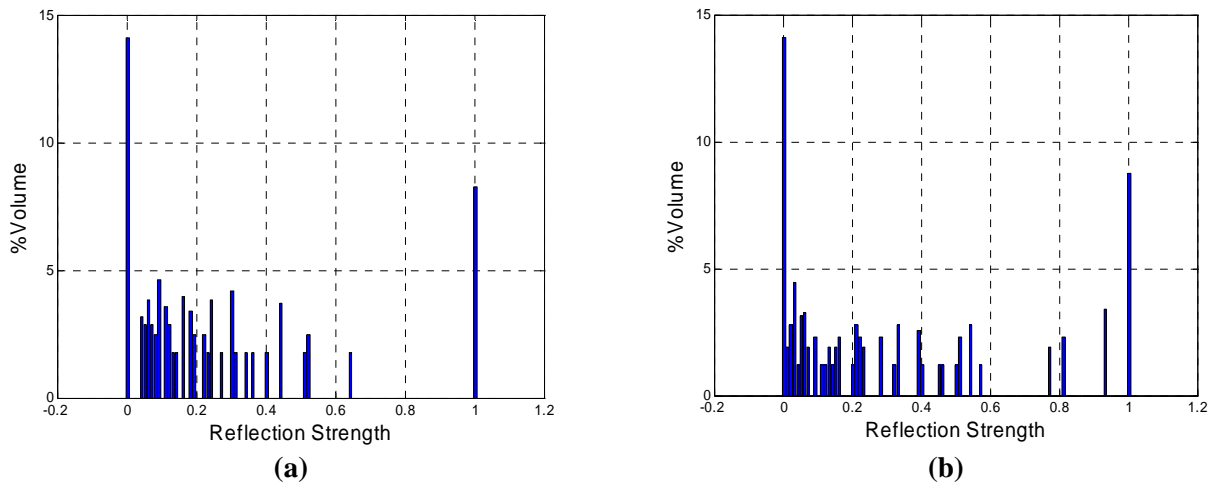
A histogram is the graphical version of a table which shows what proportion of cases fall into each of several or many specified categories. In Fig. 10, the histograms of both bridges are shown. It is worthy noting that the percentage of volume of strong reflection intensity in Carter Creek Bridge is less than Van Buren Bridge, which supports the previous analysis that the latter one is more deteriorated.

FIGURE 10 Histogram of Reflection Intensity. Carter Creek Bridge (a), Van Buren Bridge (b).
 $\text{Log}(\% \text{ volume(at each reflection strength)}) + \text{constant}$.

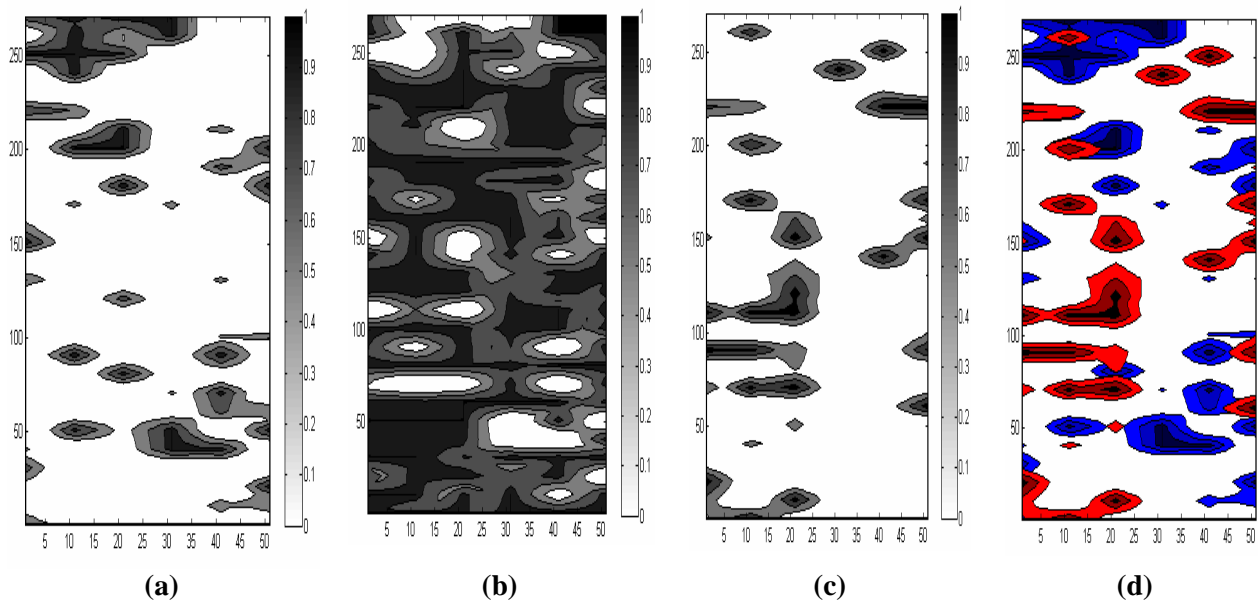
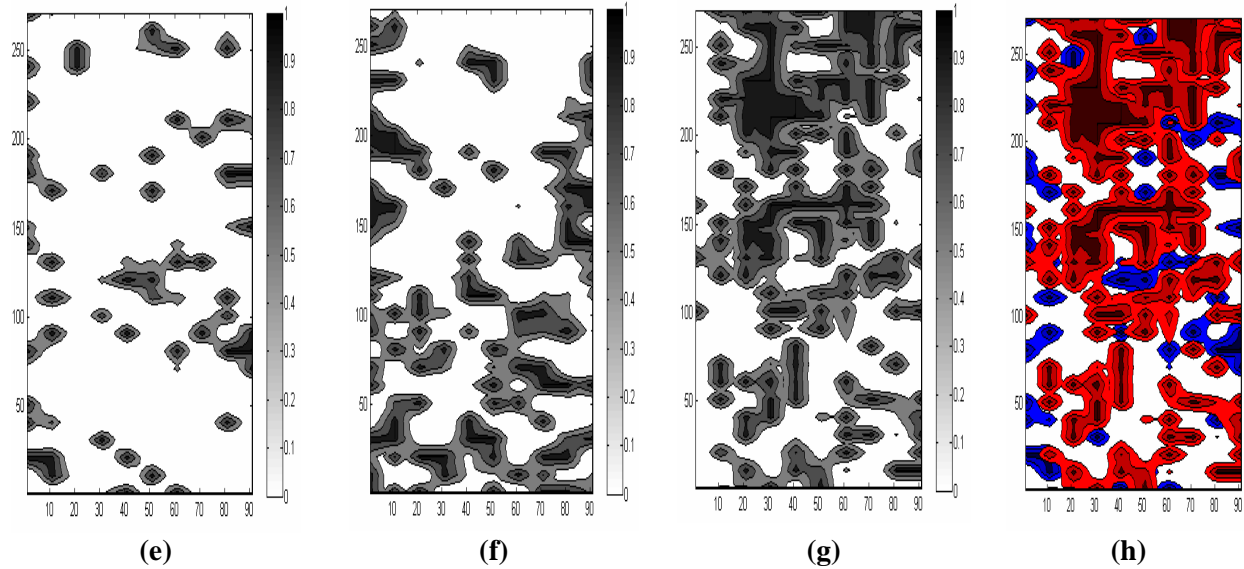
From the practical point, of highest interest and benefit is identification of zones on the deck that are in serious condition (progressed delamination) or fair to poor condition (initial delamination). The process of identification of such zones is illustrated in Figure 11. Initial delamination (fair to poor conditions) is primarily identified by medium to strong reflections at the depth corresponding to the position of the top rebars. This is illustrated in Figures 11a and 11e for Carter Creek and Van Buren bridges, respectively,

with strong reflection maps for slices between 7 and 13 cm. Similarly, sound zones of the deck are identified by strong reflections from the bottom of the deck, or in this case described by slices between 16 and 24 cm depth in Figures 11b and 11f. (Clearly, the Carter Creek Bridge deck is in a better condition.) Finally, progressed delamination (serious condition) can be described by strong reflection maps for the slice for the depth deeper than the depth of the bottom of the deck. This is illustrated by the strong reflection maps for slices between 30 cm and 1 m in Figures 11c and 11g. To obtain the map of zones candidates for repair, the map for serious condition is superimposed on the map of initial delamination, as e.g. repair map in Figure 11d is obtained from the map in Figures 11c superimposed on the map in Figure 11a. A comparison of maps for Carter Creek Bridge in Figure 11d and Van Buren Bridge in Figure 11h points clearly to significantly higher deterioration and need for repair of the latter one.

FIGURE 11 Plan view contour plots for deck repair. Top: Carter Creek Bridge, Bottom: Van Buren Bridge. Left to right: the maximum reflectance in the “delamination zone” slice (0.07m~0.13m) (a)(e), in the “bottom of the deck” slice (0.16m~0.24m)(b)(f), and in the “apparent deep reflector” zone (0.3m~1m)(c)(g). Identified deteriorated zones (d) and (h) (red - serious condition, blue – fair to poor condition).
