Bryant, M orcid.org/0000-0003-4442-5169, Farrar, R, Freeman, R et al. (3 more authors) (2014) Galvanically enhanced fretting-crevice corrosion of cemented femoral stems. *Journal of the Mechanical Behavior of Biomedical Materials*, 40. pp. 275-286. ISSN 1751-6161

Galvanically Enhanced Fretting-Crevice Corrosion of Cemented Femoral Stems

M.Bryant^a, R. Farrar^b, R. Freeman^b, K. Brummitt^b, J. Nolan^c, A. Neville^a

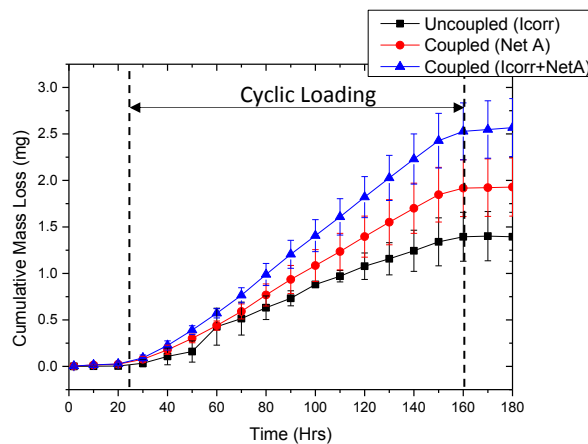
Figure 6- Cumulative ionic mass loss for uncoupled and coupled polished femoral stems when subjected to dynamic loading

Integration of the current vs. time curve was conducted in order to observe the cumulative ionic mass due to chemical dissolution (Figure 6). Galvanic coupling significantly increases the ionic mass loss from 1.39 ± 0.26 to $2.56 \pm 0.31 \text{ mg}$. ICP-MS further supported these findings demonstrating a TIML of 1.44 ± 0.11 and $2.74 \pm 0.19 \text{ mg}$ for uncoupled and coupled femoral stems respectively. Table 3 summarises these findings. An increase in the rate of ionic mass loss due to corrosion ($\frac{\partial m}{\partial t}$) from 4.70×10^{-3} to $1.71 \times 10^{-2} \text{ mg hr}^{-1}$ was seen for uncoupled and coupled femoral stems respectively under fretting conditions.

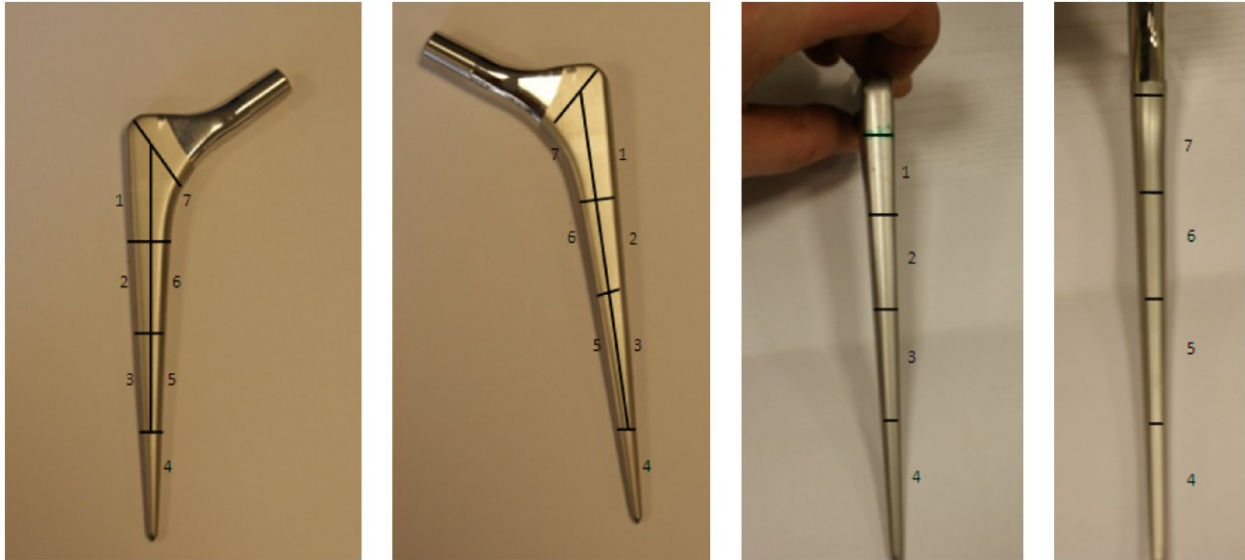
Figure 7 - Location and orientation of Gruen zones used to map fretting corrosion in this study (Bryant et al., 2013d).

Upon the completion of 500,000 cycles, each femoral stem was carefully removed and the surfaces of the CoCrMo femoral stem observed according to the grading and sectioning method present in Figure 7. Upon removal of the uncoupled femoral stem, fretting corrosion could be macroscopically seen in the proximal anterior-lateral and posterior-medial regions of the femoral stem in Gruen zones 1 and 7. Towards the distal regions of the stem, localised areas of pitting corrosion was seen typically in Gruen zone 3. Qualifications for the Gruen Zones can be found in (Bryant et al.; Bryant et al., 2013d)
