M.H. STAIA, E.S. PUCHI-CABRERA, Alain IOST, E. CARRASQUERO, Y. Y. SANTANA MENDEZ, J. G. LA BARBERA SOSA, D. CHICOT, Adrien VAN GORP - Sliding wear of a-C:H coatings against alumina in corrosive media - Diamond & Related Materials n°38, p.139-147 - 2013

# Sliding wear of a-C:H coatings against alumina in corrosive media

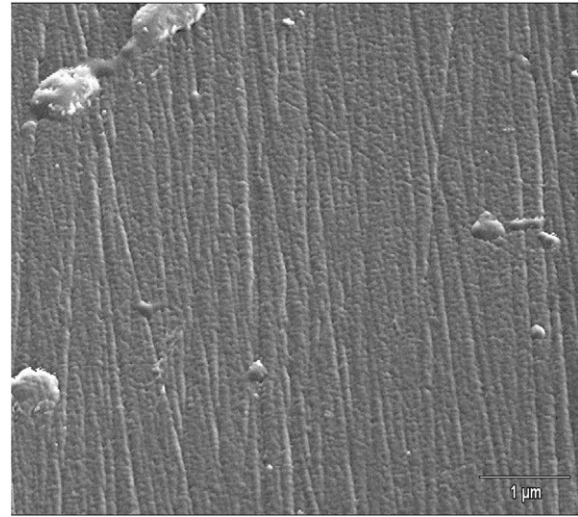
Fig. 1. SEM micrograph, indicating the morphology of the a-C:H coating on 316L stainless steel.

The overall coating thickness determined by Calotest (CSEM, Switzerland) was of 2.2 μm. The morphology of the coating (see Fig. 1) shows the presence of the typical defects that are inherent to the deposition process. The mechanical properties of the substrate, as well as the hardness of these coatings, have been determined and published elsewhere [18].

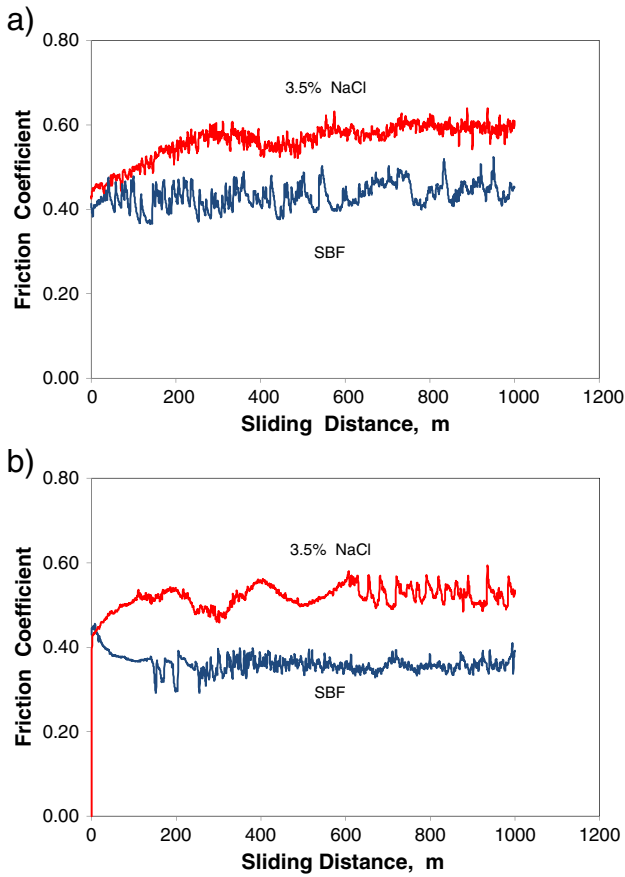
**Fig. 2.** Friction coefficient vs. sliding distance for 316L stainless steel in the SBF and 3.5% NaCl corrosive solution at a normal load of: (a) 2 N; (b) 5 N.

Fig. 2a and b shows the variation of the friction coefficients for the 316 stainless steel samples against the alumina ball as function of sliding distance in both corrosive solutions for the normal loads used during the tests. It can be observed that the friction coefficient in the 3.5% NaCl solution is 0.6, a value that is 25% higher than that of the corresponding experiments conducted with the SBF solution. The same trend was observed when a higher normal load was employed.

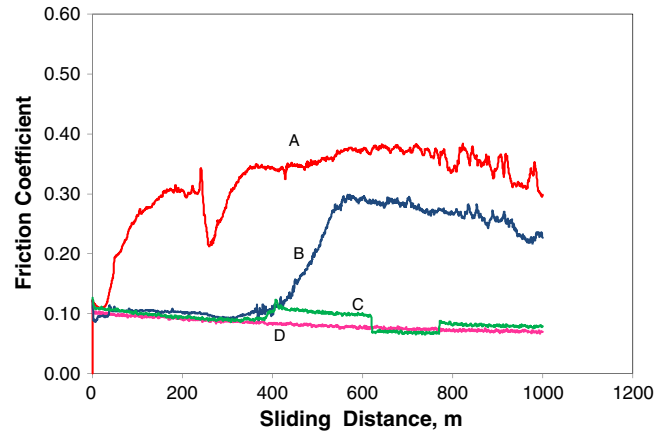
**Fig. 4.** Variation of the friction coefficient with the sliding distance for a coated sample tested with a 5 N normal load: (A) in the SBF solution; (B) in the 3.5% NaCl solution; (C) coated sample tested a 2 N normal load in a SBF solution; (D) coated sample tested a 2 N normal load in a 3.5%NaCl solution.

The typical friction behavior of the coated samples under the conditions tested in this work is shown in Fig. 4. It can be observed that the friction coefficient for the samples tested employing a 2 N normal load shows values of 0.08 and 0.09 for the NaCl and SBF, respectively. Some small events take place, as indicated in curve C corresponding to the coated sample in the presence of the SBF solution, which could be attributed to the interaction of the liquid under this load with the coating defects, producing locally a higher amount of debris.

In both cases, the coatings have been worn due to the interaction with the alumina ball, but have maintained their adherence to the substrate without spalling or delamination. However, the friction coefficients exhibited by the coated samples under a normal load of 5 N are considerably higher and the events taking place during the friction evolution curve with the sliding distance indicate that coating failure has occurred starting from the first meters of sliding for the sample A and around 400 m for the sample B.

It is interesting to mention here the fact that, for the system immersed in NaCl solution, the presence of the coating has changed the expected behavior of the substrate in this type of solution (see Fig. 3) since the high amount of wear debris resulted from the action of the NaCl solution in contact with bare steel has been considerably diminished, as consequence of the creation of a totally new surface, which exhibits a higher resistance to corrosive wear (see Figs. 4 and 5b).

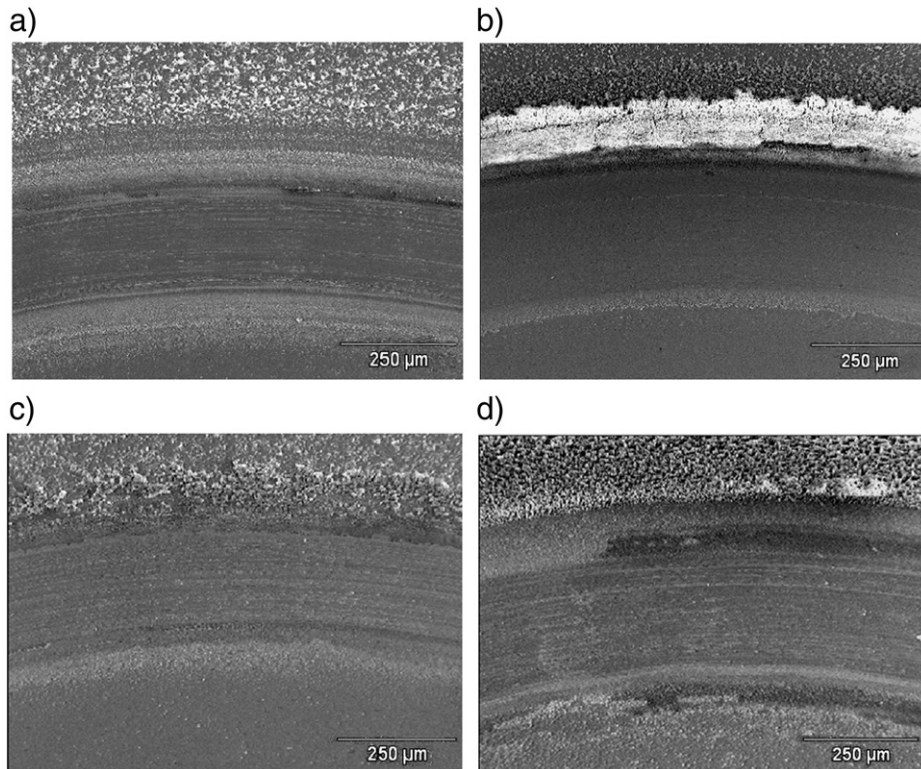
**Fig. 3.** SEM micrographs of the wear track corresponding to the 316 stainless steel samples tested in: (a) SBF solution at 5 N; (b) 3.5% NaCl solution at 5 N; (c) SBF solution at 2 N; (d) 3.5% NaCl solution at 2 N.

Fig. 3 illustrates the characteristic morphological features of the wear tracks determined by SEM analysis corresponding to the steel substrate, whose friction coefficients were reported previously in Fig. 2. In general, it is observed that a higher quantity of debris is produced when the substrate is immersed in the NaCl solution than in the SBF solution and their amount increases with the applied load.

As shown in Fig. 3, at a higher load of 5 N the depth and width of the wear tracks are much larger when compared with the wear tracks obtained for a load of 2 N. In this case, it was easier to determine the

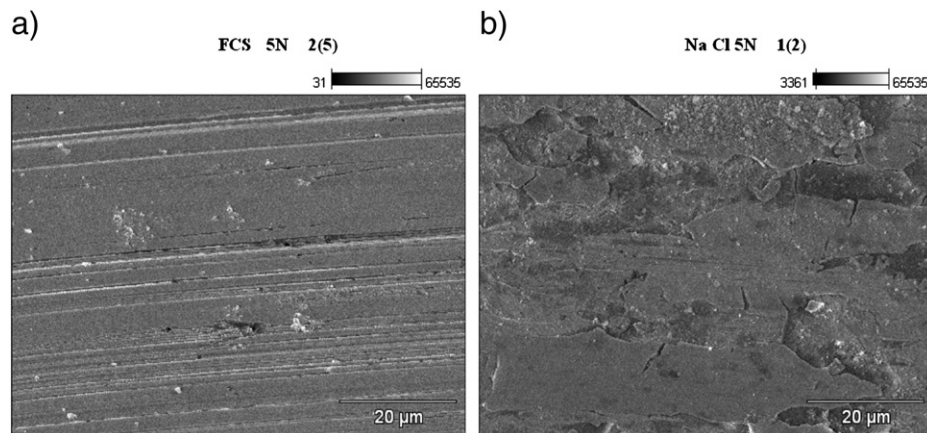
Fig. 5. SEM micrographs corresponding to the morphology of the center of the wear tracks of the coated samples for the load of 5 N: (a) sample immersed in the SBF solution indicating the presence of some abrasive features on the bare steel surface and showing the coating absence. The white particles correspond to the alumina debris from the ball; (b) sample immersed in the 3.5% NaCl, where the fractured coating is still present and some parts have been embedded into the substrate surface.

Fig. 5a and b shows the morphological characteristics of the worn coated surface, indicating the presence of abrasive features produced as a consequence of the differences between the hardness of the two counterparts.

As it can be observed, in the case of the sample immersed in the 3.5% NaCl solution (see Fig. 5b), the fracture of the coating has taken place and some parts have been embedded in the substrate, giving rise to a new surface with different tribological characteristics.

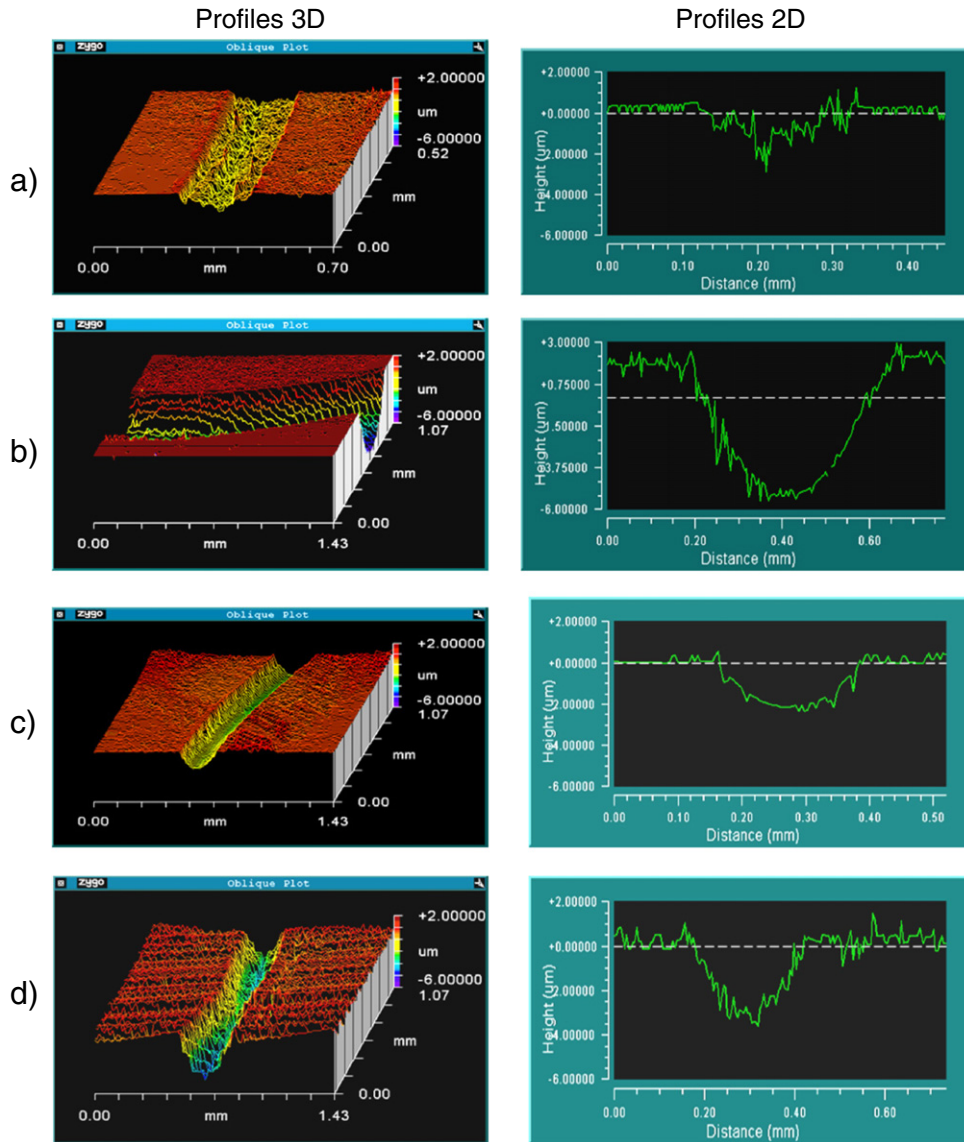
Fig. 6. Profiles of the wear tracks corresponding to the DLC coating tested in: (a) SBF solution at 2 N; (b) SBF solution at 5 N; (c) 3.5% NaCl solution at 2 N; (d) 3.5% NaCl solution at 5 N.

The 2D and 3D profiles obtained by means of the optical profilometer of the wear tracks for all the coated systems tested under the experimental setting described previously are shown in Fig. 6.

From Fig. 6 it can be clearly observed that when the normal load employed corresponds to the lower value of 2 N, the coatings are still present on the stainless steel substrate and, therefore, the value of the intrinsic rate constant can be calculated by dividing the wear volume by the product between normal load and the sliding distance (see Table 1).

However, the wear track profile corresponding to the sample tested in the SBF solution has an irregular shape, which makes the evaluation of the cross sectional area with the same precision as for the sample immersed in the NaCl solution difficult. Nevertheless, it was found that the value of the wear constant,  $k$ , was of approximately  $2 \times 10^{-6} \text{ mm}^3/\text{Nm}$  and no significant differences were obtained between the wear rate of the DLC coating in 3.5% NaCl and the SBF solution, respectively.

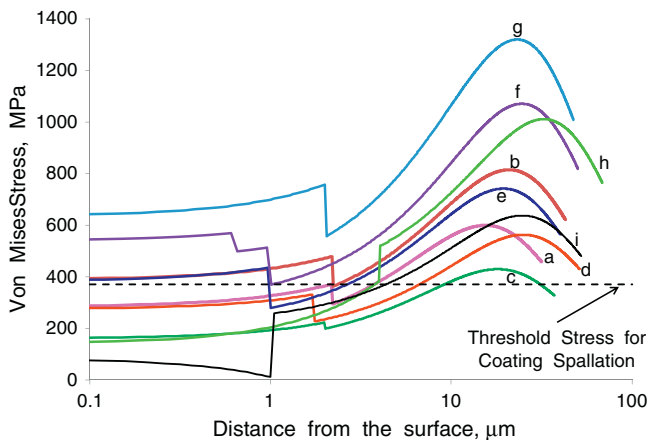
**Fig. 7.** Variation of the von Mises stress with the distance from the surface for the systems under study and for other DLC coated systems reported in the literature and described in Table 2.

However, it should also be borne in mind that below the coating, the existence of a 316L stainless steel layer could provide an elastic support to it. For example, for curves a and b in Fig. 7, corresponding to the tests conducted in the present research, it can be seen that when a normal load of 2 N is applied (curve a), the thickness of the elastic layer, of about 8.3  $\mu\text{m}$ , is approximately 4 times the thickness of the coating and decreases to 5.5  $\mu\text{m}$  for a load of 5 N (curve b). Consequently, it will be expected that plastic deformation of the substrate occurs at a distance from the surface greater than approximately 3  $\mu\text{m}$  (curve f) and that during a wear test carried out in air, for both values of the applied load, no cracking will occur that could give rise to the coating detachment.

As can be seen in Fig. 7, the state of stress for the coated system under a load of 5 N (curve b) is more severe than in the case of a 2 N load (curve a). Therefore, it could be argued that its severity enhances the corrosive action of the solutions, similarly to the commonly observed stress corrosion-cracking phenomenon.
