Stereophotographic Measurement of Joint and Bedding Orientation at Thornton Quarry, Illinois

Christopher J. Stohr, Justine Petras, Donald G. Mikulic, and Jason Thomason

Circular 579 2011

ILLINOIS STATE GEOLOGICAL SURVEY
Prairie Research Institute
University of Illinois at Urbana-Champaign

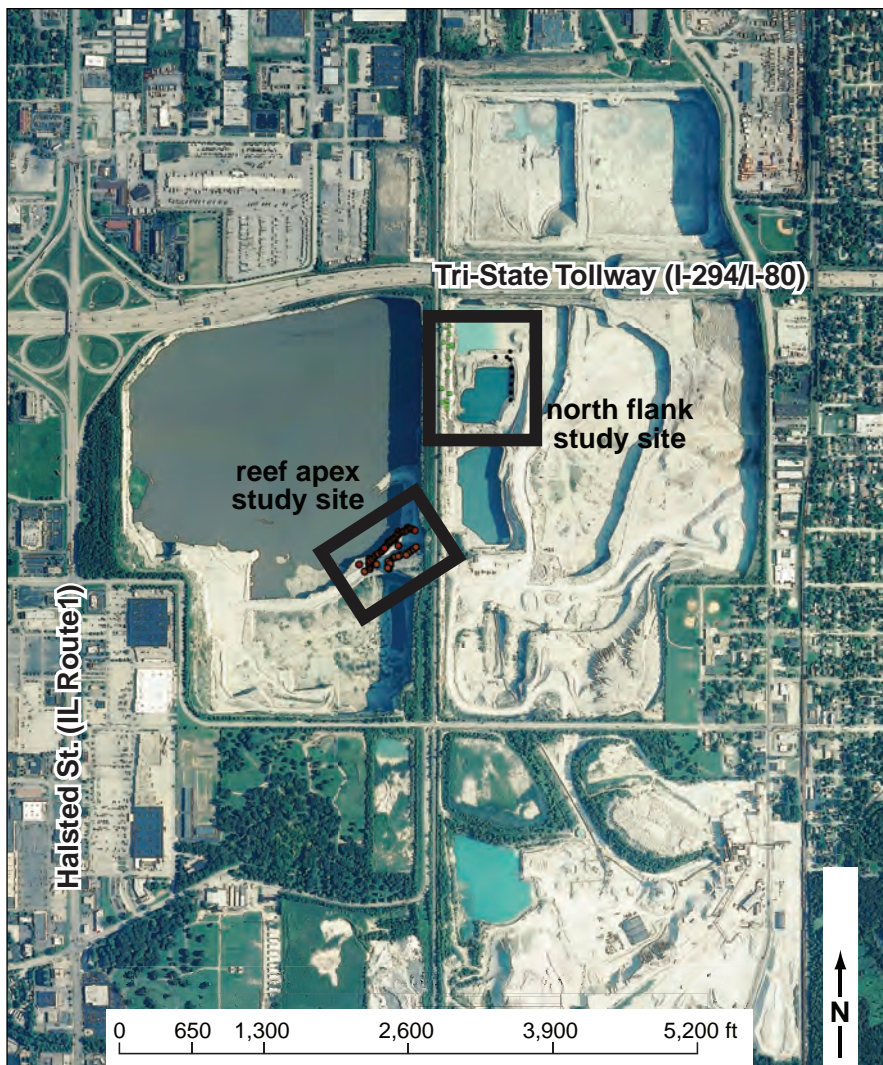
Figure 3 A color orthophotograph showing study sites at the reef apex and north flank of the main lobe. (Imagery is from the 2010 National Agricultural Imagery Program.) Study sites are shown in detail in Figures 7 and 8.

(MWRDGC) has begun using part of the quarry as a storm water reservoir with a capacity of 3.1 billion gallons (Figure 3). Floodwater is diverted from Thorn Creek and the Little Calumet River through a tunnel to the lower west lobe of the quarry for retention until released through the Calumet Water Reclamation District Plant and discharge into the local waterways. The north lobe will become the composite reservoir when excavation is completed, and it will replace the transitional reservoir in the lower west lobe, which will be returned to quarry operations.

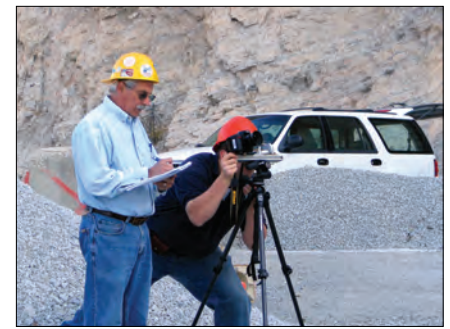
Figure 4 Collecting stereophotography at the reef apex.

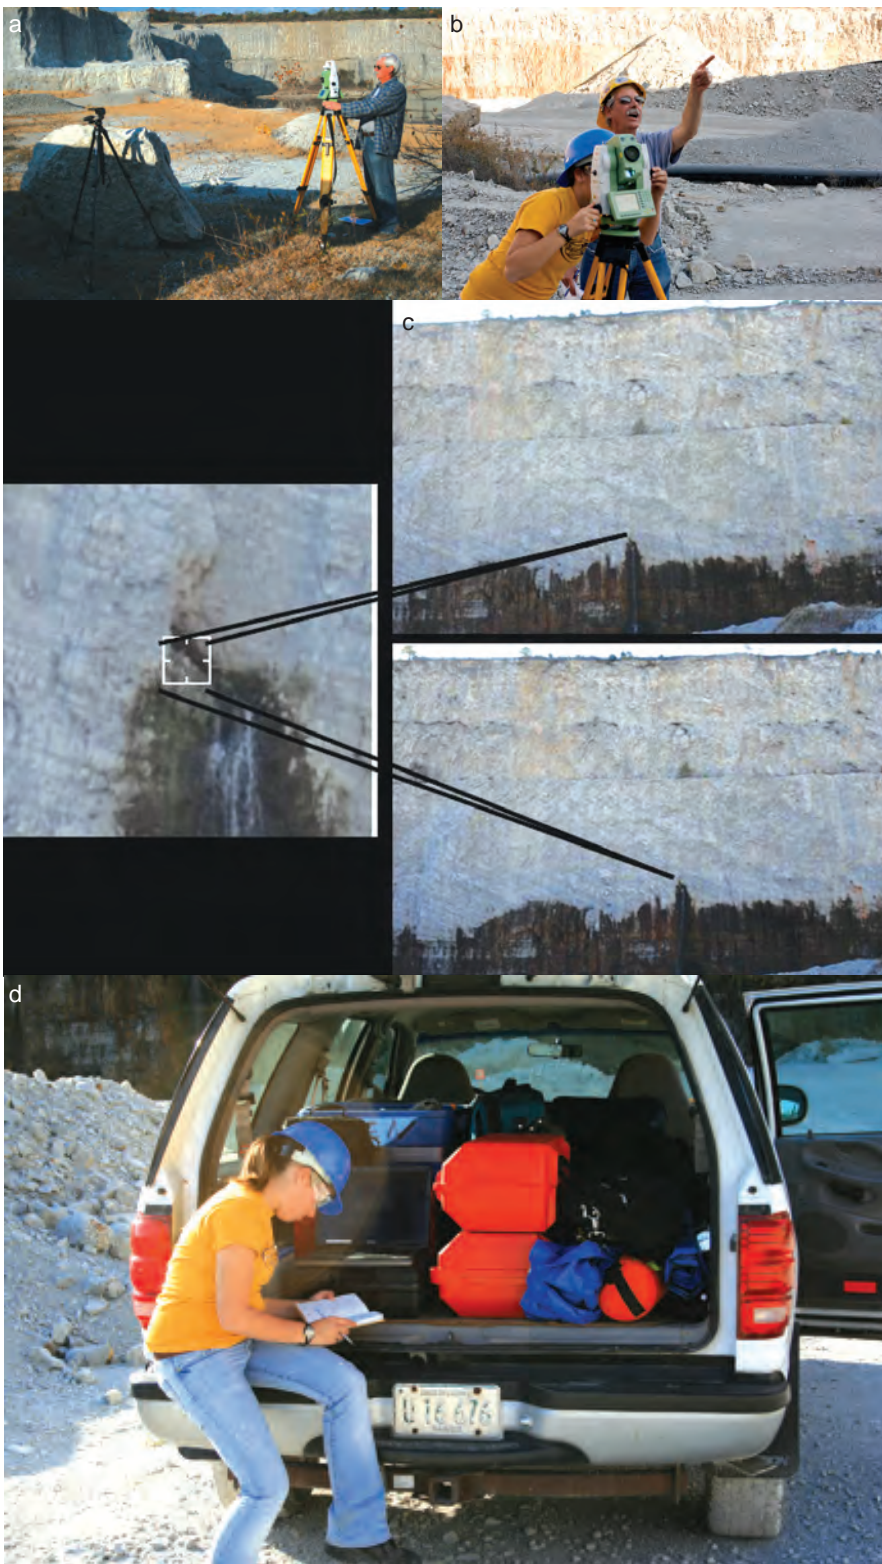
Figure 5 Surveying the camera station (a) and the reference mark on quarry wall (b and c) and noting the mark location on the photomosaic on a notebook computer (d).

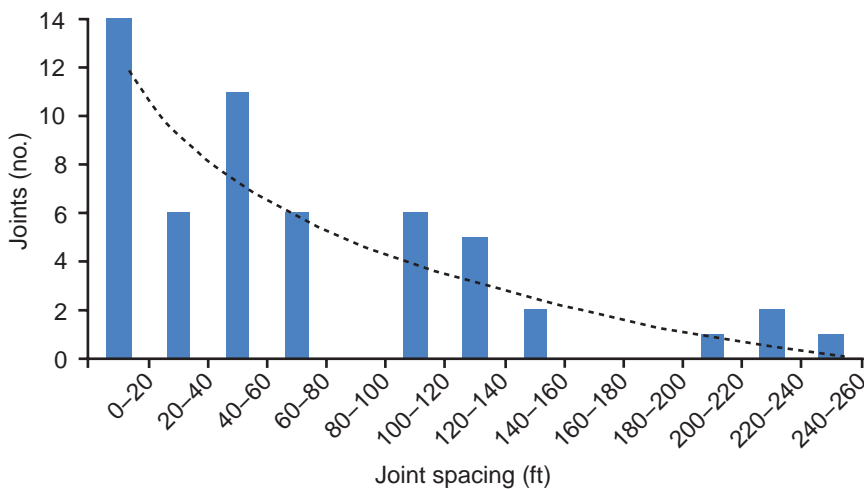
Figure 10 Joint spacing at the north flank study site. The logarithmic trend has been fitted to the data.

Distance between the joints ranges from 6 to 250 feet. The average spacing of joints in all stereomodels of the north flank is 71 feet, although the trend appears to have a log-normal distribution with multiple deviations and gaps (Table 1 and Figure 10). Comparison of joint spacing (Figure 10) with joint length (Figure 11) shows that short joints tend to be closely spaced, and long joints are more distantly spaced. This distribution suggests that there are multiple causes of joint formation from natural forces such as regional stress and fracturing caused by quarrying activities.

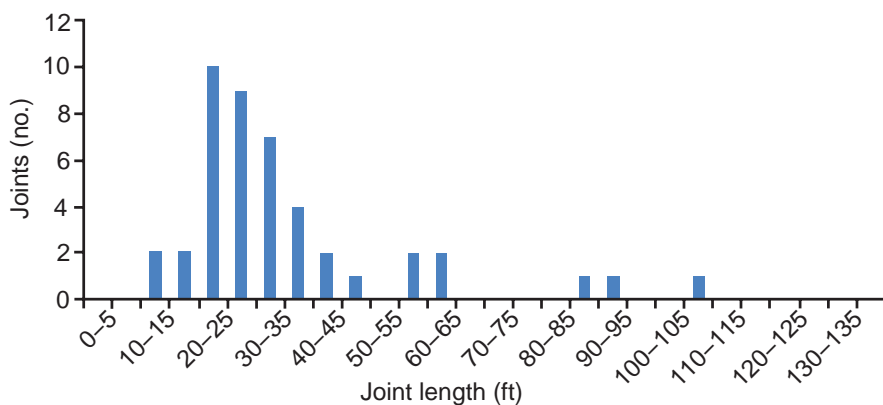
Figure 11 Length of joints at the north flank study site.

Most joints are between 20 and 40 feet in length and average about 36 feet (Figure 11 and Table 2). Lengths are considered to be accurate within the range of error described later in the error of control section. Seven joints are longer than 50 feet, and only a single joint was longer than 100 feet. None extended the entire 300-foot-high quarry wall. Longer joints are more nearly vertical. Short joints might be a consequence of blasting or quarrying activity or polygonal fracturing and deformation. Some of the joints measured are shown in Figures 6 and 9.

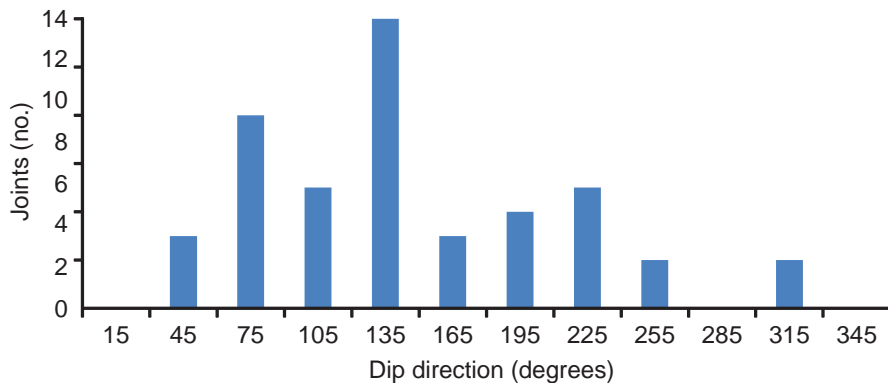
Figure 13 Histogram of joints and dip direction at the north flank site.

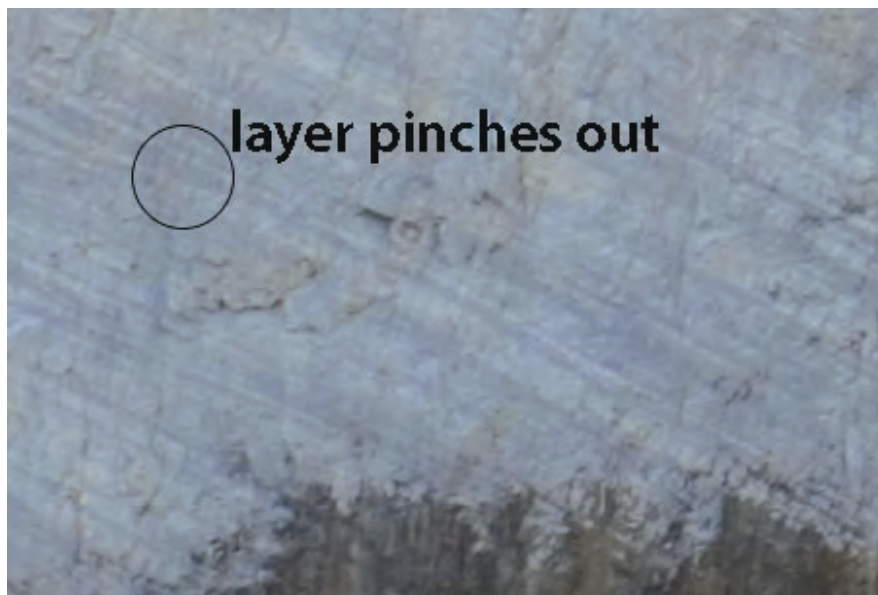
Figure 14 Change in bedding thickness and continuity at the north flank site. Circle shows where a light-toned bed exhibits pronounced change in thickness. The light-toned bed pinches out completely. Note the dark algae and stains from groundwater on the lower edge.

Two lithologic formations are seen within the stereomodels; both are dolomitic reef rocks of Silurian age. The Racine Dolomite (Niagaran Series) unconformably overlies the older Sugar Run/Joliet Dolomite (Mikulic and Kluessendorf 1999). Joints and bedding in the lower units are difficult to see because water stains and rock piles obscure part of the wall (Figures 6, 9, 14, and 15). Only those joints within the Racine Dolomite were digitized.

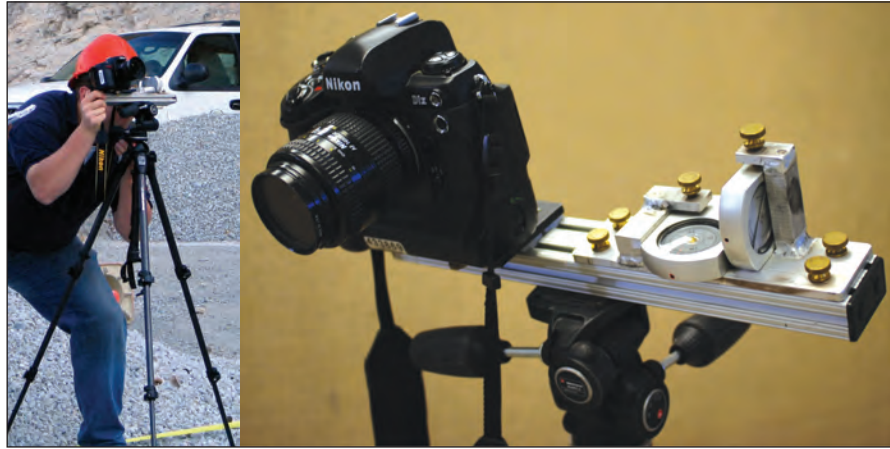
Figure A1.2 Recording a tilted image using a specially built bracket devised by Michael Dodd at the ISGS. The Nikon D80 camera is mounted on the tripod and Dodd bracket with compass and clinometer (right). The clinometer is on the left of the bracket, the compass is in the middle of the bracket, and the camera mounting plate is to the right.

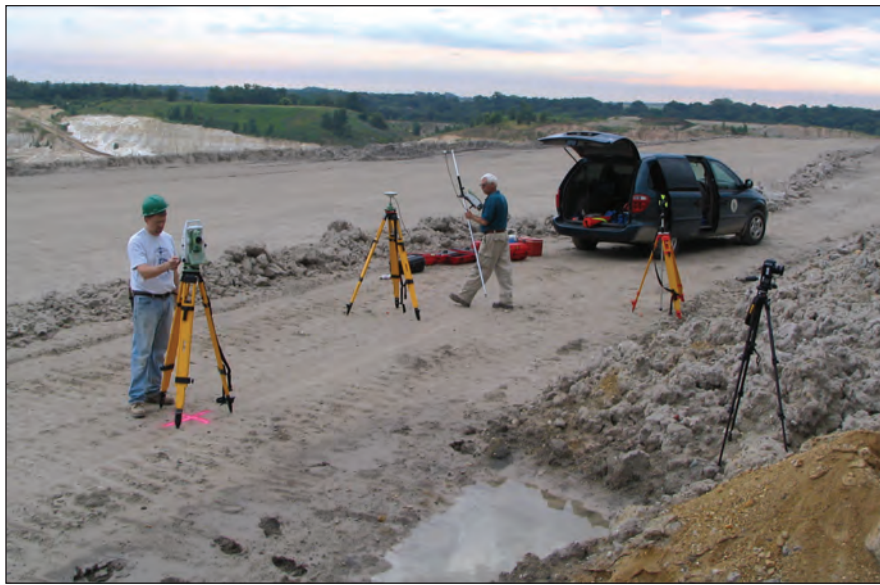
Figure A1.3 Typical field setup with a total station and operator (left), GPS base station (middle), and RTK GPS rover (carried by operator), backsight prism (right), and camera (foreground). Photographs for stereomodels are spaced 1/7 of the distance between the outcrop and the camera station.

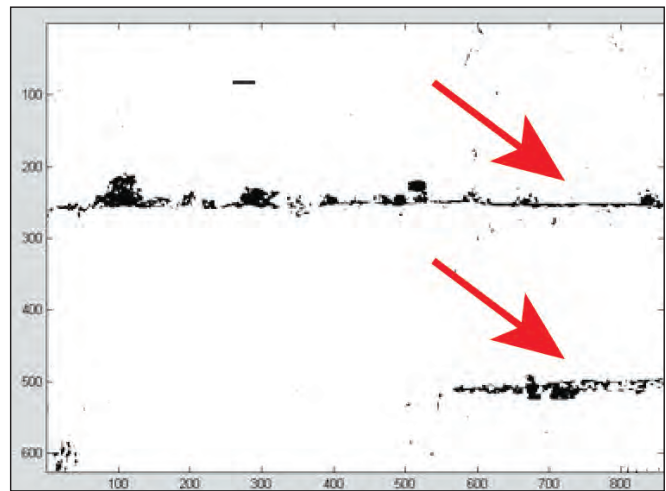
Figure A2.4 Matched (98%) and unmatched area of stereomodel 3006-3007. Most of the unmatched areas are bushes and small trees along a prominent bench above the middle of the image and a second short bench in the lower right.

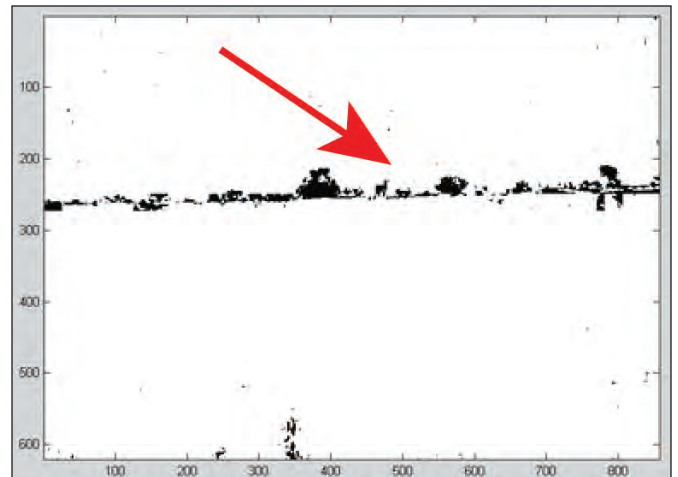
Figure A3.4 Matched (98%) and unmatched area of stereomodel 3007-3008. Most of the unmatched areas are bushes and small trees along a prominent horizontal bench across the middle of the image and a stained area with a cave issuing freely flowing water in the lower center.

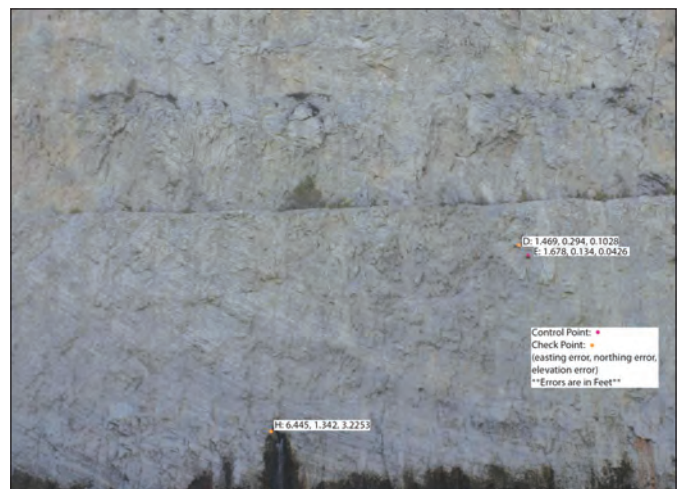
Figure A3.9 Control point E and check points for orthophoto-graph 3007-3008. Errors are shown in feet for easting, north- ing, and elevation.

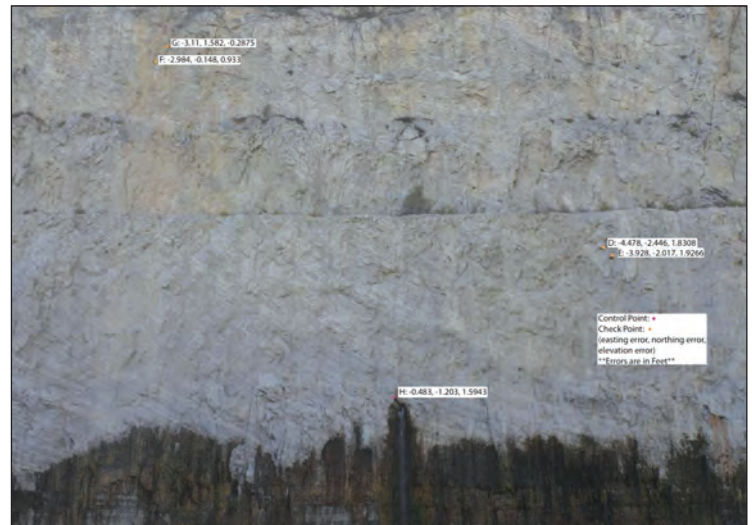
Figure A4.9 Control point H immediately above a small cave issuing water and check points for orthophotograph 3008-3009. Errors are shown in feet for easting, northing, and elevation.

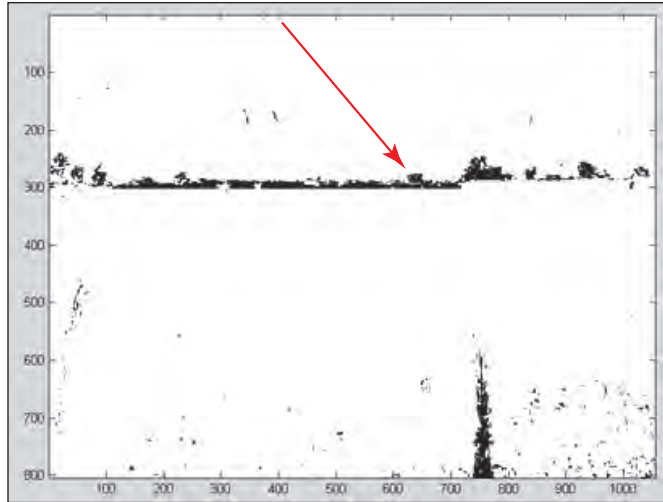
Figure A5.3 Matched (98%) and unmatched area of stereo-model 3009-3010. Most of the unmatched areas are small trees and bushes on a prominent horizontal bench above the middle of the image and a stained area in lower right.

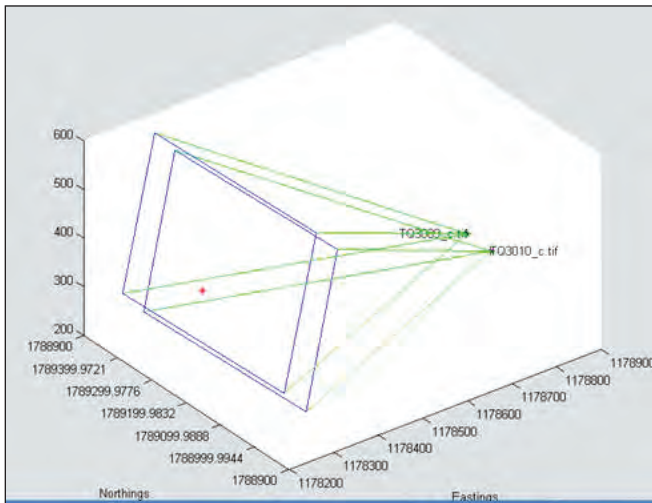
Figure A5.2 Orientation, overlap, and alignment of stereo-model 3009-3010 in relation to control point H (marked by a red cross).
