Contract Report 2001-09

**River Geometry, Bank Erosion, and Sand Bars
within the Main Stem of the Kankakee River
in Illinois and Indiana**

**Prepared for the
Illinois Department of Natural Resources
Office of Realty and Environmental Planning**

June 2001

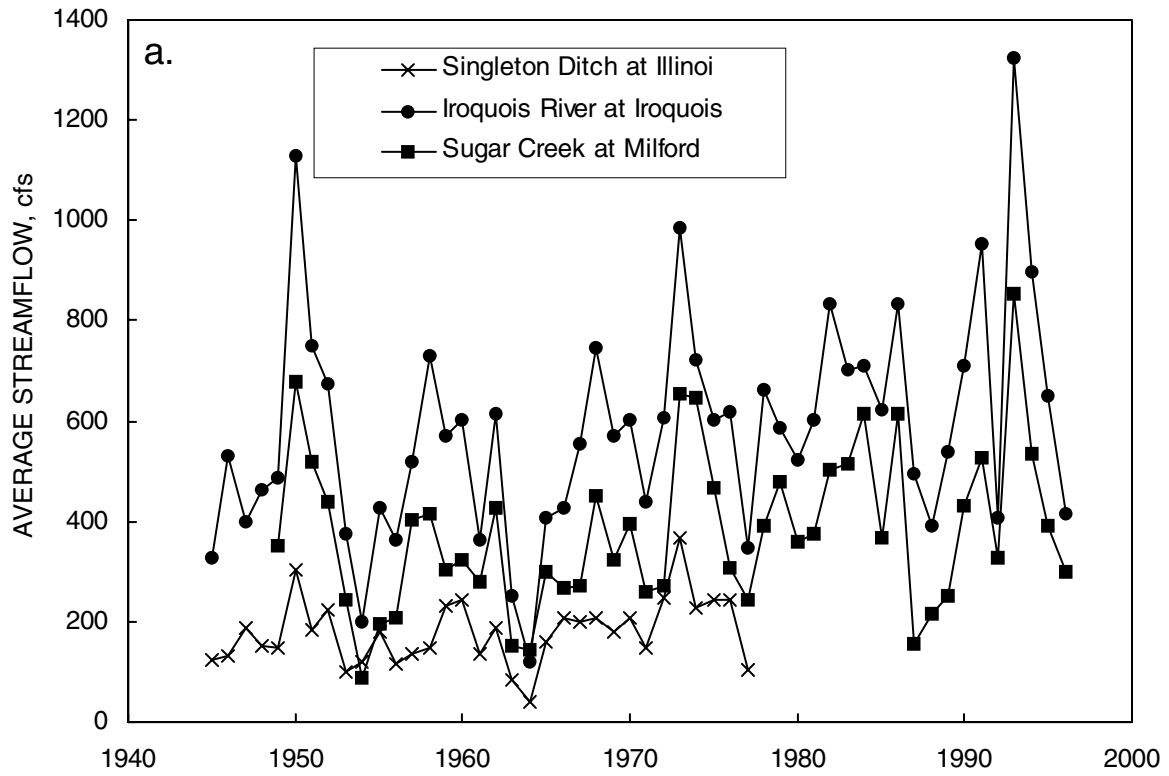
Figure 3. Average annual streamflows for gaging stations in the Kankakee River basin in Illinois

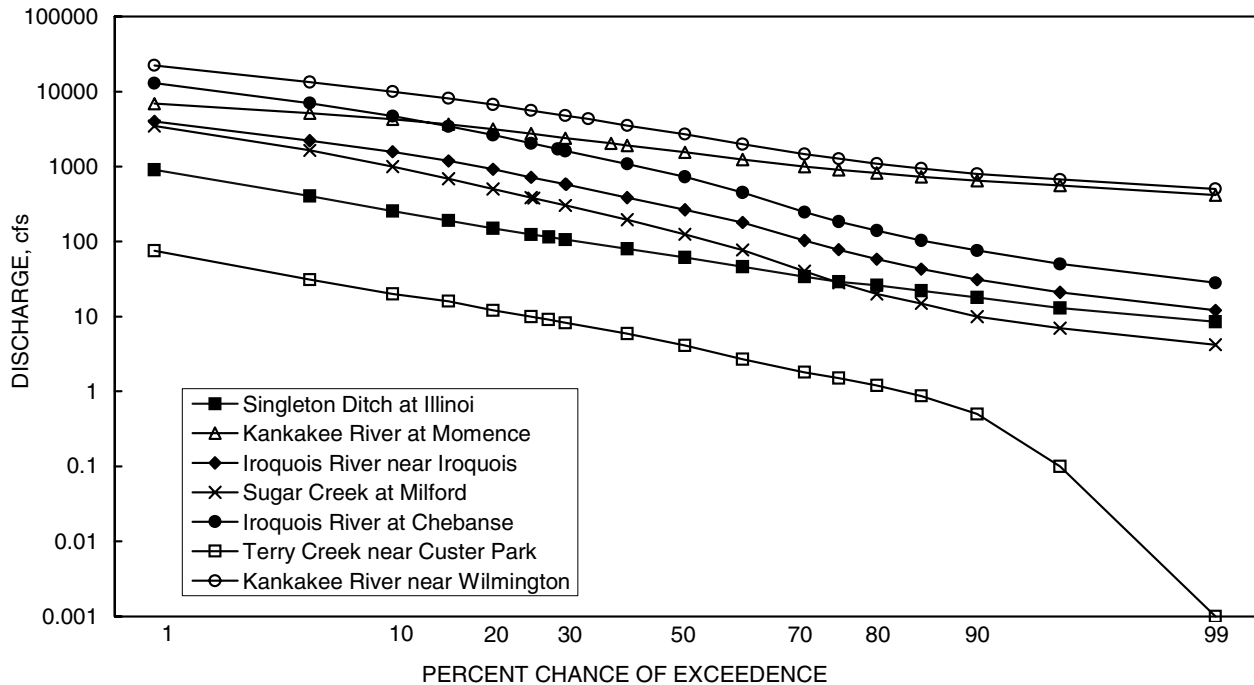
Figure 4. Flow duration curves (discharge vs. probability) for gaging stations in the Kankakee River basin in Illinois

Variations in the general shapes of the flow duration curves often can point to significant differences in the hydrology of each stream. The Kankakee River at Momence and the Iroquois River near Chebanse drain watersheds of similar size and have similar average flow rates. However, the variability in flows for the Kankakee River at Momence is considerably smaller than that for the Iroquois River, as seen in Figure 4. This reduced range in flows for the upper Kankakee River basin is caused by 1) its coarse-grained soils, which have increased infiltration and less direct surface runoff, and 2) the direct connection of the river and its tributaries with shallow sand-and-gravel aquifers. Much of the streamflow in this region originates from the ground water and, as a result, the upper Kankakee River has substantial low flow even during the most severe droughts.

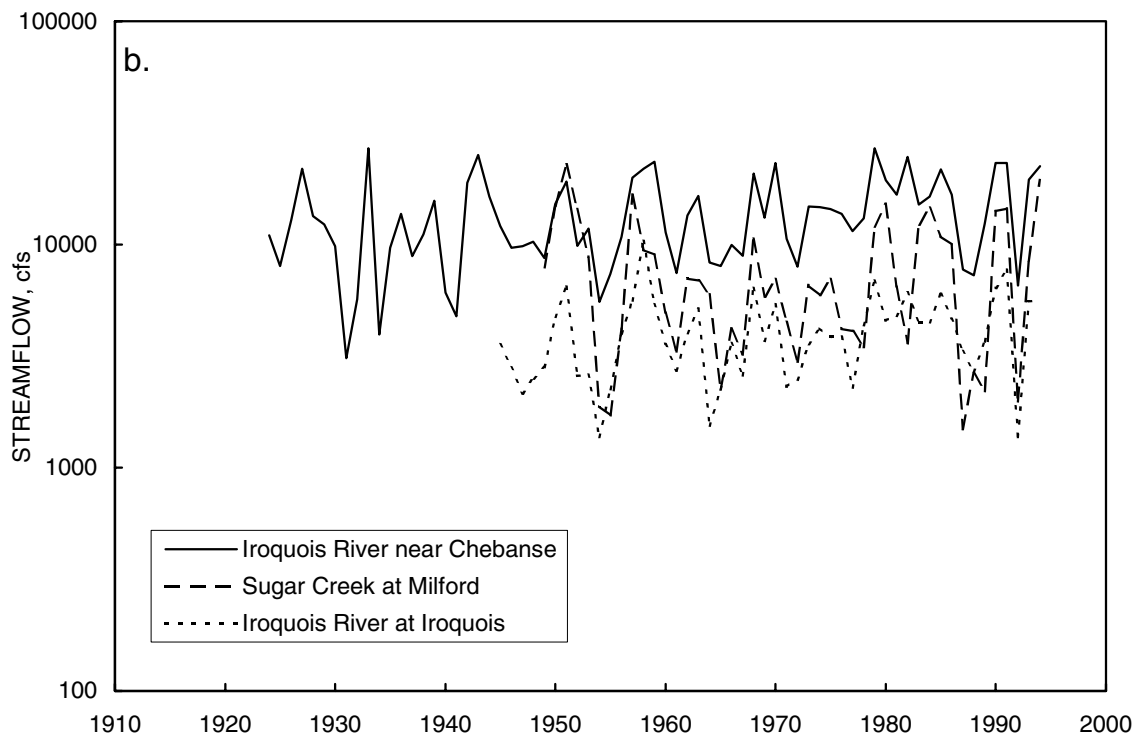
Figure 5. Annual peak discharges for gaging stations in the Kankakee River basin in Illinois

Figure 5 shows the annual series of peak flood discharges for the Kankakee River and tributaries in Illinois. Examination of this figure indicates a distinct increasing trend in peak discharges for the Momence and Wilmington gages on the Kankakee River. On the Iroquois River, the magnitude of the high flood levels has not changed substantially; however, the frequency of moderate flood events has increased, and there are fewer years with little or no flooding. Part of this increase in flood frequency is related to the corresponding increase in average flows and average precipitation that have occurred since the 1960s.

The Kankakee River, more than any other river in the State, shows definite increasing trends of high, medium, and low streamflows. Streamflow records on the Kankakee River show that a major jump in the flow amounts occurred in the mid- to late 1960s. All trends appear to be related to a coincident increase in average annual precipitation. Examination of land use in the watershed has not identified a direct cause for the increase in average flow conditions, but such changes may play a secondary role in high and low trends. Irrigation withdrawals from streams have some impact on reducing low flows during drought years. Trend analysis does not identify any continued increases in high or low flows over the past 30 years.

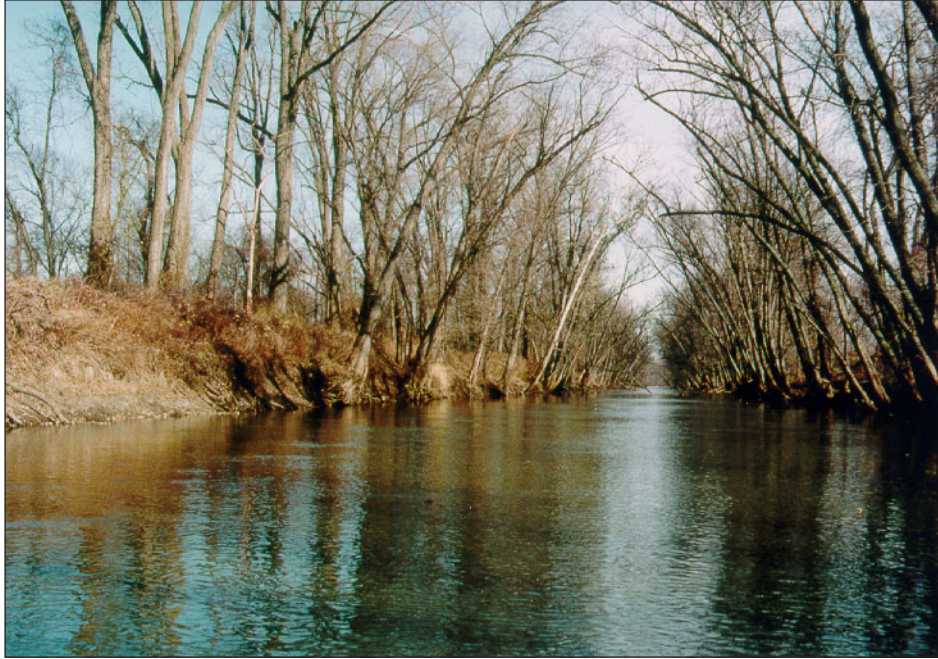
Figure 6a. A typical view of the Kankakee River channelization and bank vegetation in Indiana (from Bhowmik and Demissie, 2000)

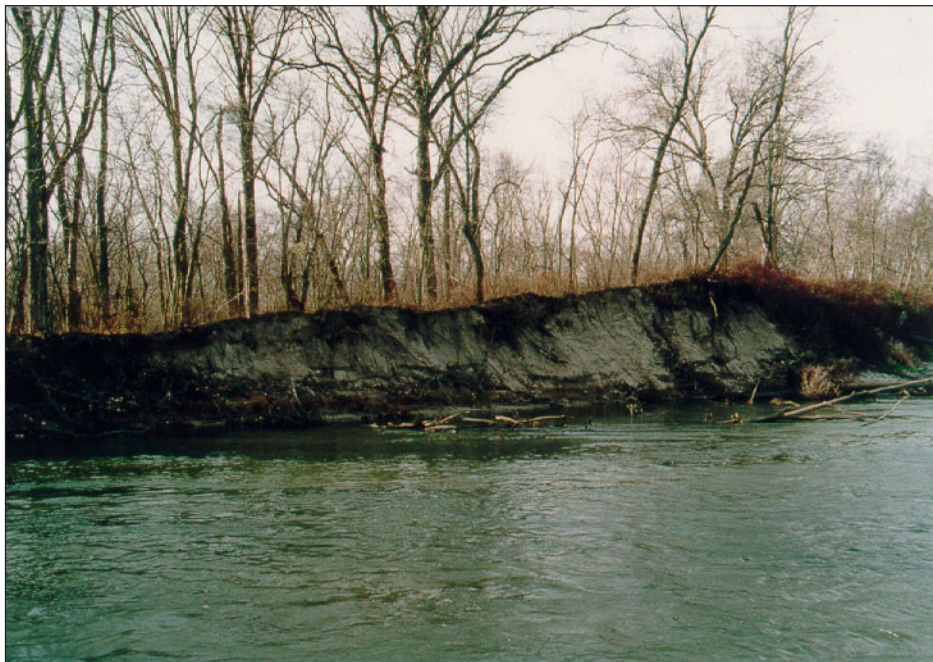
Figure 6b. An example of a 5-foot scarp with underlying piping above a steep sandy bench on the Kankakee River in Indiana (from Bhowmik and Demissie, 2000)

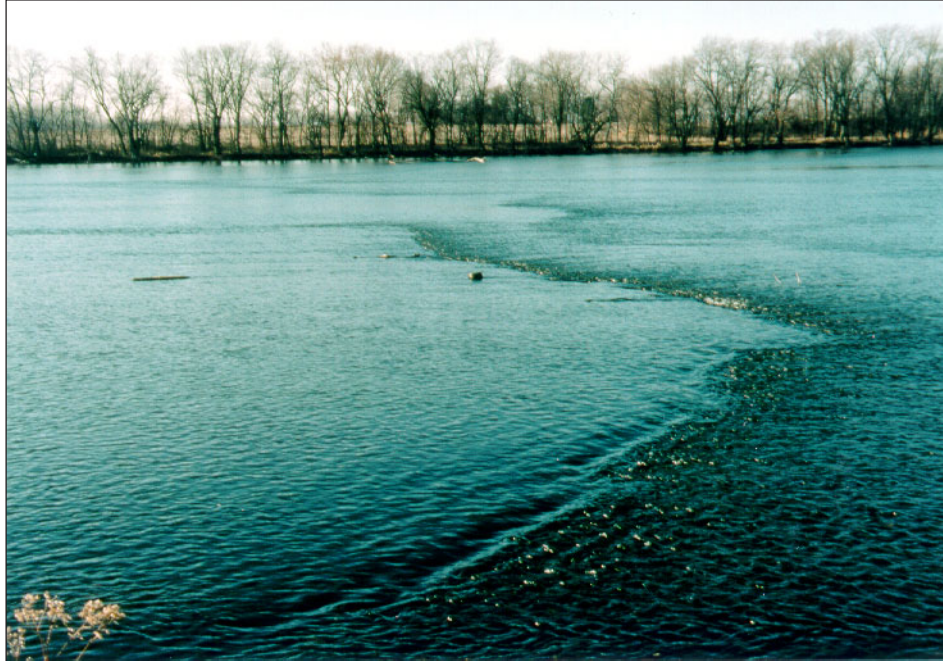
Figure 7a. An example of a riffle formed by the edge of a bedrock section and gravel deposits on the Kankakee River in Illinois (from Bhowmik and Demissie, 2000)

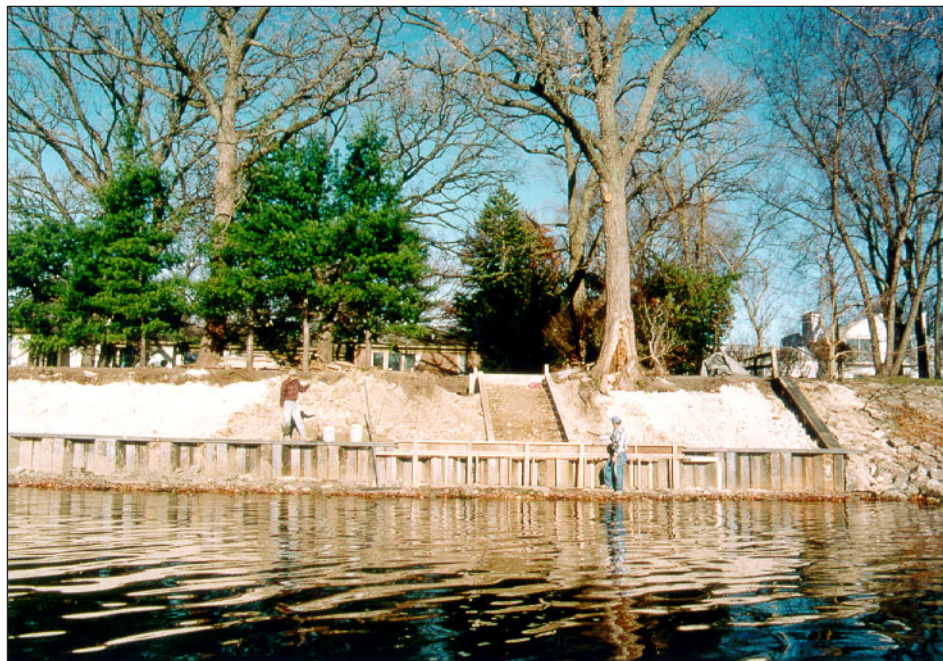
Figure 7b. An example of the installation of bank protection residential sheet-piling on the Kankakee River in Kankakee, Illinois (from Bhowmik and Demissie, 2000)

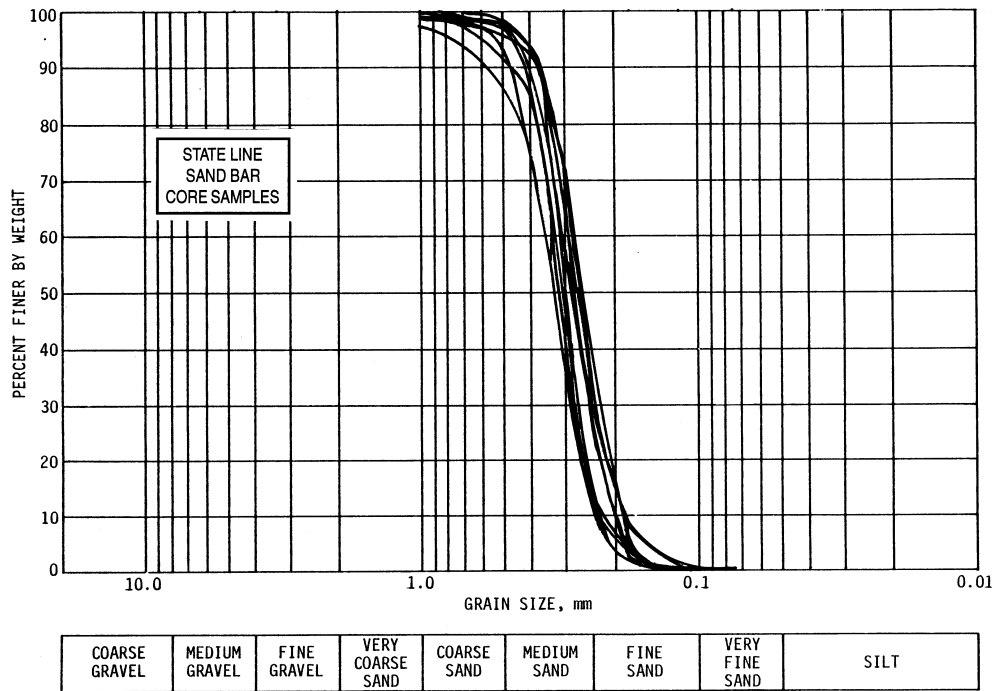
Figure 12. Particle size distributions of core samples from the sand bar near the State Line Bridge (from Bhowmik et al., 1980)

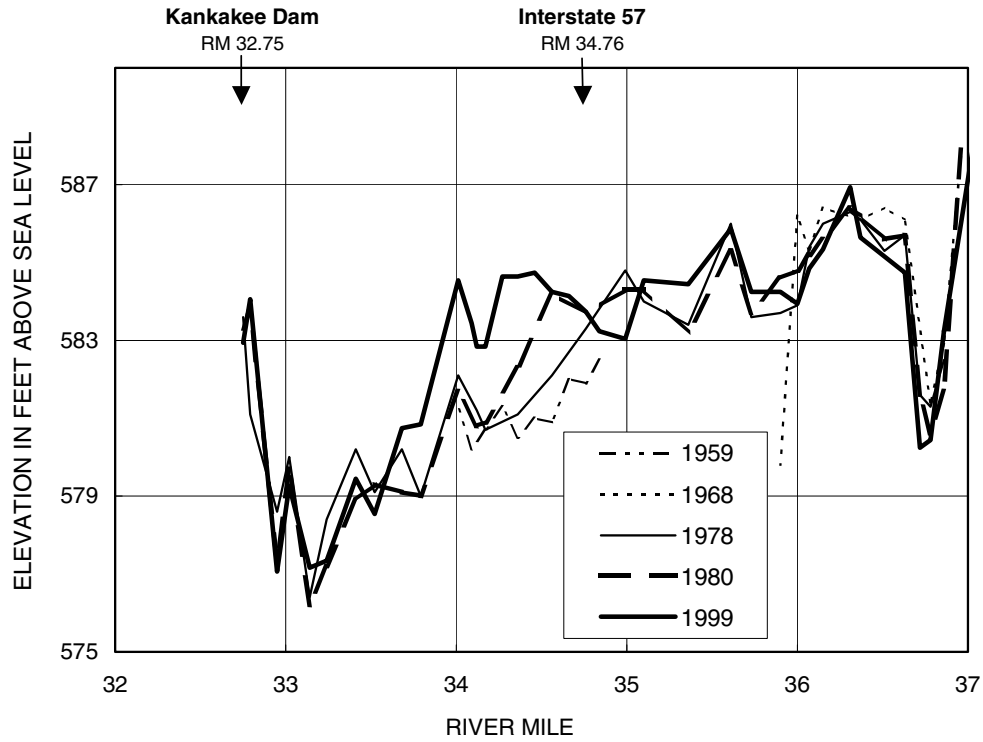
Figure 26. Invert elevations for various periods for Six-Mile Pool

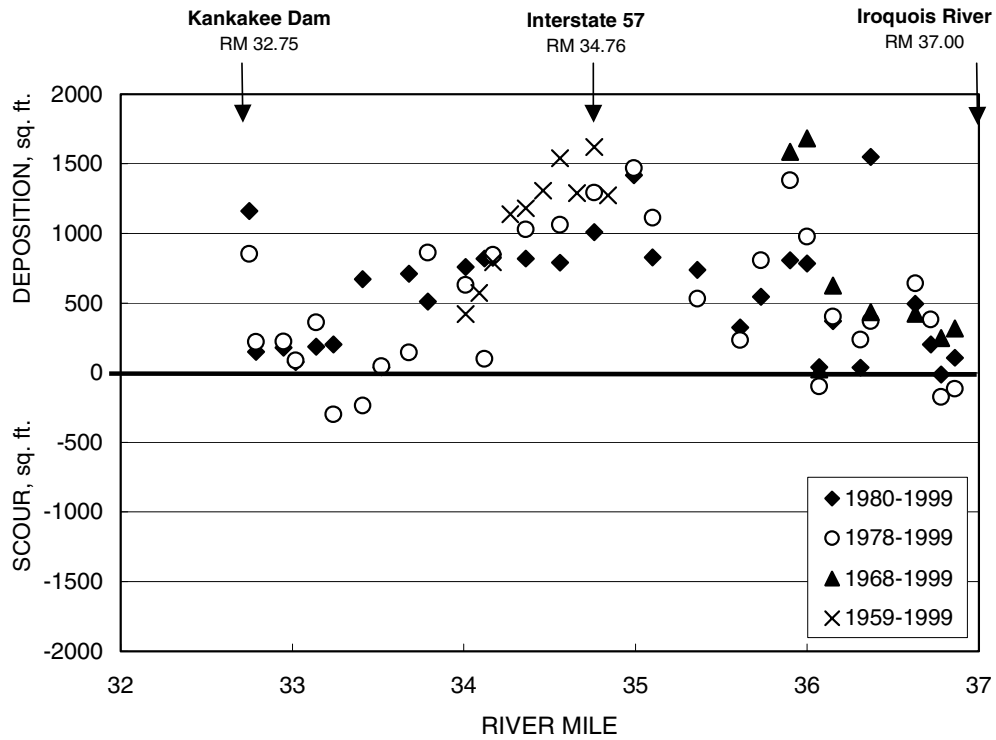
Figure 27. Changes in cross-sectional areas within Six-Mile Pool between 1959, 1968, 1978, and 1980, compared with those collected in 1999, in square feet

Figure 27 shows the differences in cross-sectional data between 1959, 1968, 1978, and 1980 with those observed in 1999. All cross-sectional areas were computed below an average water surface elevation of 595 feet above mean sea level (ft-msl). Whenever the cross-sectional area measured at any particular cross section in 1999 was less than that measured in the previous surveys, the difference is the area that has been filled by the deposition of sediment. Conversely, whenever the cross-sectional areas measured in 1999 at any particular cross section were more than those measured in any previous surveys, then those cross sections have shown the scouring activities.

Figure 27 indicates that the pool is accumulating sediments from just upstream of the dam at RM 32.75 through RM 33.14, scour at or near RM 33.24 to RM 33.41, heavy sediment deposition from around RM 33.41 through RM 36.37, some scouring at or near RM 36.72 and RM 36.78, and deposition upstream of RM 36.86. The apparent scour zone around RM 33.24 and RM 33.41 could be explained in terms of the flow patterns that could generate upstream of an in-channel dam within a very confined channel. It appears that as the water

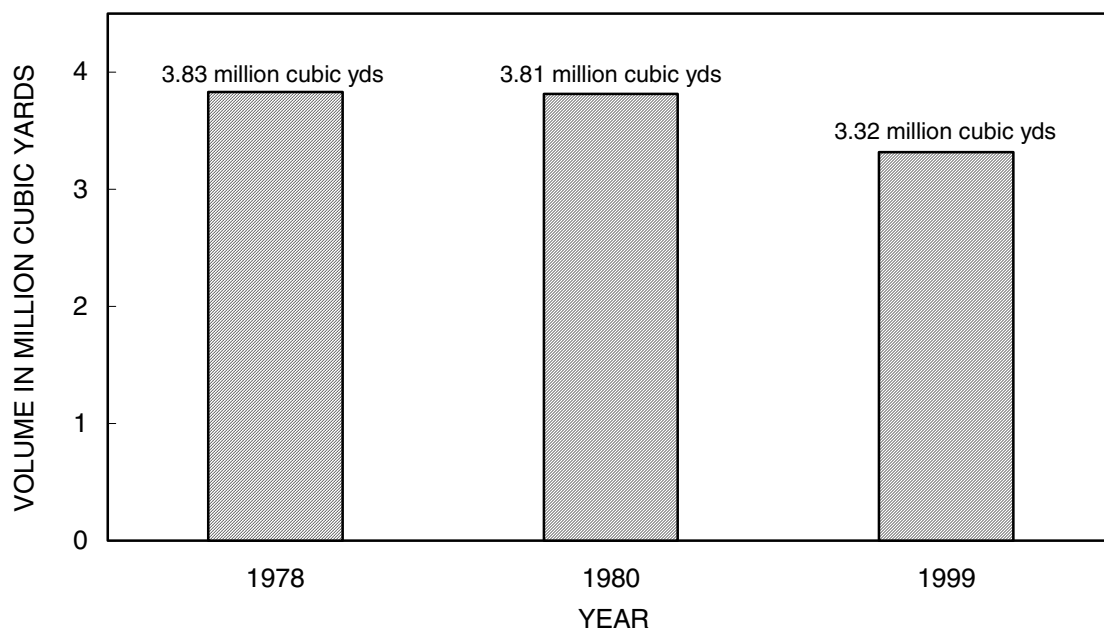
Figure 28. Volume of Six-Mile Pool below 595 ft-msl in 1978, 1980, and 1999

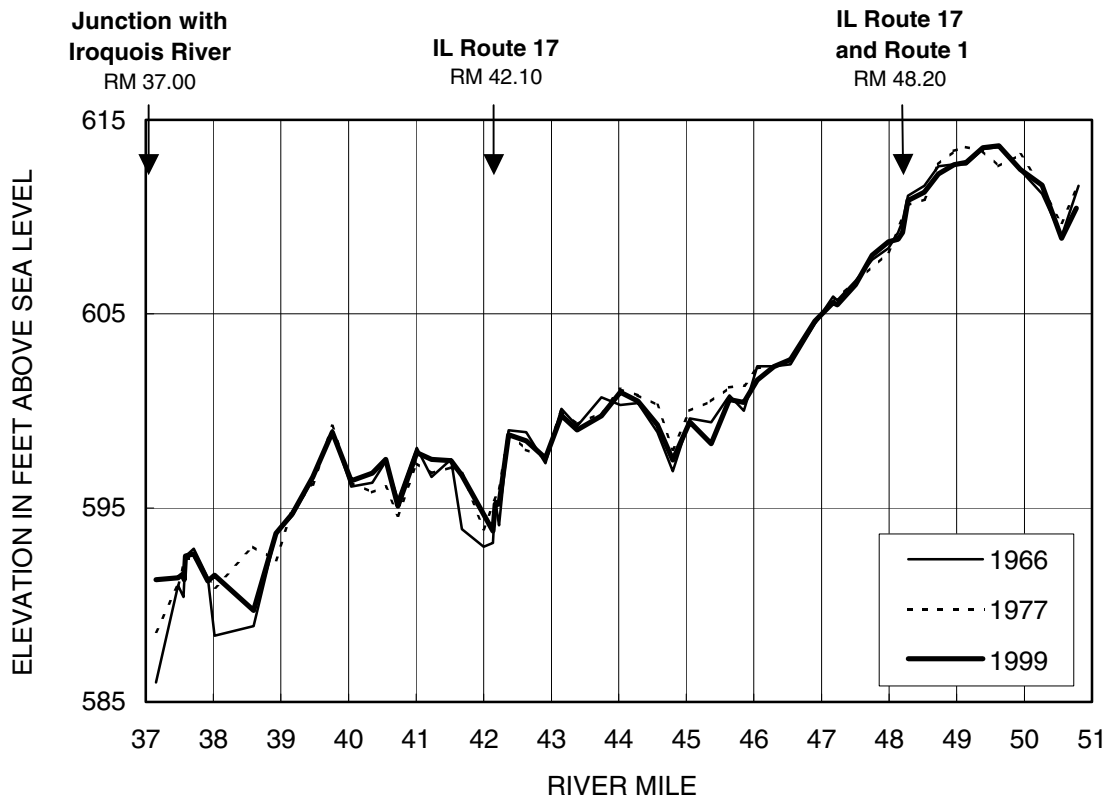
Figure 29. Invert elevations for various periods from Aroma Park to Singleton Ditch

Figure 29 shows the average invert elevations of the river from Aroma Park to Momence. A review of this illustration shows the river aggrading at a few locations, some scour at other locations, and no change in river bed elevations since 1966 at other locations. These conditions are further illustrated with the aid of several river cross-sectional plots (Figures 30 and 31).

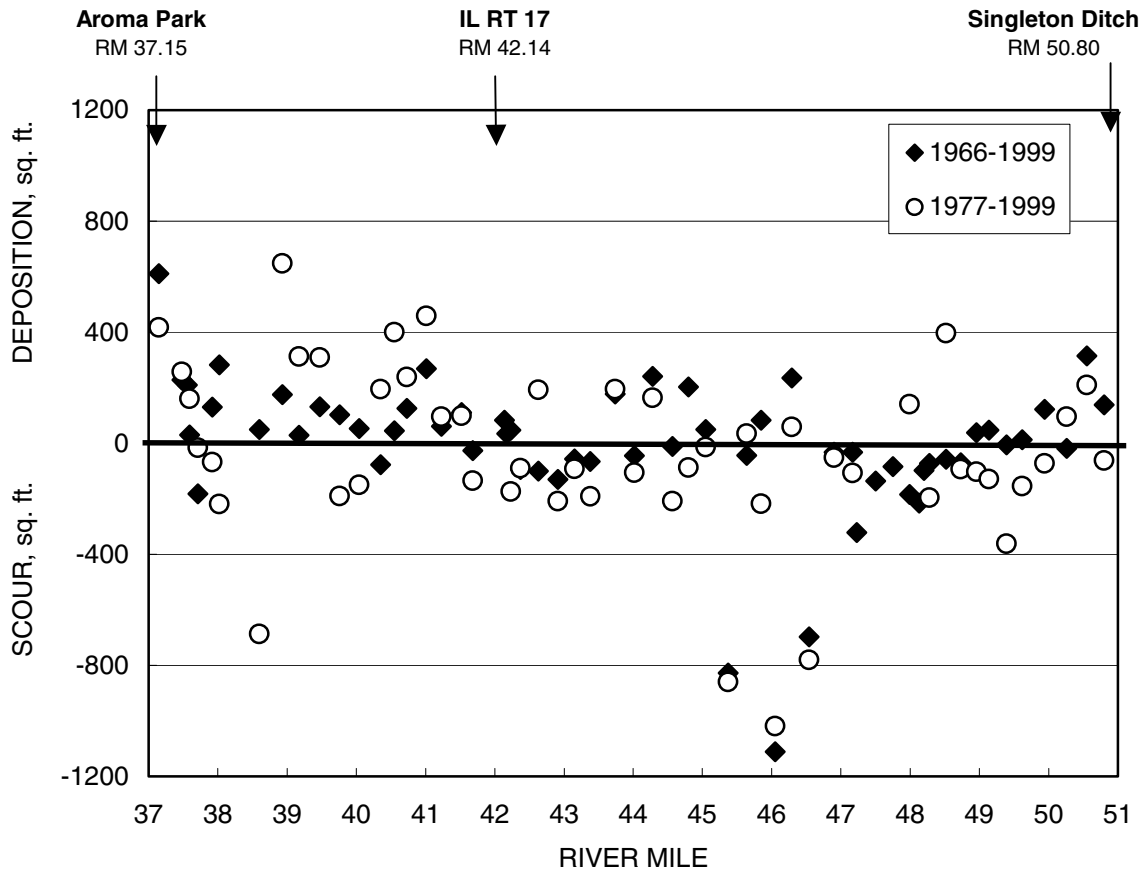
Figure 34. Changes in cross-sectional area in the reach from Aroma Park to Singleton Ditch between 1966 and 1977 compared with those collected in 1999, in square feet

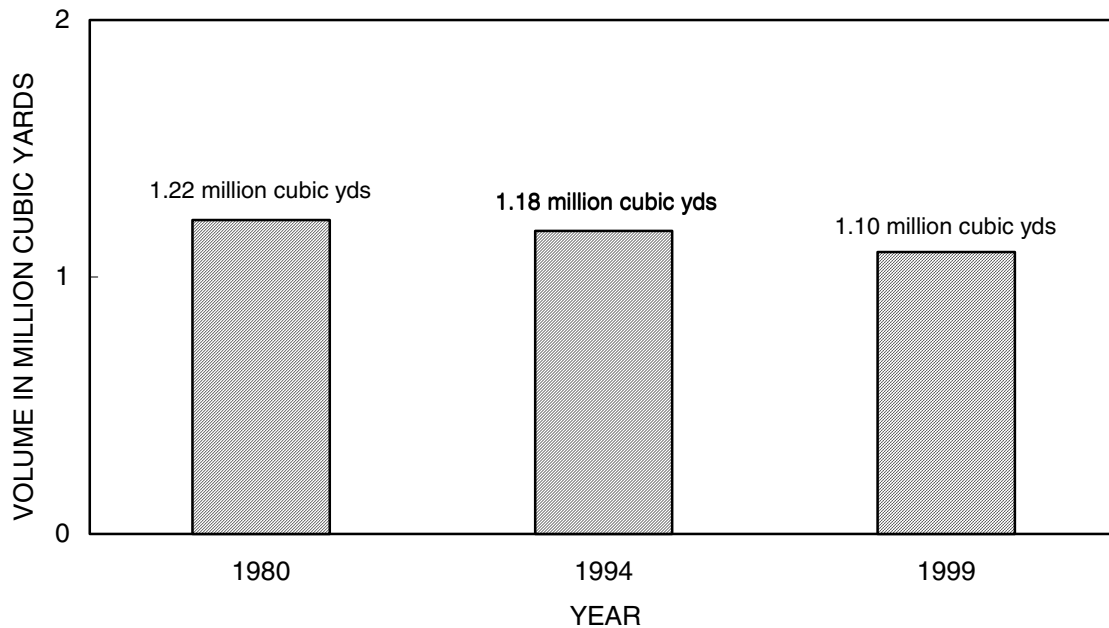
Figure 41. Volume of Momenca Wetland (from Singleton Ditch to State Line Bridge) within river banks in 1980, 1994, and 1999

These losses in capacities could be used as a surrogate to estimate the movement of coarse-grained materials from Indiana to Illinois through the main stem of the Kankakee River. Some of the coarse-grained material, which is presumed to be moving as bed loads, must have passed through the river to its downstream reaches. However, if it is assumed that most of the bed load stayed within the stream channel and probably in the Momence Wetland area, then it appears that the stream channel within the Momence Wetland and between the river banks had an accumulation of 127,440 cubic yards of sediment between 1980 and 1999.

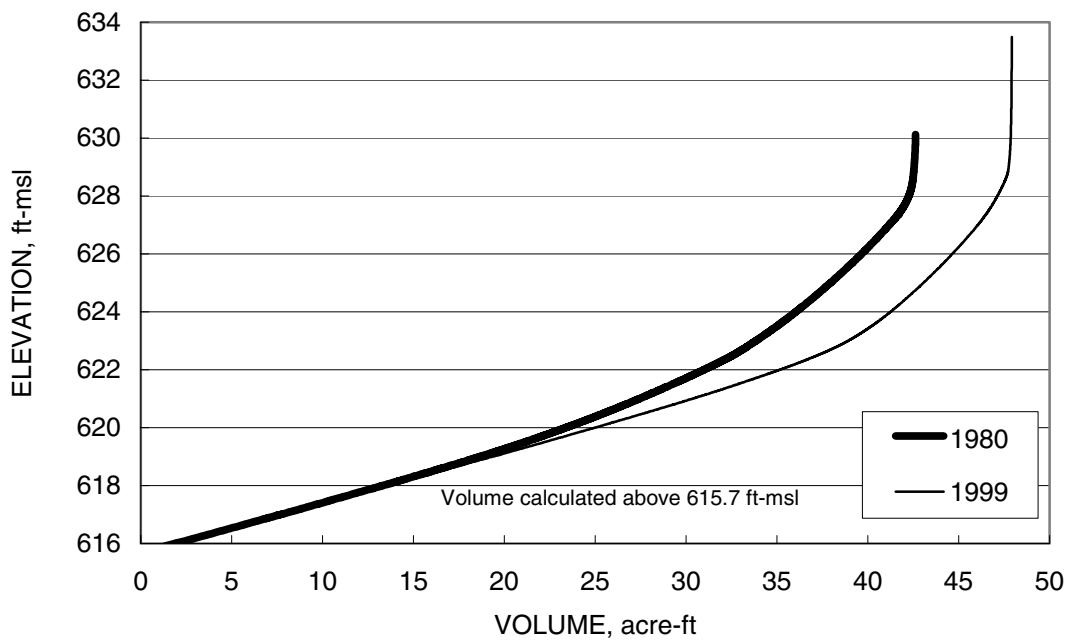
Figure 51. Elevation versus volumetric deposition of sediments in State Line sand bar, 1980 and 1999
