**The Replacement of a
Truss Bridge by a Concrete Arch**

**THE REPLACEMENT OF A TRUSS BRIDGE BY A
CONCRETE ARCH**

T H E S I S

DEGREE OF BACHELOR OF SCIENCE

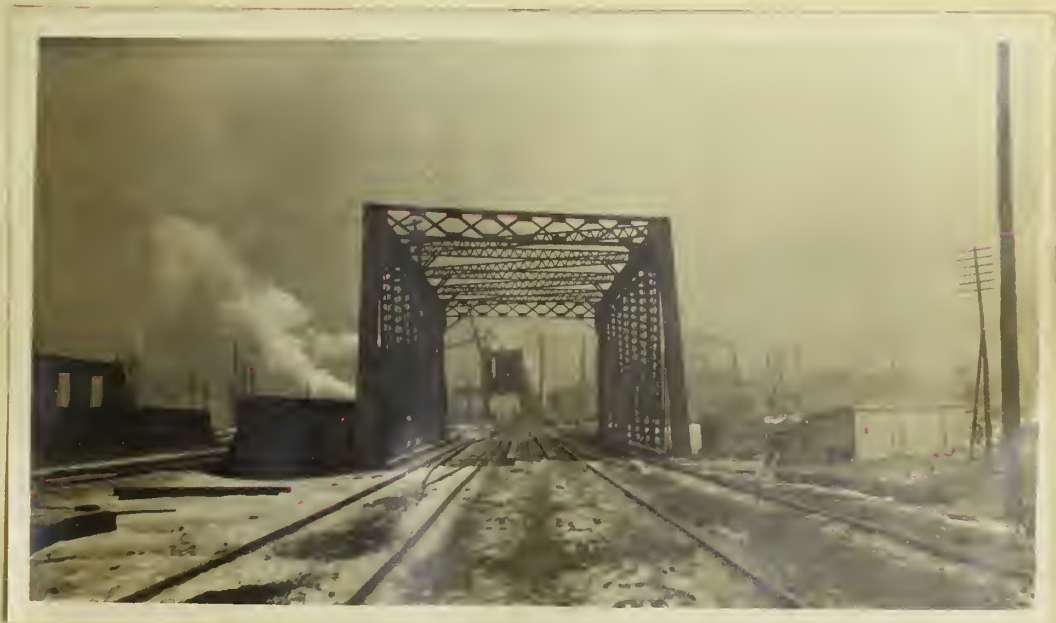
Fig. 2.

truss bridge had provided for only two tracks (Figures 2 & 37), the concrete arch would allow three to be used (Figures 37 & 43). Hence, the economical advantage was of no little consequence. A concrete arch would be more pleasing to the eye than a common steel bridge of the truss or girder type so frequently used by railroads over this canal (Figure 2). For these reasons, then, a reinforced concrete arch was decided upon. Drawings were made and the work was started as soon as possible. The arch, designed to fulfill all requirements, including a clearance of 165 feet above datum for a width of 30 feet for boats passing beneath, and a necessary span of 61 feet, was to be three centered and three ribbed, each rib supporting one of the tracks above and resting upon a suitable foundation.

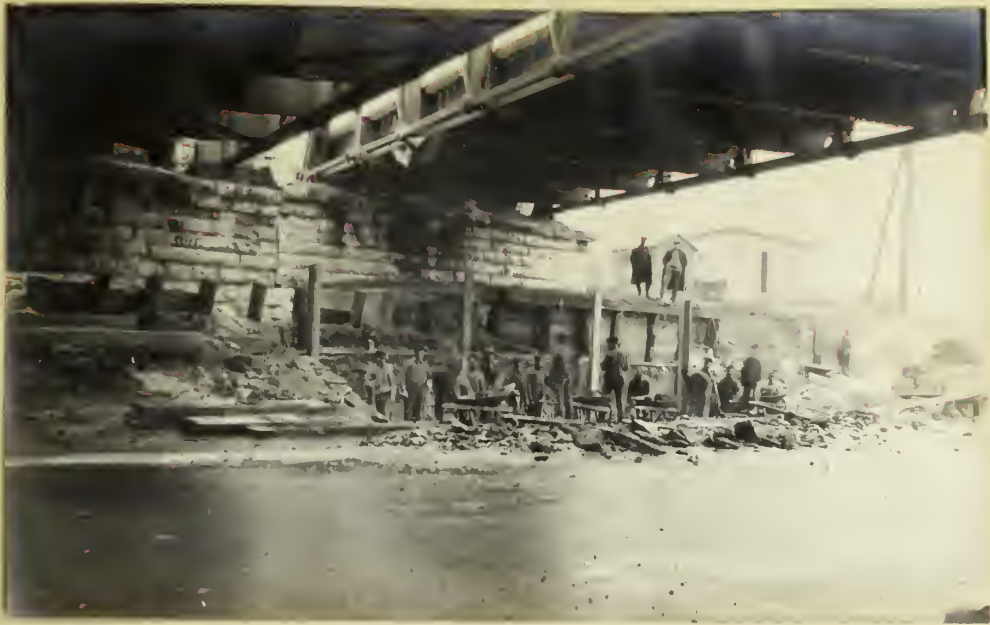
Fig. 3.

Early in February the excavation was started (Figures 3 & 4). As the depth increased, sheeting consisting of white pine planks 2" x 10" x 12' long, and pointed at one end, was driven as shown in the photograph (Figure 10). This sheeting was held in place by means of ranges or wales of 6" x 6" timbers which were fastened along the sides and braced with cross timbers as shown in Figure 11. A double row of planks on the exposed or water side aided in keeping the water out of the hole. Clay was also banked up outside of the sheeting so as to keep the water from seeping through the joints (Figure 6).

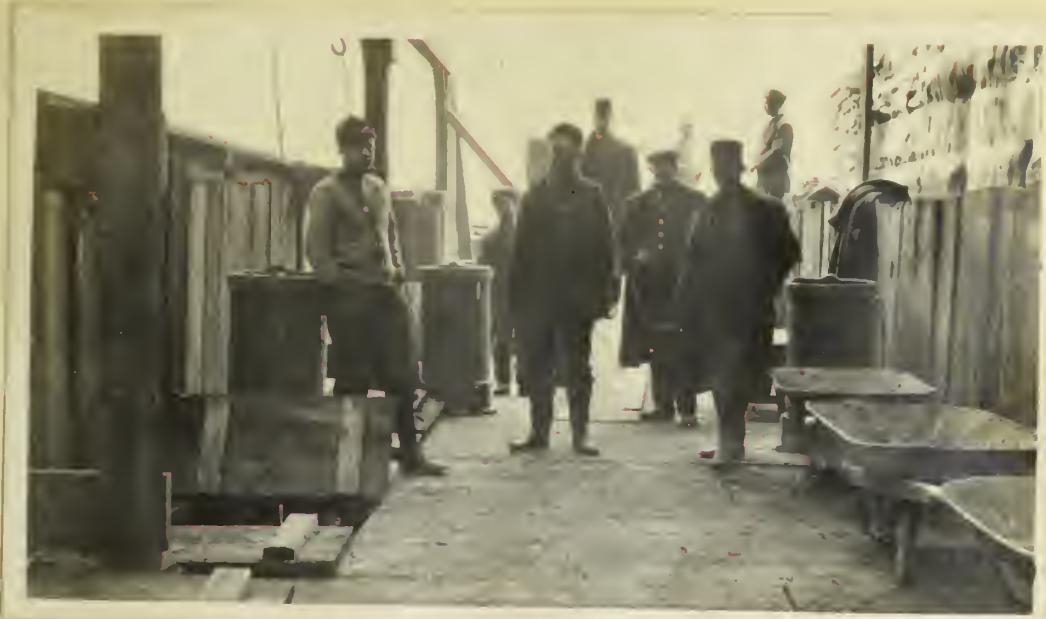
Fig. 5.

Excavating Wells, Putting in Flooring, Doors, etc.
(Figure 5)

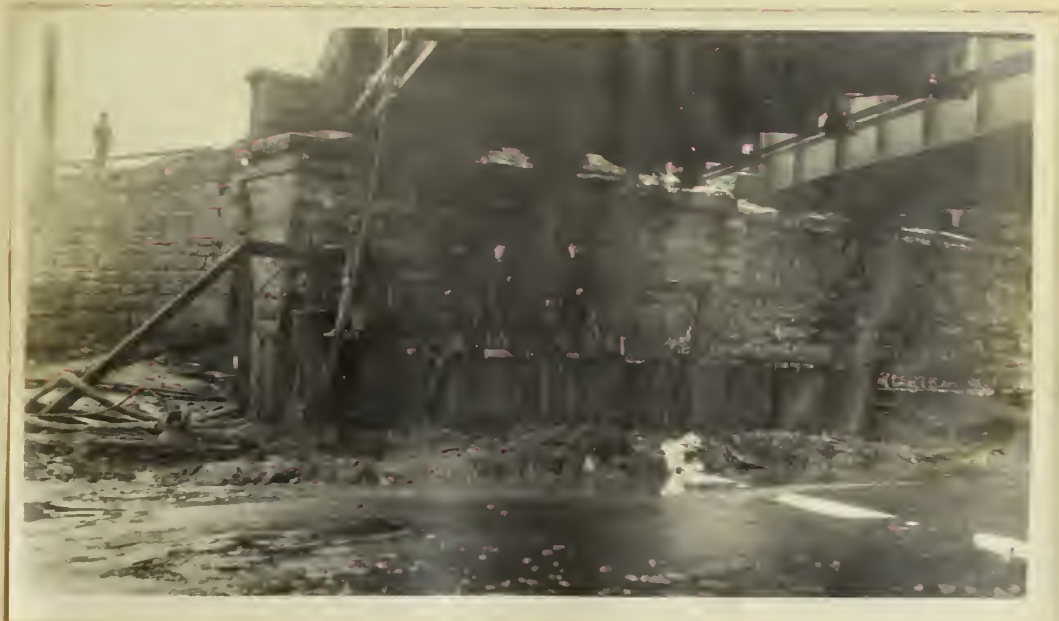
Fig. 6.

When the north and south abutments had been excavated to hard pan, well-digging was started on the south side. Twelve wells, each four feet in diameter, were to be dug to bed rock in each abutment. A plank floor was built in the excavation and double doors arranged over each hole (Figure 5). Vertical posts supported, at intervals, a continuous beam of 10" x 12" timber running horizontally the length of the excavation and about 10 feet directly above the line of centers of the wells (Figure 6). Into this beam a large screw eye was fastened over

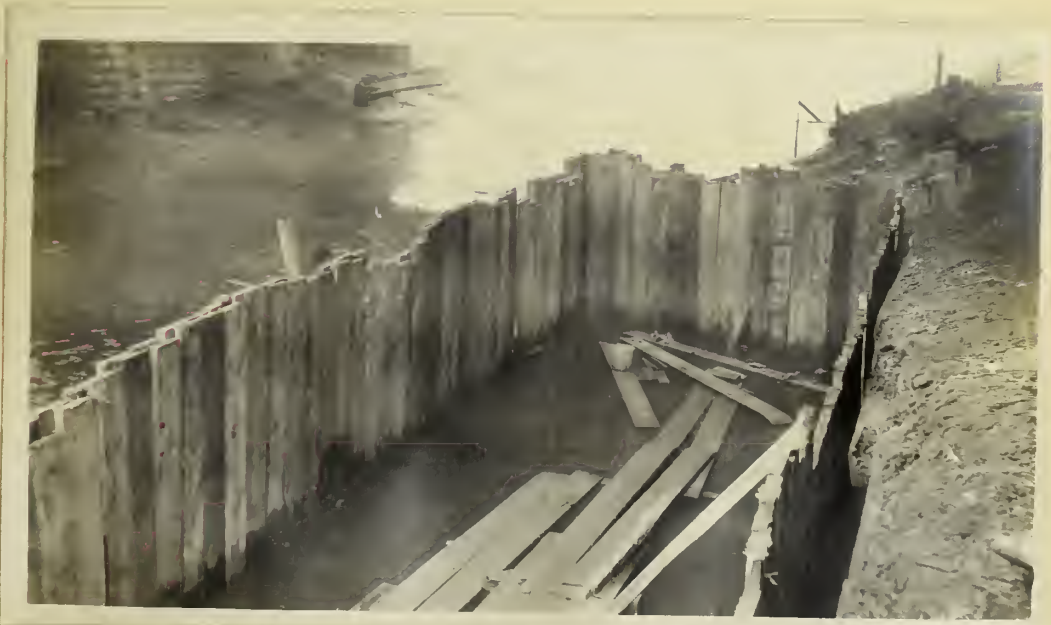
Fig. 8.

Excavation had not proceeded far before it was found that trouble, due to changes in water level caused by "locking" the canal to let boats through, was to be expected. The double sheeting and puddle-wall of clay were not sufficient to keep the water out of the excavations when the level was raised (Figure 8) to within a few inches of the top of the

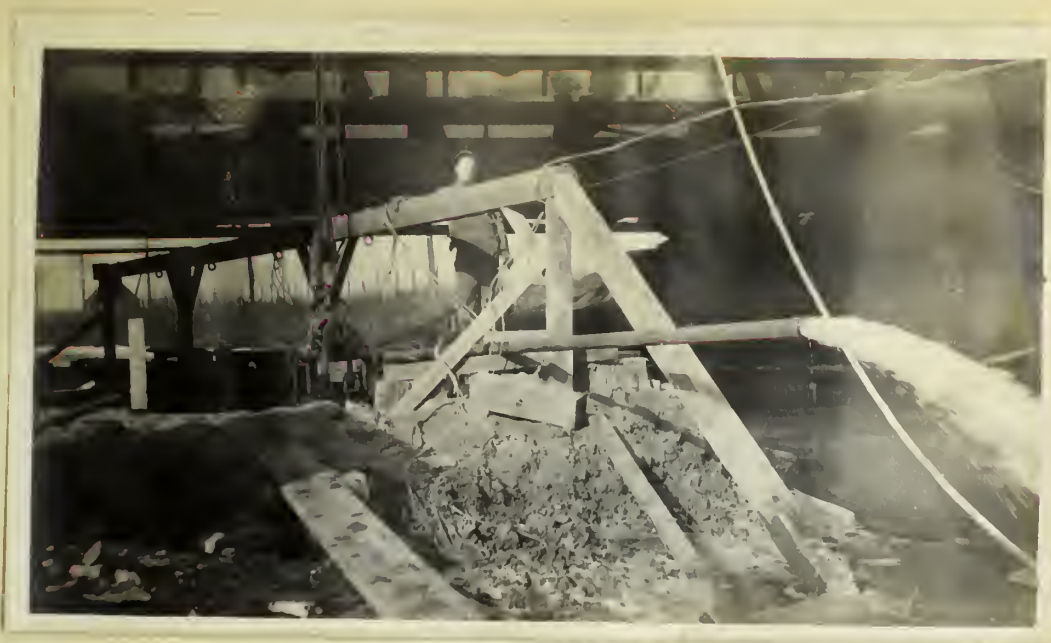
Fig. 9.

sheeting. An elaborate coffer dam was thought to be too expensive to construct. As a result, it was decided to fill the excavation which had been made to hard pan with concrete, building forms which would keep the concrete from filling in where the wells were to be dug (Figure 14). In this way the well excavation could be carried on after the main part of the concrete footing had been established (Figures 13 & 16). In each footing, two 24" I beams were set so as to have one end imbedded in the concrete and the other in contact with the pin at the second panel point of each truss (Figures 13, 16, 17, and 25). These beams were lined in with the transit so that their center lines would lie in a vertical plane parallel with the length of the truss. In this way, after the concrete had set, the truss was braced to some extent, and a means afforded for tying the next section of concrete to the footing. The wooden timbers for well work were also imbedded in the footing (Figures 13, 16, & 25), the top of which was at an elevation of 2.03' below city datum. Clay was puddled against the outside face of the concrete to prevent any possible seepage through the joint between the hard pan and the concrete (Figure 16). After the concrete in this footing had set, very little trouble was caused by the water. Only once or twice was the level of the water raised to such a height as to flood the holes. It did not take long to remove this water by means of a centrifugal pump operated by electricity (Figure 9).

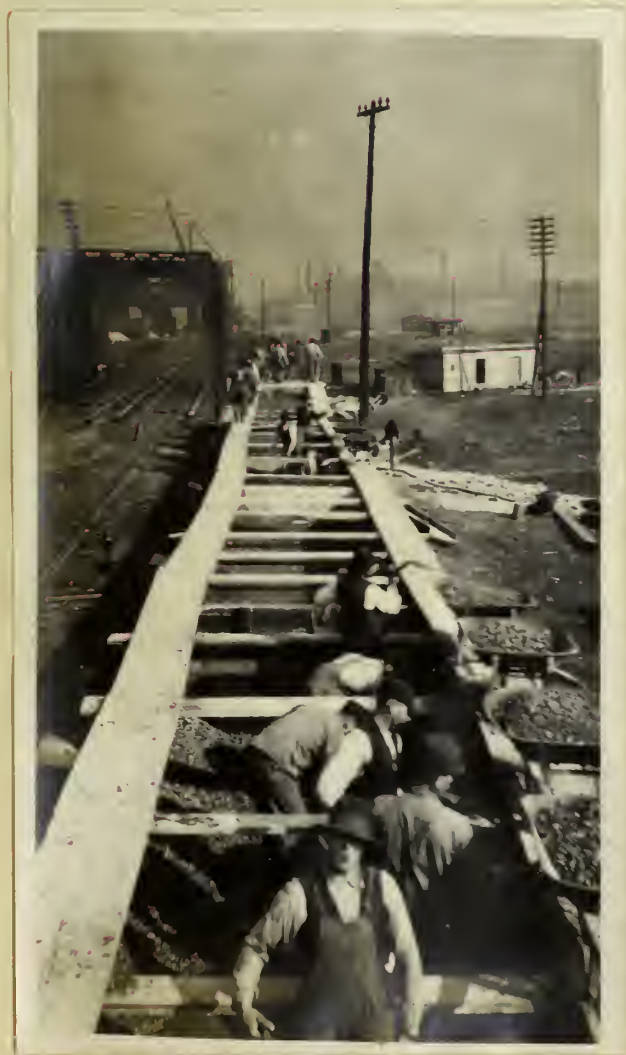
Fig. 12.

they were on their first trip to the mixer (Figure 12). These were then wheeled to the drum while the first set was being re-filled. In this way the process was continuous and all the material that the mixer could use was delivered at a minimum cost of labor. When thoroughly mixed, as judged by a skilled laborer, a metal apron was inserted into the drum. The concrete upon the inside of the drum fell upon this apron and slid into a wooden trough which led to the abutment or well which was to be filled (Figure 27). In case the concrete had to be turned from one chute into another, a laborer was stationed at the angle to see that the concrete was not impeded in its course (Figure 15). Laborers in the abutment below saw that the mixture was properly spread over the whole opening and that it was well tamped into the corners and around the edges especially. The mixture was not a dry one as water came to the surface without much tamping.

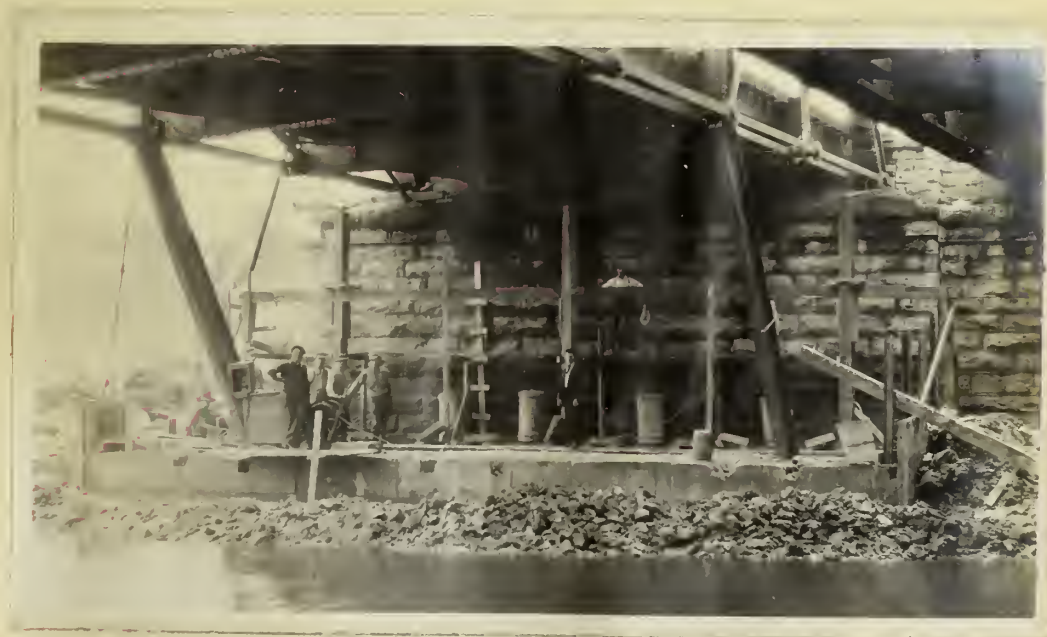
Fig. 16.

With these points determined, the forms were started. A small coffer dam was first constructed of clay to keep the water from the face of the footing (Figure 16) so as to allow the bottom of an 8" x 16" timber sill to be set at an elevation of 4.125 feet. After this was firmly secured, the arch centering for each rib was placed. The centers proper were cut at the mill from 3" x 14" x 9'-8" pine timbers, the radius being 86'-4" and each piece being beveled on the curve at an angle of 67 degrees and 42 minutes. Each rib of the arch, when finished, was to be seven feet wide, not including the six inch coping on the two outside ribs. Four rows of centering were used for each rib (Figure 20). Two arch centers and a length of 6" x 12" timber sufficient for the first section of the arch - 17'-4" - were first assembled on shore before the strut thus formed was fixed in place. A 12" x 12" diagonal brace was used for the two outside struts to allow horizontal bracing to be bolted to them as shown (Figures 20, 22, and 24). The west strut of the west rib and the east strut of the center rib were first carefully lined in with the transit, use being made of the points previously suspended from the bridge to locate the soffit. These struts were held in place by timbers running horizontally to the back of the abutment, and fastened to

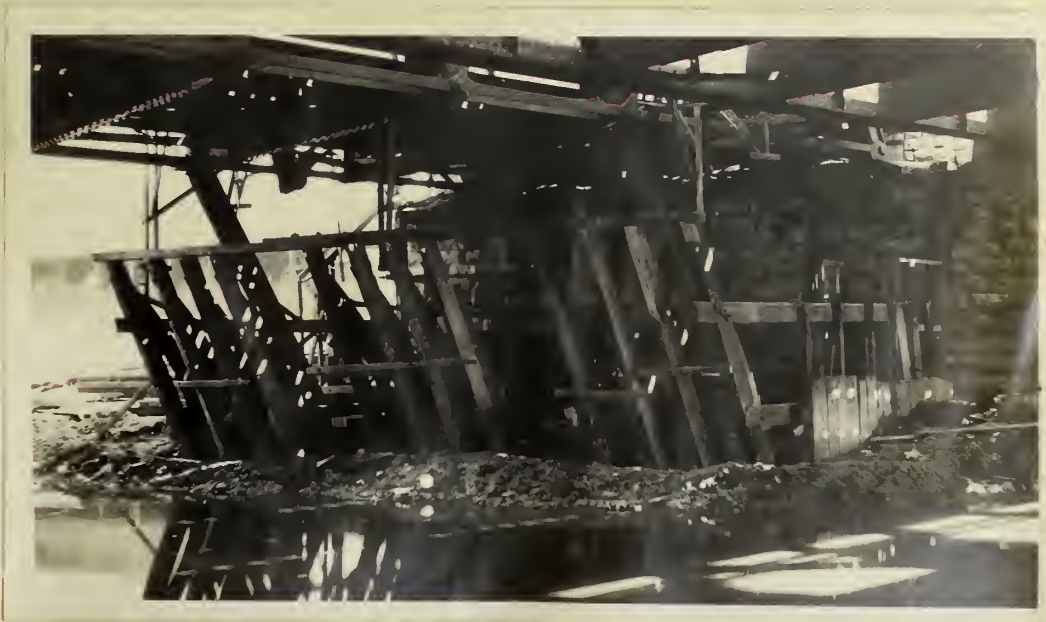
Fig. 20.

steel rails partly imbedded in the concrete (Figure 20). The remaining outside struts of the two ribs were then placed as accurately as possible and the 6" x 12" cap was bolted to these four struts. The east strut of the east rib was then located accurately and fastened to another length of 6" x 12" which was spliced to the first piece. The other intermediate struts were then lined in and secured to the cap, leaving a framework as shown in Figure 20. Vertical studding, 6" x 6", was erected on both sides of each rib and spaced three feet center to center except on the east and west sides where 6" x 12" timbers were used. Four horizontal stiffeners (6" x 12") spaced about 3'-6" center to center were bolted to these studs. White pine (2" x 8") dressed on four sides was used for the concrete facing except on the soffit of the arch where 2" x 6" dressed pine was used. A bulk head was built to enclose the shoulder of each rib and when this was done the structure resembled three large, oddly shaped boxes open at the top (see Figures 21 & 22). The outside faces of the forms were then carefully aligned with the transit, and the two sides of the box were held firmly together by a series of long rods which were enclosed in old gas pipe, cut to proper lengths so as to permit the rods to be unbolted and removed from the concrete after it had set (Figure 23). Each stud was braced by wire passing around it and part of the lower chord. Four long 80# rails were set diagonally in each rib with their ends projecting out of the form. This was done for the purpose of reinforcing the rib and also to furnish a bond between the first and third sections in the concrete (see photograph, Figures 23, 24, 29 & 30). Each rib was filled with concrete to within about five and one half feet of the top of the rail.

The most difficult part of the work was to fix the outside points of the arch in line and at an elevation for the stopping place in the first stage. Points had to be located in some way so that they would be not only at the correct elevation but also in the vertical plane of the face of the rib as well as in a line parallel to the short axis of the proposed arch. In order to do this it was necessary to construct some form of wooden support which would enable the point to be located. This was done by fastening a horizontal timber at right angles to the lower chord of the bridge and then nailing a vertical length of 2" x 4" to this piece. To the bottom of this, a short piece of 2" x 4" was nailed parallel to the truss (Figures C, 17, 18, 20, & 25). By

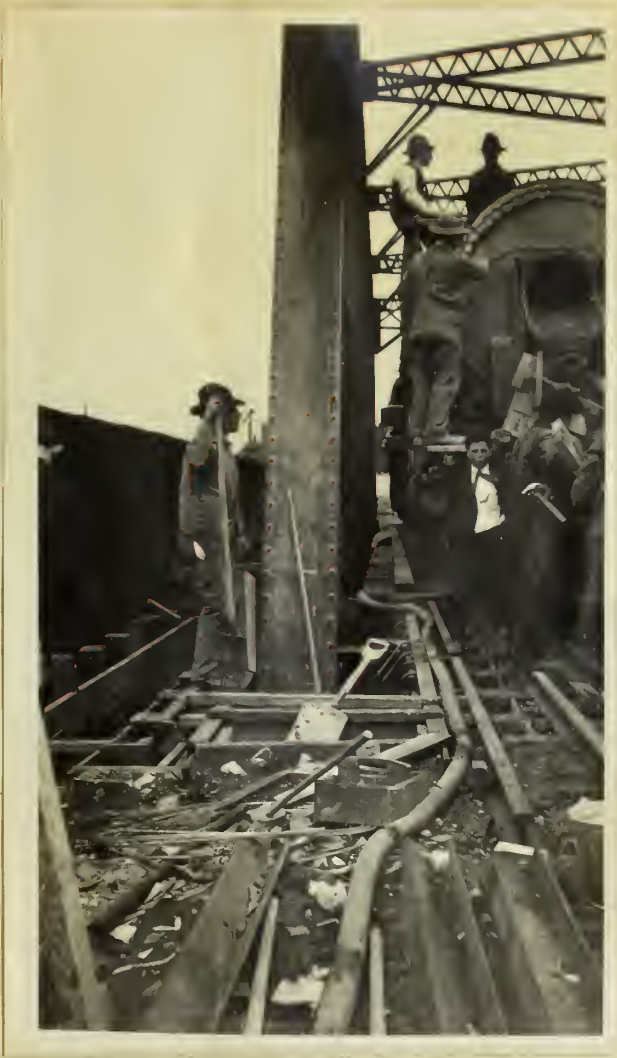
Fig. 27.

When the three sections of this track had been set, and the reinforcing of the floor slabs completed, the final batch of concrete was mixed for the first section of the arch (Figure 27). After allowing this to set for several days, during which time trains were made to proceed very slowly over the bridge, the forms were removed. This work was facilitated by removing the bolts from the gas pipe lengths which were then left in the concrete, the end holes being later filled with grout. The various elevations and alignments were checked and it was found that the forms had moved only a very little and without any serious effect on the intrados (Figures 29, 30, & 31).

On account of the old track with its long ties, and also on account of the trusses themselves, which came between the two rails of the outside tracks under the new layout, it was very difficult to set the new sections of each of the three tracks and hold them rigidly in place until after the concrete had set. It was necessary to cut the old ties close to the rail of the old track so as to furnish room for the new (Figure 28). The rails and "Z" bars were fastened to the ties as far as possible before placing the new track. These were then supported and braced in correct line and elevation, repeated "shots" with both transit and level being taken before the alignment and elevation of every point on the rail were correct. Anchor bolts passing through the "Z" bars and bent diagonally downward at an angle of 45 degrees were to help anchor the track to the concrete (Figures 27 and 28).

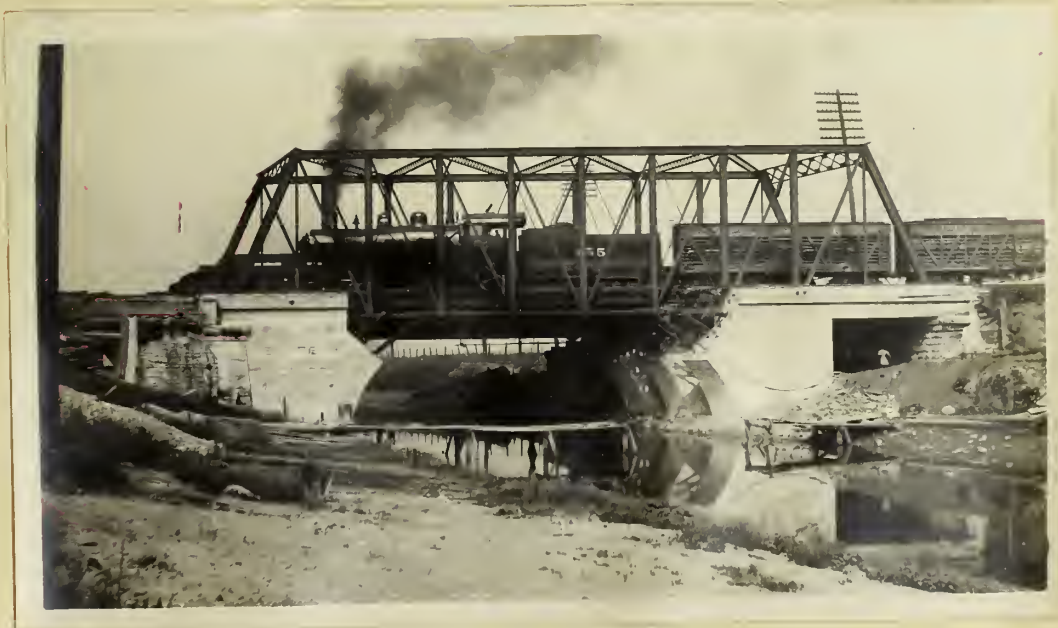
Fig. 38.

With the first two sections of the arch thus completed, the work had the form shown in (Figure 38). To complete the arch and to put in the center sections of the three new tracks was all that remained to be done before the old tracks could be removed and the trusses taken down. To accomplish this, it was necessary to provide some means of supporting the forms for the arch soffits and also for the outside faces of the ribs. The plan adopted was to complete the arches on the two outside ribs with a thickness of concrete of two and one half feet, not including the six inch coping. To complete the whole rib at once would bring too much weight on the forms - but by allowing two and one half feet of concrete to set, the remaining forms and concrete could be supported in safety. As reinforcing for these segments, a box girder was placed in each. This girder was built of two small trusses latticed together at a distance of twenty-seven and one half inches back to back of angles. The lower chord was in the form of the arc

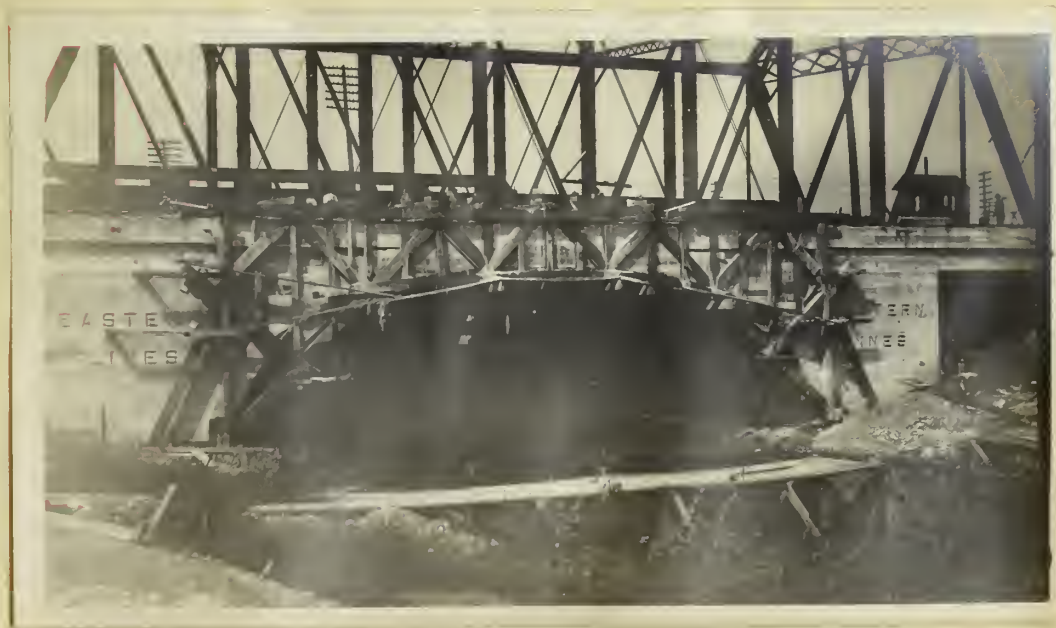
Fig. 40.

crete mixed for these two segments (Figure 40).

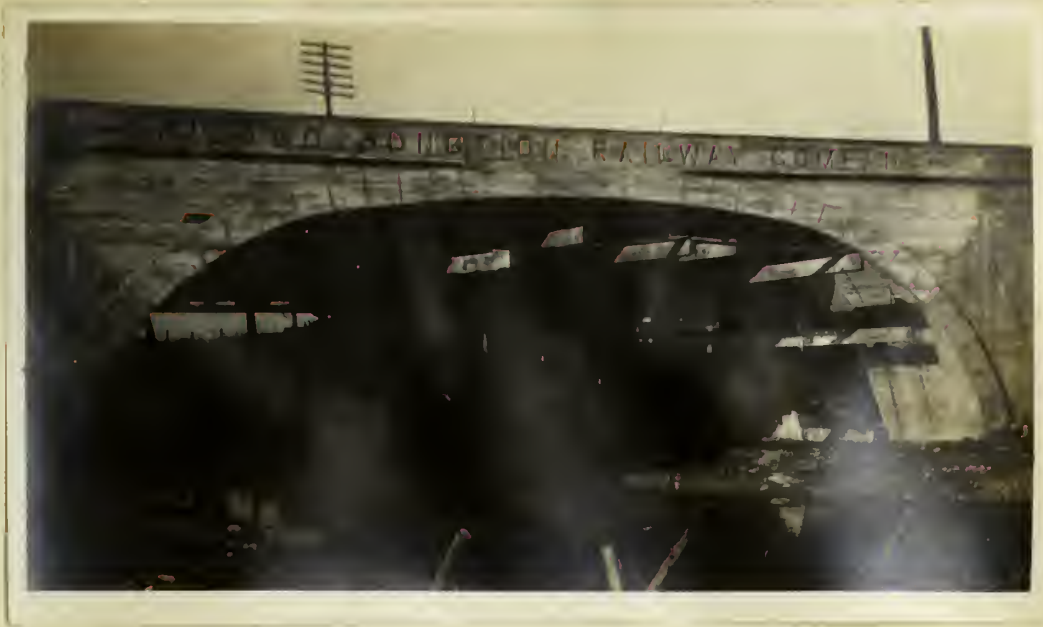
Fig. 41.

After the concrete had set, a safer means of support for the remaining work was established (Figure 41). The wooden trusses were left standing so as to form additional support and to provide means for fastening the remaining forms. Long rods were left projecting through the concrete so that timbers could be supported horizontally from rib to rib (Figure 41). By means of such braces, the arch centers were supported, and to these the facing was nailed. The middle sections of the three tracks were also set and connected to the first two sections already imbedded in concrete. Concrete was then mixed and deposited as carefully as possible, all trains running over the bridge being flagged and made to proceed slowly to prevent unnecessary jarring and shaking. After the concrete had been allowed to set for about ten days, the forms were removed. The structure now had the appearance of a double bridge - that is, with a steel truss above and a concrete arch below. Five tracks were also on the bridge at this stage (Figure 37). The only step now necessary to complete the work was to remove the truss and old track layout from the bridge so as to connect the new layout on the bridge with the main tracks.

presence of a portion of the trusses buried within the concrete, was to be seen from the outside (Figures 41, 42, & 43).
