VALUE OF CONCRETE  
FOR  
REINFORCING STEEL I BEAMS

THESIS FOR THE DEGREE OF BACHELOR OF SCIENCE  
IN ARCHITECTURAL ENGINEERING

COLLEGE OF ENGINEERING  
UNIVERSITY OF ILLINOIS  
PRESENTED JUNE, 1904

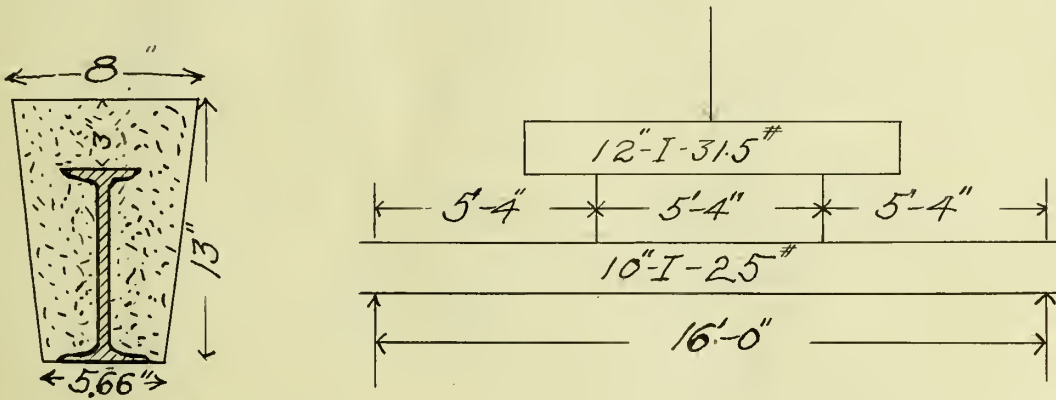
## Test of Beam No. I

This beam was a 10"-25<sup>#</sup> I, 16'-6" long, span of 16'-0". The loads were applied at the third points 5'-4" from each end.

Deflections were taken at center and third points and values at center were used in plotting for comparison with the concreted beam.
