TEST RESULTS FROM AN INVESTIGATION OF PARALLEL-CHORD, TOP-CHORD-BEARING WOOD TRUSSES

Research Report 85-1

Small Homes Council-Building Research Council
University of Illinois at Urbana-Champaign

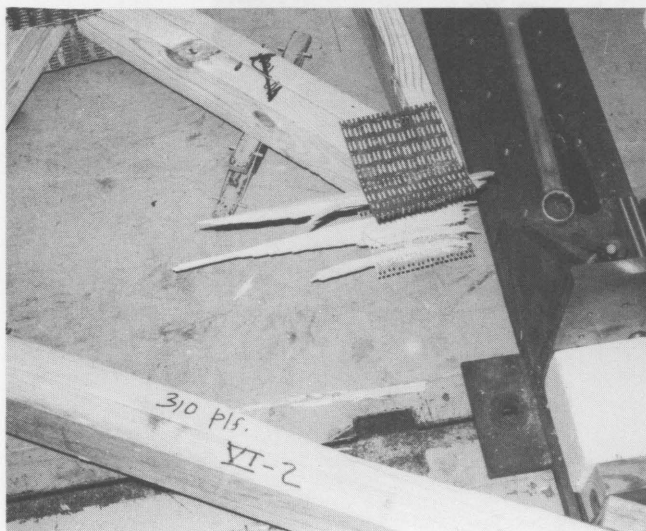
Figure 5. Representative Failure Types

The configuration of each truss type is included in Appendix A, with a description and location of failure at the recorded loads. In addition, several photographs are shown as representative of the various types of joint or lumber failures recorded in the study. (See Figures 5, 6, and 7.)

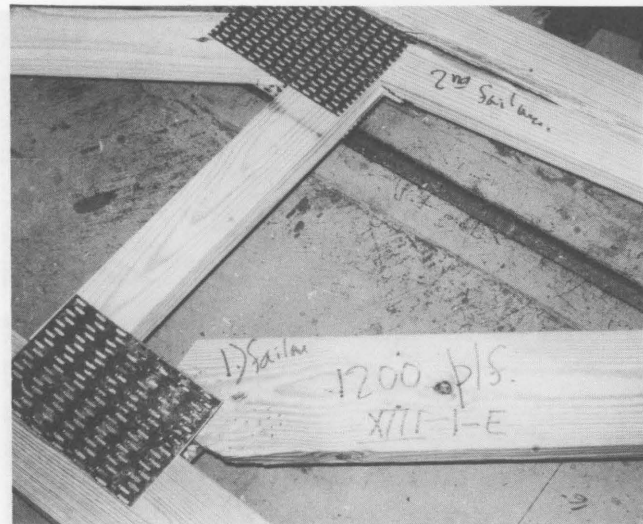
Figure 6. Representative Failure Types

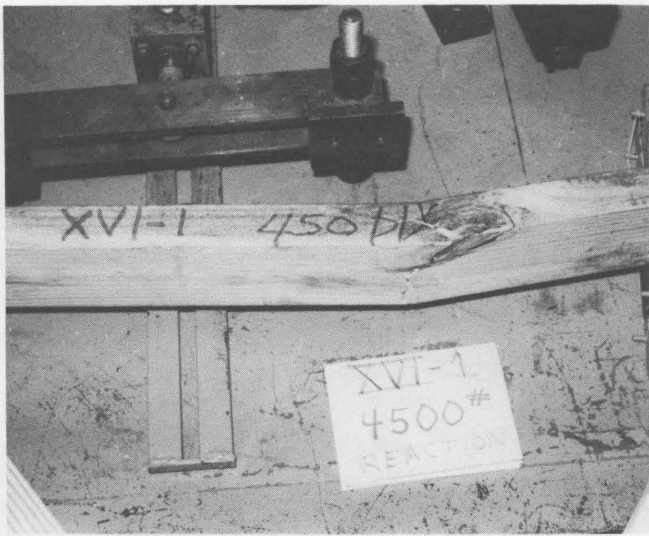
Figure 7. Representative Failure Types

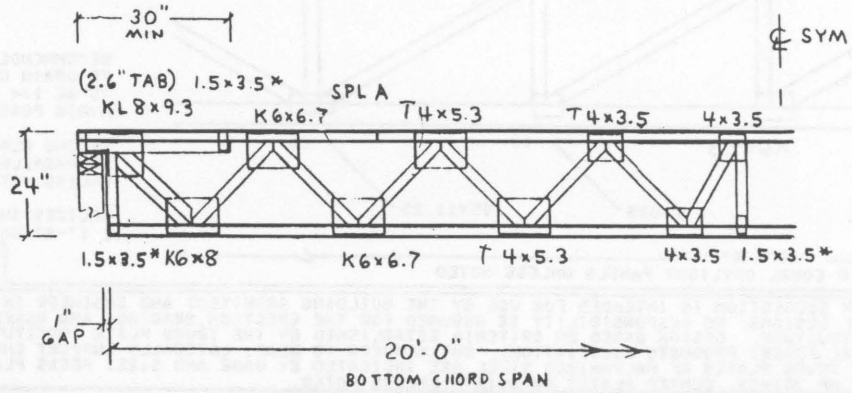
DEFLCTIVE .45 IN. L/ 526 TOTAL .45 IN. L/ 526
 SID PANEL DIM = 30.00 IN.
 14 STD WEBS = 25.81 IN. 54.5 DEG.
 SPC PANEL DIM = 8.06 IN.
 2 SPC WEBS = 22.47 IN. 69.1 DEG.
 CHASE DAYLITE DIM = 8.00 INCHES

KL 8x9.3/5.3 x 2.6
