THE CHURCH OF SAN MICHELINO IN FORO IN RIMINI: HISTORY, ANALYSIS AND PROJECT

Keywords: San Michelino in foro, Templars, architectural restoration, frescoes, Rimini

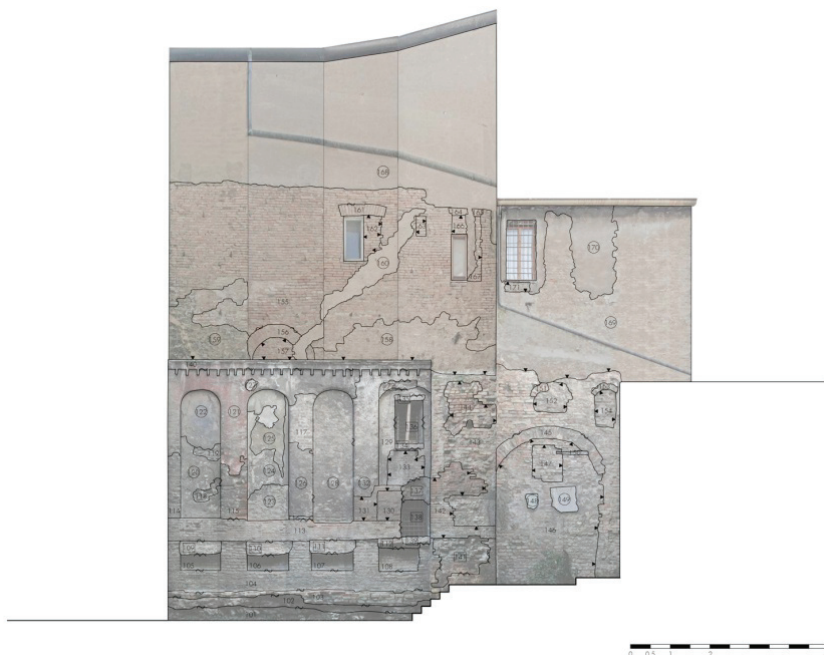
Figure 3. Stratigraphic analysis of the apse.

The foundations of the oldest church are visible in the lower part of the apse (stratigraphic units 101 and 102), on top of which there is a string-course marking the ancient floor level and a portion of wall built contemporarily (stratigraphic units 103, 104, 114, 115, 116, 117) characterized by the presence of large blind arches (stratigraphic units 105-108 and stratigraphic units 118, 119, 129). At the top of the apse with blind arches there is a dentil cornice made of brick, built at the same time (stratigraphic unit 140).

The presence of river gravel aggregates of medium-large grain size (\varnothing minimum 2mm; maximum \varnothing 6mm) in the mortar of the lower and upper part of the apse, but not in the band that 'splits' into two parts the large blind arches (stratigraphic unit 113), has allowed us to establish the existence of different times in construction. The presence (stratigraphic units 102 and 103) of ocher-colored fired bricks of secondary use was also noted, which, owing to their size (larger dimension 30x15x7 cm), can be assumed to be of Roman origin.

The outer level of the soil must have gradually risen. This led to the need to create new foundations (stratigraphic breaking units 109-112) and a new base (stratigraphic unit 113) for the church. The blind arches were then broken into two parts and took on the appearance seen today. The construction of the new base could also date back to the eighteenth century after the earthquake of 1786, which, by compromising the stability of the building, may have made it necessary to carry out some consolidation work.

bricks are not hidden by layers of plaster (Figure 3). In order to analyze the masonry on Via San Michelino, hidden by plaster, it was necessary to rely on photos dating back to 1943 deriving from a private archive²⁰. In these photos in fact, it is still possible to view the brickwork without plaster (Figure 4).

The part of the wall with blind arches and the new base (stratigraphic unit 113) have very similar sized bricks (prevailing size 26x14x5 for the blind arches; prevailing size 27x15x5 for the new base). It is the different gravel aggregate size of the two mortars that makes it possible to distinguish two different construction times.

However, it is hard to determine the relative and absolute dating of the stratigraphic units covering the apse. It is possible to assume that it is plaster dating from the nineteenth century, made with natural lime mortar. Instead, plaster made with cement mortar is found on the upper polygonal part, which would suggest a later dating.

The fourth blind arch from the left has greater stratification. The creation of new openings (stratigraphic units 136 and 138) almost certainly dates back to the nineteenth century. When the church lost its religious function and became a private warehouse it was necessary, after the construction of an intermediate floor, to open windows to illuminate the indoor spaces that had been divided. The creation of new openings probably led to structural collapses that later required consolidation (stratigraphic units 130,131,133). The grating of these openings are made of iron rods using a method of construction which allows us to date it to the nineteenth century²¹, probably at the same time the openings themselves were made.

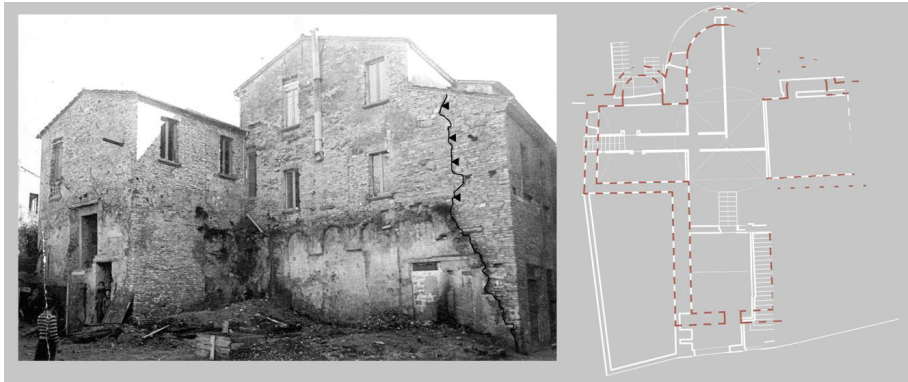
Figure 4. Stratigraphic analysis on a photo of 1943; hypothetical plan of the original Church

As regards the views visible from the Via San Michelino, from the analysis carried out on a photo of 1943 a number of hypotheses can be made. In the picture, there are some suspended arches and at the point they are interrupted, is a line of interface between the two different stratigraphic units. To the right of the arches you can in fact find a later stratigraphic unit, resting on the masonry with arches. From this it can be assumed that the nave of the church ended where the arches end and that the view giving onto Via San Michelino visible today is subsequent to it.

On closer observation it can be seen that at the base of the left abutment and on the left impost of the arch several portions of the wall are visible which would suggest the start of a second apse with a vault. The negative stratigraphic unit 141 confirms the hypothesis of the existence of a second apse on the transept: the masonry in fact, has evident marks of a pickaxe used for the demolition of a portion of wall that leaned against it. Assuming that the church had a symmetrical shape, we can say that the church originally had a plan with three apses.

The analysis of the consistency of the masonry shows us that the bricks in the highest part of the construction are clearly of a later period compared to those of the lower part. The original covering of the old church was positioned above the cornice with dentils.
