# A RESTORATION AND CONSERVATION PROJECT OF THE “SAINT DOMINIC” MONASTERY IN SORIANO CALABRO, ITALY

**Nazzareno Davolos**

Architect, Master on the “Restoration of historic Monuments”, Roma

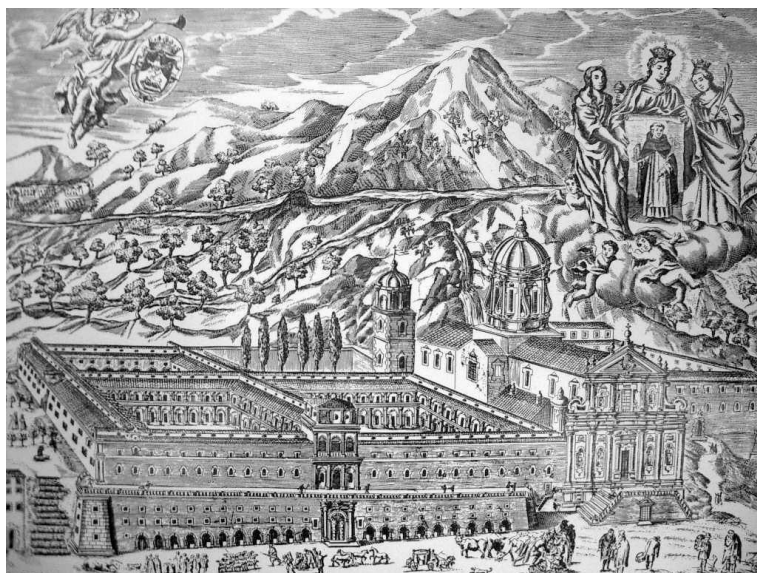
Figure 2. St. Dominic Monastery before the 1783 earthquake, engraving by F. Miotte.

aged during the 1638 earthquake but broke down almost completely in 1659 earthquake. Thanks to Philip IV, the rebuilding of the monastery started in larger shapes designed by architect Bonaventura Presti<sup>14</sup> (fig. 2).

The “Saint Dominic” Monastery was very different from the adjacent built up area for its impressive dimension; in particular for the big dome and for the enormous bell tower of the Church (fig. 2). Both had a peculiar function: the first one became a symbol for the pilgrims, the second one was connected to the Count’s title, held by the Prior since year 1652. Therefore, the bell tower played an important role in turning the Monastery into both a religious and a political centre; indeed, the tolls of the bells marked the friars daytime and the events of the citizens’ daily life.

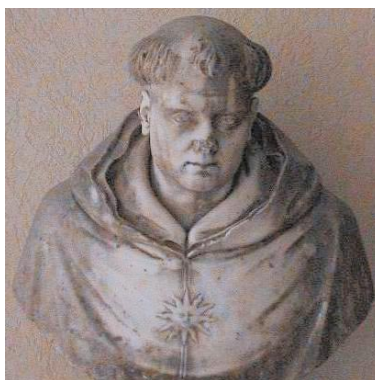
*Figure 3. The symbol of the sun in the white marble statue representing St. Thomas Aquinas (1225-1274).*

The Saint Dominic Monastery unitary project was formulated according to the typical Baroque plants. The plant itself was probably connected to a specific religious or a philosophical theory<sup>15</sup>; the symbolic values played important roles in the definition of the spaces. Two orthogonal axes can be found: the first one in the east-west direction, and parallel to the longitudinal direction of the Church, emphasized by the vertical tower at the entrance, while the bell tower emphasized the second axis showing the entrance to the cloisters of the square. The matrix of the four directions related to the main four cardinal points, can be assigned to a popular model of settlement in which the Christian cross is a symbol of the religious authority (fig. 3).

- <sup>15</sup> A modular regularity and perfect geometric forms were proposed: the quadrangle that contains the circle as a symbol of the sun is regularly reproduced in the marble statues that adorned the church, see fig. 3.

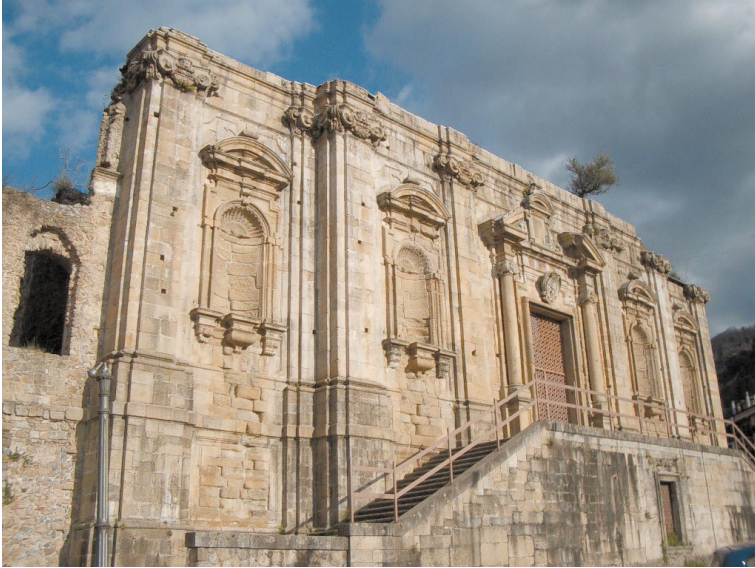
Today the facade is so ruined that it is impossible to see the most of the decorations (fig. 6). The restoration of the facade with tiles in brickwork and with lead plates, made by architectonic Departments in year 1970, have been efficacious to remove the

*Figure 6. Facade of the ancient St. Dominic Church (photo by ND, year 2007).*

rain although they caused inevitable draining. Finding the reasons of deterioration is important to preserve the monument with an accurate procedure. The granite weathering in the facade is produced by a combined action of physical, chemical and biologic factors; the facade is subjected to changes of temperature between winter and summer time, it is subjected to the rain, to the wind, to the moisture. All these phenomena produce a structural weakening. Through the inspection of the crypt designed to the friar's burial, it is possible to observe how the lack of ventilation and the draining of the rain caused the humidity in the facade; for this reason it is expected to renew the floor, to carry out the right slopes for the draining and the canalization of the water, to build a system of ventilation in the basement. The stone presents a "natural" deteriorating helped by the lacking of preservation. Moreover, the presence of spontaneous vegetation such as musk and lichen emphasize the condition of general weakening. The peculiarity of the stone employed has been analysed. The today dressing can not avoid the penetration of water, but the lack of a preservation increased the weathering phenomena. The above-mentioned phenomenon can be slackened with the following treatments:

- 1) Application of a biocide spray and weed killer.

- 2) Cleaning and removal of products with nebulized water, manual extirpation of the roots grown in depth.
- 3) Strengthening of the deteriorated stone to improve the compactness and the mechanical peculiarity. According to the laboratory analyses and to the disgregation of the facade, the silicate of ethyl like RC70, applied with a brush until to saturation is suitable. In any case it is convenient to test the effect on the small surface.
- 4) Filling in the empty with parget, similar to one of the stone. Finally it is necessary to plug the granitic surfaces with a solvent, to avoid dust, and to apply a protective substance (which we can last from five to ten years).
