Toumpis, Athanasios and Galloway, Alexander and Molter, Lars and Polezhayeva, Helena (2015) Systematic investigation of the fatigue performance of a friction stir welded low alloy steel. Materials and Design, 80. pp. 116-128. ISSN 0261-3069 , <http://dx.doi.org/10.1016/j.matdes.2015.04.046>

Systematic investigation of the fatigue performance of a friction stir welded low alloy steel

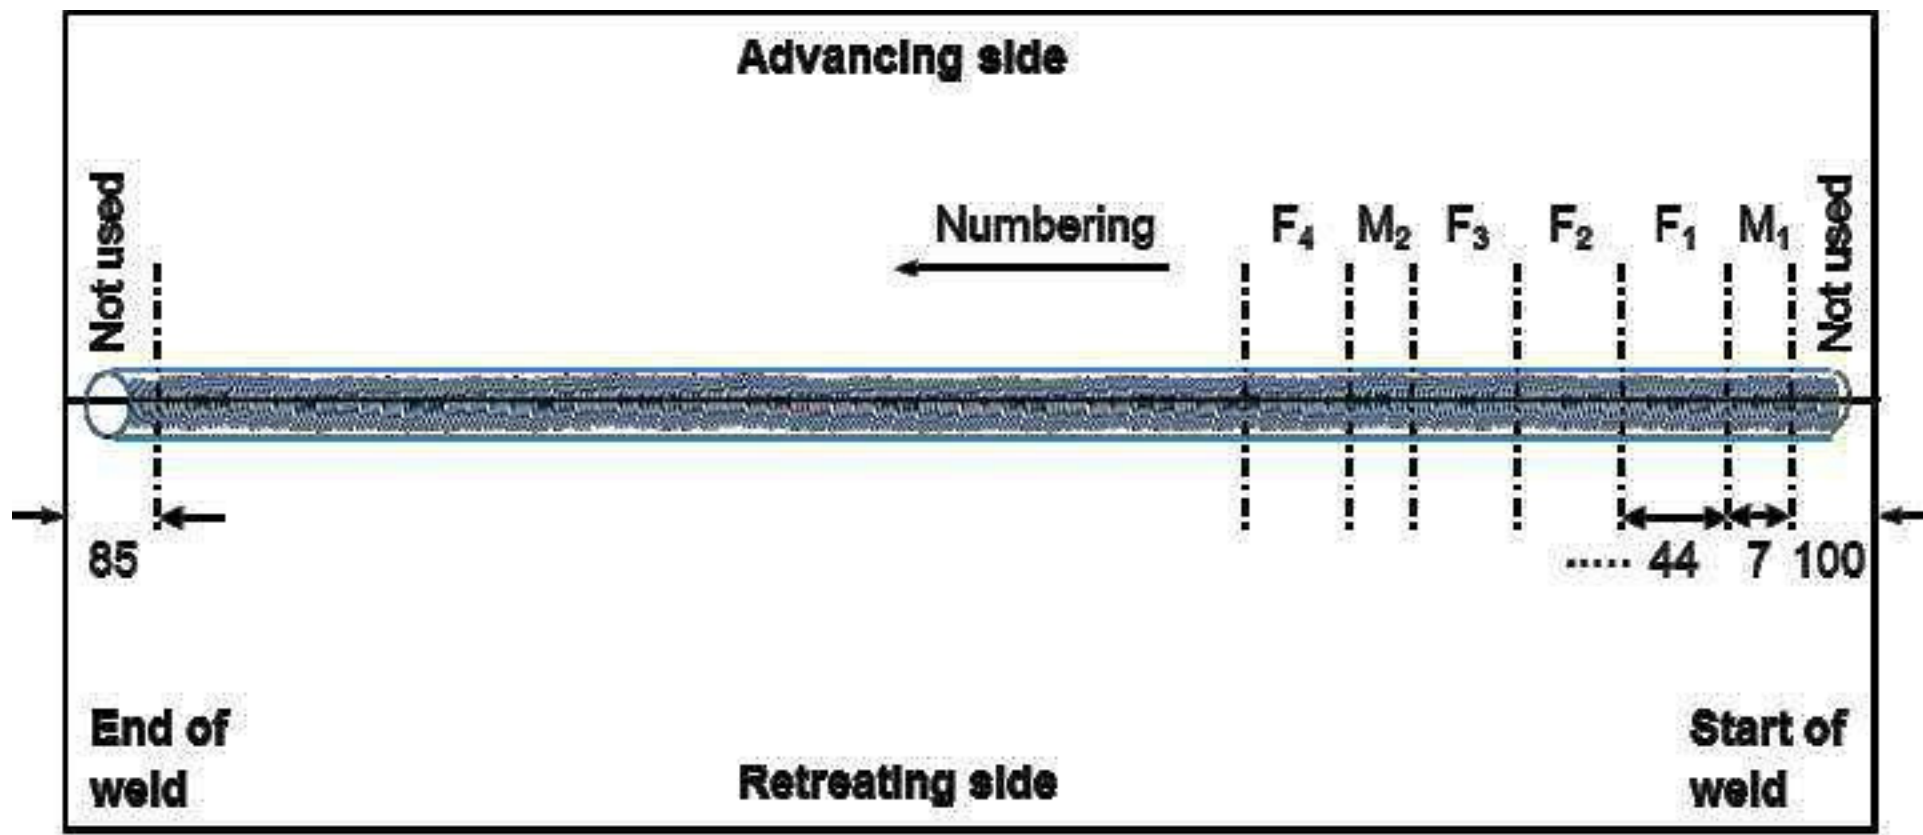
Figure 1
[Click here to download high resolution image](#)

The position and sequence of all fatigue and tensile test samples with regard to the start of the weld was consistently marked before sectioning (Figure 1). The specific preparation stages adhered strictly to BS 7270 [19]. The samples' sides were polished longitudinally to diminish the contribution of any transverse machining marks to the fatigue performance, particularly from the parallel length, up to a surface finish of at least $0.2 \mu\text{m} R_a$ [19]. To ensure that the required surface roughness was achieved, a large number of randomly chosen samples were

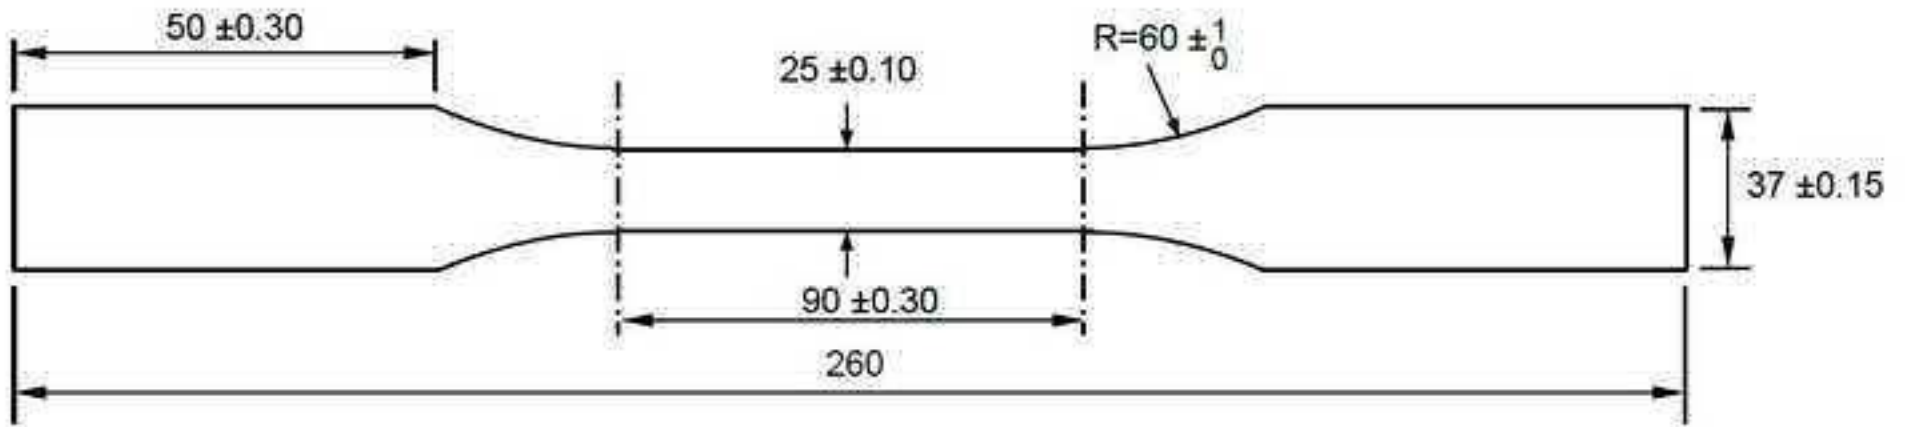
Figure 2
[Click here to download high resolution image](#)

validated using a Mitutoyo surface roughness measuring system. In contrast, the samples' top and bottom surfaces were tested in the "as-welded" condition. Fatigue and transverse tensile samples were prepared with the same basic dimensions, which are outlined in Figure 2.

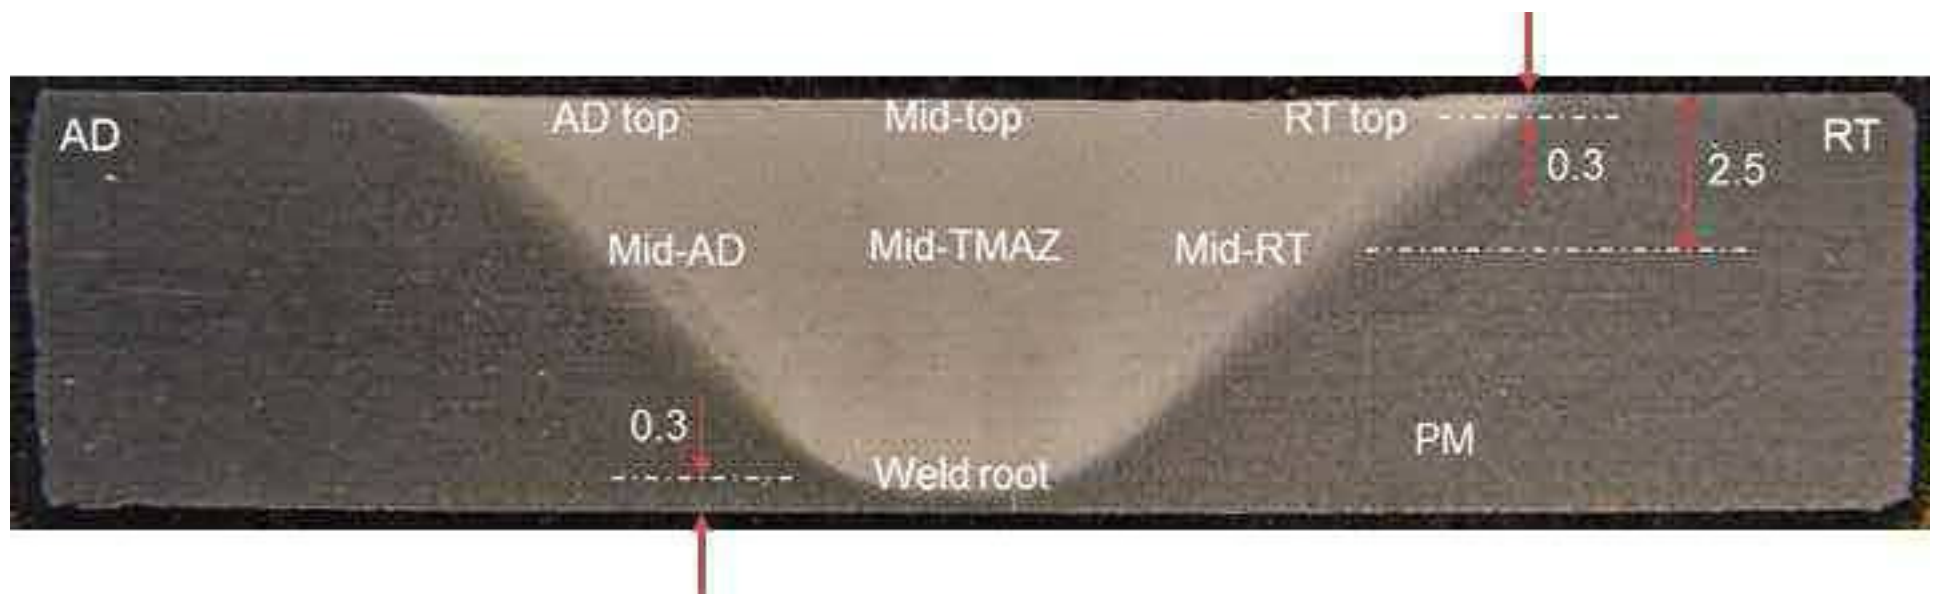
Figure 3
[Click here to download high resolution image](#)

Micro-hardness measurements were recorded for several positions which were deemed representative of the weld zone, consistently for all three welds (Figure 3) to provide an understanding of the hardness distribution of the weld zones. The measurements were taken using a Mitutoyo hardness tester and by applying a load of 200 gf.

The micro-hardness measurements for the three welds are presented in Table 6, where the values are supplied as an average of two measurements per position marked in Figure 3 (two samples measured in the intermediate speed). The hardness values follow the anticipated order; the hardness of the weld is seen to increase as the welding speed is increased. This is attributed to the increasing cooling rate which develops harder phases such as bainite. The

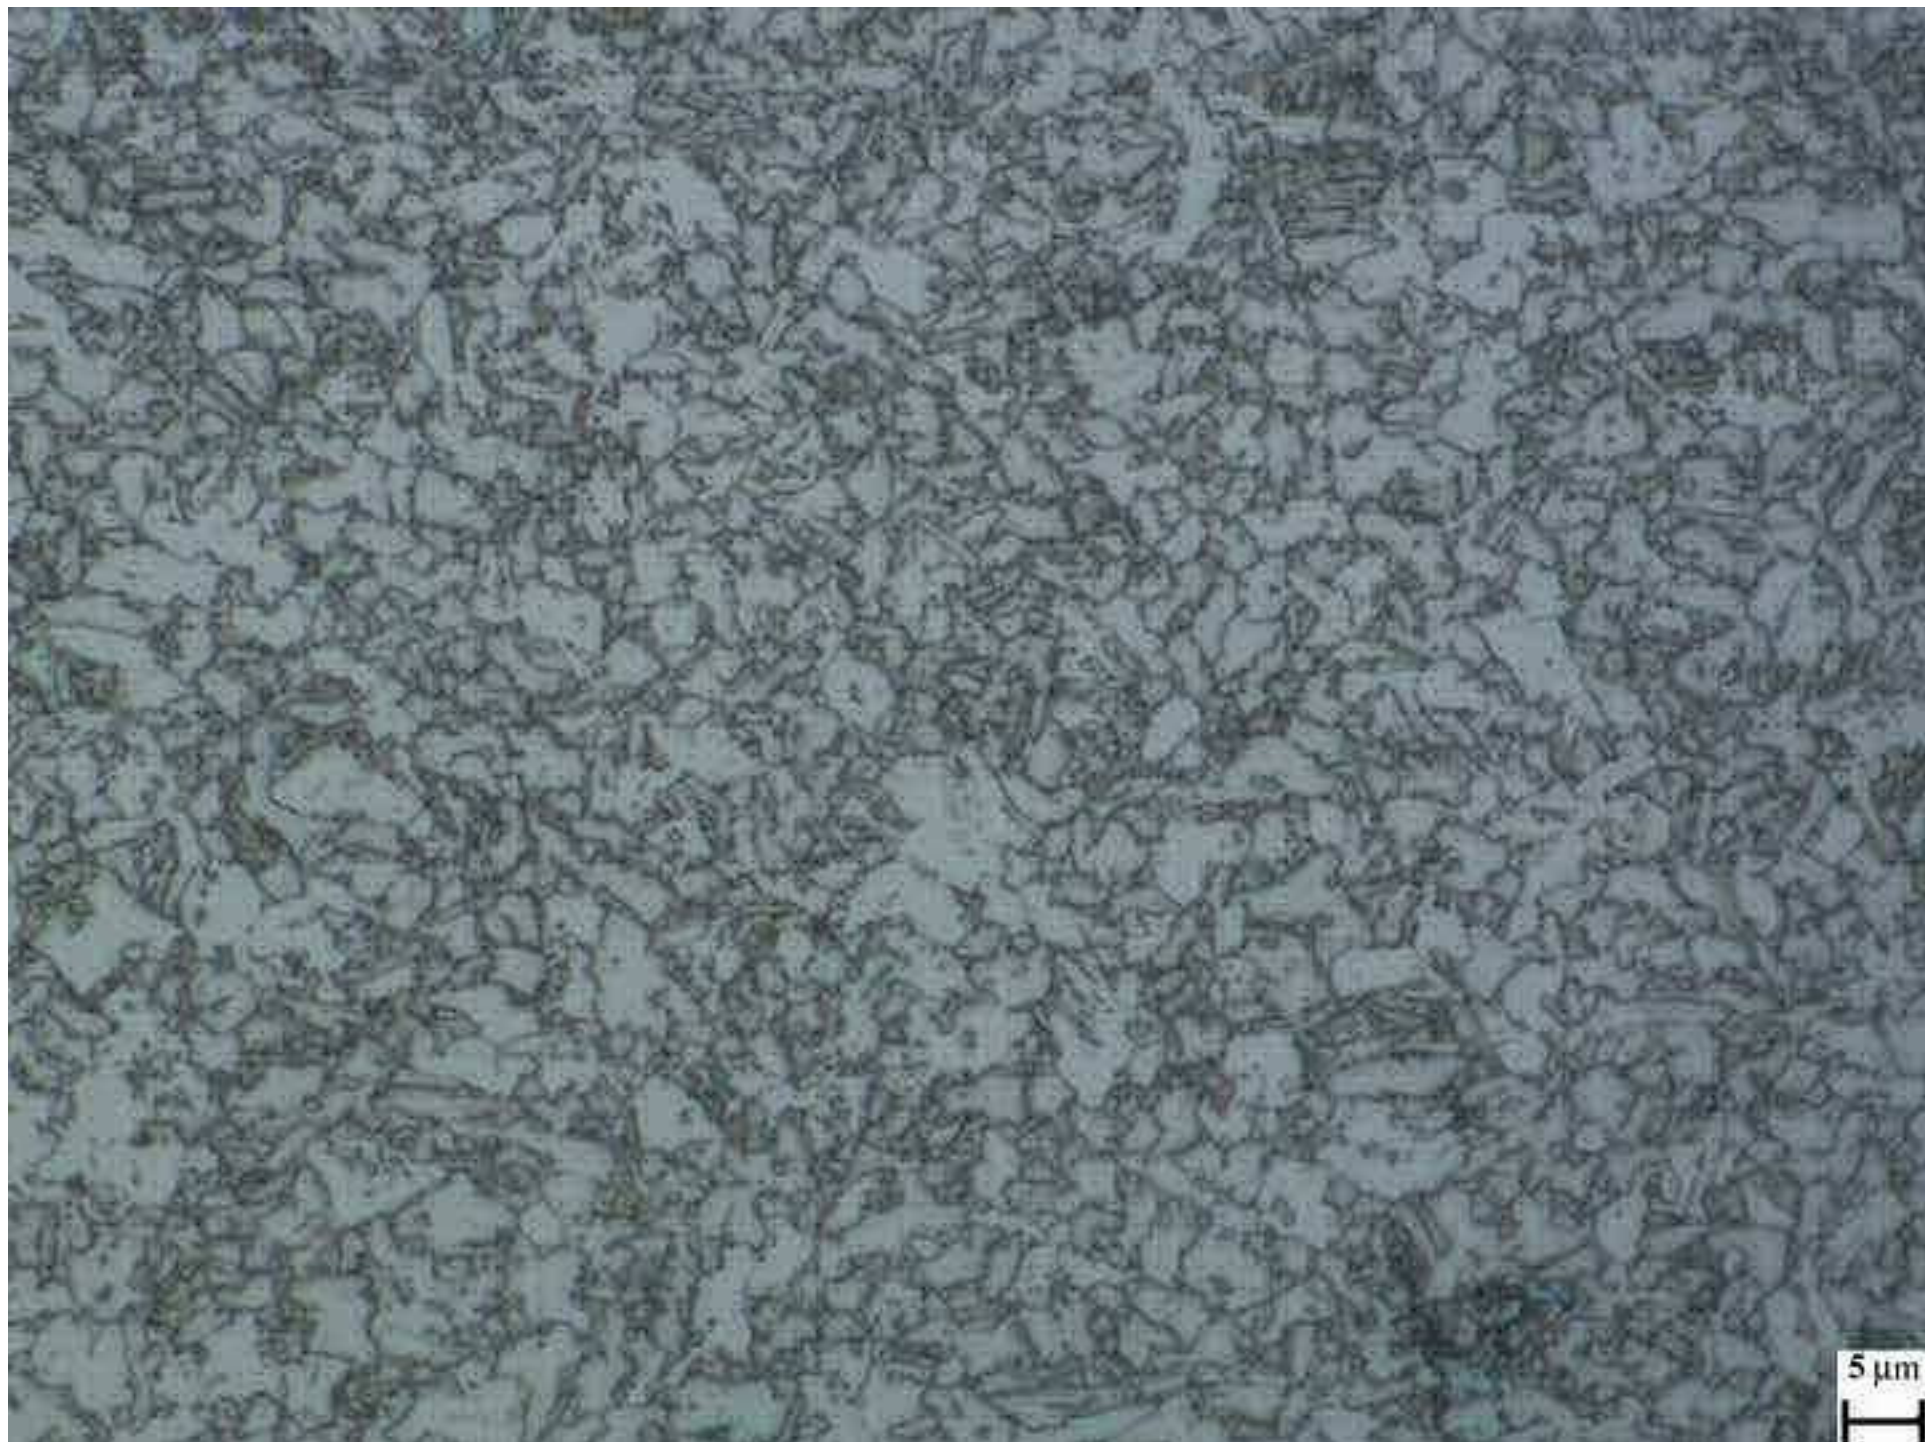
Figure 4

The slow traverse speed weld (100 mm/min – 200 rpm) presents a ferrite predominant, homogeneous microstructure with significant grain refinement in comparison to the PM (Figure 4). The formation of highly refined ferrite grains has been reported previously whilst examining the FSW of steel grade E36 [3], a shipbuilding steel comparable to DH36 in terms of chemical composition and mechanical properties, and of a mild steel where it is associated with DRX [8]. The ferrite grains appear to be of random geometry, with minor traces of small acicular shaped grains (Figure 4). This observation is in good agreement with the findings on the slow welds discussed in an earlier work [4]. As expected for this mild set of welding parameters, no flaws are visible in the bulk of the TMAZ, the transition from the heat affected zone (HAZ) to the TMAZ is smooth (Figure 5a showing the retreating (RT) side), and the non-metallic inclusions introduced in the weld from the plates' surfaces are not completely mixed but remain interconnected. The weld's top surface appears slightly uneven but gradually improving towards the end of the weld. Both sides of the top surface present signs of non-metallic inclusions interconnected in incomplete fusion regions, however insignificant in size (Figure 5b).

Figure 4. Slow weld, microstructure of mid-TMAZ [x1000, Etched].

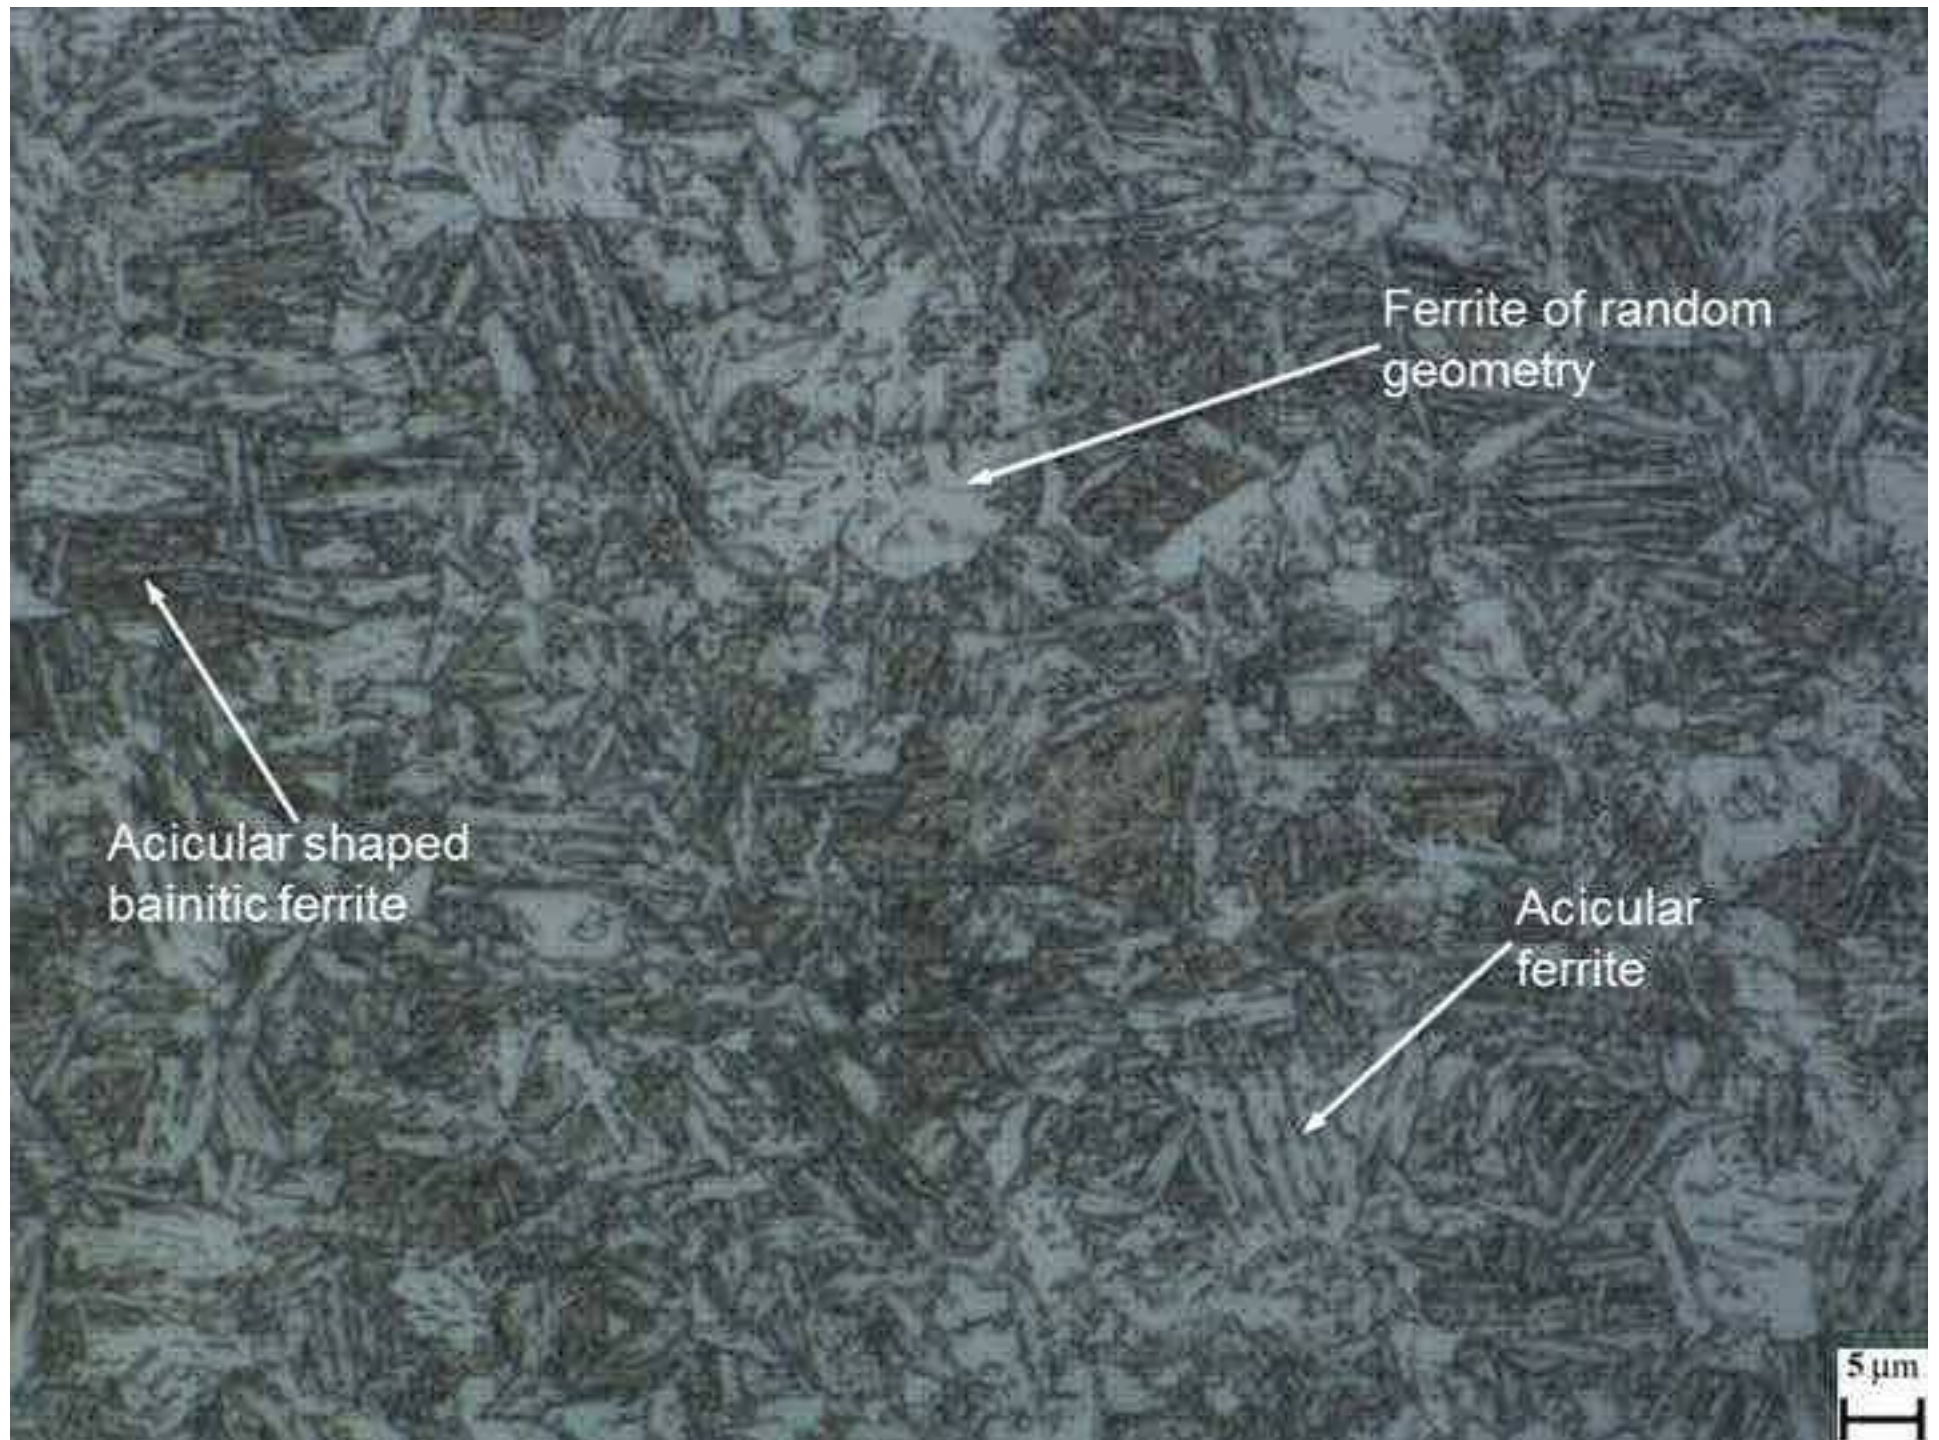
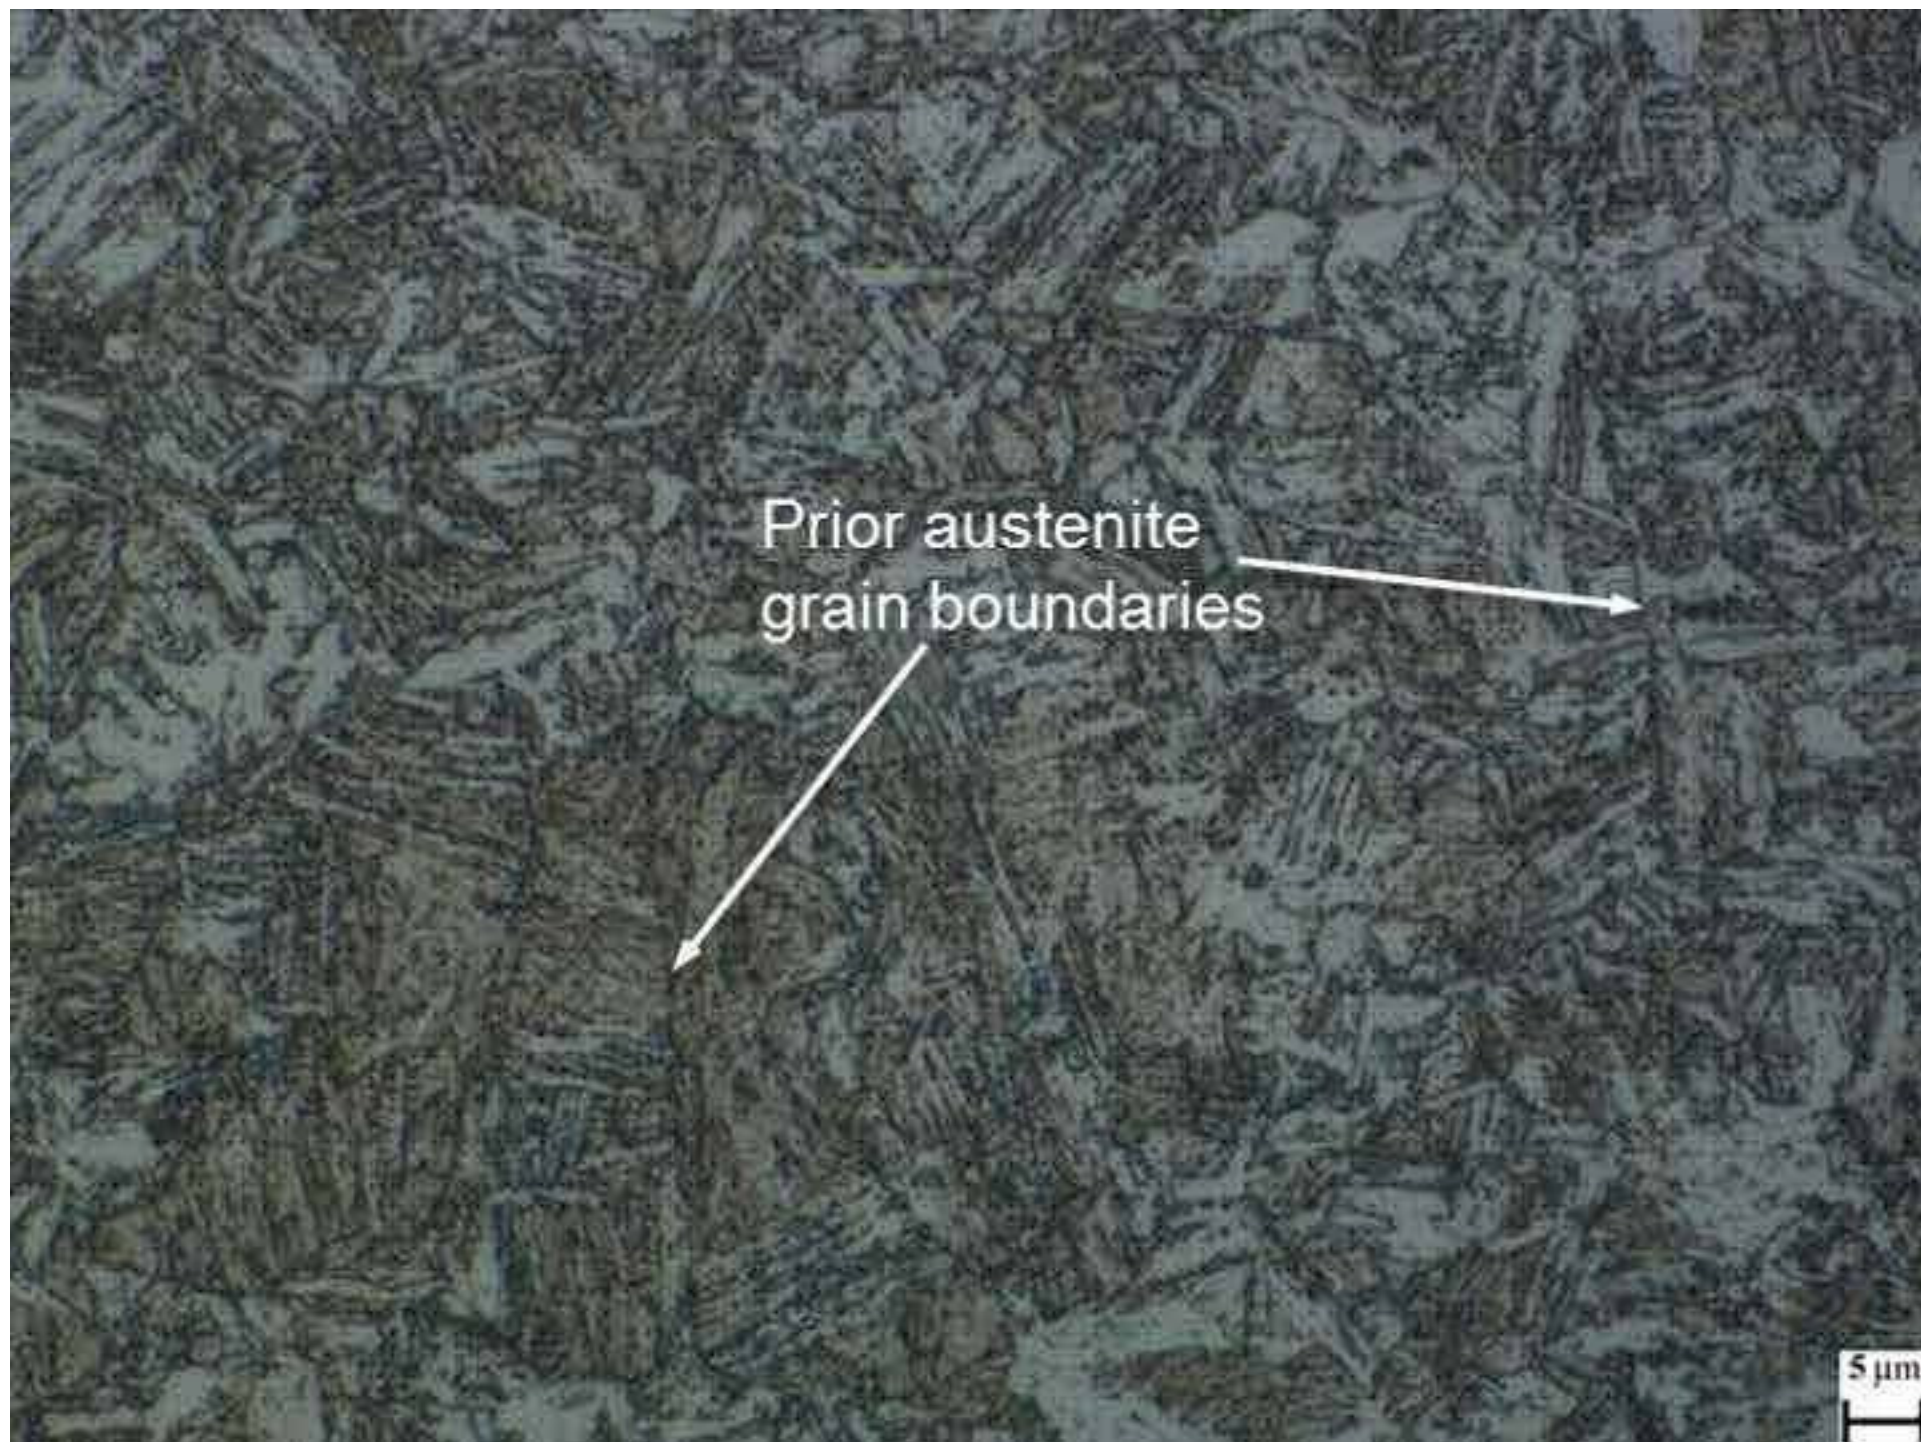
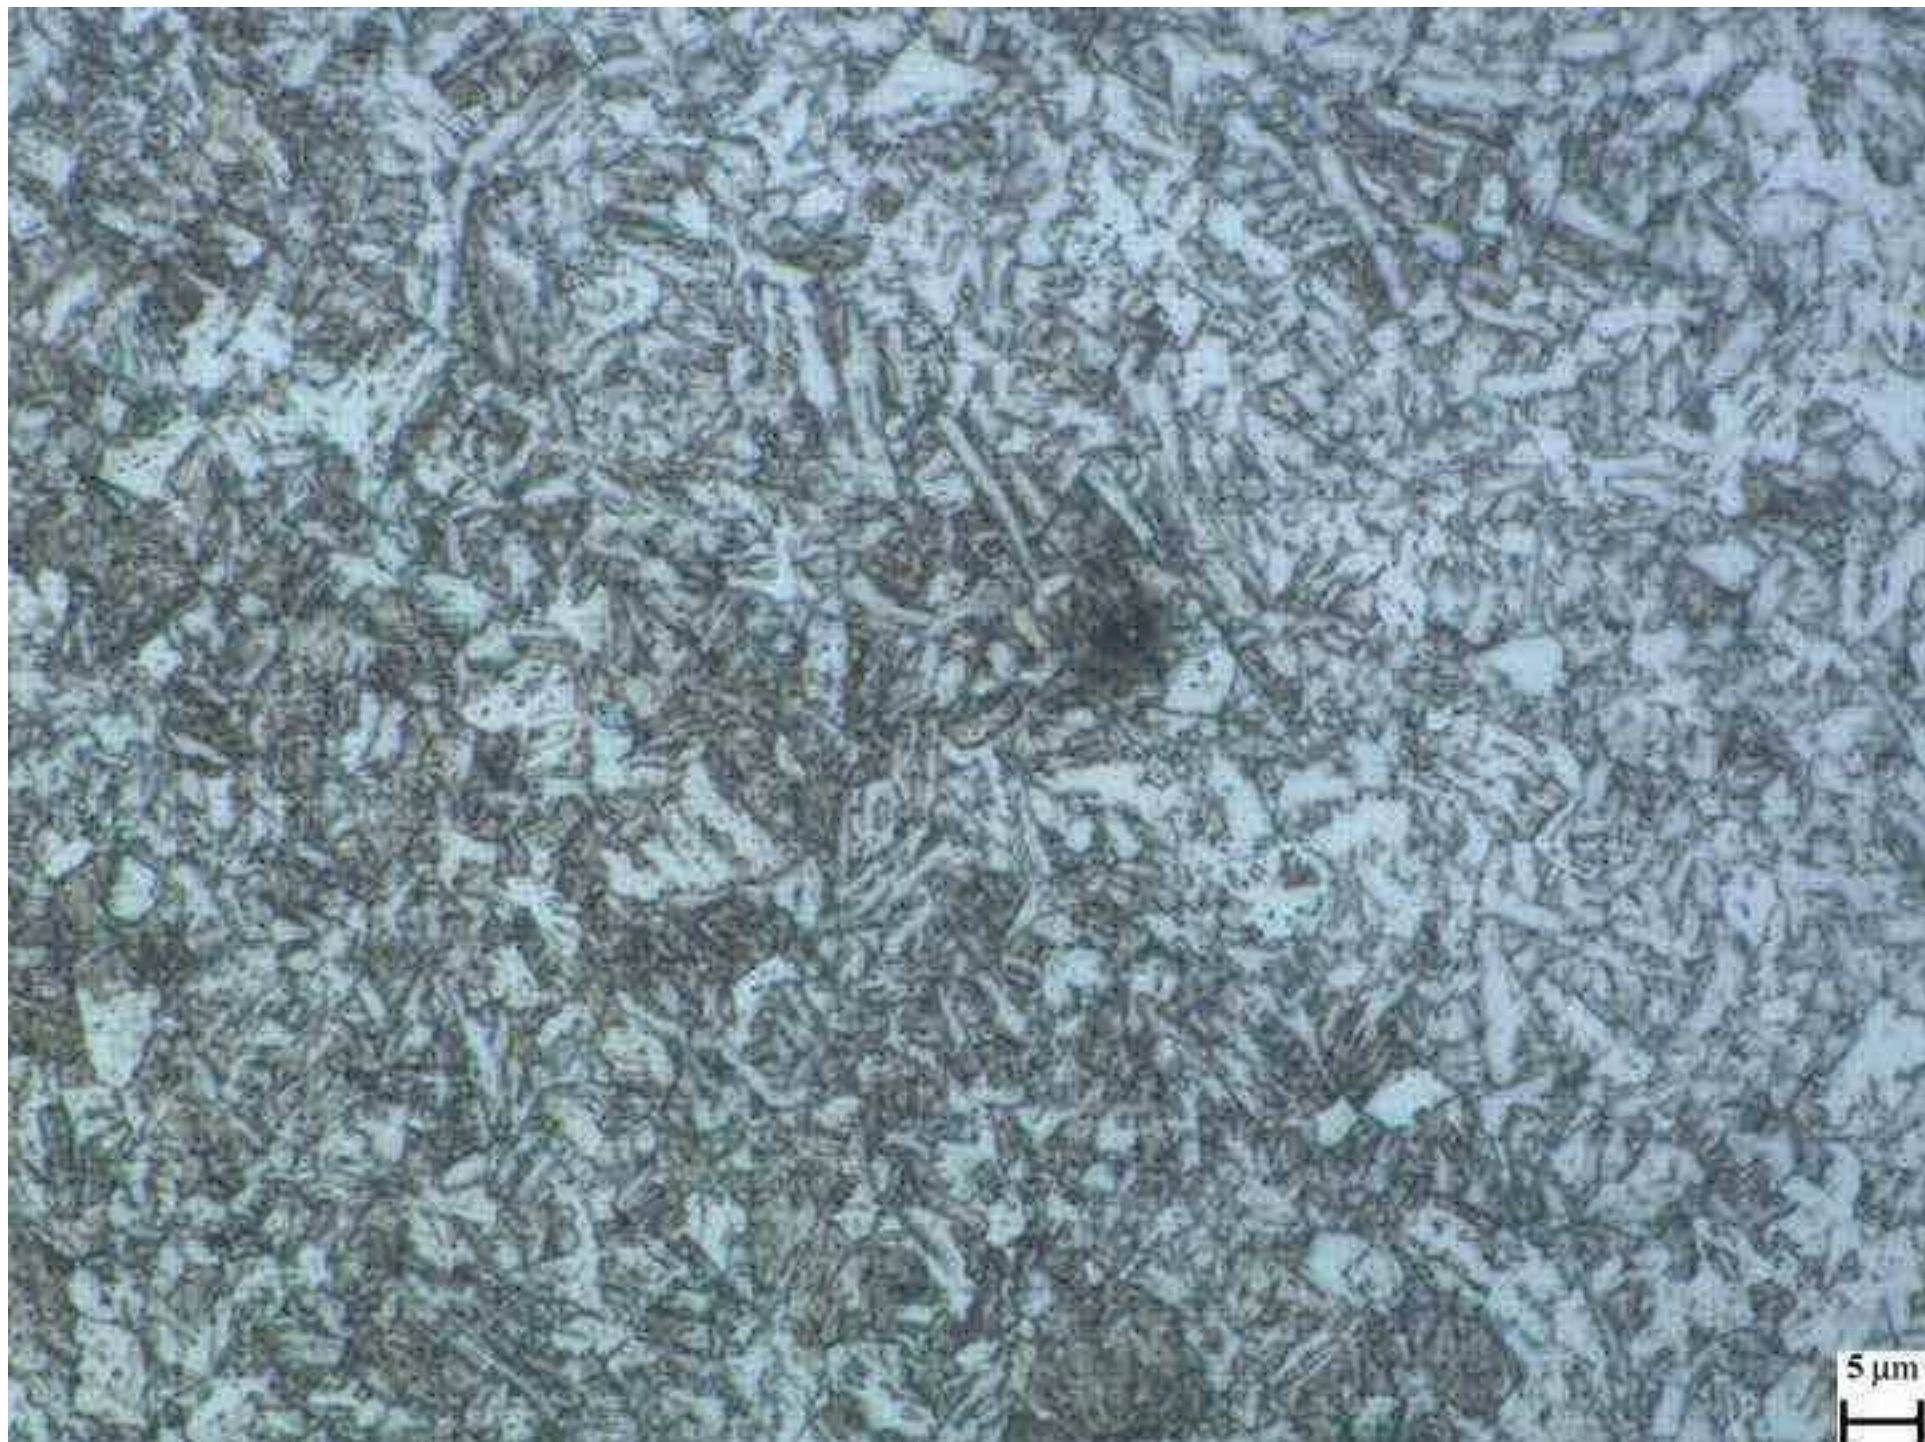
A heterogeneous microstructure is exhibited by the weld at 250 mm/min – 300 rpm (intermediate traverse speed); this consists of acicular shaped bainitic ferrite rich regions and ferrite predominant regions of either acicular shape or of random geometry (Figure 6a & 6b). Prior austenite grain boundaries are faintly observable in the bainite rich areas of the TMAZ (Figure 6b). The resultant acicular ferrite and acicular bainitic ferrite phases have been disclosed in previous studies on the same grade of steel [5] and for identical welding parameters [4]. The microstructure differs towards the bottom and outer sides of the weld, shifting to predominantly refined ferrite grains of random geometry (Figure 6c). This image also features a non-metallic inclusion which appears to have created a discontinuity in the surrounding phase, i.e. a cavity.

Figure 6. Intermediate weld [x1000, Etched]: (a) & (b) microstructure of mid-TMAZ; (c) microstructure of outer AD TMAZ.

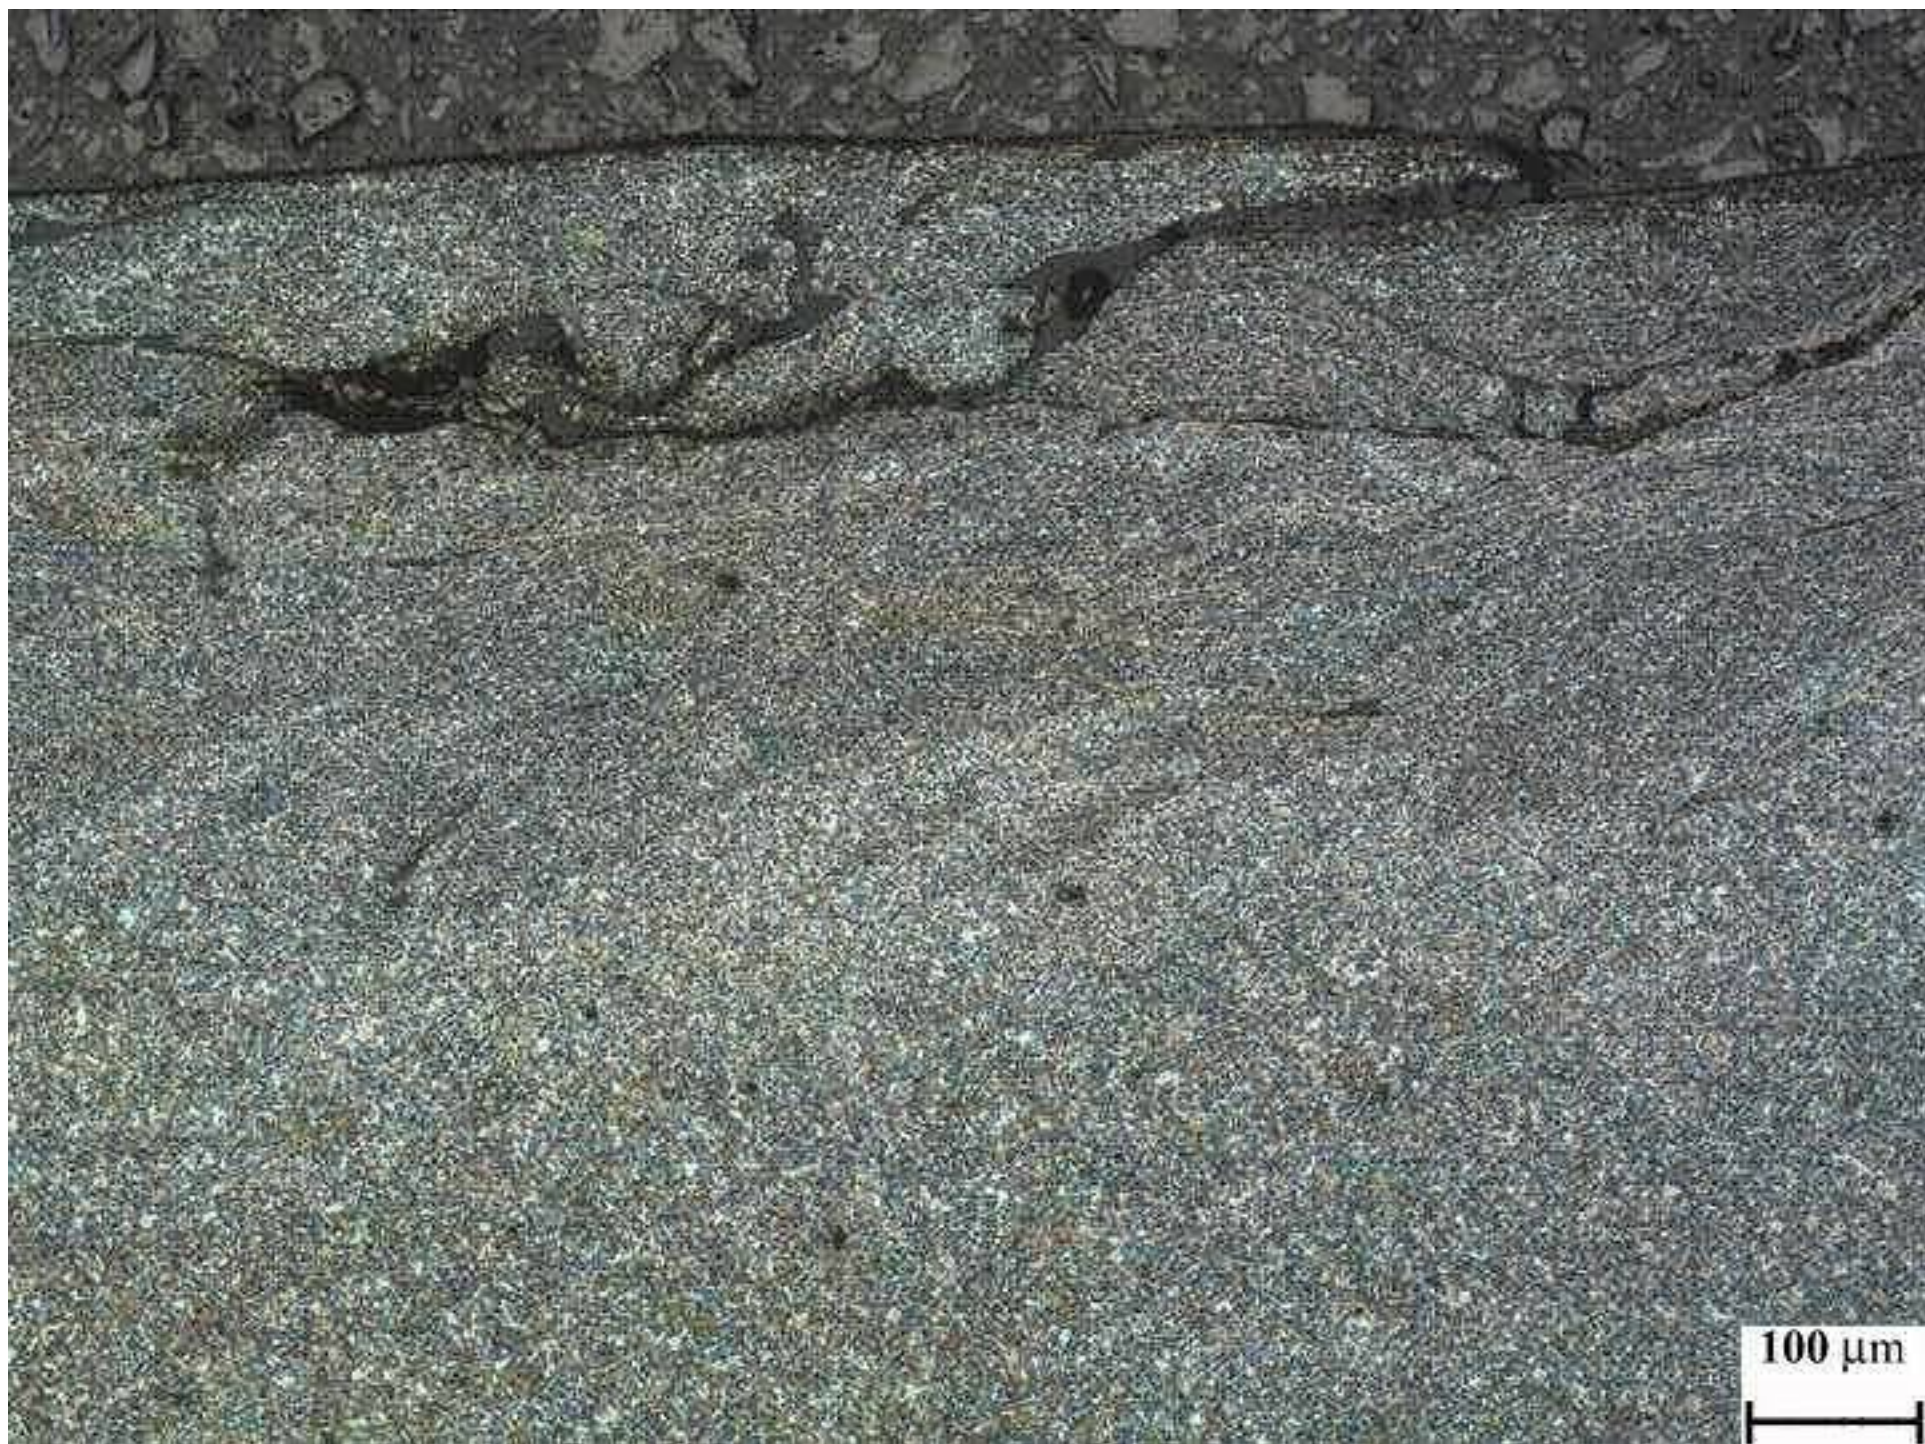
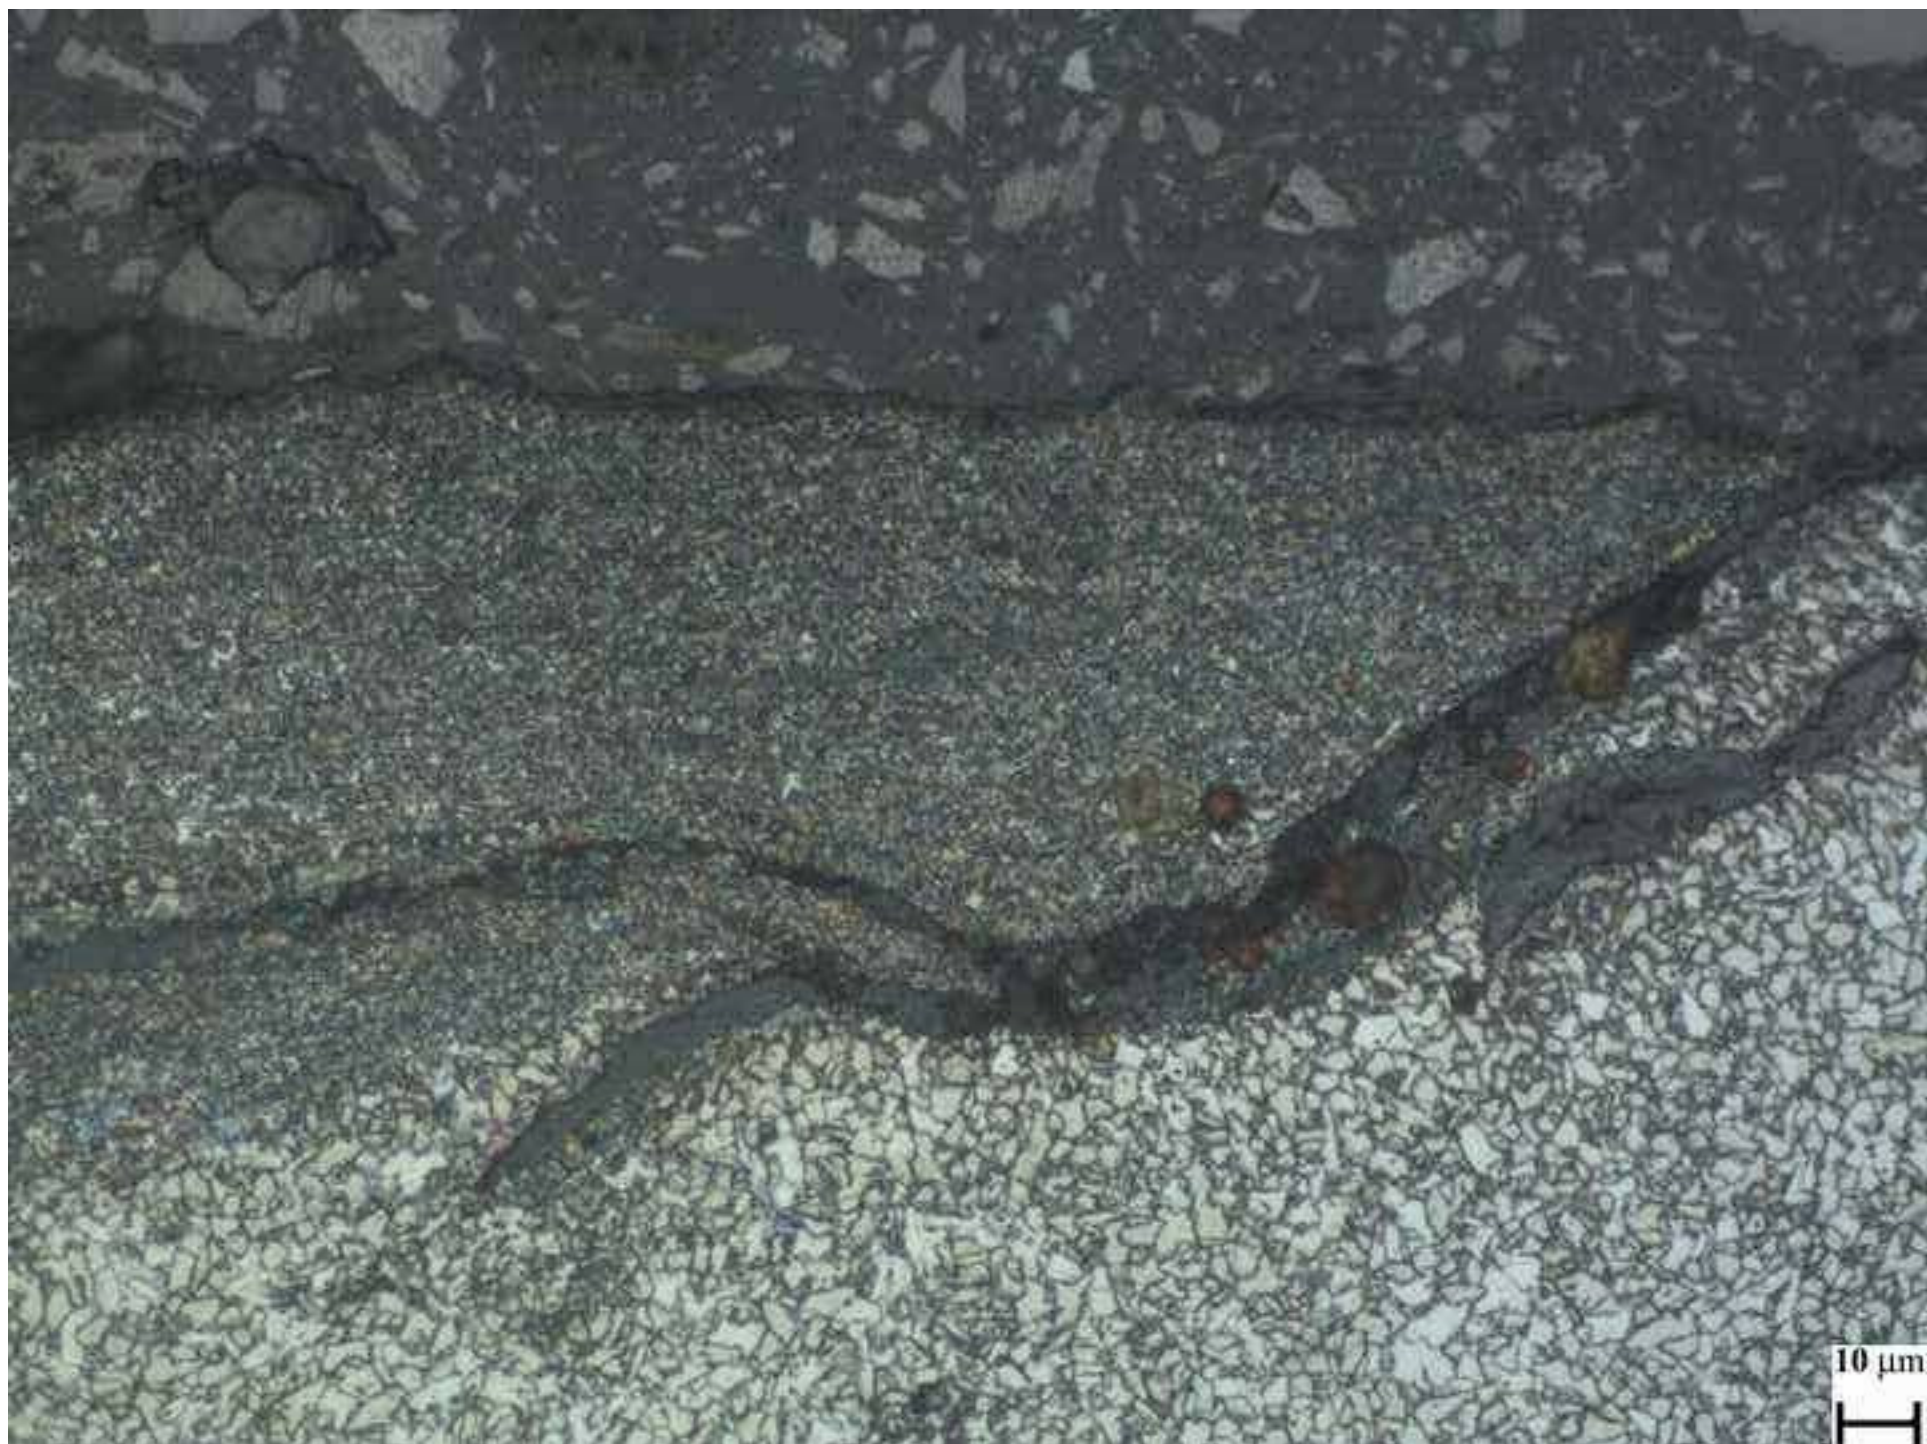
The top surface of the intermediate weld is mildly uneven, indented by the tool shoulder's threads. There is a small number of incomplete fusion paths, or laps [20] observed particularly on the outer top RT side (Figure 7), with entrapped and interconnected non-metallic inclusions in various stages of oxidation (seen in different shades of grey). These laps are seen to provide crack initiation sites during fatigue testing (see section 3.3). The weld root has been fully fused, and the microstructure of this region comprises recrystallized ferrite and pearlite. There has been no substantial mechanical stirring of the steel in this area; therefore, the driving force for the transformation (DRX in this case) is the thermal energy which has dissipated from the bulk

Microstructural observations and subsequent measurements on the captured micrographs (Figure 7) with suitable software have shown that the deepest top surface lap defect found in the intermediate speed weld is approx. 0.45 mm. Since this defect has been the decisive factor in fracture initiation, it is fitting to assess the weld's fatigue behaviour should this process related feature had been avoided. For this purpose, three fatigue tests were performed at a stress range of 90% of YS employing intermediate weld samples from which the top 0.5 mm had been removed by grinding and polishing. The three tests were terminated at 3.2×10^6 cycles or above; the samples revealed no discernible evidence of fracture initiation features after these tests.
