Toumpis, Athanasios and Galloway, Alexander and Molter, Lars and Polezhayeva, Helena (2015) Systematic investigation of the fatigue performance of a friction stir welded low alloy steel. Materials and Design, 80. pp. 116-128. ISSN 0261-3069 , <http://dx.doi.org/10.1016/j.matdes.2015.04.046>

Systematic investigation of the fatigue performance of a friction stir welded low alloy steel

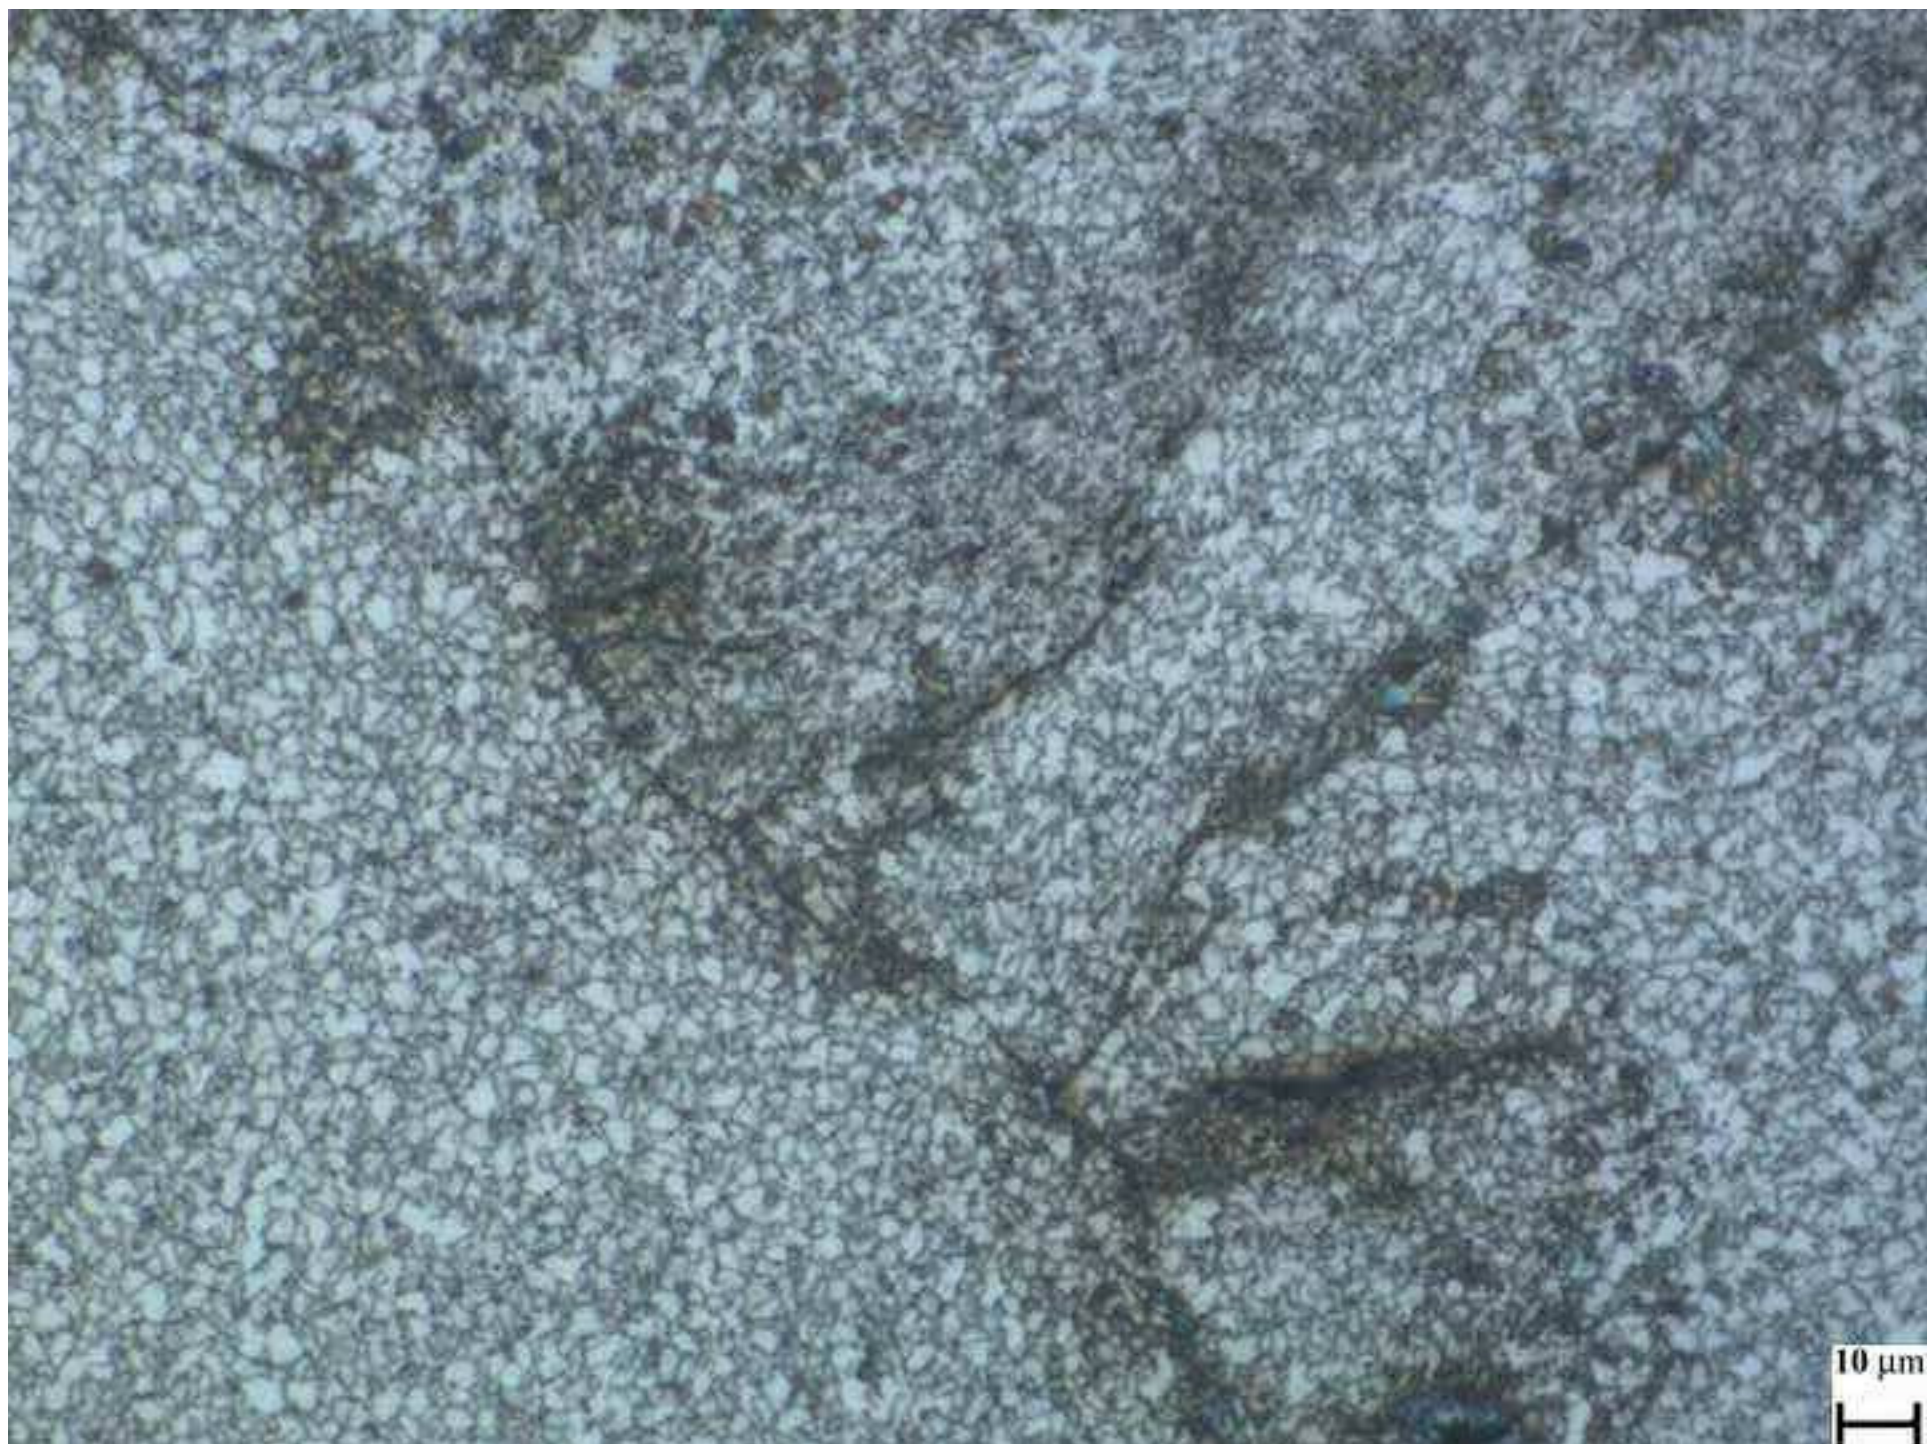
Figure 8
[Click here to download high resolution image](#)

of the weld. More, there is strong indication of a recurrent region of insufficient fusion, also labelled cold shut [20], observed at the mid-AD side of the intermediate weld (Figure 8).

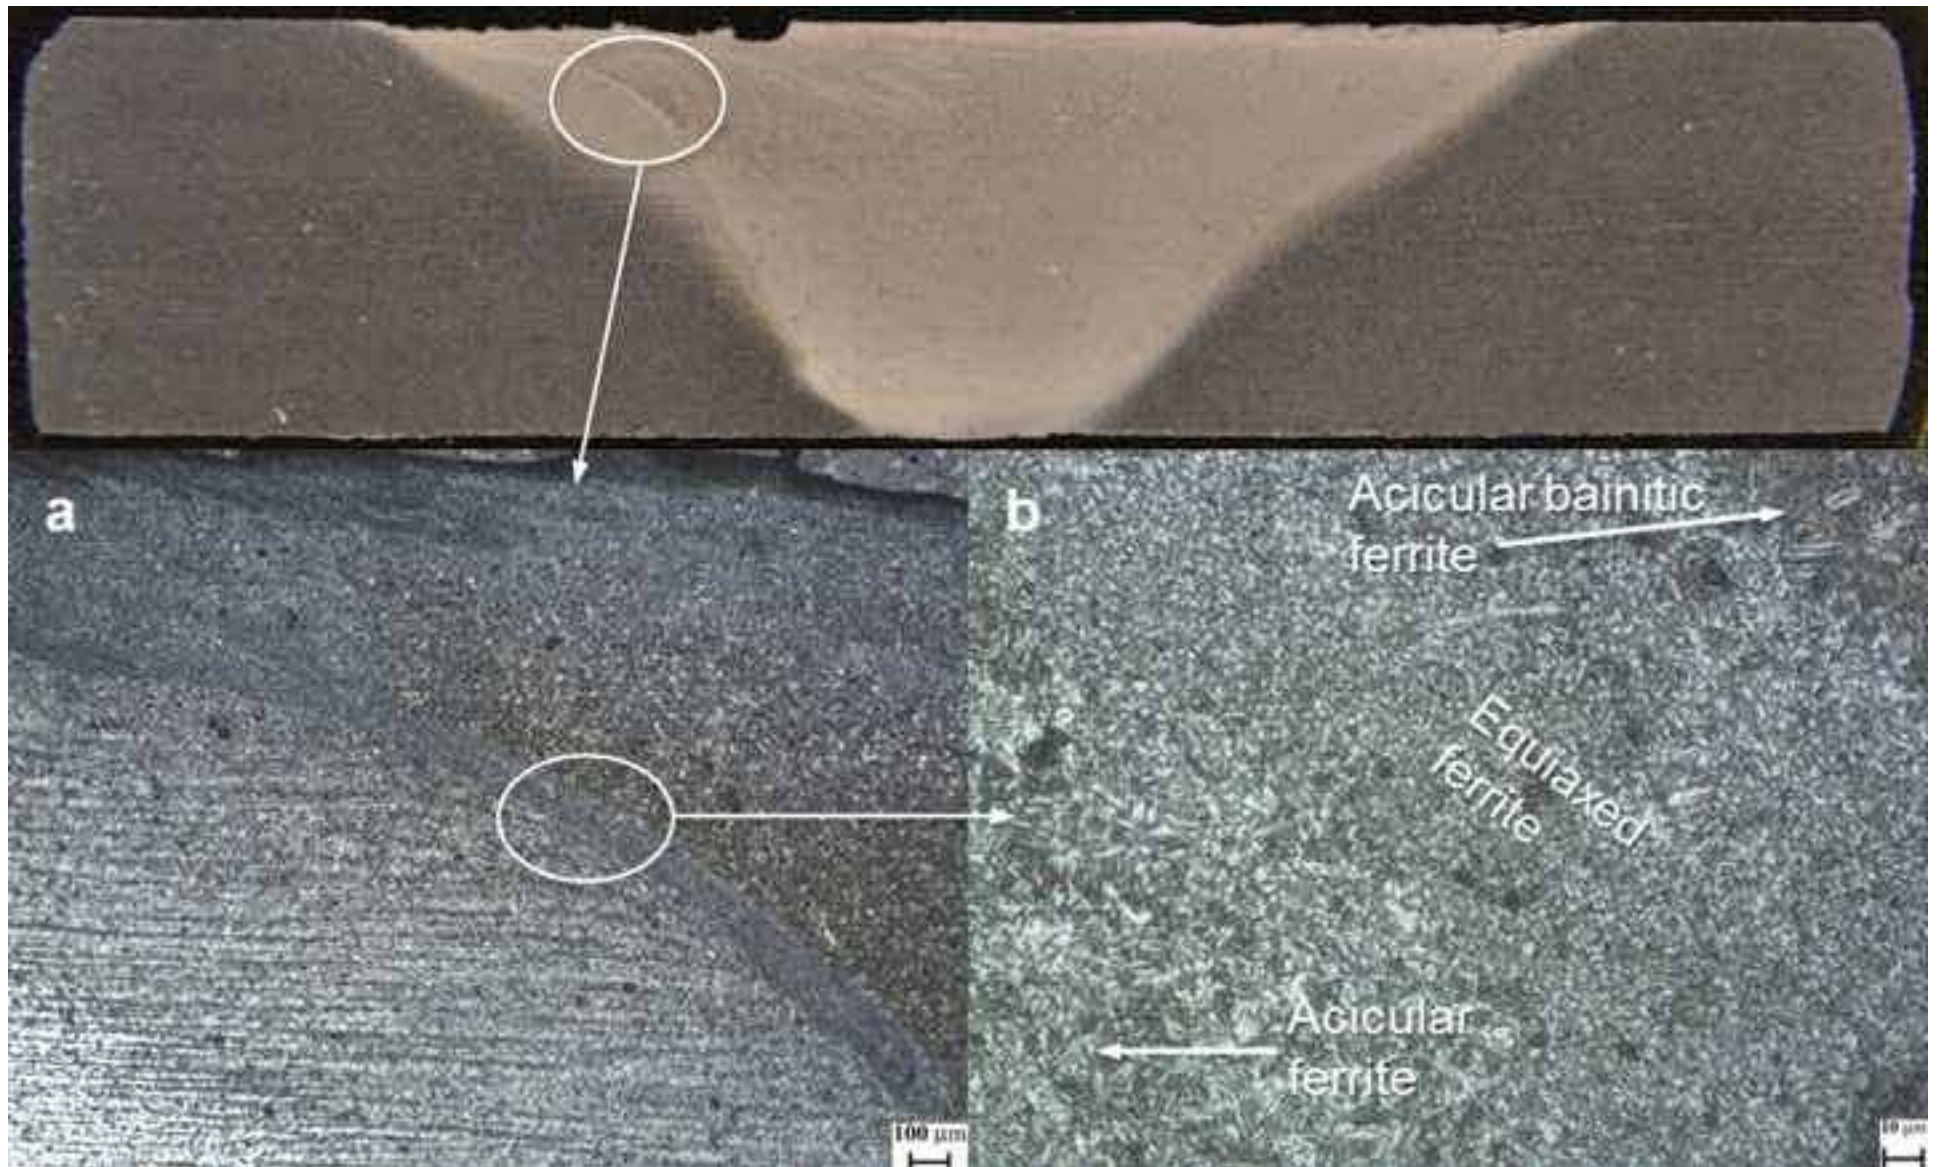
Figure 9 (a&b)
[Click here to download high resolution image](#)

A particular characteristic of one of the examined samples from the intermediate speed weld is worthy of note. There is one material flow line in the outer top AD side with a microstructure very distinct from the surrounding regions (Figure 9a). This is a predominantly ferrite phase of refined and equiaxed grains inside the previously discussed acicular bainitic ferrite and acicular ferrite of the TMAZ (Figure 9b). Thus, this particularly heterogeneous area may have been formed by metal having been transported from another region (perhaps the outer bottom side where a slower cooling rate occurred) due to the powerful stirring action of the tool during FSW.

The typical shape of a friction stir butt weld is curved towards the bottom surface of the two welded plates (e.g. macrograph of Figure 9). The fracture plane of all fatigue samples is practically perpendicular to the weld top surface (Figure 20). Thus, cracks have initiated at the outer RT side of the top surface (lap defect upper "lip" marked in Figure 20), propagated for a short part of the cross-section in the outer TMAZ and then advanced in the PM. The highly refined microstructure of the weld has diverted the crack propagation path away from the weld zone and into the PM. Consequently, the bottom layer of all samples fracture surfaces (both samples in Figure 19), the final fracture region [17], is the PM which exhibits mainly ductile fracture as anticipated. Furthermore, examination of the regions which appear to be better welded thus exhibiting ductile fracture (right side regions of both samples' fracture surfaces in Figure 19) reveals similar crack initiation sites on the top surface. The lap defect is observed continuously along the weld length but with varying intensity and depth. Therefore, some weld

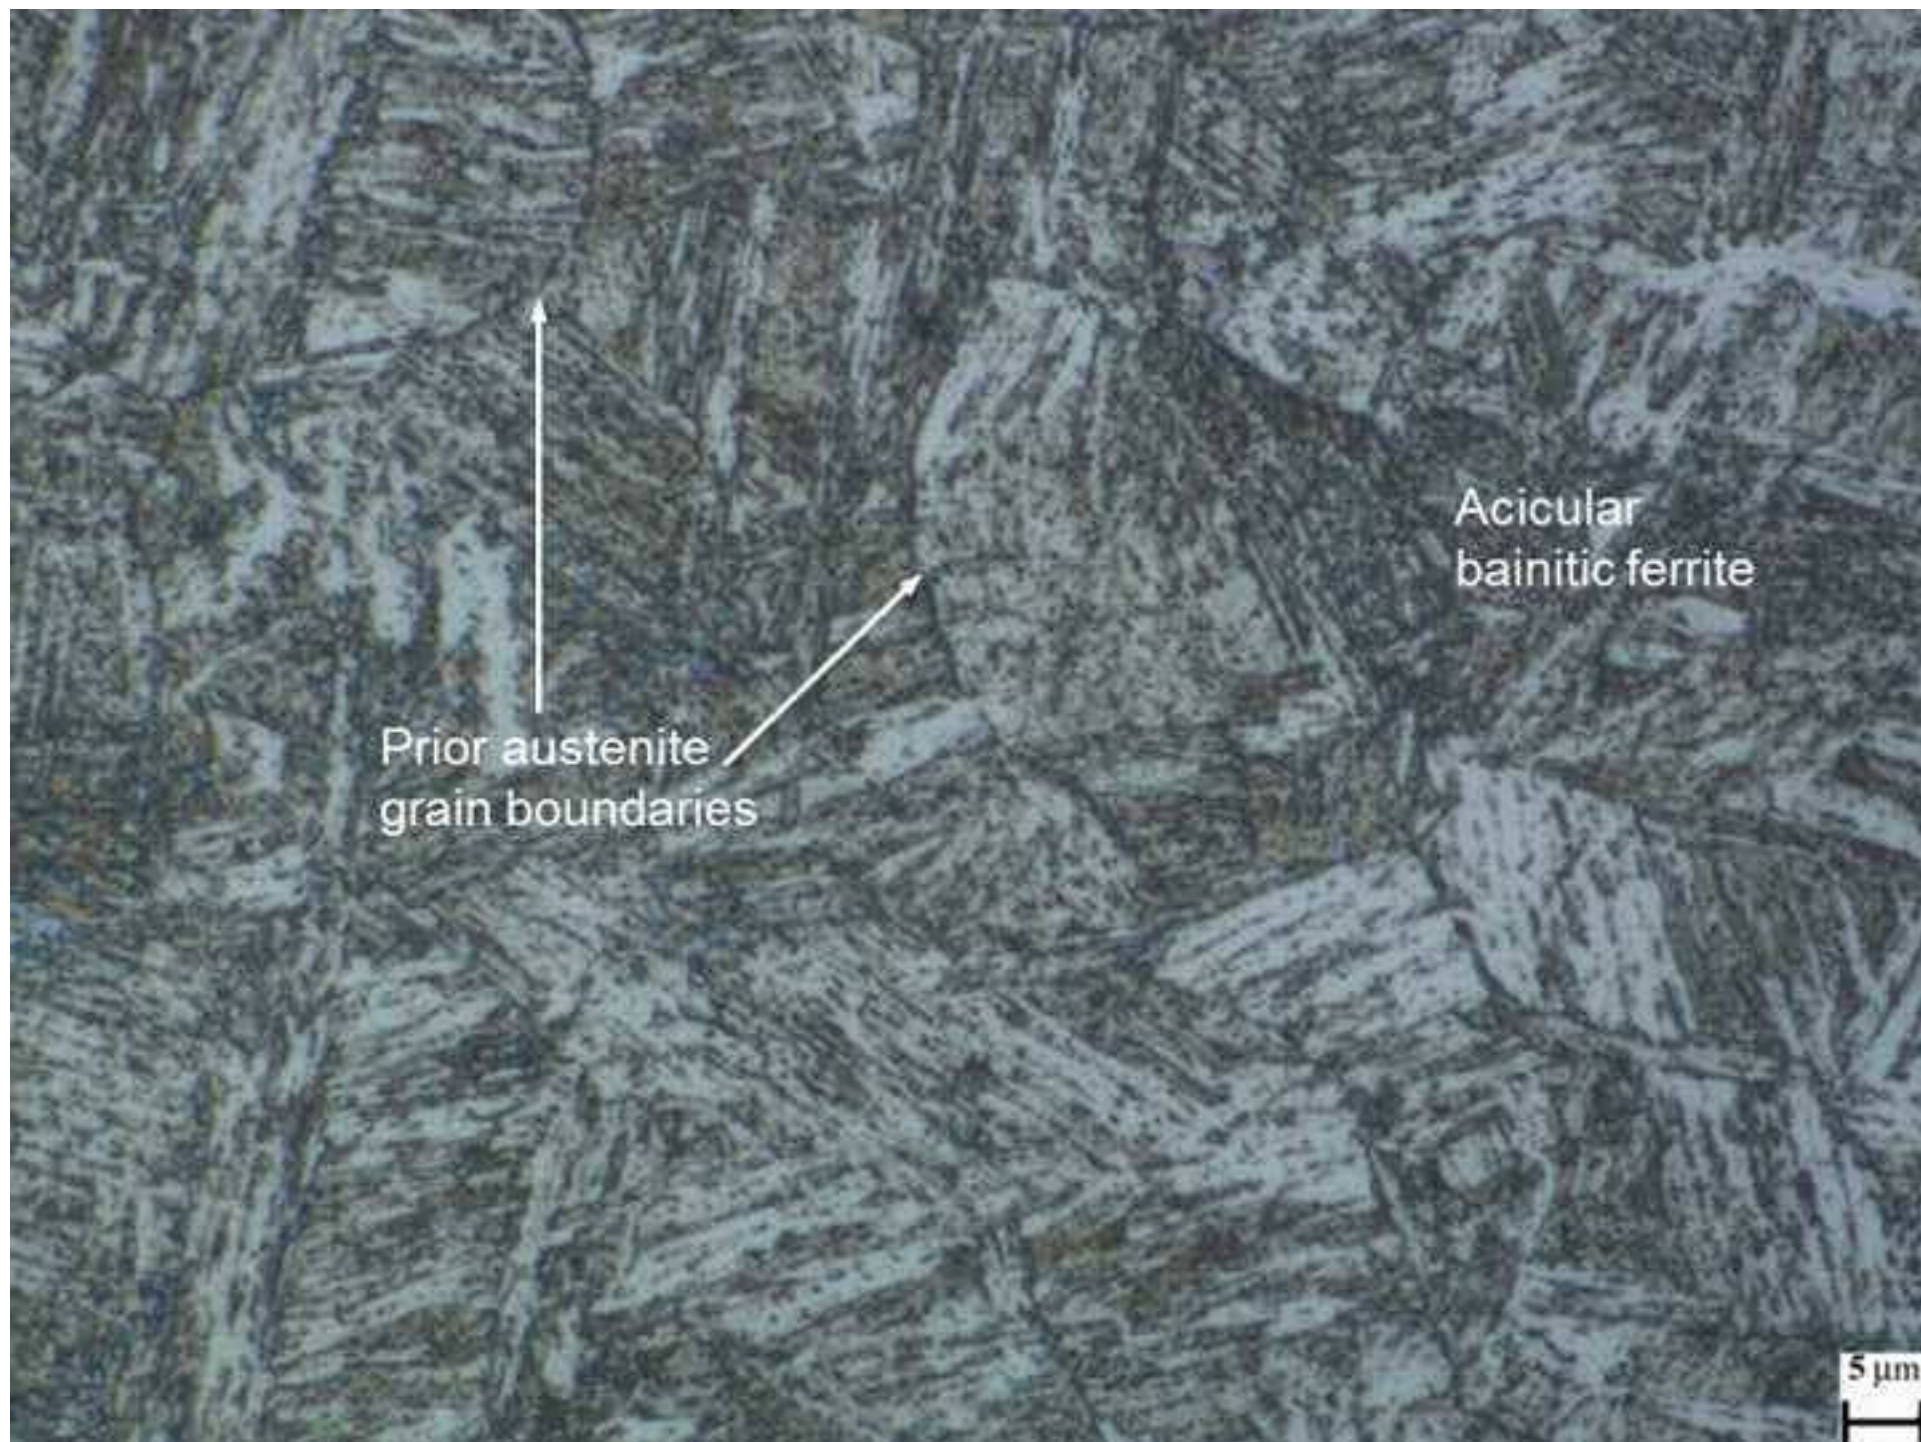
Figure 10
[Click here to download high resolution image](#)

The fast traverse speed weld (500 mm/min – 700 rpm) features what seems to be a heterogeneous but predominantly acicular shaped bainitic ferrite microstructure with small regions of acicular ferrite (Figure 10); this microstructure is identical to the one described previously [4]. The increased bainitic content is a direct consequence of the higher cooling rate due to the higher traverse speed of this weld. More, prior austenite grain boundaries are clearly detected (Figure 10); acicular shaped grains appear to nucleate perpendicular to these boundaries. Earlier studies in the FSW of steel [1] noted bainitic and martensitic phases in DH36 for comparable welding speeds; increased knowledge on steel FSW has led to recent studies achieving martensite-free welds [7].

Figure 10. Fast weld, microstructure of mid-TMAZ [x1000, Etched].

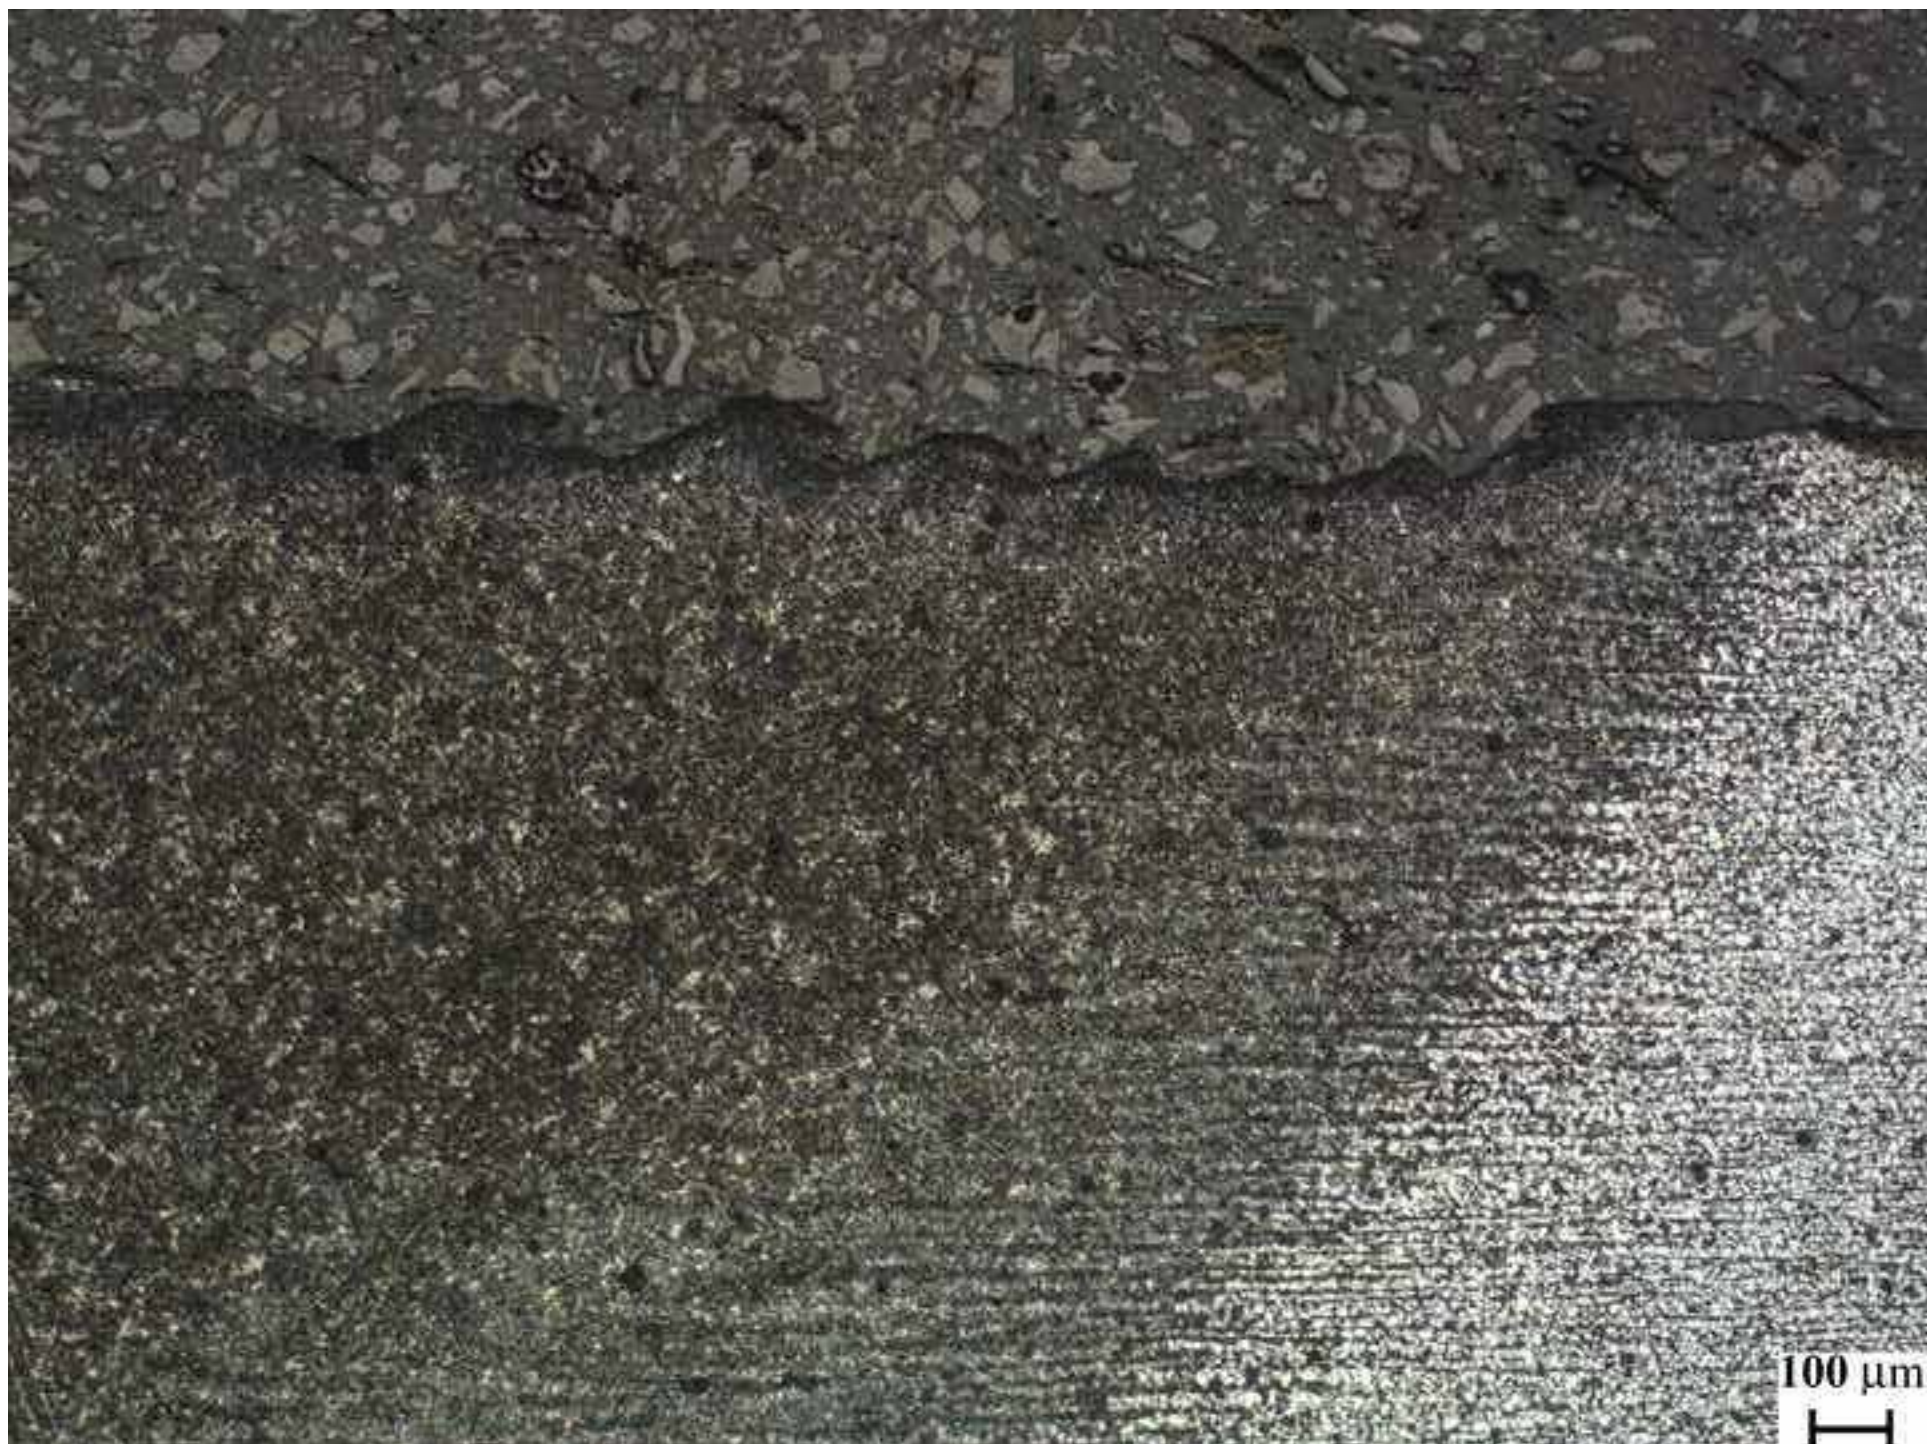
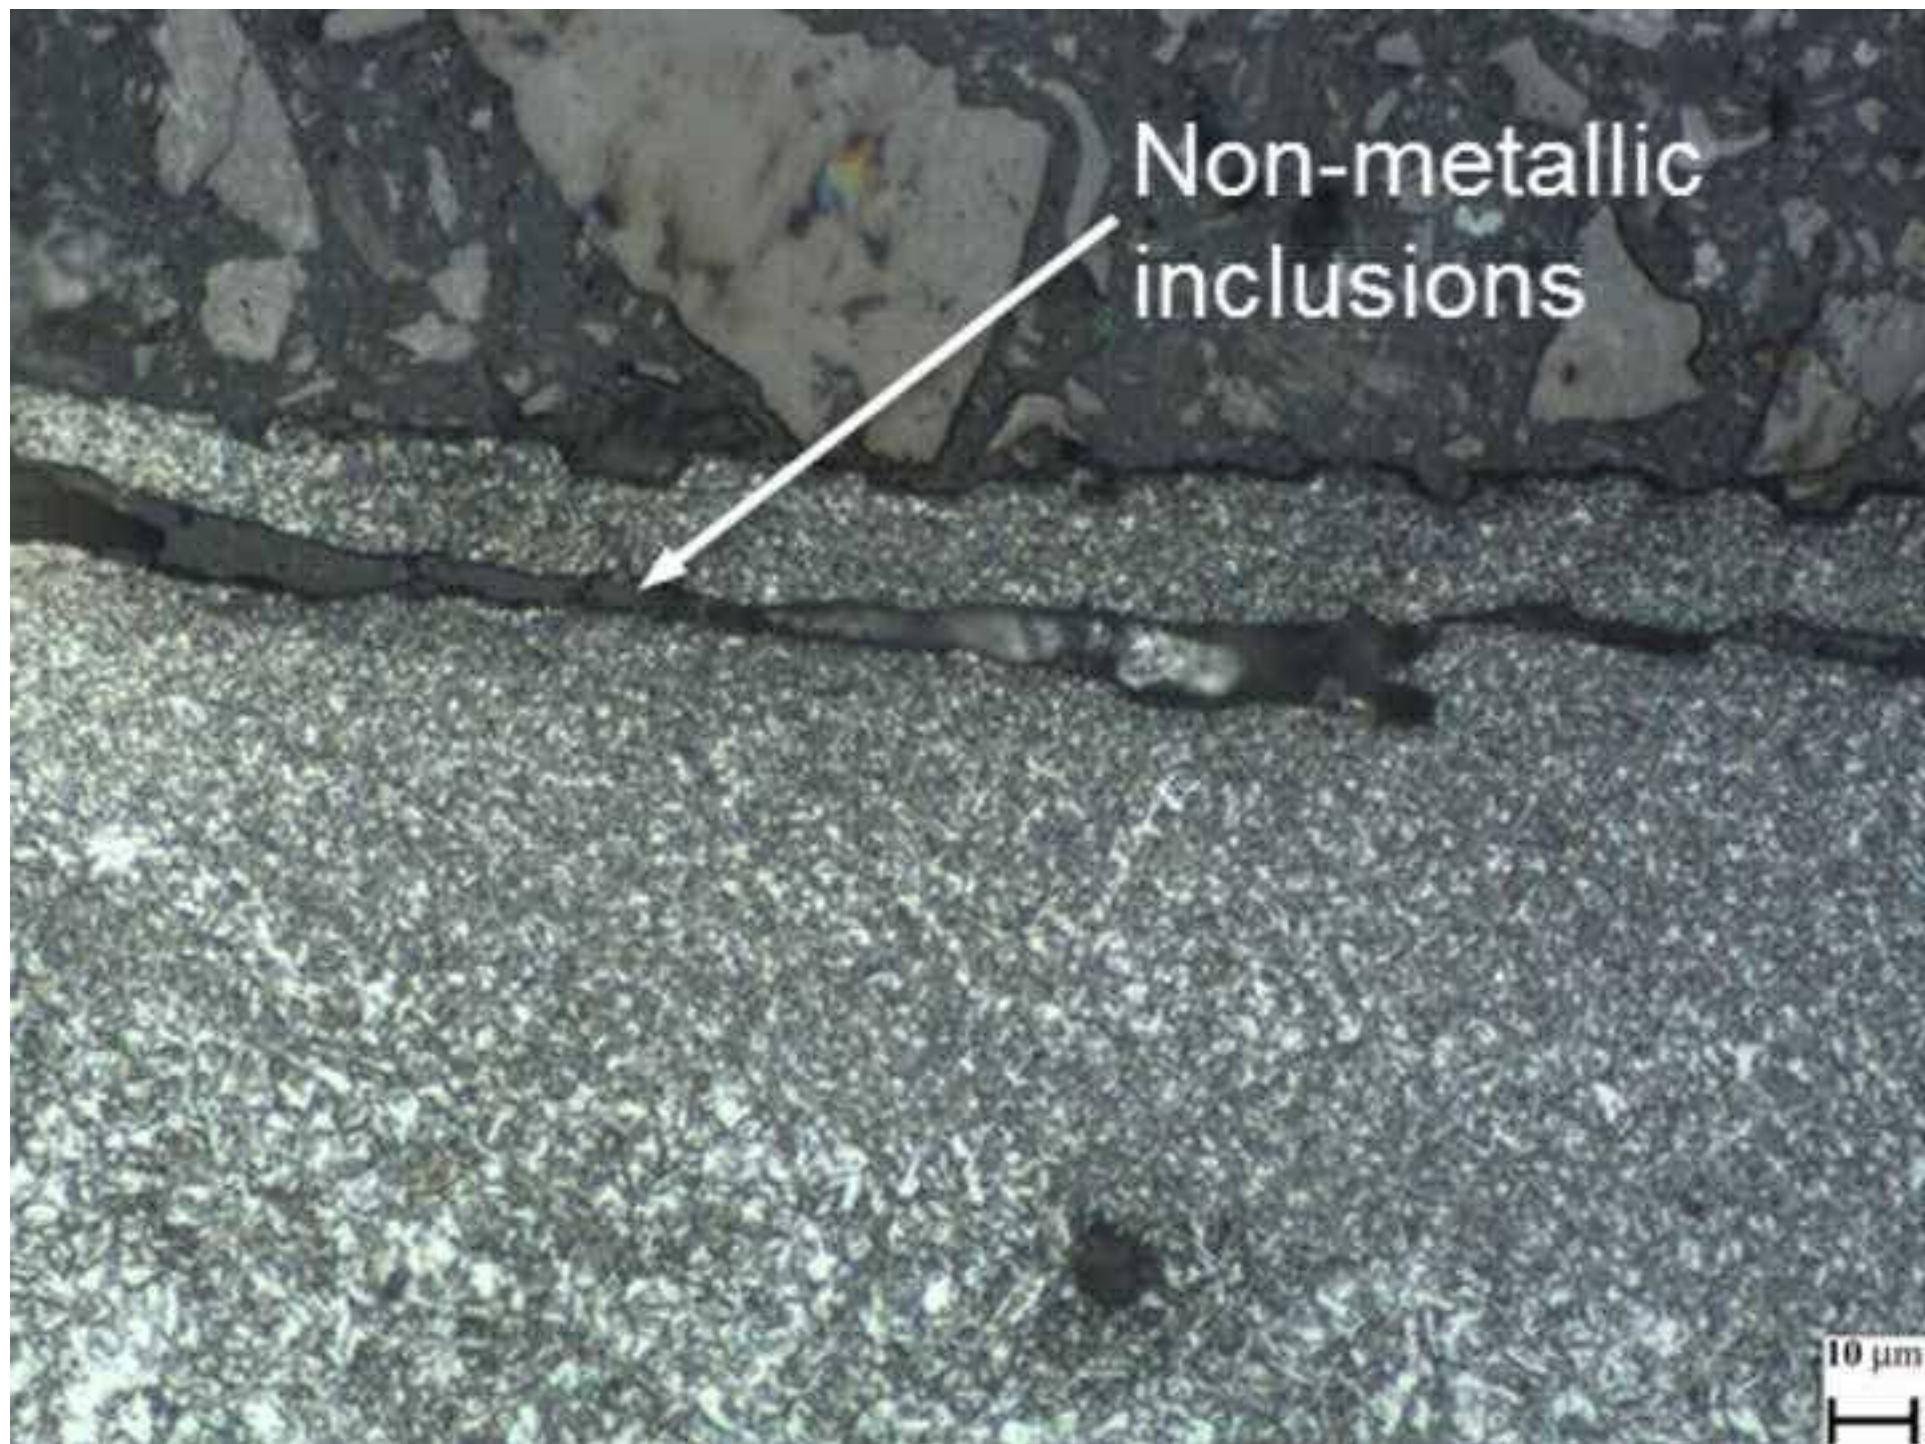
The weld demonstrates a poor quality top surface with marks on both sides corresponding to the tool shoulder's features (Figure 11a), and laps introducing non-metallic inclusions in the TMAZ which appear in post-weld oxidation (Figure 11b); again, these are stress concentration regions which are expected to provide crack initiation sites hence influence the weld's fatigue performance. Similar poor top surface with fissures is seen on the HSLA-65 shipbuilding steel welds of an earlier publication [2] and confirmed by optical microscopy. Konkol *et al.* attribute this process related flaw to the tool shoulder and clarify that it could compromise the weld's fatigue performance [2].

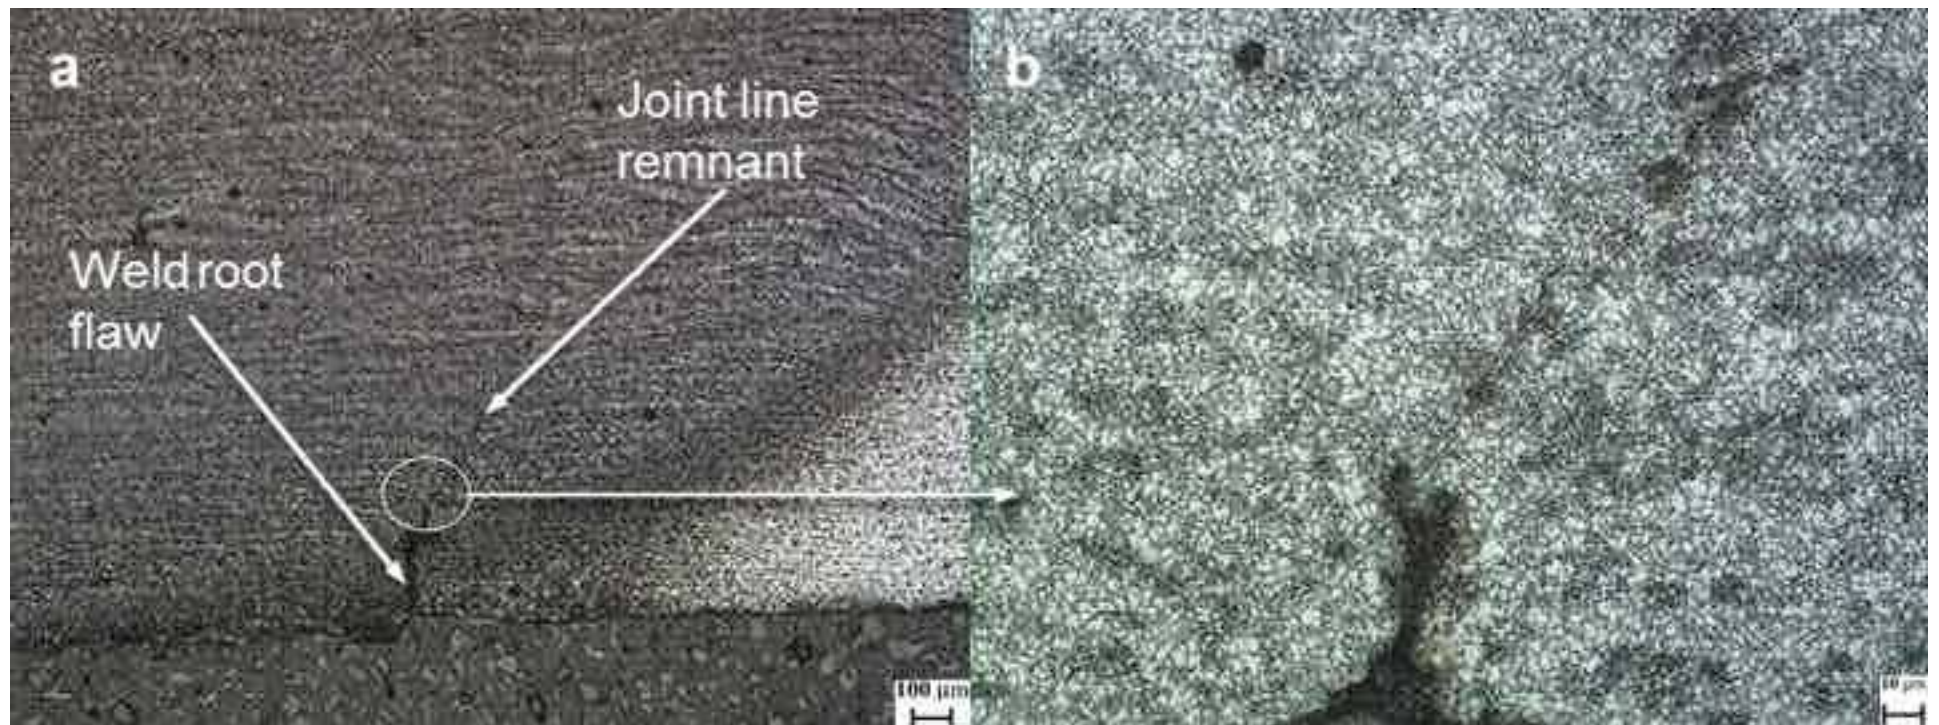
Figure 12 (a&b)
[Click here to download high resolution image](#)

The FSW tool appears to have deviated slightly off centre as it traverses through the original plate interface developing evidently intermittent insufficient fusion at the weld root, i.e. a weld root flaw (Figure 12a). Since there is almost no stirring action of the tool's probe on the steel in this region of reduced temperature, the thin film of non-metallic inclusions on the surface of the two plates being welded is not fully dispersed, thus forming a joint line remnant as an extension of the weld root flaw (Figure 12a). For the same reason of minimal mechanical deformation, the microstructure of this region is very different from the bulk of the weld (TMAZ). This consists of highly refined, almost equiaxed ferrite grains, where the prior ferrite / pearlite PM grain structure is still barely visible (Figure 12b). This transformation is primarily attributed to the thermal energy dissipating towards the bottom of the plate. The boundary between HAZ and TMAZ on the mid-AD side of the weld contains few entrapped non-metallic inclusions which have not allowed the material to flow properly during welding, hence producing small cavities, or cold shuts, around them. Still, it is anticipated that such flow-related embedded flaws will not be detrimental to the weld's behaviour under fatigue.

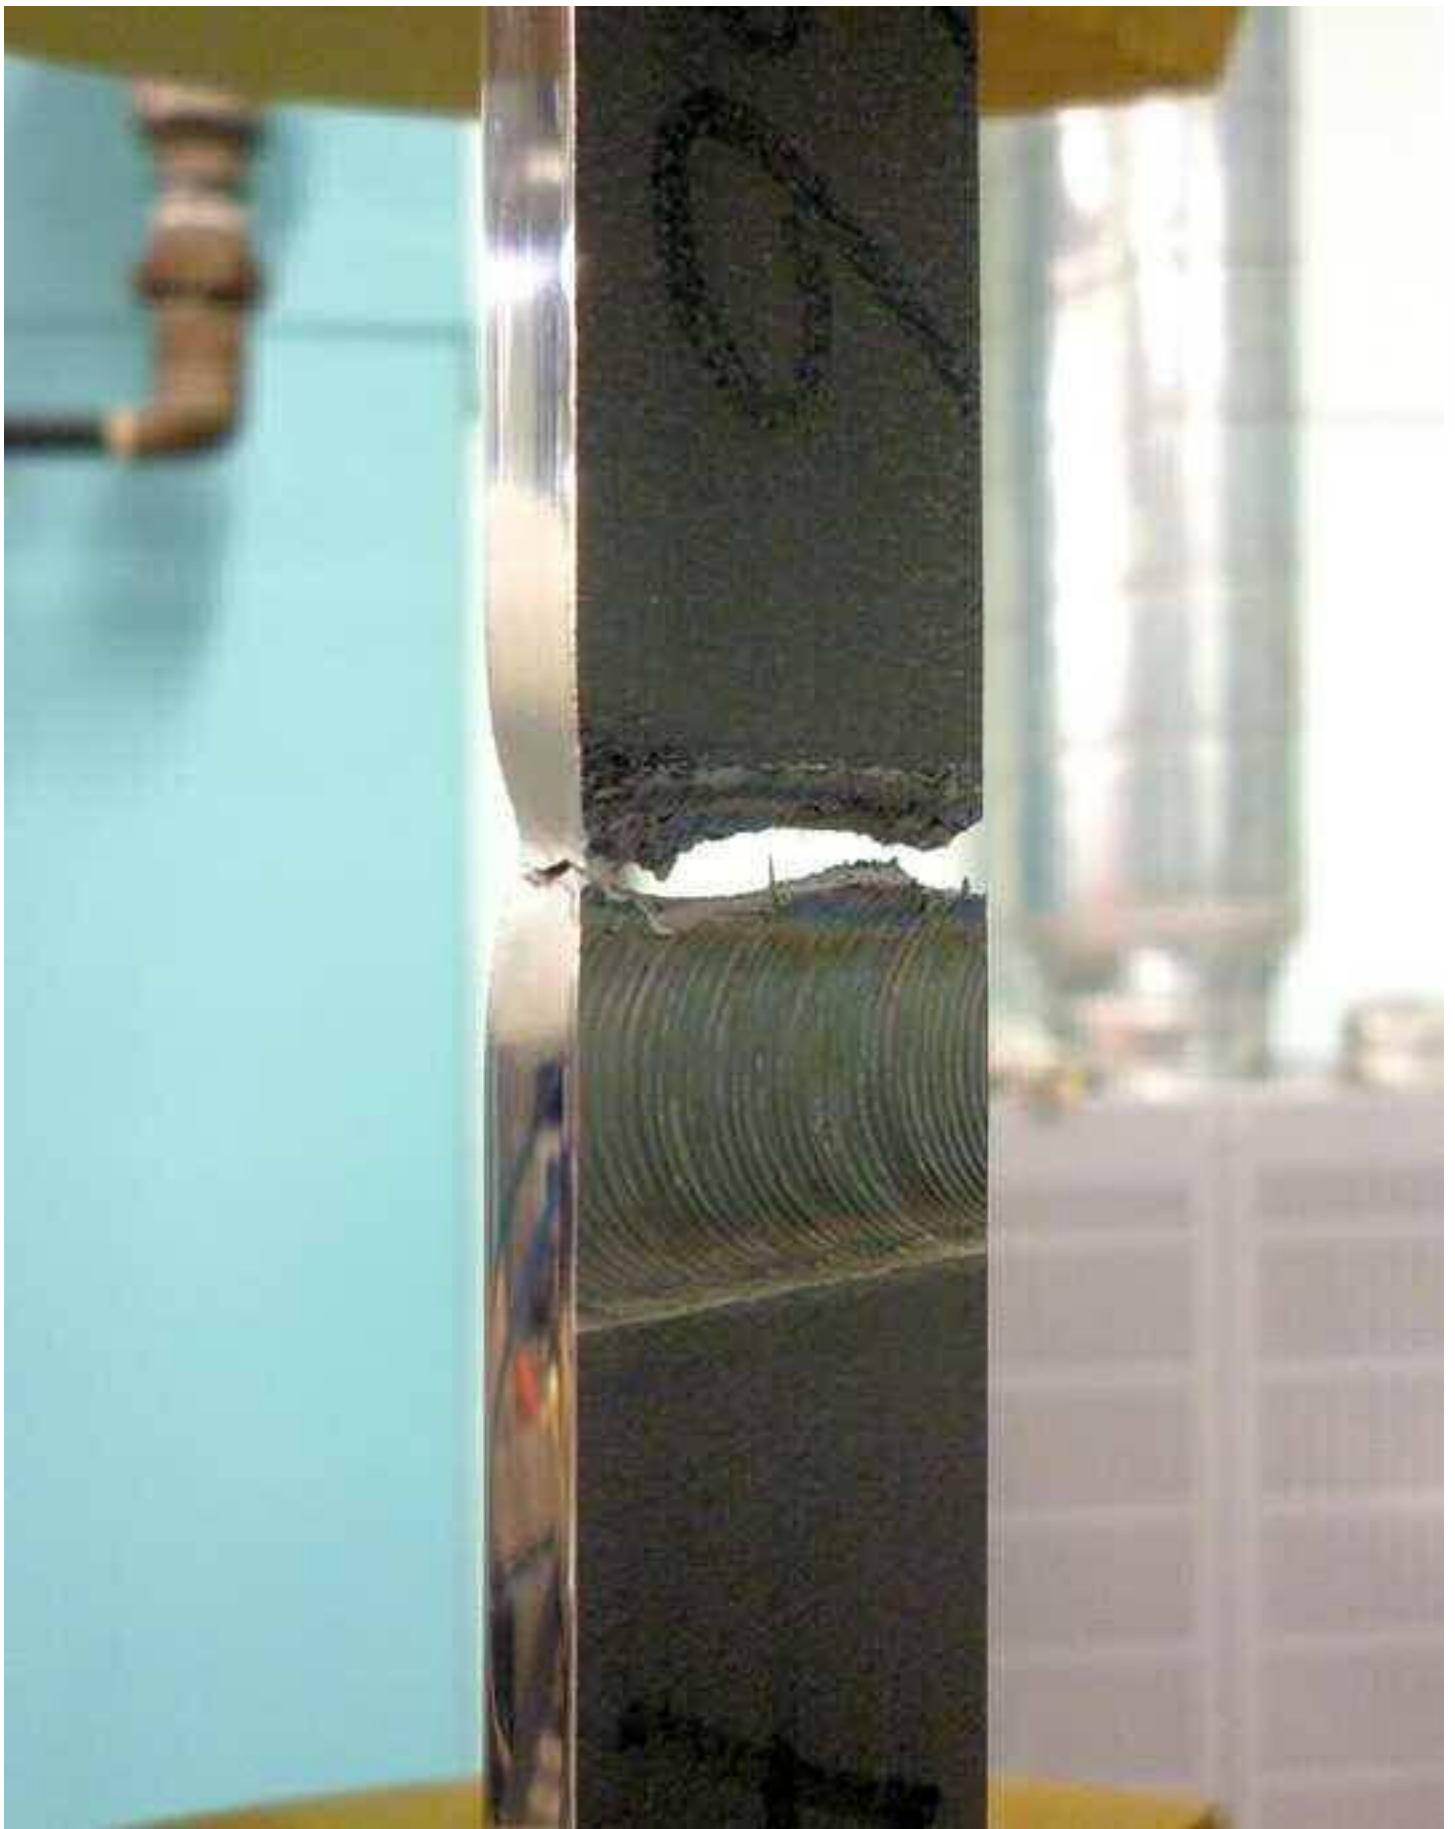
Figure 14
[Click here to download high resolution image](#)

Figure 14. Typical fracture position of intermediate weld sample.

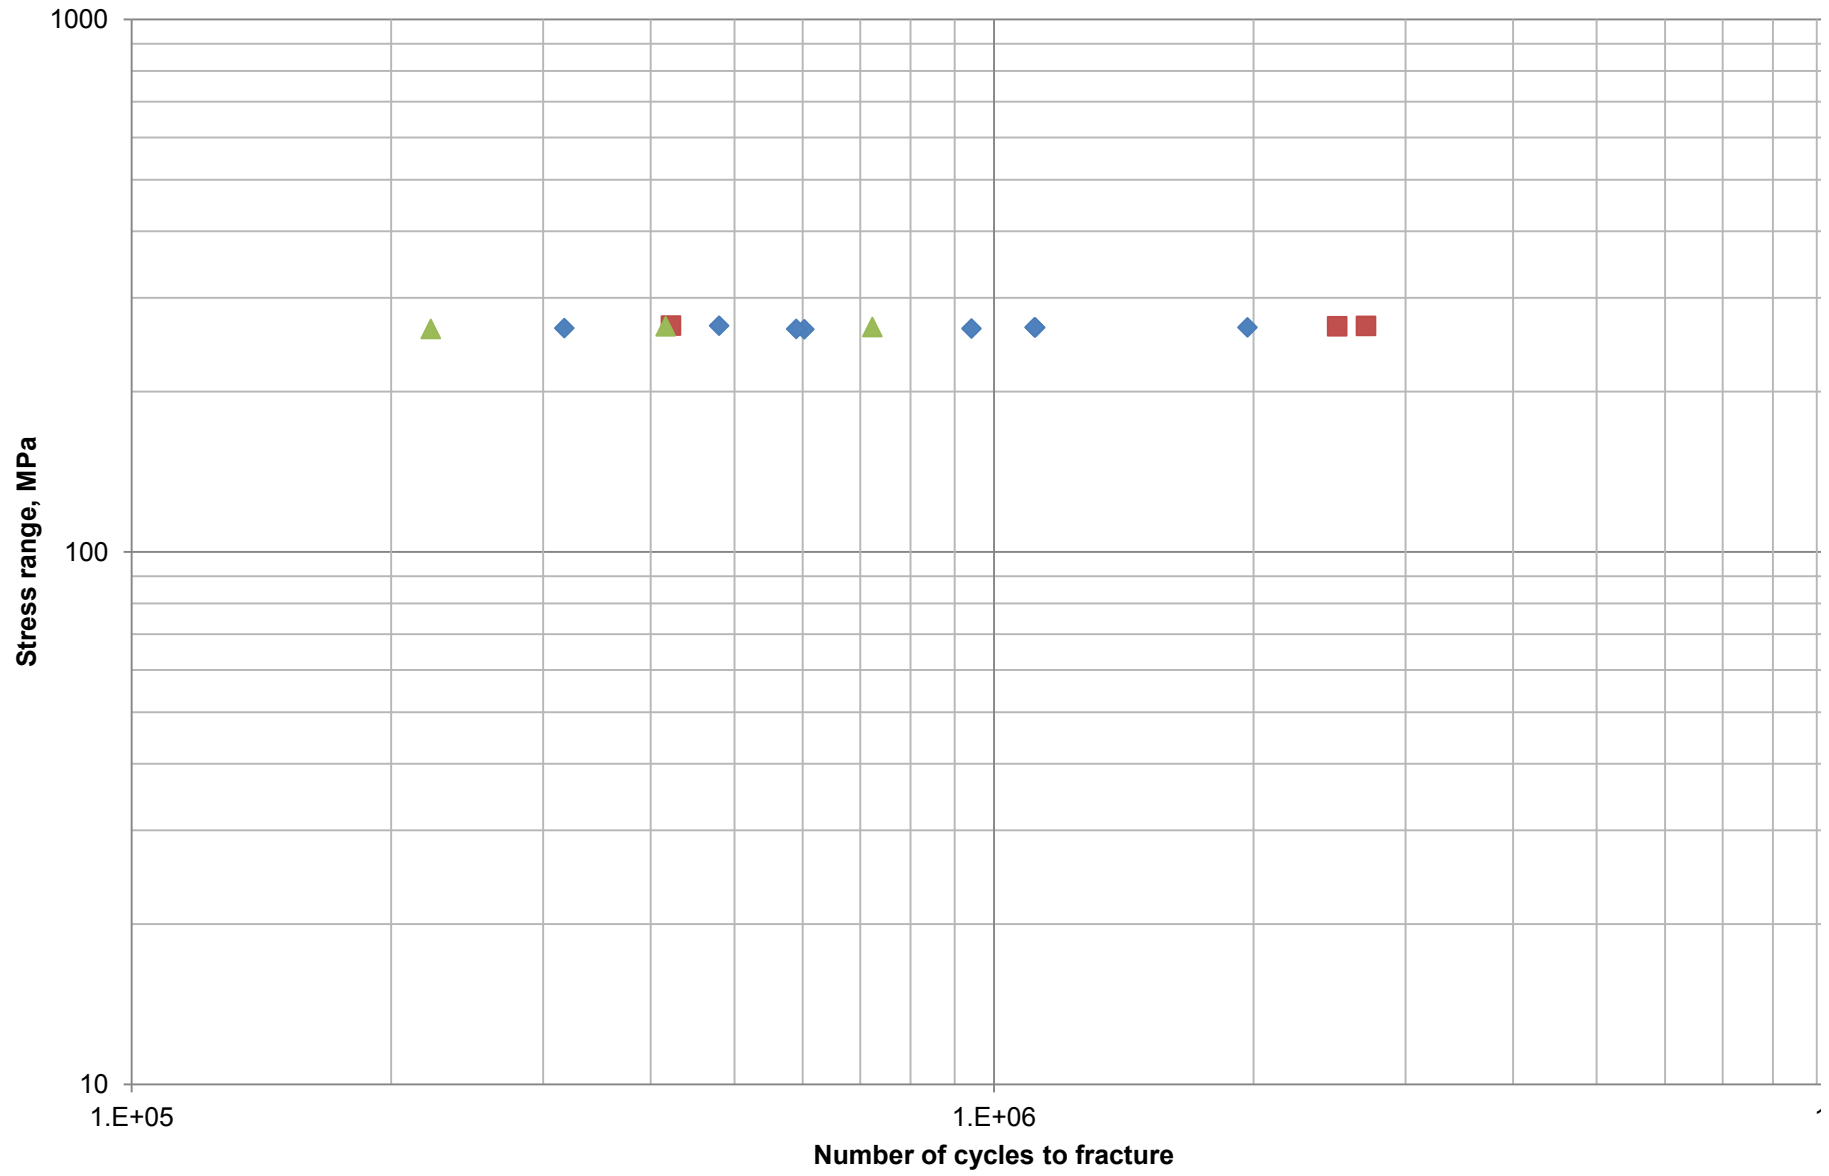
The fatigue test results for the slow and fast welds at 80% of YS are plotted in Figure 15 together with the intermediate weld results of the same stress range for comparison. Two samples of the slow (100 mm/min) weld exhibited excellent fatigue behaviour; the tests were terminated at 2.5×10^6 cycles without fracture. One sample fractured prematurely at 4.2×10^5 cycles (although higher than the lower limit of cycles that was set) on the AD side of the weld, and this is attributed to the incomplete fusion paths observed in this section of the weld (see section 3.3). The fast (500 mm/min) weld samples demonstrated a rather mixed fatigue behaviour; all three samples recorded fatigue lives higher than 10^5 cycles but with some scatter of the results, from 2.2×10^5 to 7.2×10^5 , and contrasting fracture regions. The varying intensity of the flaws observed in this weld is primarily responsible for this phenomenon. Fracture initiated for two samples from the weld root flaw which has been documented earlier (Figure 12). The fracture initiation region on the third sample corresponds to the lap defects seen in Figure 11b. Table 7 outlines the fracture location of each welding speed sample that was tested in fatigue loading.
