Toumpis, Athanasios and Galloway, Alexander and Molter, Lars and Polezhayeva, Helena (2015) Systematic investigation of the fatigue performance of a friction stir welded low alloy steel. Materials and Design, 80. pp. 116-128. ISSN 0261-3069 , <http://dx.doi.org/10.1016/j.matdes.2015.04.046>

Systematic investigation of the fatigue performance of a friction stir welded low alloy steel

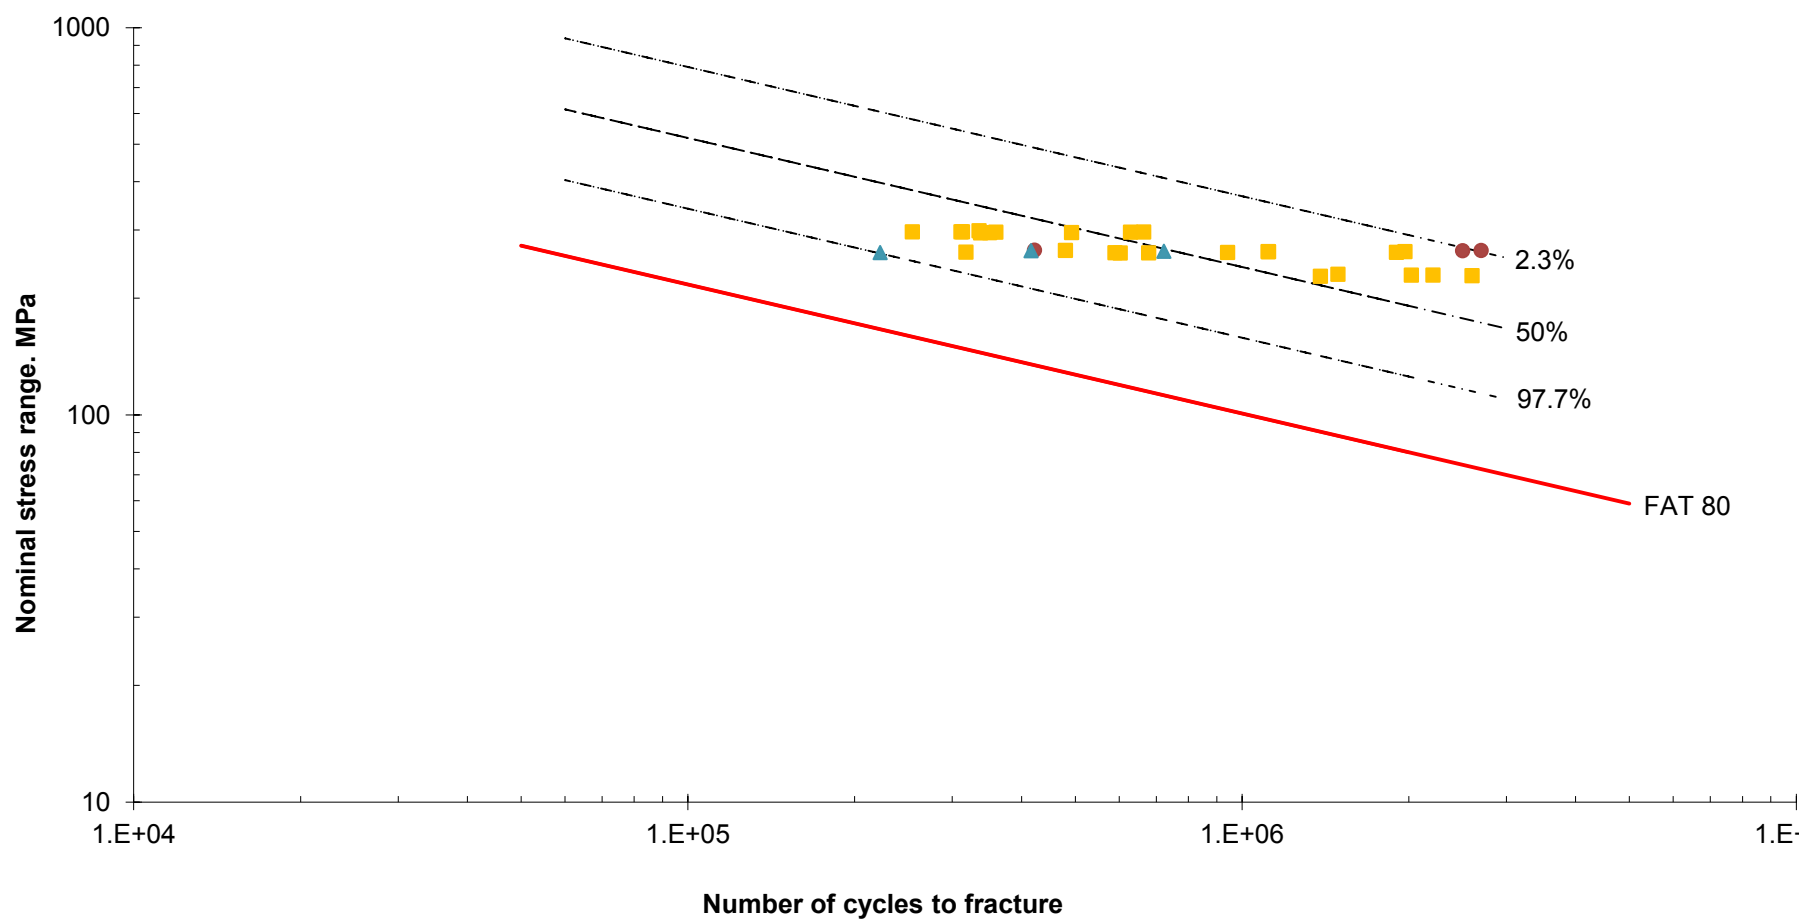
Figure 16 displays the S-N curve for the intermediate speed weld; the slope of the curve is $m=3$ according to the IIW recommendations. The dotted lines represent the probability of survival at 97.7%, 50.0% (mean) and 2.3%. The solid line indicates the IIW FAT 80 weld detail class for single sided butt welded joints at 97.7% probability of survival (detail No. 214 in Ref.21). The fatigue strength of the FAT 80 class at 2×10^6 cycles where the samples' fatigue strength is evaluated is 80 MPa for 97.7% probability of survival. The results demonstrate higher fatigue strength for all samples of the intermediate weld in comparison to the FAT 80 class. The FSW samples' fatigue strength is calculated at 125 MPa (for 97.7% probability of survival); this is 56% higher than the strength stated in the IIW recommendations. Since no standards for assessing the fatigue behaviour of steel FSW exist, analogous comparison to IIW-recommended fatigue design classes is employed by one more publication, in which the FSW fatigue data are contrasted to the FAT 112 class [18]. The examined welds' fatigue performance is higher than this class, which is the most demanding in fusion welding of steel [18].

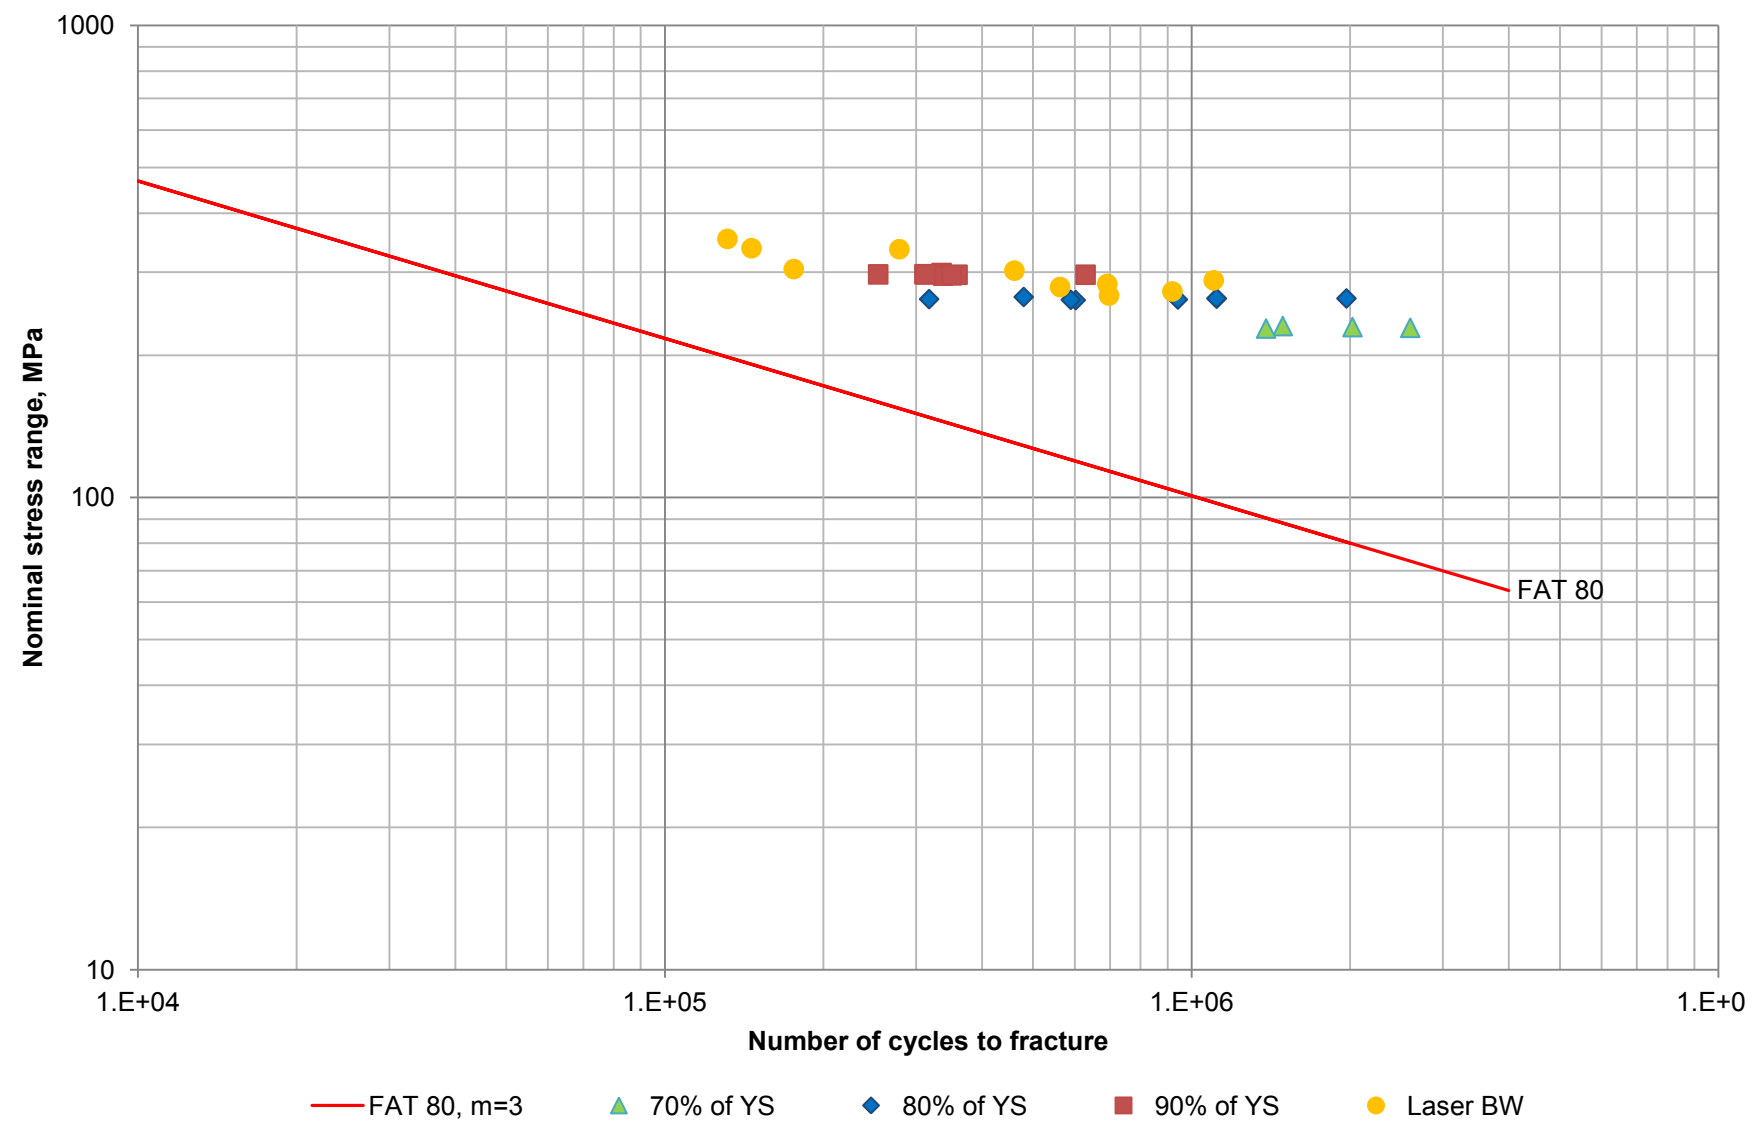
Figure 17 provides a point of reference for the intermediate FSW fatigue test results when compared to the results of high quality laser welded butt joints (3 mm thick DH36 welds in transverse cyclic loading at 10 Hz) generated in a prior investigation [22]. Both sets of results display similar fatigue strengths for comparable stress ranges; in fact, FSW appear to produce marginally longer fatigue lives at the highest stress range. As a general note, the fatigue performance of the tested samples illustrates a considerable potential of steel FSW; the welds show better overall fatigue strength in comparison to the IIW recommendations and comparable to laser welding, irrespective of any minor surface breaking and embedded flaws that were detected.

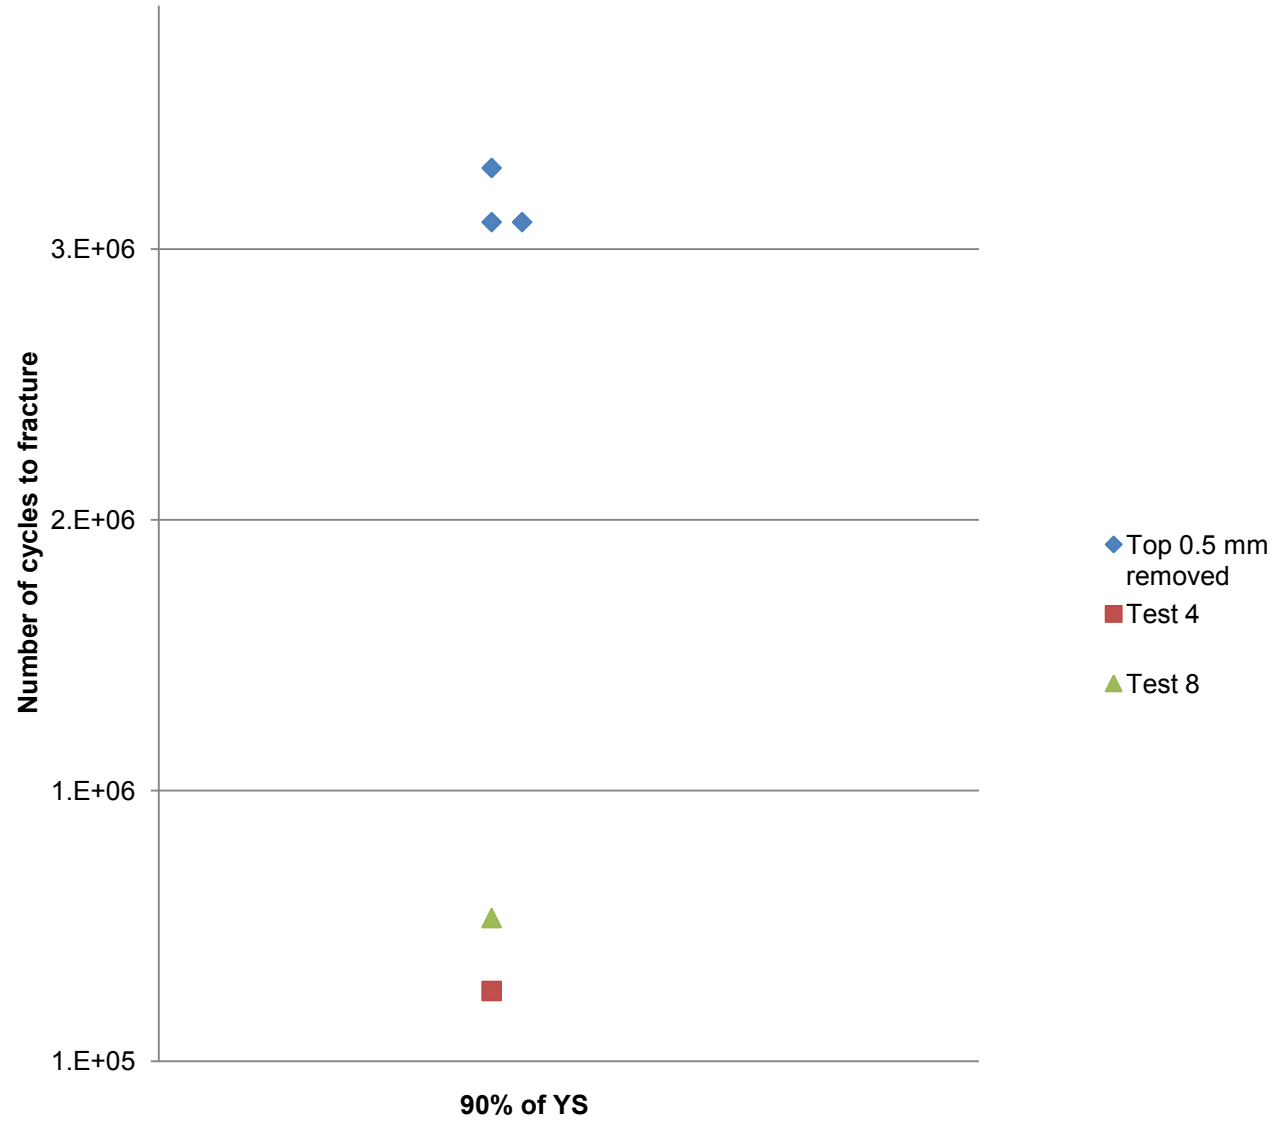
Figure 18

The additional samples' fatigue lives are plotted with two standard fatigue samples also tested at 90% of YS, and sectioned from neighbouring (to the additional) sites of the intermediate weld

(Figure 18). The supplementary samples with the top 0.5 mm removed are seen to substantially outperform the standard fatigue samples for the same stress range. This comparison offers further confirmation of a substantial improvement in fatigue life by the simple removal of the lap defect and an indication of the potentially impressive fatigue performance of the process when an acceptable quality weld (specifically, without surface breaking defects) has been achieved. A comparable approach has been followed by a separate study evaluating the influence of the post welding top surface condition on the fatigue performance of friction stir butt welded AA8090 [14]. As-welded samples are tested opposite to top surface treated ones by grinding which removed any weld irregularities. The surface treated samples reveal higher fatigue lives than the corresponding as-welded, principally for lower stress ranges; fracture is found to initiate for the former in the PM or HAZ whereas for the latter in the weld nugget. Thus, the research concludes that post weld surface finishing can offer clear improvement to the fatigue behaviour because it eliminates process related flaws which serve as crack initiation sites [14].

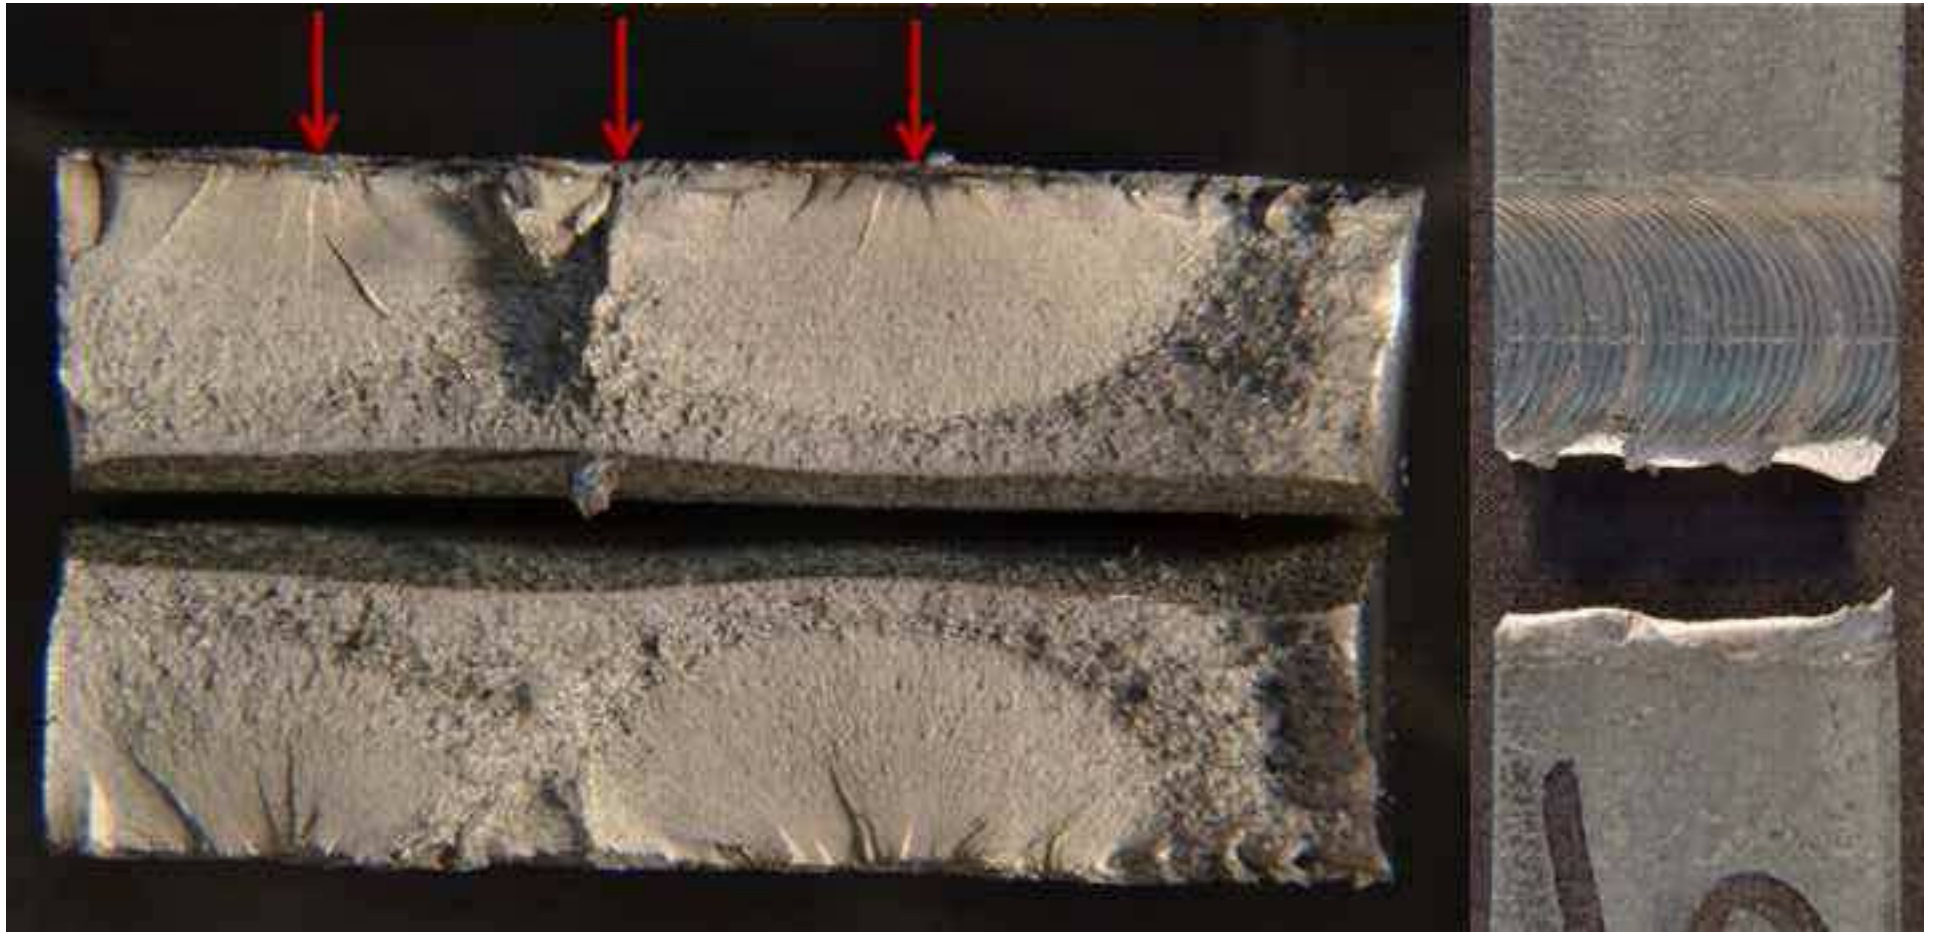
In the case of one slow speed weld sample which actually fractured, the crack initiation sites appear to be originating from incomplete fusion paths on the AD side (Figure 21). These paths which have formed in the direction of material flow contain interconnected non-metallic inclusions, and are quite steep; hence excessive concentration of stresses must have been present. The fracture surfaces of this sample are identical to the surfaces of the intermediate weld samples (Figure 19a).

Similarly to the intermediate samples above, the two fast weld samples where cracks initiated from the weld root flaw display a fracture plane perpendicular to the plate thickness and fracture surfaces comparable to Figure 19a. The crack propagated in the middle of the weld, almost exactly in the path of the original plate interface (Figure 22). The importance of the weld root flaw as a limiting factor in the fatigue performance of FSW and the difficulties in eradicating it have been established in prior studies [14, 17]. The third sample however reveals fracture surfaces identical to one of the high speed welds' samples discussed in an earlier publication [4]. It was then argued that these surfaces are product of the FSW tool probe's features, indication that lower than required heat input was provided in this region, leading to insufficient plasticisation of the metal which was ultimately mechanically worked rather than thermo-mechanically stirred by the tool [4]; this description is fitting in illustrating this sample's fracture surfaces (Figure 23). The same figure offers evidence of uniform crack initiation from the tool shoulder's markings on the weld top surface (indicated on Figure 23).

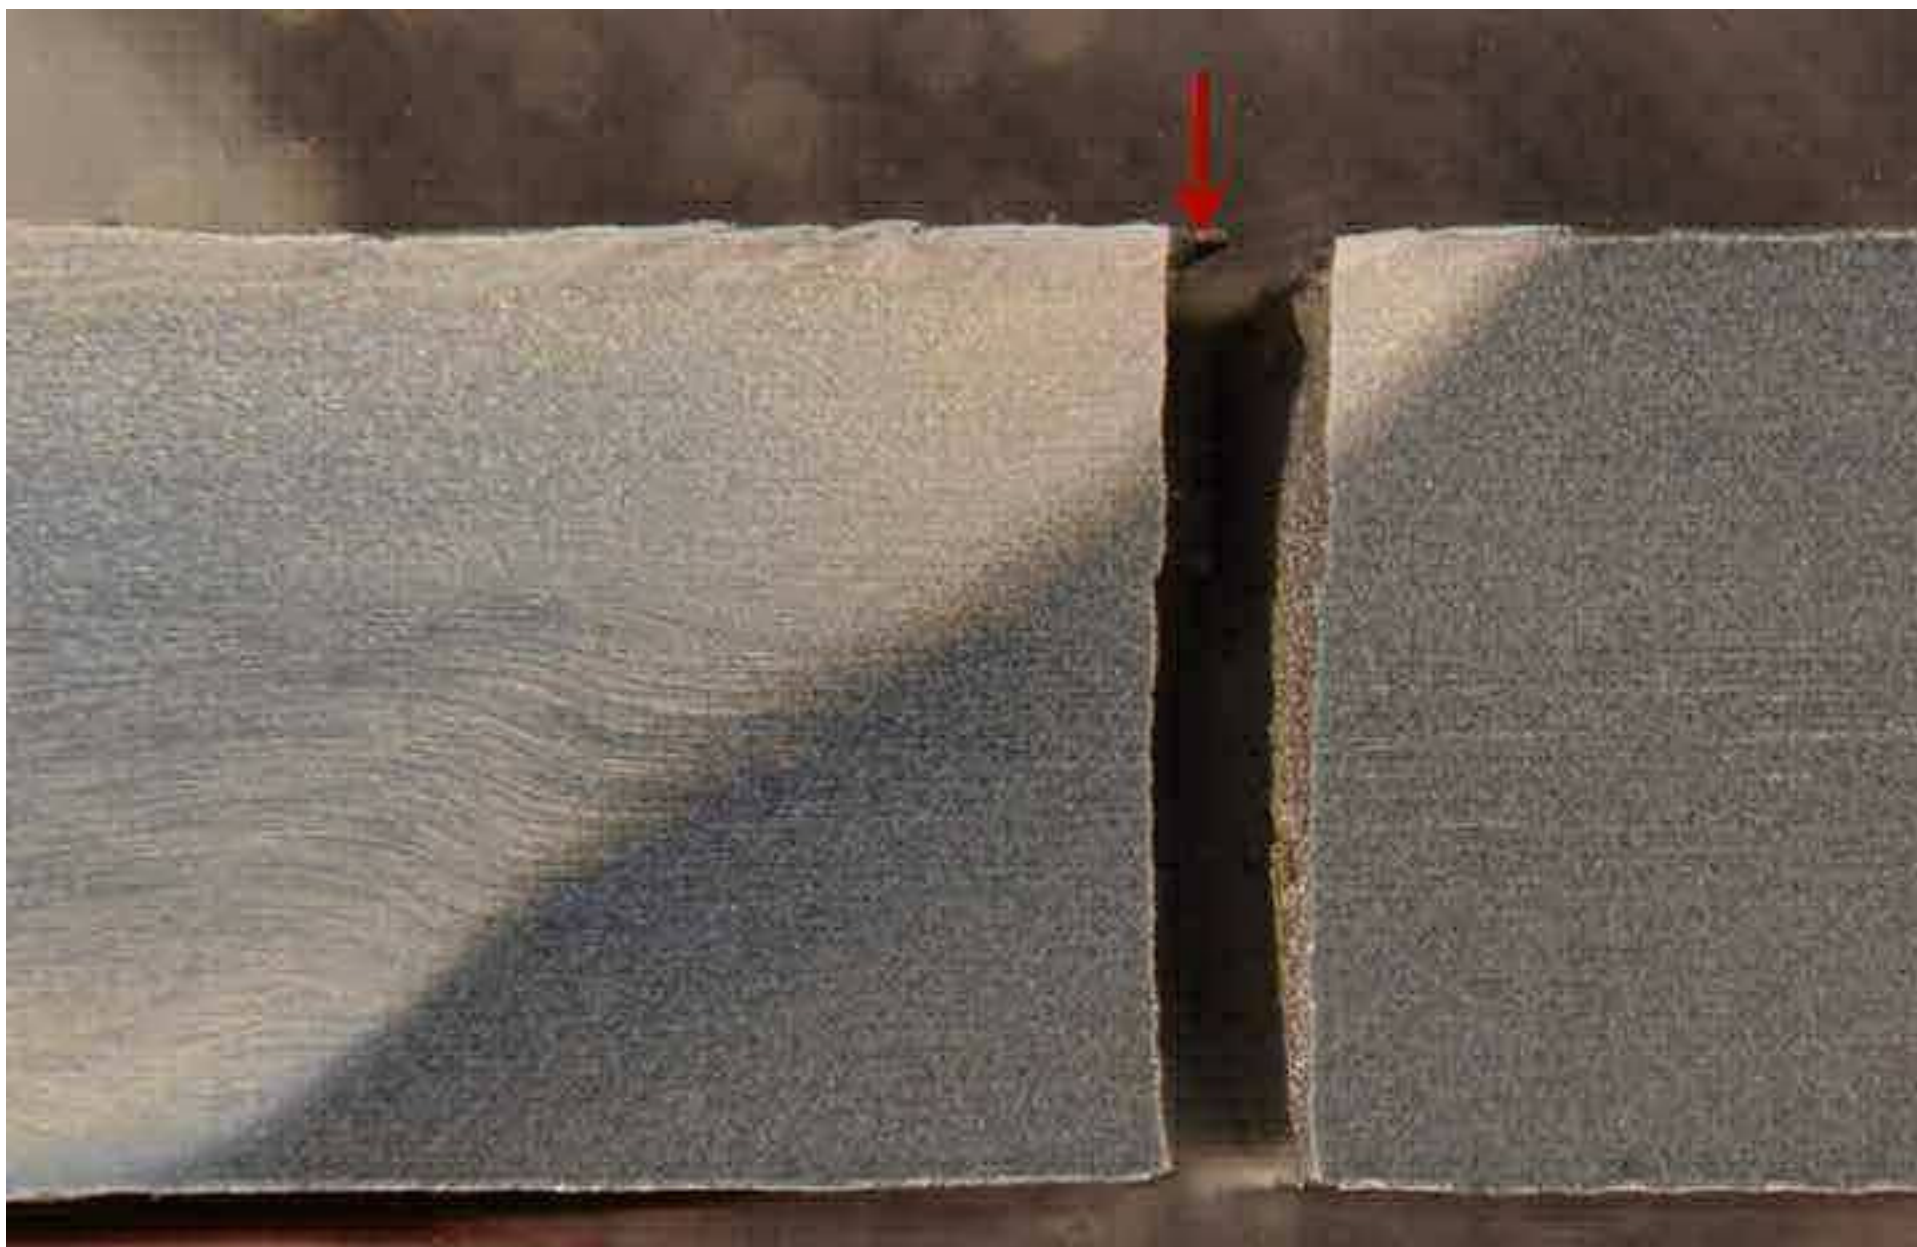
Figure 20
[Click here to download high resolution image](#)

Figure 20. Macrograph of intermediate weld sample's fracture path (side view) [Etched].

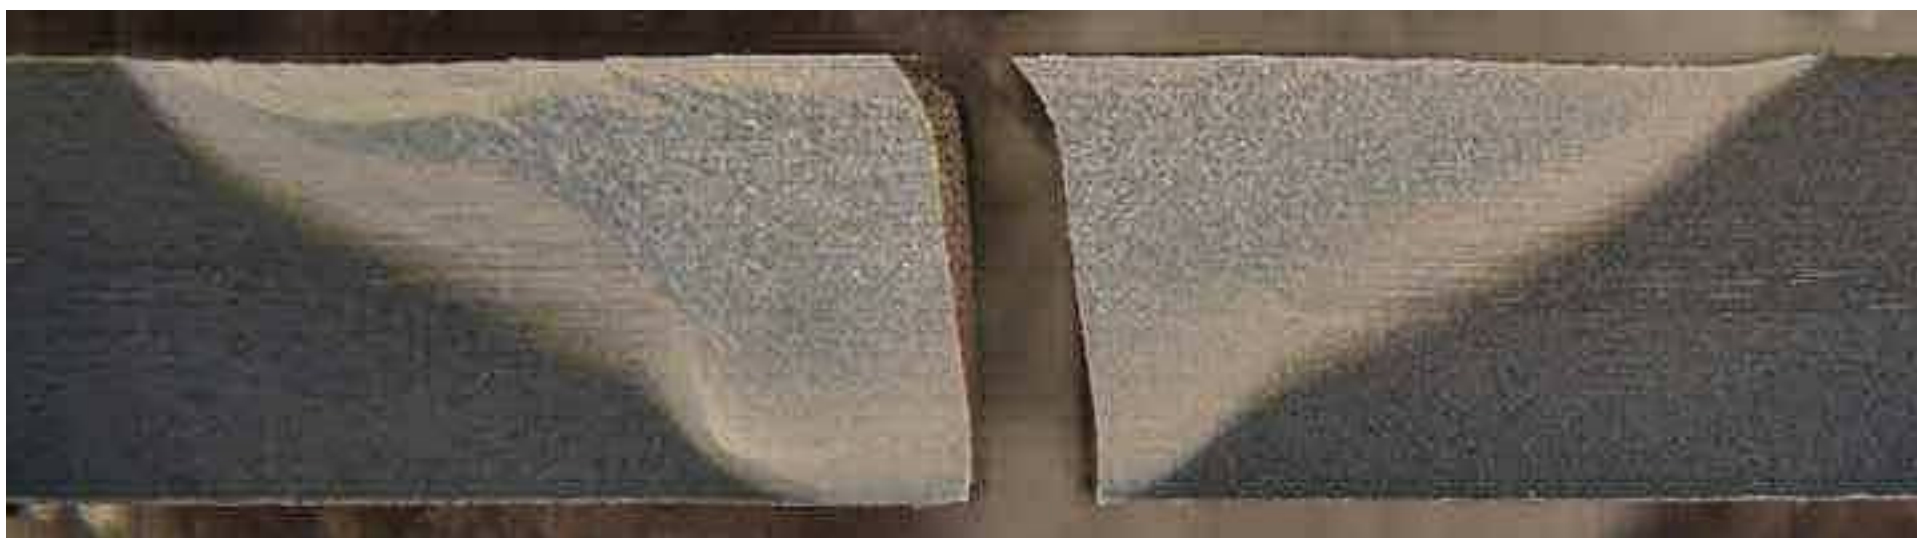
Figure 22

Figure 22. Macrograph of fast weld sample's fracture path (side view) [Etched].

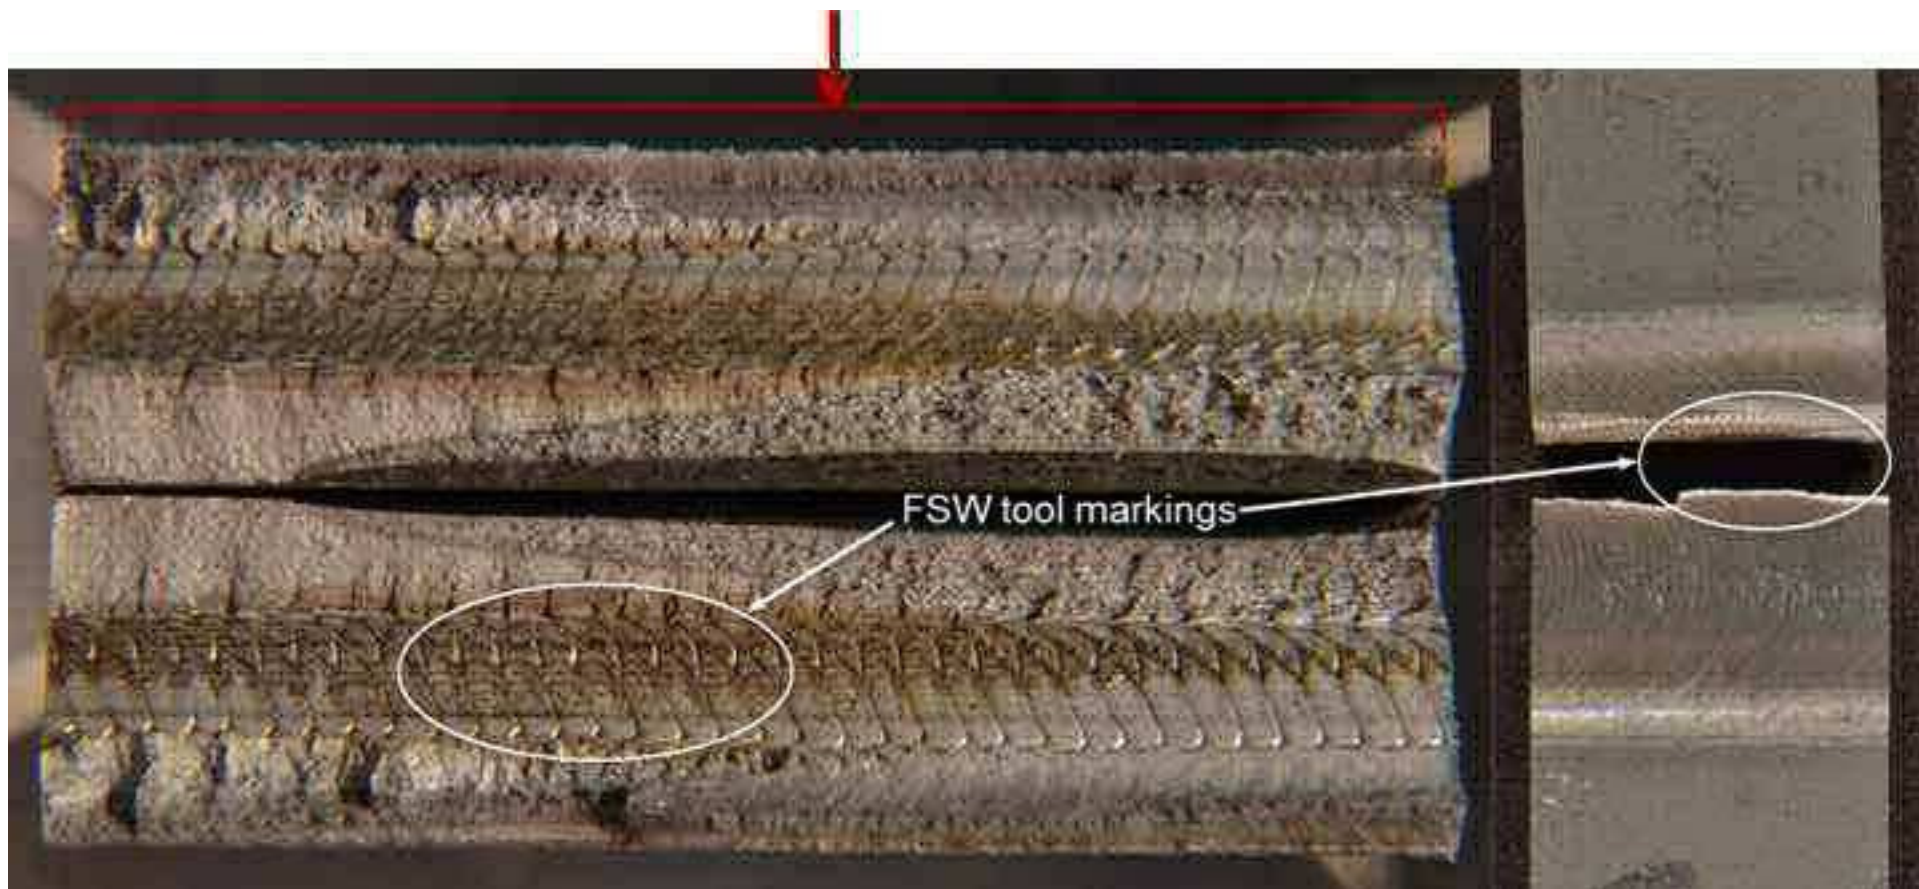
Figure 23
[Click here to download high resolution image](#)

Figure 23. Fast weld sample tested at 80% of YS (222,272 cycles to fracture).
