J. SE Asian Appl. Geol., Jul–Dec 2009, Vol. 1(2), pp. 37–48

# SUMMARY OF RESEARCH WORK ON THE EVALUATION ON LONG TERM STABILITY OF ARTIFICIAL SLOPE PROTECTION

*Application of GPR, RedExplorer1.4 and GeoStudio2004 have been used to evaluate the overall stability condition of a steep slope along Kalibawang irrigation channel km 8.5, Kulon Progo Regency, Yogyakarta Special Province, Indonesia, that this slope slid down in 1990 and was restabilized by cut to be gentler and covered by shotcrete. Topographic map and engineering geological map in scale 1:2000 have been established prior to the detail investigation. Three drilling logs with in-situ test, SPT and CPT, and samplings have been made and sent to soil mechanic laboratory for index properties tests, and a slope profile along the main axe will be also created for stability analysis through GeoStudio2004. Moreover, GPR has been used to run on a full slope surface to detect the distribution of fractures and/or cavities behind the shotcrete and the results have been interpreted by the aid of RedExplorer1.4. Three profiles showing the rate and depth of fractures and/or cavities are established whereas the slope stability analysis th

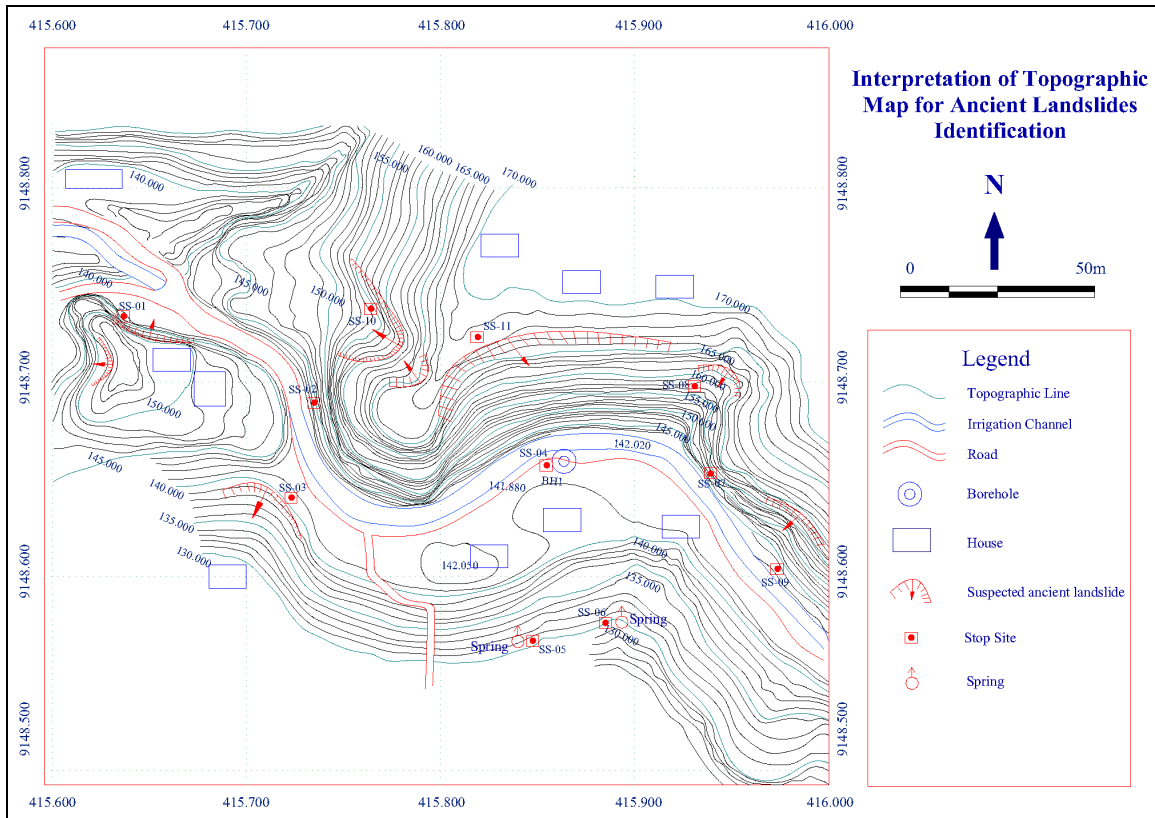
Figure 3: Interpretation of topographic map for ancient landslides identification

**Surficial Mapping** In this stage, aerial photograph and existing topographic map in scale 1:2000, Figure 3, along with GPS, compass, geologic hammer and other necessary objects have been used to do the mapping. These actions were undertaken aiming to record all detail geological conditions that can help us to understand clearly the nature of ground conditions of the study area. Furthermore, during the investigation, several important tasks have been made such as identifying histories of ancient landslides, hydrogeological feature

Again, the outcrops have been found at SS-01, SS-02, and SS-03 that the exact locations are plotted in the topographic map Figure 3. Through careful observation and interpretation, the outcrops compose of Tuffaceous fine sandstone of Sentolo Formation with moderate to high joints/fractures and also moderate to high weathered as illustrated in 5a–c. What's more, at SS-05 and SS-06 at the valley, the lower slope, two springs Photo 2a and 2b, have been found. Both springs of water are at the elevation of 130m above the sea. The water is seeping out from the contact of clayey sand and tuffaceous breccia. This contact might have the lowest shear strength comparing to other contacts due to high water pressure development and existence of outflow water force. By interviewing people, the water flow out for domestic usage for people living in that area everyday of the year. This situation can lead us suspect that this contact might be the one of the potential slip surface of the suspected slope failures in the research area.

**Boring investigation** One drilling hole until 16m depth was under taken as indicated in Figure 3. A drilling rig comprising of a rotary drill and simple winch mounted on a tripod. The results from drilling core logging, Table 1, show that the materials are relatively heterogeneous. From 0.00 to 5.70m depth we have found brownish white Tuffaceous Fine/Medium Sandstone and Tuffaceous Breccia with greenish white with fragments. These three rock types are slightly loose weak rocks which are high weathered. The permeability is  $k = 6.8 \times 10^{-5}$  cm/s from 1–3m depth and  $k = 5.15 \times 10^{-5}$  cm/s from 3 to 6m depth but from 5.7 to 11.30m depth we found hard and very hard Tuffaceous Breccia and the color becomes dark white to grayish white with moderate to slight weathering. Furthermore, brownish white Tuffaceous medium and fine Sandstone were found until 14.8m depth and continue with Tuffaceous breccia which is compacted and hard.

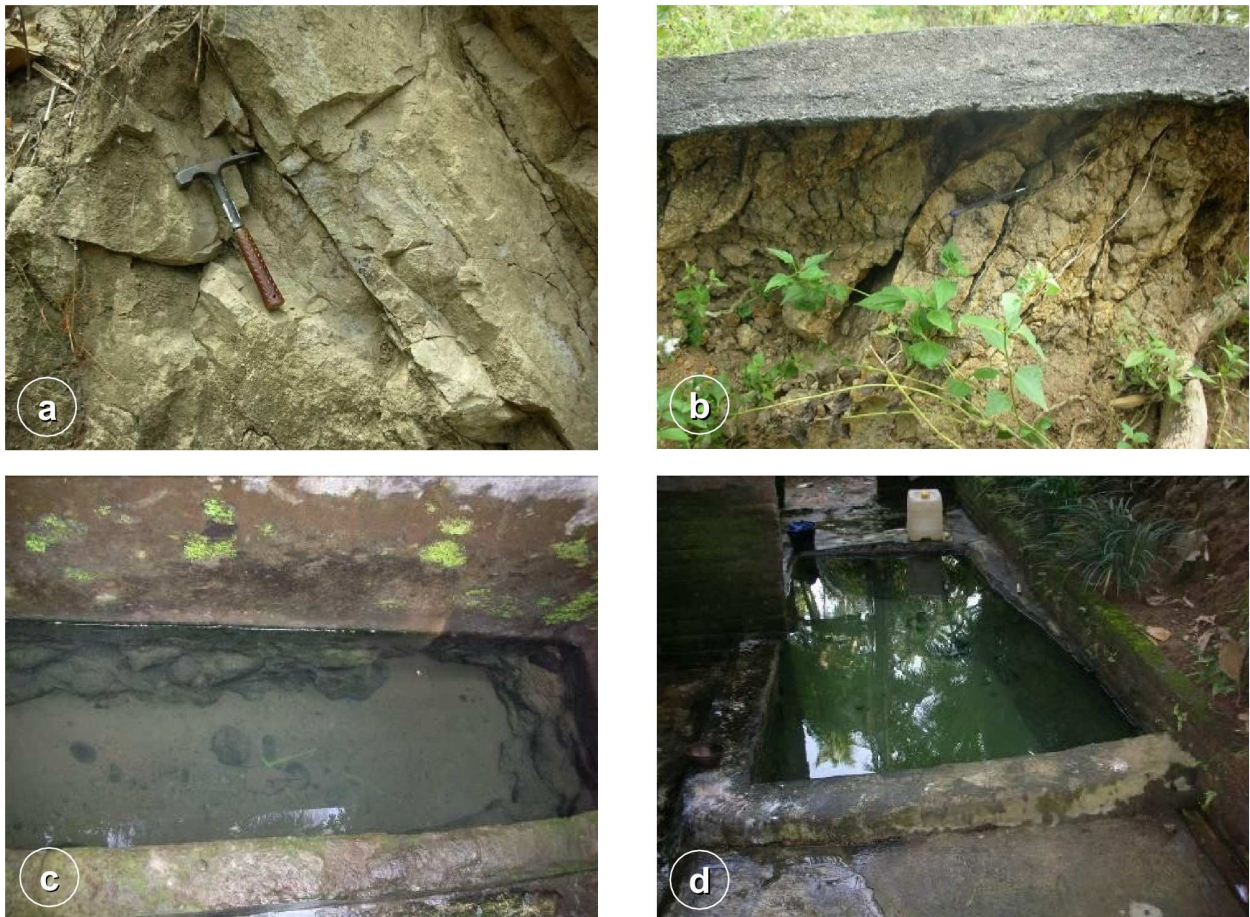
Figure 5: a) Outcrop of slightly weathered tuffaceous sandstone of Sentolo formation, SS-01. b) Outcrop of highly weathered tuffaceous sandstone of Sentolo formation, SS-02. c) Spring at the contact of clayey sandstone and tuffaceous breccia, SS-04. d) Spring at the contact of clayey sandstone and tuffaceous breccia, SS-05

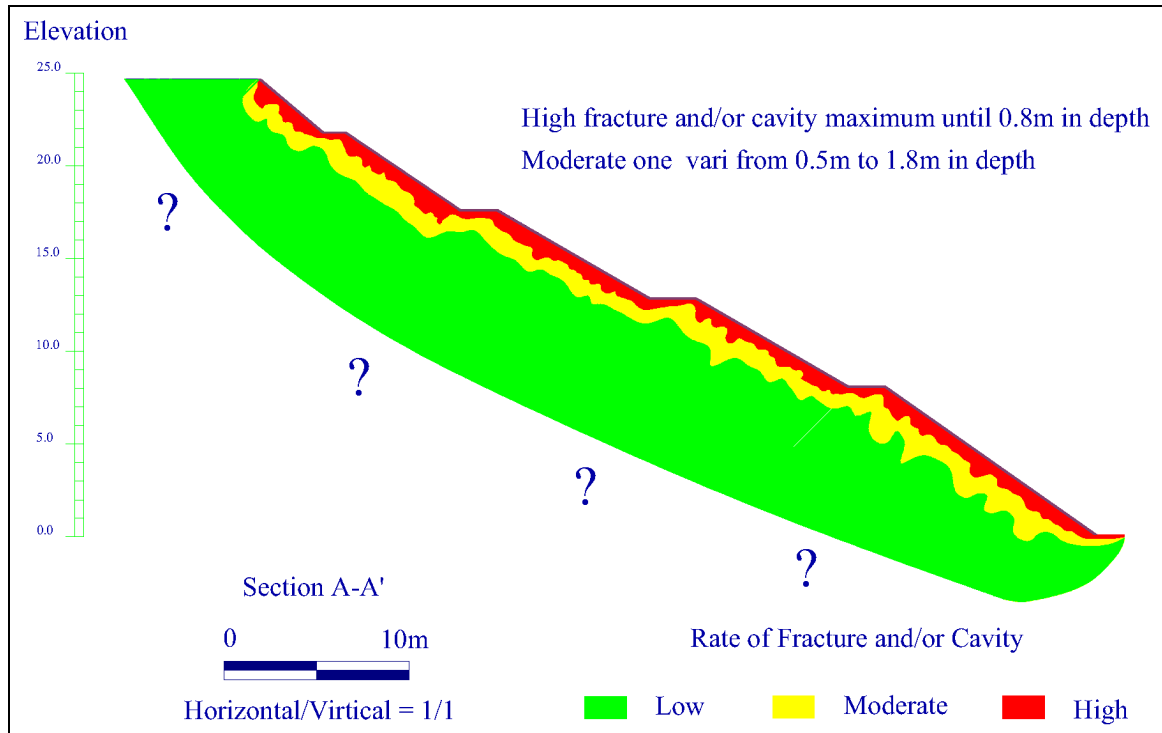
Figure 6: Rate of fracture and/or radargram along axis A-A'

Ground Penetration Radar GPR with antenna 500MHz frequency, high resolution, has been operated at site to detect the intensity of fractures and/or cavities behind the shotcrete. Consequently, through the interpreted radar-gram, there is a very high intensity of cavities and/or fractures on slope material especially near the contact between slope material and shotcrete. Full surface of shotcrete has been divided into a regular pattern for GPR survey. The results of GPR have been interpreted under the help of RedExplorer1.4 and have been depicted on the surface of the shotcrete. Moreover, three slope profile, Figure 6a, 6b and 6c, has been made along three main survey lines A-A', B-B' and C-C'. These profiles illustrate the rate and depth of fractures and/or cavities behind shotcrete. Furthermore, by observing those profiles, the depths of cavities are locally 1.3m while at the shallow depth, around 0.8m in depth from the surface of the shotcrete, shows a continuous of very high fractures and/or cavities material. The rate and depth of fracture and/or cavities are divided as high, moderate and low. This result indicates the instability of the slope leading to shallow sliding.

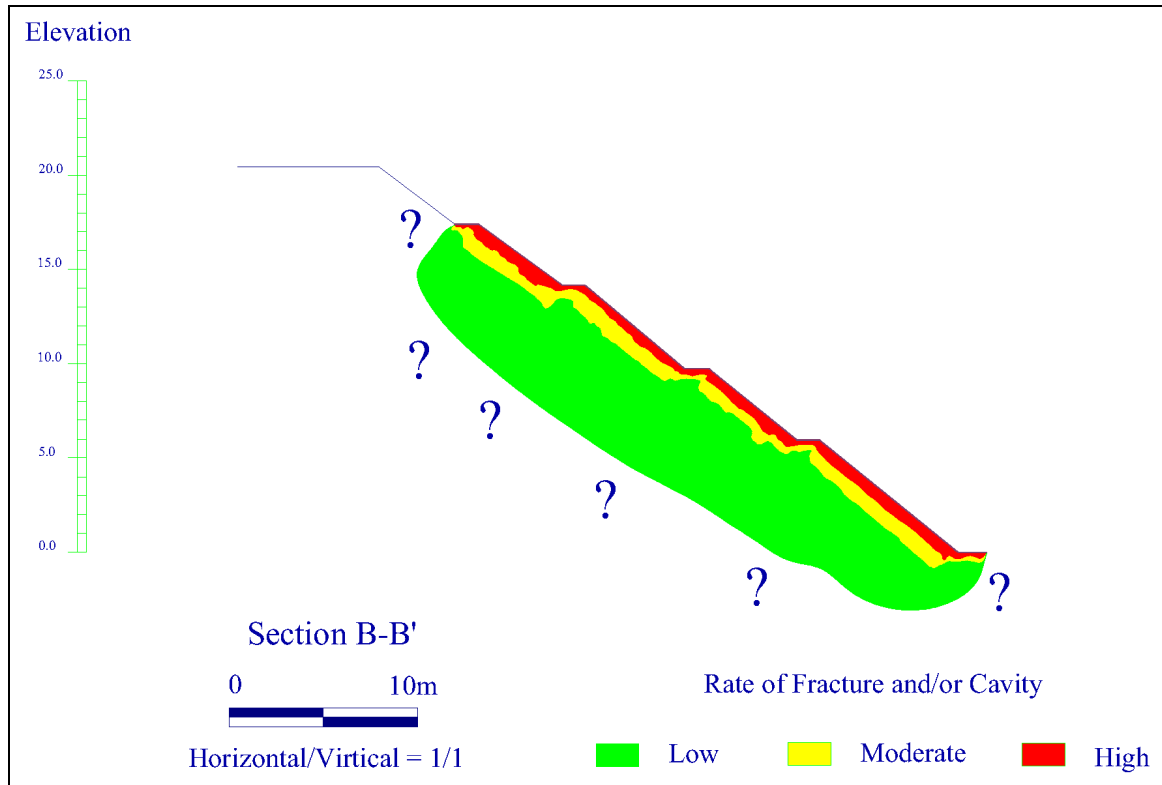
Figure 7: Rate of fracture and/or radargram along axis B-B'

tensity of fractures and/or cavities behind the shotcrete and two suspected potential slip surfaces have been recognized. From GPR results, we can summarize that the fractures and/or cavities at the back of the shotcrete distribute over a full surface with very high intensity and continuously at shallow depth, 0.8m from the shotcrete surface. Moreover, the contact where the spring occurs and made from weak tuffaceous breccia and fresh tuffaceous breccia are still unclear to be the most unstable surface due to the fact that it needs to be analyzed more clearly through GeoStudio2004 to know exactly the value of safety factor of each surface. However, these results still can be used as a preliminary conclusion of the research. Last but not least, the author strongly believes that the overall stability of the researched slope will be revealed after an exact slope profile with dipping bedded has been made and analyzed through the available numerical simulation, GeoStudio2004, which is the final step of this research.
