Atoll Rim Expansion or Erosion in Diego Garcia Atoll, Indian Ocean? Comment on Hamylton, S.; East, H. A Geospatial Appraisal of Ecological and Geomorphic Change on Diego Garcia Atoll, Chagos Islands (British Indian Ocean Territory). *Remote Sens.* 2012, 4, 3444–3461

Charles Sheppard

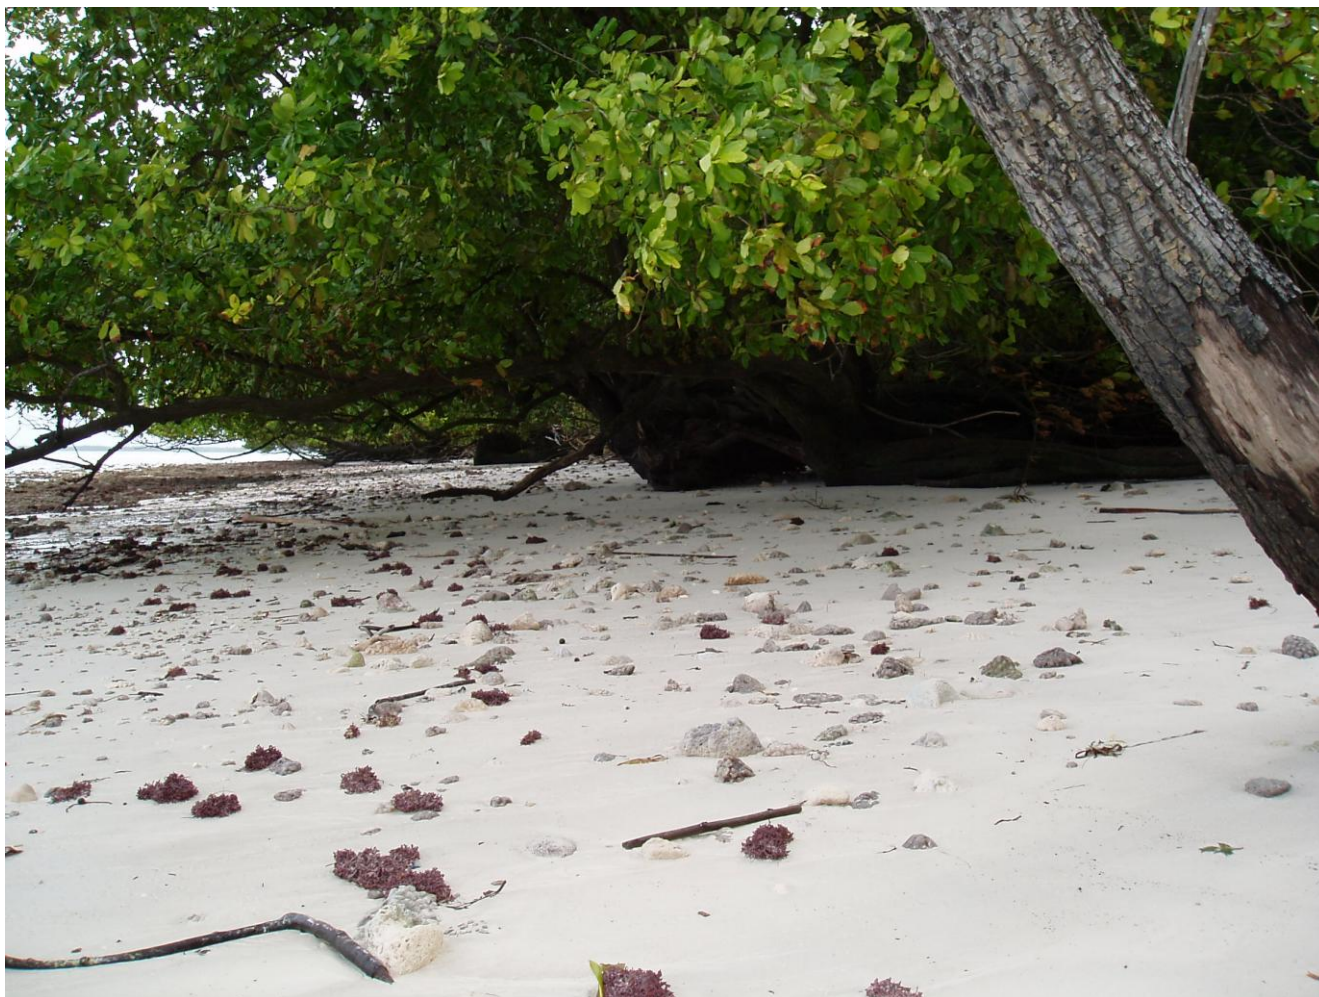
Figure 2. Hardwoods with large canopies now overhang the beach, instead of smaller canopied palms. These overhangs alone can add a few tens of metres to any measurement of shoreline position that uses vegetation edge to define extent of land.

Secondly, Hamylton and East say that “vegetation edge was used as a proxy for shoreline position”. While commonly perfectly reasonable, in the 1960s the atoll was a run-down coconut plantation, with coconut trees with relatively small canopy. It was then abandoned, and its coast now is vegetated partly with hardwoods with much larger canopies that overhang the beach (Figure 2). The overhangs alone (which can occur at both ends of any transect) can add a few tens of metres to any measurement of shoreline position.

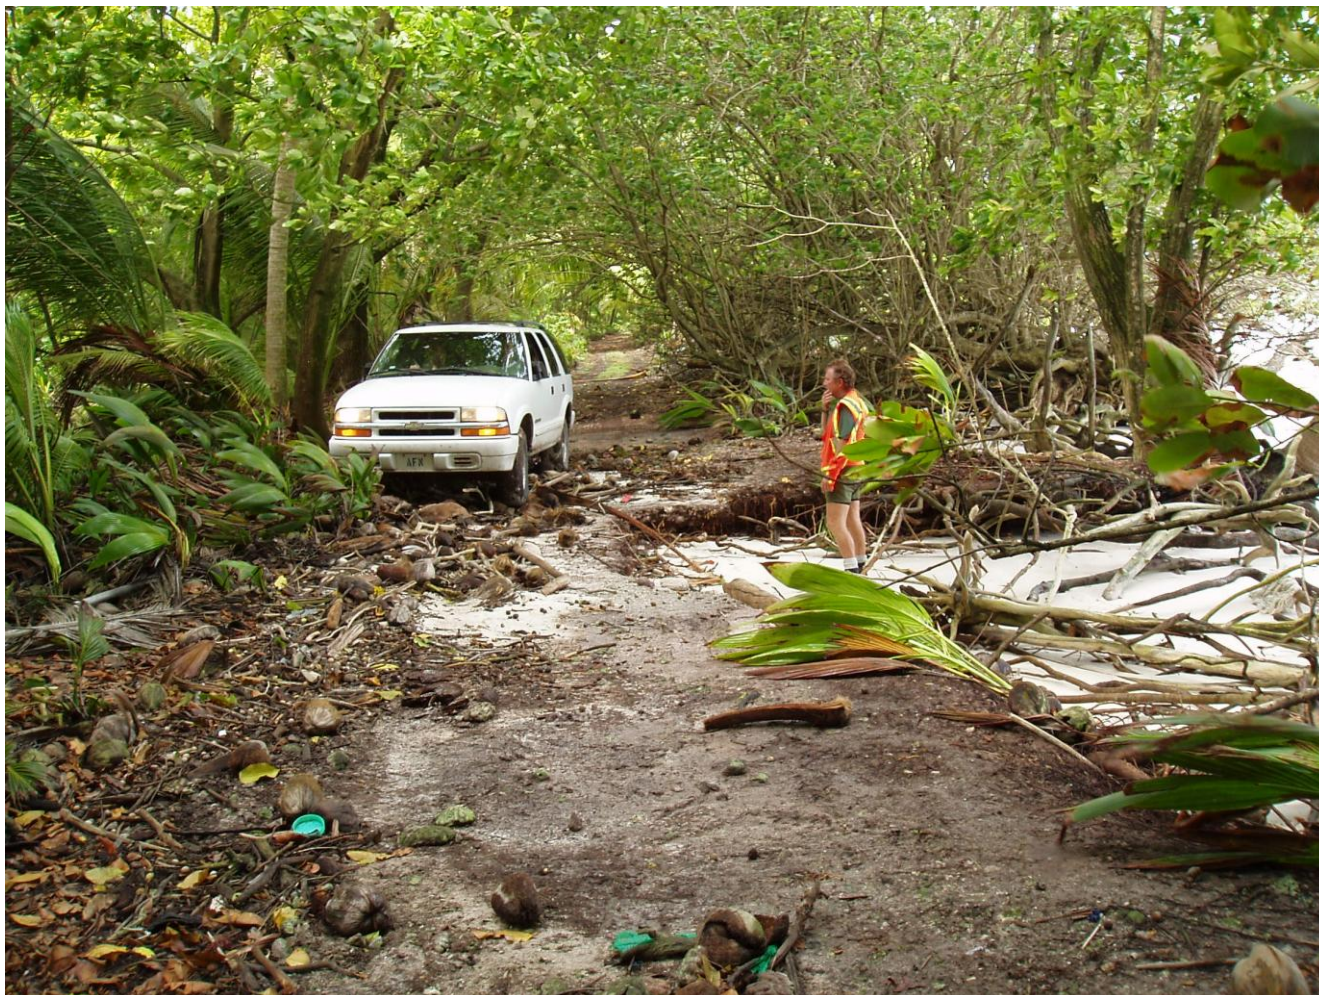
Figure 3. Erosion on a sheltered, lagoonal facing shoreline. The erosion is of mature, dark soil, not transient white sand banks.

Regarding erosion and accretion, we need also to distinguish between what we may term “white sand” movement and “brown earth” movement. All coral islands have mobile shorelines that ebb and flow seasonally, on decadal timescales or with longer cycles. New sand that is washed up is white—freshly made from ground-up corals, for example. Large banks of it can develop, and disappear. However, “brown earth” is “old”, its dark colour coming from humus developed over many decades. It is richer in dark organic matter. It is this that is also increasingly eroding in many places in this atoll—more of a one-way process (e.g., Figure 3).

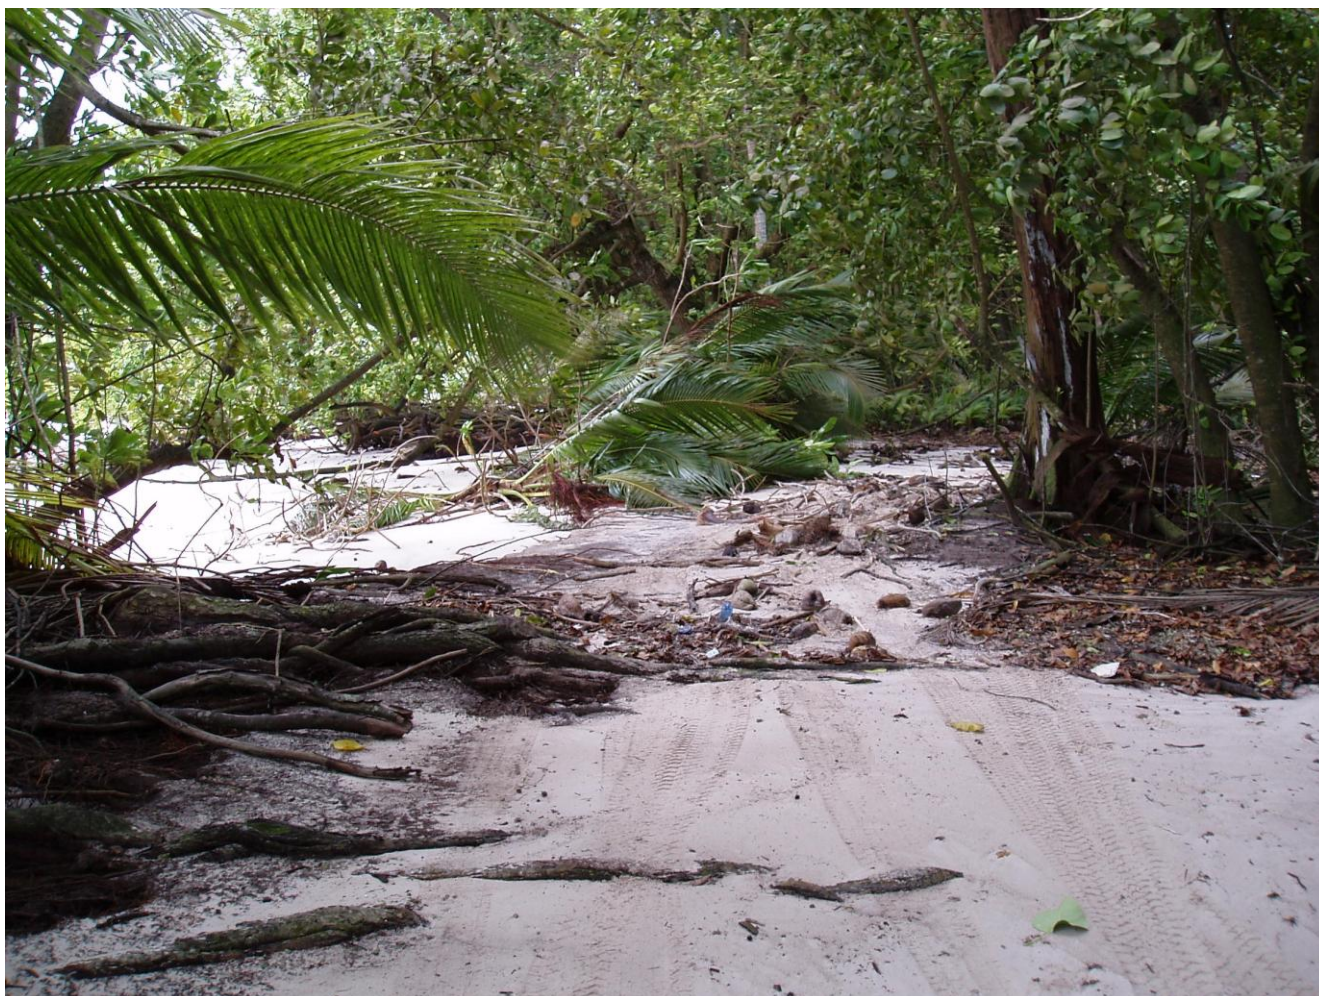
Figure 4. Sheltered, lagoon facing shore showing ingress of white sand onto the island. The raised ridge that mostly separates the beach from the interior of the island has disappeared along considerable lengths of the lagoon facing shore.

In this area, there are further important changes that are not observable from vertically above. In the southeastern part of the atoll, the land is very low lying, becoming inundated more frequently at high tides in the last decade, by increasingly noticeable amounts. The raised ridges or berms that usually separate beaches from the interior of coral islands have been washed away in several areas, to the extent that they have completely disappeared over long stretches of lagoon coast, easing seawater

ingress at high spring tides (Figure 4). A report available online illustrates several examples (Sheppard 2012, [4]).
