Microscopy of glazed layers formed during high temperature sliding wear at 750C

Microscopy of glazed layers formed during high temperature sliding wear at 750 °C

I.A. Inman^a, S. Datta^{a*}, H.L. Du^a, J.S. Burnell-Gray^a, Q. Luo^b

Abstract: The evolution of microstructures in the glazed layer formed during high temperature sliding wear of Nimonic 80A against Stellite 6 at 750 °C using a speed of 0.314 ms⁻¹ under a load of 7N has been investigated using scanning electron microscopy (SEM), energy dispersive analysis by X-ray (EDX), X-ray diffraction (XRD) analysis, scanning tunnelling microscopy (STM) and transmission electron microscopy (TEM). The results indicate the formation of a wear resistant nanostructured glazed layer. The mechanisms responsible for the formation of the nanopolycrystalline glazed layer are discussed.

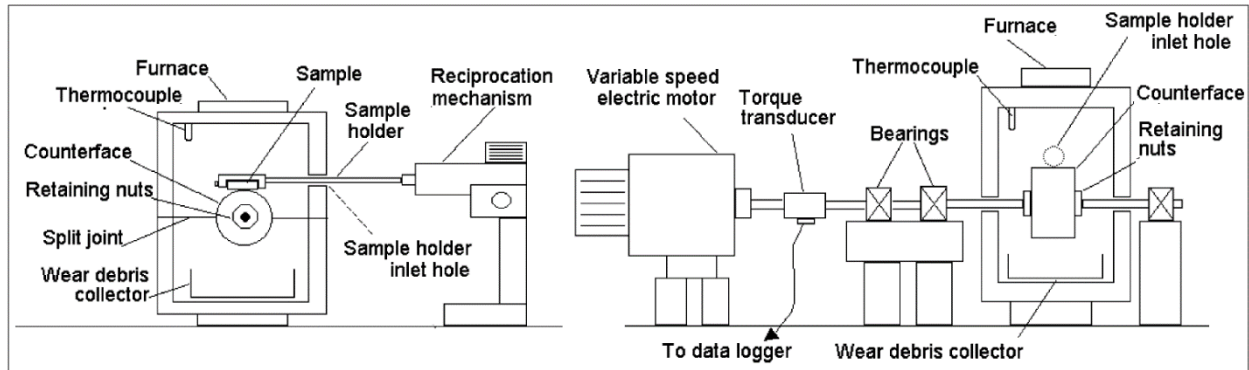
Fig. 1. Reciprocating high temperature block-on-cylinder wear rig, as used in the experimental programme.

All high temperature wear tests were carried out on a high temperature reciprocating wear rig in open air, as illustrated in Fig. 1. Details of the high temperature wear machine used have been described previously [1,2]. Basically, the machine was a block-on-cylinder arrangement (the cylinder being the counterface and the block being the sample). A variable speed electric motor rotated the shaft and connected counterface (Stellite 6) of diameter 50 mm and length 50 mm at various speeds. Samples of Nimonic 80A, of dimensions 5mm × 5mm × 45 mm were

held against the counterface using the sample arm in reciprocating motion, with reciprocation at three cycles

per minute with a constant stroke of 12 mm. The tests were carried out at a sliding speed of 0.314ms^{-1} (this being the speed of rotation of the counterface) under a load of 7N at various temperatures. Attention in this paper has been focused on the situation at $750\text{ }^{\circ}\text{C}$.

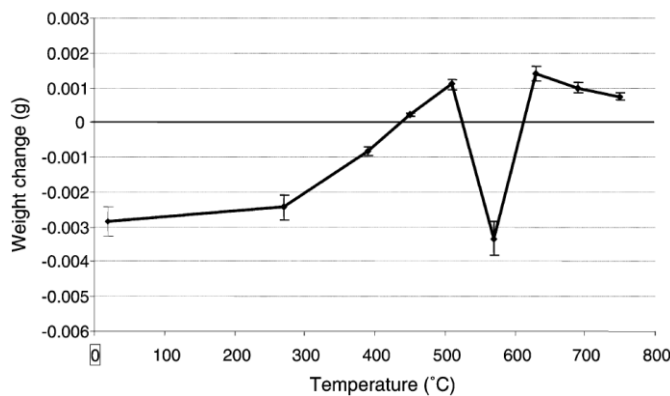
Fig. 2. Weight change vs. temperature for Nimonic 80A against Stellite 6 at $750\text{ }^{\circ}\text{C}$.

Fig. 2 displays the wear data on Nimonic 80A / Stellite 6system as a function of temperature under a load of 7 N at 0.314 ms^{-1} for total sliding distance of 4522 m. Weight changes were extremely low for all temperatures, with the largest mean change being 0.002(4)

g at 270 °C. Slight gains were observed for all test temperatures between 450 and 750 °C, with the maxima in mean values at 510 and 630 °C of 0.001(1) g and 0.001(4) g, respectively. The wear data at a

570 °C shows a departure from the general trend. Repeated experiments confirmed the data at 570 °C needing further attention. This paper focuses attention on the situation at 750 °C.

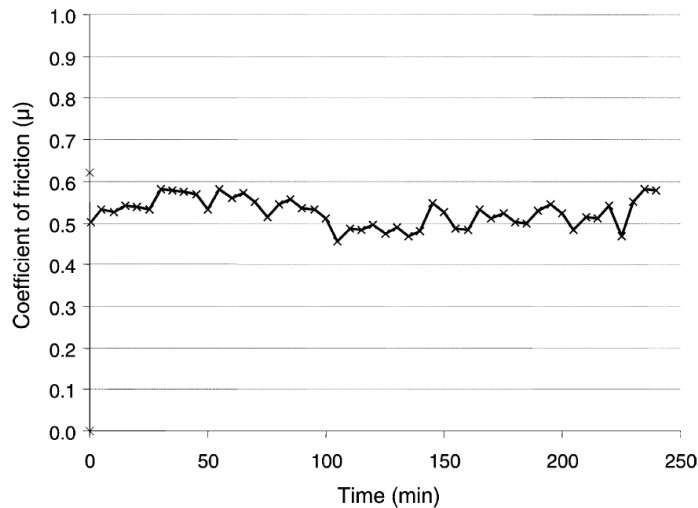
Fig. 3. Coefficient of friction vs. time for Nimonic 80A vs. Stellite 6 at 750 °C.

The coefficient of friction values measured during each of the tests showed an initial period of rapid change, before in many cases settling down into a ‘steady state’ situation with reduced variation. The measured friction coefficients in Fig. 3 show no significant changes with time after an initial peak at the very beginning of testing. This indicates that the onset of the formation of a glaze layer was virtually almost immediate giving, the lack of variation indicating a “steady state” in the values of the friction coefficients due to the presence of the glaze on the worn surface.

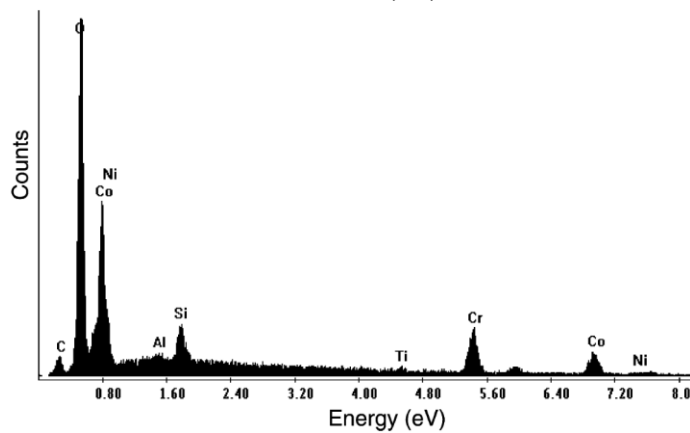
Fig. 4. EDX surface spectrum for Nimonic 80A vs. Stellite 6 at 750 °C.

The spectrum by EDX analysis of the surface generated under sliding wear at 750 °C for 4 h, shown in Fig. 4, reveals the dominant presence of Co, Ni, Cr and O on the glaze surface. Quantification of the results, on average, gives Co = 34.2, Cr = 36.2, Ni = 16.7, Si = 3.8 and Fe = 1.3 (at.%). However, the presence of these elements was also confirmed by TEM EDS which showed some location-to-location variation. The dominant phases identified by XRD included CoCr_2O_4 and $\text{Ni}_{2.9}\text{Cr}_{0.7}\text{Fe}_{0.36}$ (Fig. 5).

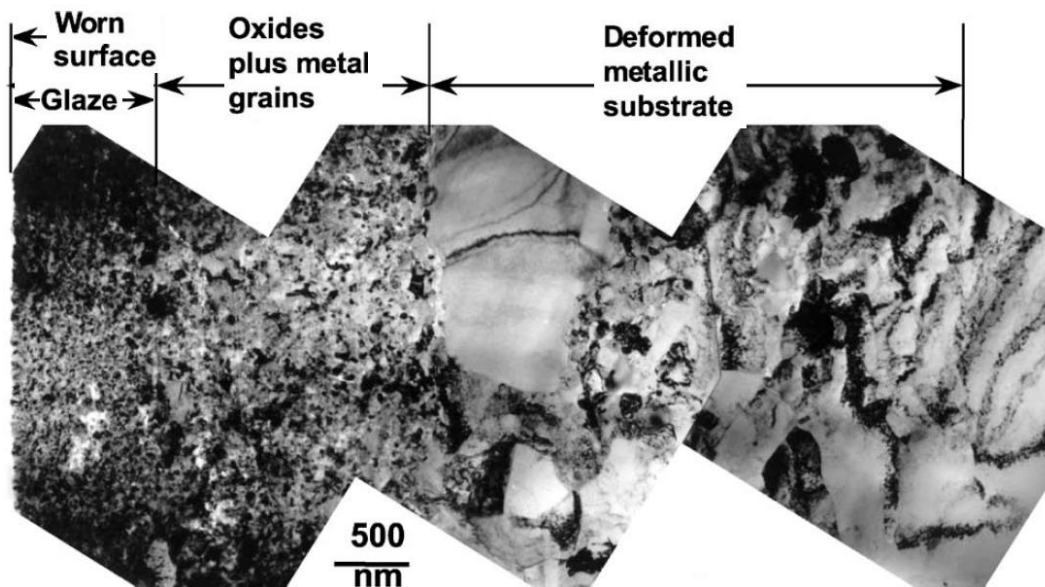
Fig. 6. TEM bright field image: wear-induced polycrystalline glaze layer and deformation of substrate.

Fig. 6 illustrates a cross-sectional composite transmission electron micrograph of the surface formed during wear test at 750 °C. The micrograph demonstrates the presence of the surface layer (glazed surface), the deformed substrate and the glazed layer/substrate interface. The wear-

affected region (total thickness $\sim 3 \mu\text{m}$) consisted of three layers—the topmost layer (the glaze layer) showed the presence of uniform grain structure of size 5-15 nm; some of the grains displaying contrast—the dislocation density in this area was low. The interfacial layer consisted of grains of size 10–20 nm and had a higher dislocation density. The layer just beneath the interfacial layer showed sub-surface deformation and the presence of elongated grains. The structure of the glazed layer and the selected area diffraction (SAD) pattern are separately presented in Fig. 7. The SAD pattern consisted of spots arranged in concentric circles indicating the presence of small grains with high angle boundaries, multiple boundaries and large misorientations (formation of misorientated lattice-fragmentation). The poorly defined irregular boundaries indicate non-equilibrium high energy configuration.

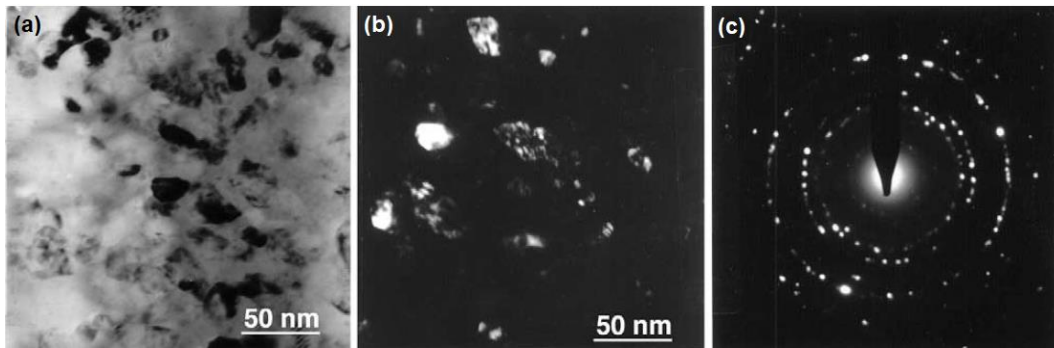
Fig. 7. TEM morphological and structural details of glaze layer: (a) bright field image; (b) dark field image; and (c) selected area diffraction.

The indexed SAD pattern also revealed the presence of oxides of Ni, Cr and Co (indexing not shown here). The dark field images further elaborate on the grain structure of the glazer layer. The occurrence of sub-surface deformation is illustrated in Fig. 8. Dislocations have been observed in the deformed substrate. These dislocations were present as networks inside the

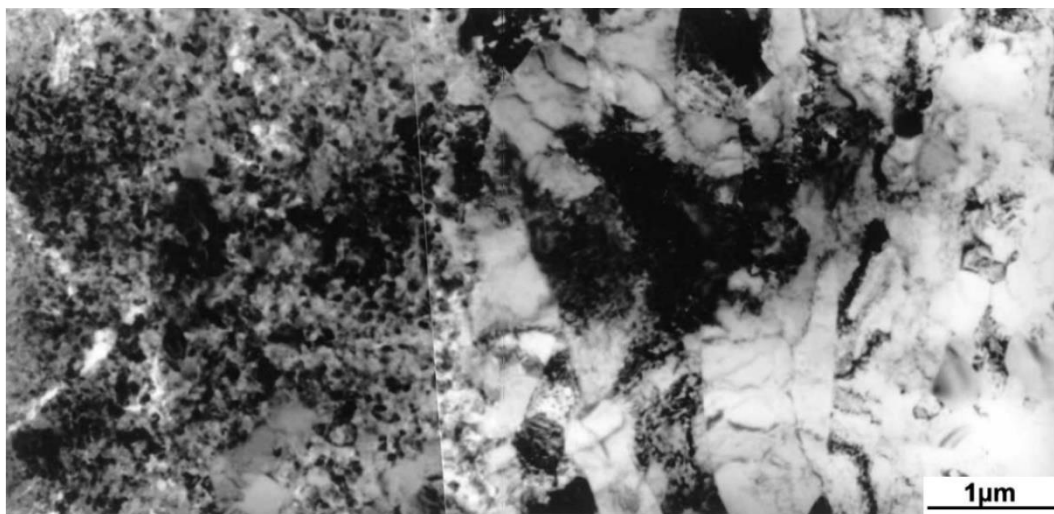
Fig. 8. TEM image showing interface of glaze layer/deformed substrate.

deformed (elongated) grains. It was evidenced that shearing deformation took place in the substrate as a response to the sliding process.
