Construction and testing of self-drilled soil nails

Published in:
Proceedings of the ICE: Geotechnical Engineering

Construction and Testing of Self-Drilled Soil Nails – a case study

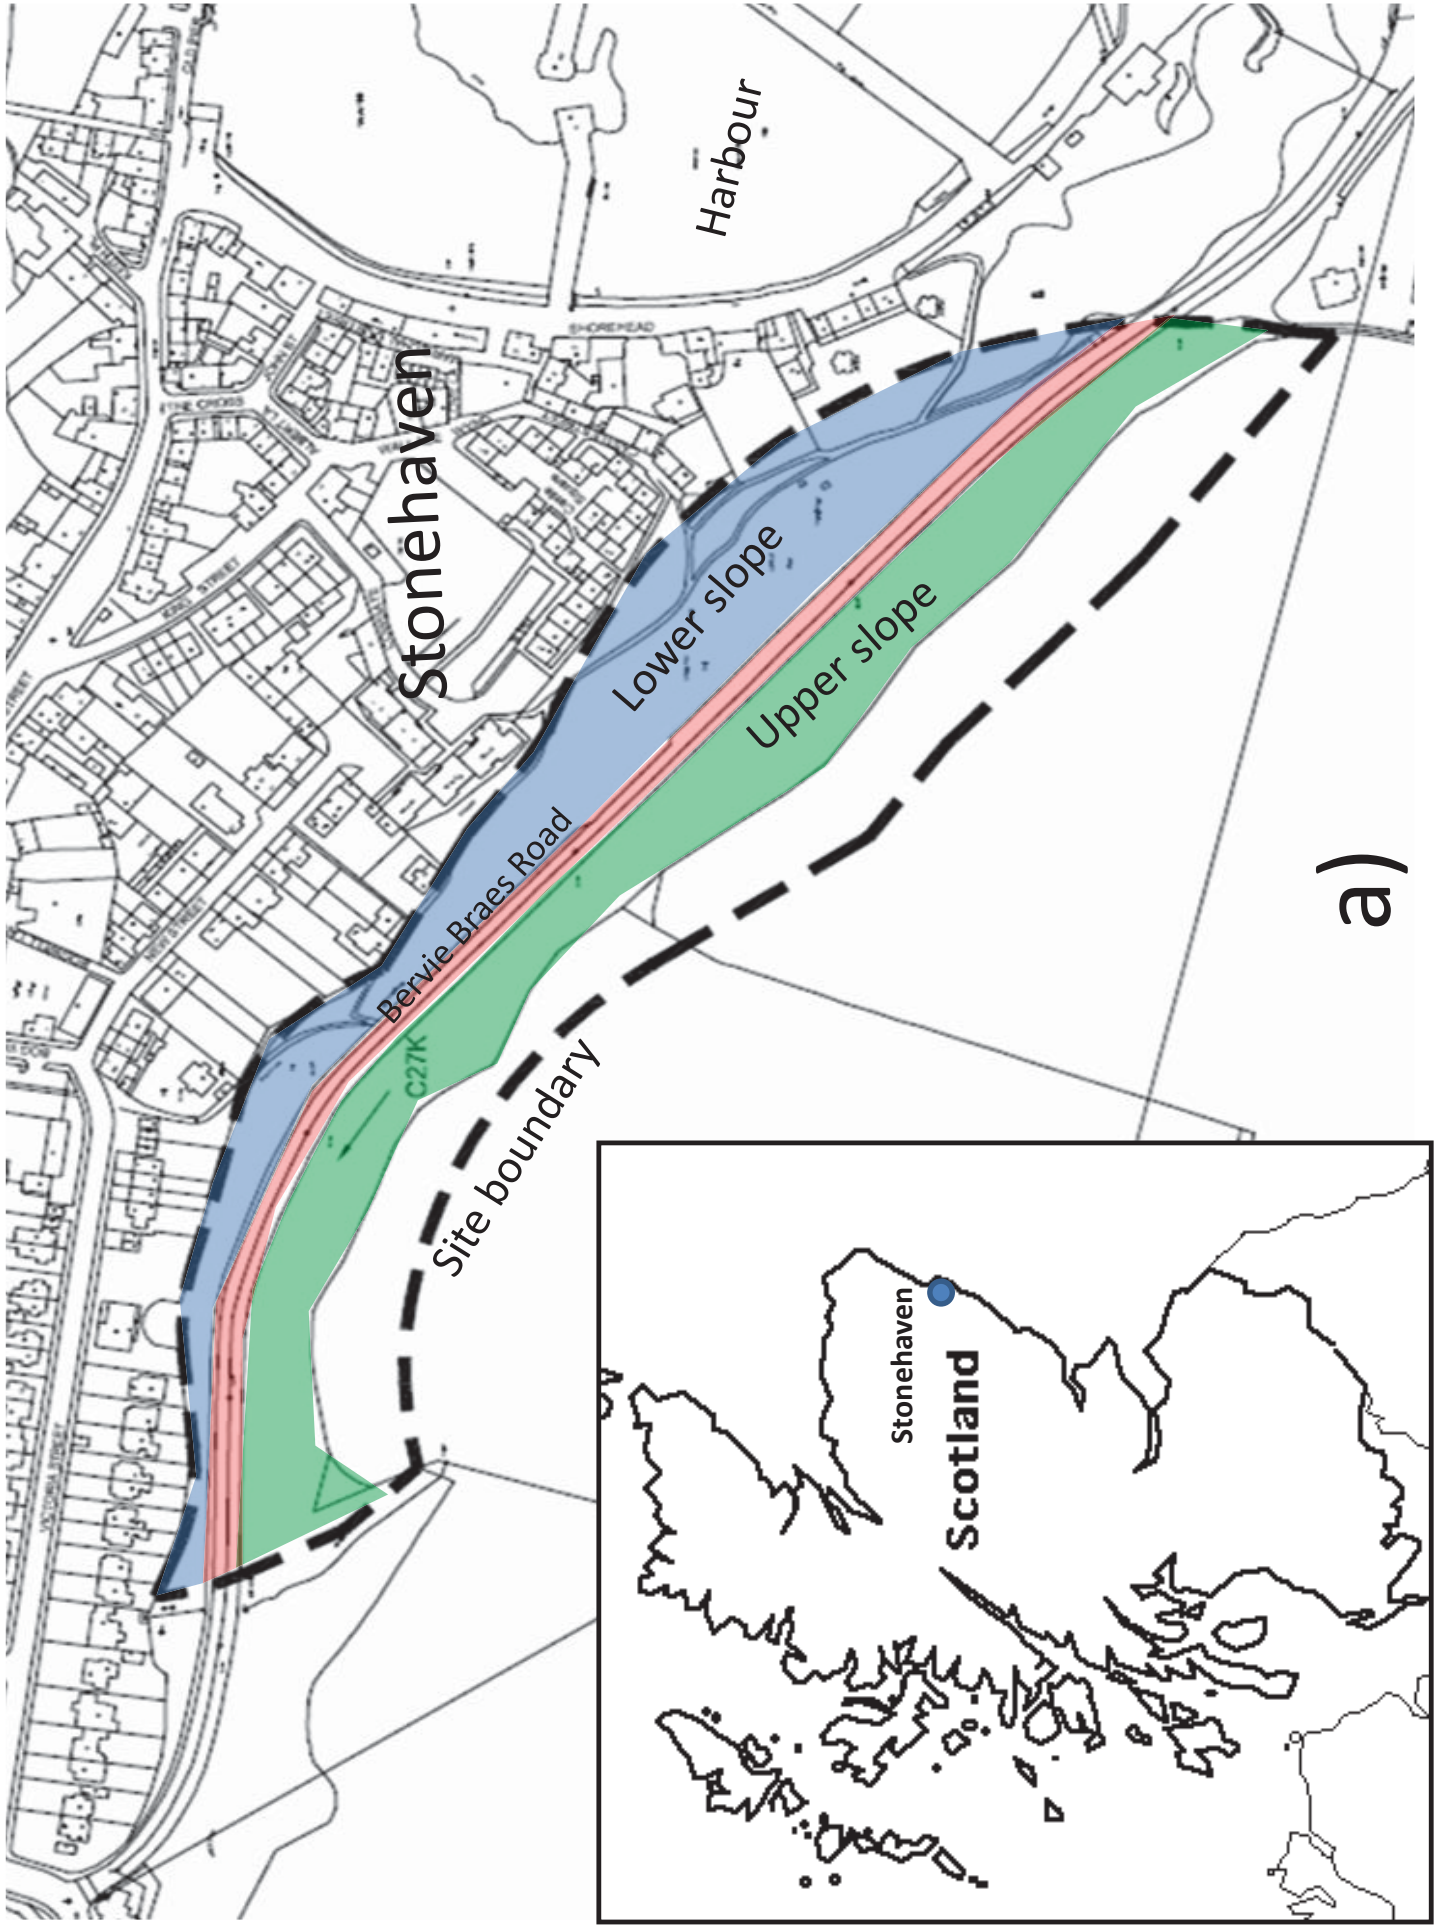
a)

8 Self-drilled hollow bar soil nails were used in a recent slope stabilisation project in Scotland. The
9 site in Stonehaven is predominately located around the former trunk road (Bervie Braes Road),
10 and includes the adjacent coastal slope (Bervie Braes). The 40m high coastal slope in
11 Stonehaven has a history of instability (typical mechanisms include failures within the weak near
12 surface soils combined with occasional shallow groundwater, or perched water at times of
13 heavy rainfall, and over-steepened ground profiles; Currie et al 2009) which has resulted in the
14 closure of the former trunk road bisecting the slope. The road runs sidelong and generally
15 northwest-southeast across the Braes. The slope stabilisation works were limited to the slope
16 below the road ('Lower slope' on Figure 2a; Mickovski 2014b).
17
18
19
20
21
22
23

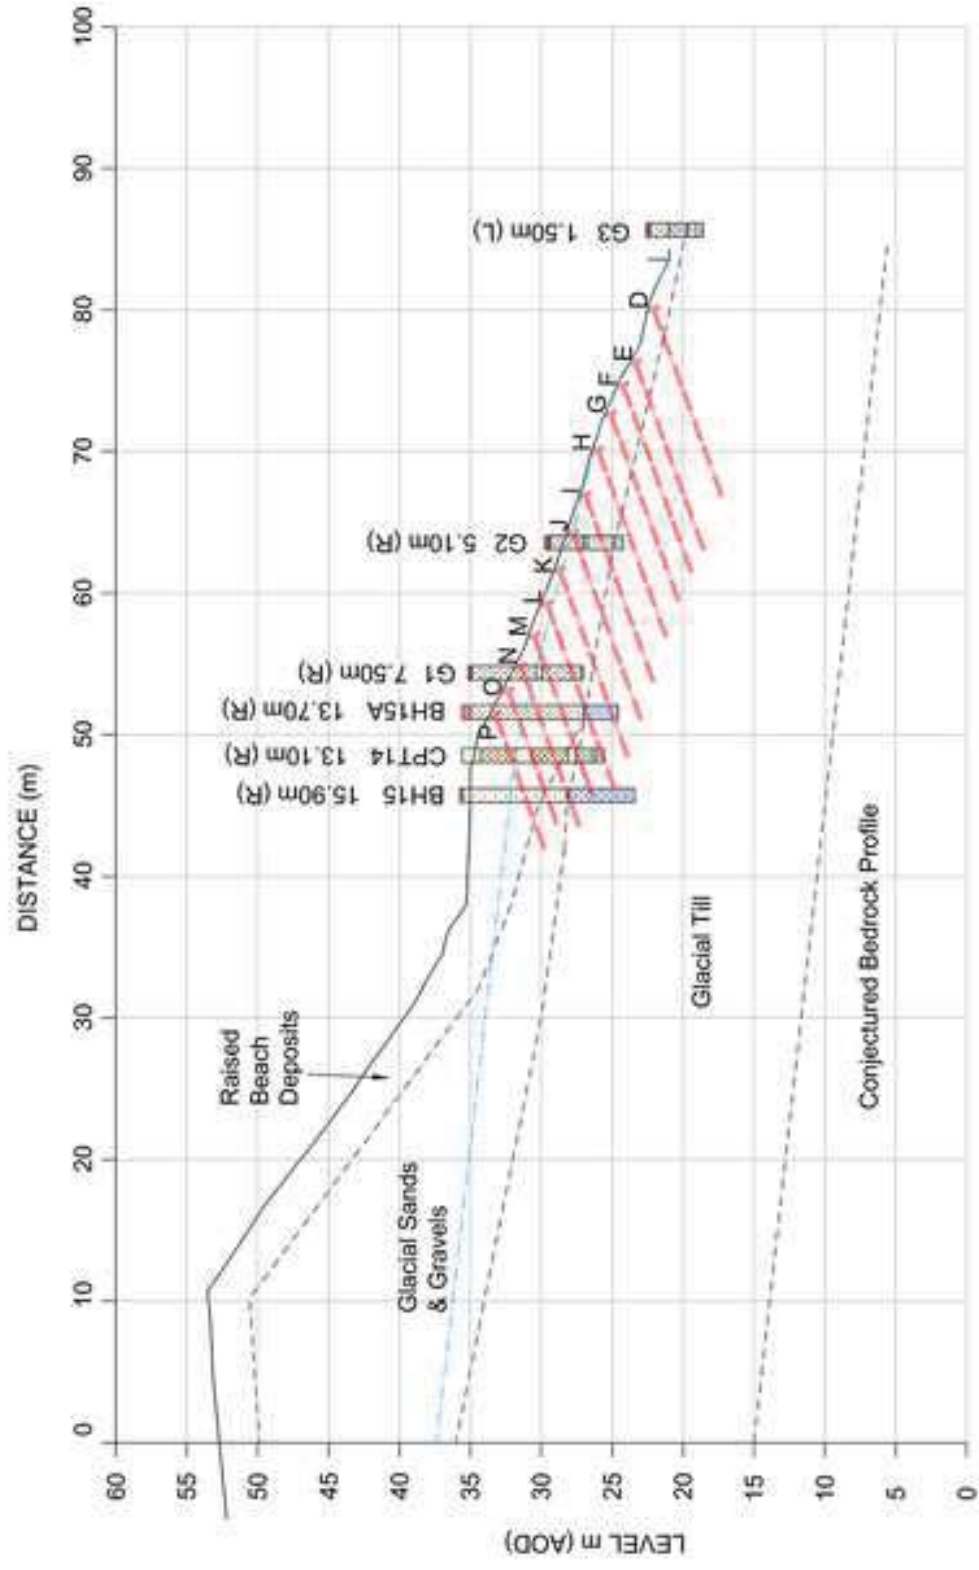
b)

24 The angle of the lower slope ranges between 25° and 30°, while the upper slope angle varies
25 between 30° and 35°. Ground investigations (Currie et al 2009) showed that the soil on the
26 lower slope typically consisted of vegetated topsoil (around 0.2m thick), overlying Raised Beach
27 Deposits comprising weak silts and silty sand with discrete soft cohesive layers with thickness
28 ranging from 1.5m to 5.0m. This stratum is underlain by medium dense glacial sands and stiff
29 cohesive Glacial Till with thickness of up to 20 m which, in turn, overlies the sandstone bedrock
30 (Figure 2b).
31
32
33
34
35
36

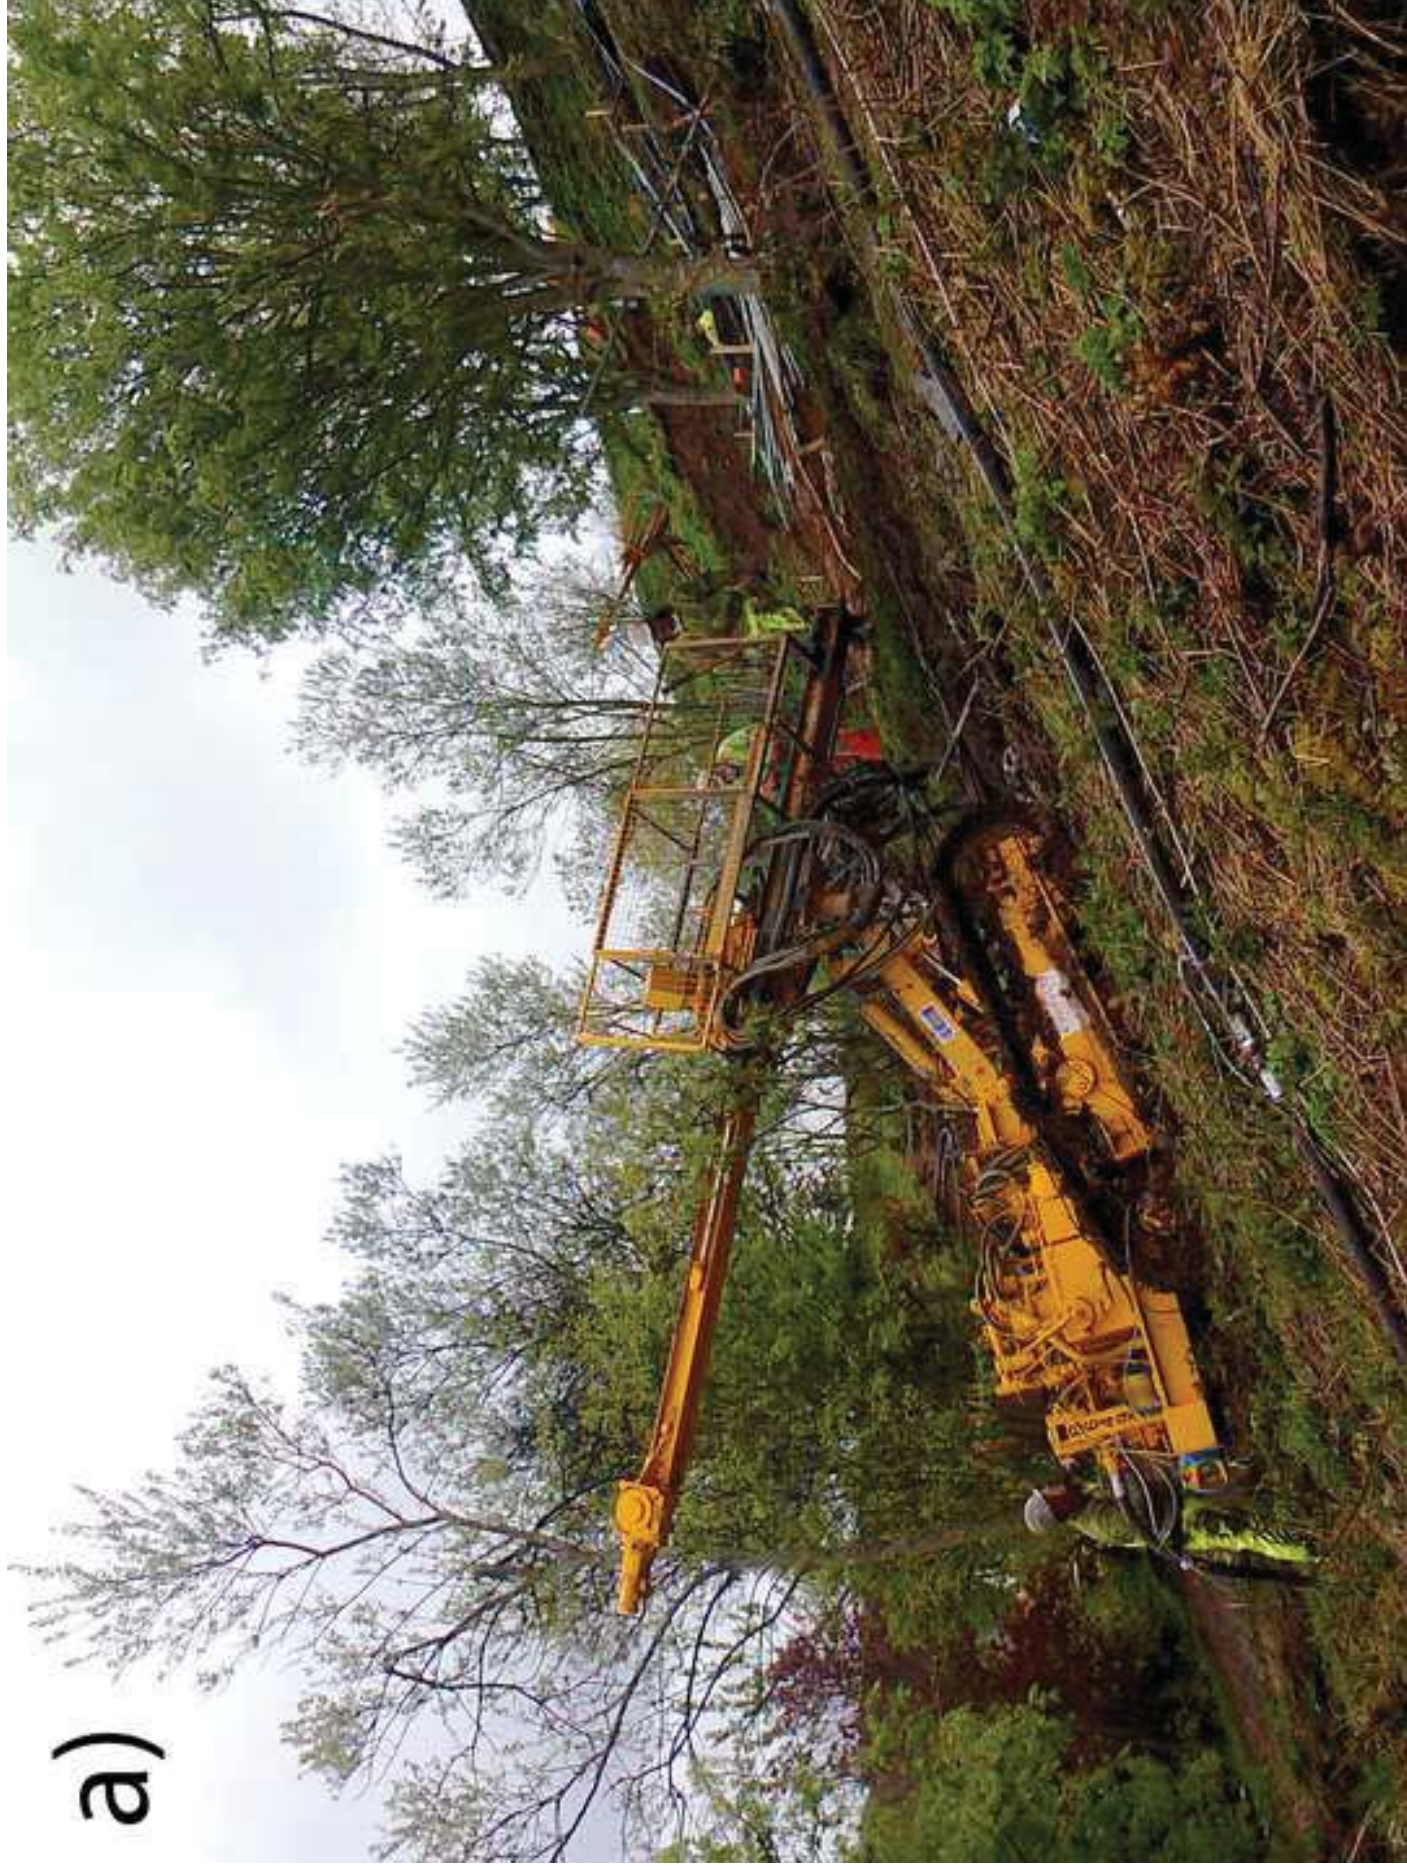
27
28 Figure 5 Test setup for the pullout testing of sacrificial nails. a) excavation (long and short nails
29 can be seen) b) testing frame installation on one of the nails of the pair c) pullout testing while
30 recording pullout force and displacement.
31
32

30
31 The pullout tests were carried out using standard () testing equipment (BS14490:2010, Phear
32 2005) including a 400 kN capacity, 200 mm diameter, hydraulic jack and displacement
33 transducers with 0.01 mm precision (Figure 5). The test duration was dependent on the pullout
34 load and it ranged between 25 minutes (failure recorded at relatively low loads) and 175
35 minutes (design yield load for the steel bar reached) per nail. The total nail testing duration on
36 the project was 60 days which included installation, setup and pullout testing.
37
38
39
40
