# Risk Assessment of Failure of Outdoor High Voltage Polluted Insulators under Combined Stresses Near Shoreline

**Abstract:** The aim of this paper is to investigate the various effects of climate conditions on outdoor insulators in coastal areas as a result of saline contamination under acidic and normal cold fog, determining significant electrical and physico-chemical changes on the insulator surface and considering the effect of discharge current, electric field distribution and surface roughness. To replicate similar conditions near the shoreline, experimental investigations have been carried out on insulation materials with the combined application of saline contamination and acidic or normal cold fog. The test samples included silicone rubber (SiR), ethylene propylene diene monomer (EPDM) and high-density polyethylene (HDPE), which were used as reference. The materials are of the same composition as those used in real-life outdoor high voltage insulators. All samples were aged separately in an environmental chamber for 150 h for various saline contaminations combined with acidic and normal cold fog, and were generated by means of the adopted experimental setup. This analysis

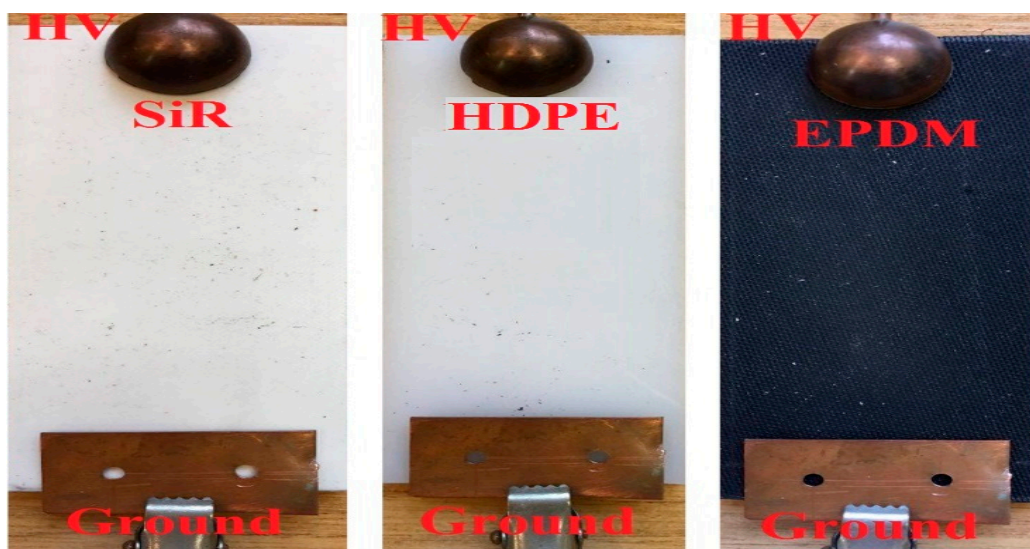
**Figure 1.** Experimental samples of SiR, HPDE and EPDM.

Different types of polymeric insulating material samples such as silicone rubber (SiR), high density polyethylene (HDPE) and ethylene propylene diene monomer (EPDM) with rectangular shape (18 cm × 4 cm × 8 cm) are taken with same composition as those used in real life outdoor high voltage insulators as test samples, as shown in Figure 1. Leakage current, electric field distribution and physico-chemical changes of the samples are investigated using the solid layer contamination method given in IEC-60507, under various environmental stresses in a chamber. The inclined plane test (IPT) for erosion, surface roughness and degradation and relationship to leakage current and electric field of polluted insulators, is used, which was standardized in ASTM D2303 [22] and IEC 60587 [23].

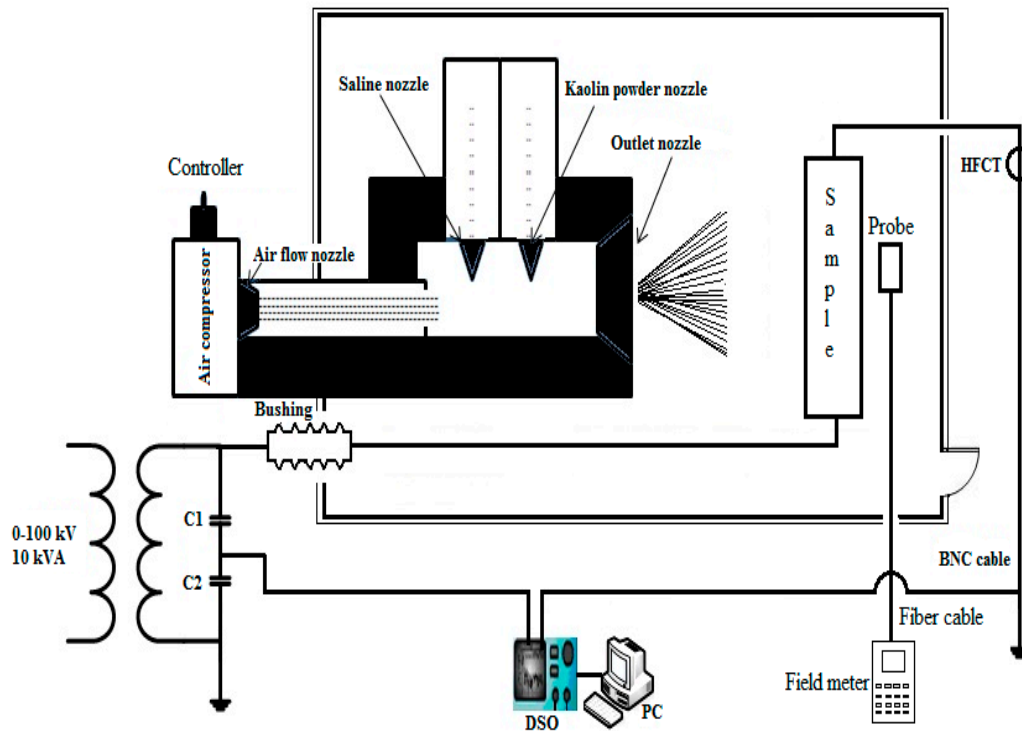
Figure 2 shows the experimental setup. In this research work the 33 kV AC test voltage was produced by a 10 kVA, 100 kV, and 50 Hz transformer. The supplied voltage can be increased manually or automatically at a rate of 1 kV/s. Acidic and normal cold fog are generated by adjusting the nozzle of the spray gun. The flow rate of fog is 2 kg/h/m<sup>3</sup>. The diameter of the spraying nozzle is 0.8 mm and the spraying pressure is 16.0 MPa. The conductivity of artificial contamination deposition is between 150 and 200  $\mu\text{S}/\text{cm}$  and conductivity of the acidic cold fog is between 700 and 800  $\mu\text{S}/\text{cm}$ , and pH of acidic cold fog is 3.6. These values are almost the same as the acidity measured in the atmosphere near the shoreline [24]. The lowest pH value is 2.4, which occurred in Scotland in 1974 [25] indicating ultra-acidic environmental conditions. The composition and density of the ion ingredients in the preparation of acidic cold fog are shown in Table 1. This composition is used as the standard acidic fog in this research to evaluate changes in surface physico-chemical properties, leakage current and electric field for all the insulator samples.

**Figure 2.** Experimental setup.

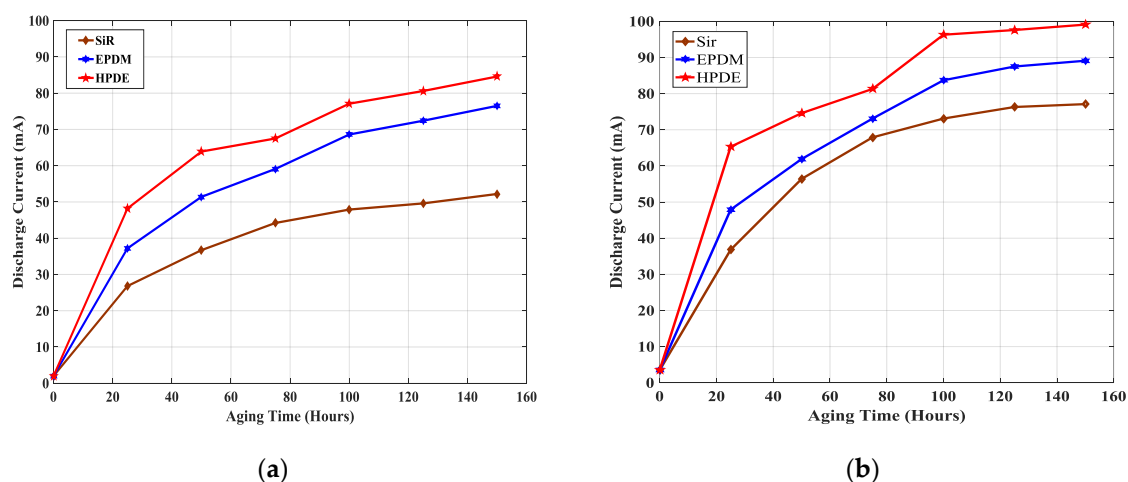
Figure 3a,b compare the discharge currents of various samples under the combined deposition of saline contamination and acidic or normal cold fog. It is observed that the discharge current increases with an increase in aging test time both in the acidic and normal cold fog and with an increase in the number of “ON” and “ON/OFF” cycles. From these figures, it is evident that the discharge current of the HDPE sample unveils a small current in “ON” when compared to the “ON/OFF” scenario, where it is too high and fails within 72 h. The EPDM sample has approximately half of this current variation both in the “ON” and “ON/OFF” scenarios over 98 h. Meanwhile, the SiR sample persists for 150 h with similar changes in discharge current in both the “ON” and “ON/OFF” scenarios. The results also indicate that the degree of surface degradation and insulator failure are not only dependent on the duration of service but are not sufficient to initiate the surface discharge phenomenon on the insulator surface. Surface degradation and failure have to be caused by a combination of electrical and environmental stresses such as saline contamination, acidic or clean cold fog and various electro-chemical reactions as well as weathering cycles and variations in the properties of the insulation materials, including SiR, HDPE and EPDM.

**Figure 3.** Discharge current: (a) Under combined stress of saline contamination and acid cold fog; (b) under combined stress of saline contamination and normal cold fog.

From the results it can be summarized that SiR performs better than the other materials, whereas HDPE and EPDM reveal that discharge current is about 43% and 27% higher than that of SiR. SiR gives a much lower discharge current as a result of its hydrophobic property. In addition, the effects of normal cold fog with saline contamination were also investigated for all materials. In fact, it can

be noted that the discharge current is reduced more than 31% for SiR compared to the combined application of saline and acidic cold fog conditions. The reason for this is that, in the SiR sample the Si-O bond has a high bond energy so that SiR has a high heat resistance against erosion and surface degradation. In addition, the SiR methyl group bonds, such as the C-H bond of CH<sub>3</sub> and Si-CH<sub>3</sub>, are highly moisture absorbable bonds, implying the diffusion of low molecular weight (LMW) polymer liquid from the bulk to the surface. However, the weak bonds in the molecular structure of EPDM, such as the C-C and C-H bonds in ethylene (C<sub>2</sub>) and propylene (C<sub>3</sub>), easily degrade in acidic cold fog because of early loss of hydrophobicity. EPDM and HDPE have slow hydrophobicity restoration in harsh environments.

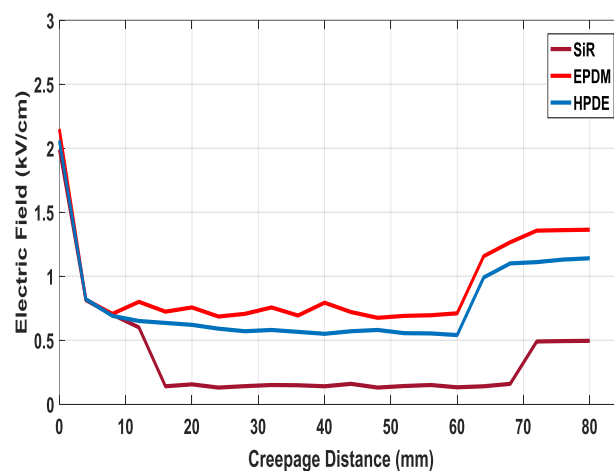
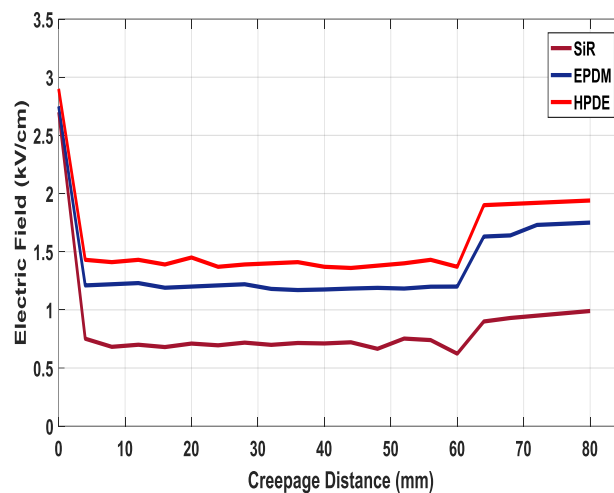
Electric field distribution along the creepage path is given in Figure 4a,b for all samples in clean and acidic cold fog respectively. Clearly, the variation of electric field among the samples results from changes in the dielectric constant. The electric field distribution for all samples is non-linear with higher amplitude near the energised than that at the grounded end. It is also observed that the field strength along the samples is completely different during combined the application of saline contamination and acidic fog as compared to saline contamination and clean cold fog. The E-field distribution was measured after 110 h of aging time. The maximum strengths for SiR, EPDM and HDPE samples in normal fog are 0.399 kV/cm, 0.401 kV/cm and 0.425 kV/cm respectively. However, these values increased to 0.533 kV/cm, 0.569 kV/cm and 0.587 kV/cm respectively after 20 min of acidic cold fog generation. The reason for this is twofold. First, relative permittivity of acidic cold fog is much higher as compared to normal cold fog, which enhances the field strength in the surrounding air. Second, water droplets deform in the direction of the field, making their curvature smaller and increasing the field further.

**Figure 4.** E-field distribution along creepage distance: (a) During combined stress of saline contamination and acidic cold fog; (b) during combined stress of saline contamination and normal cold fog.

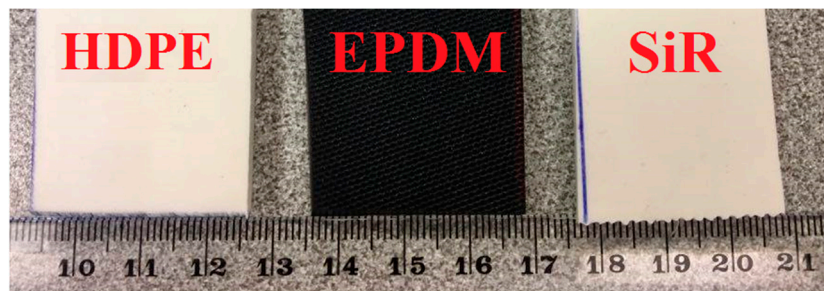
**Figure 5.** Pieces of aged samples for physico-chemical analysis.

The lifespan of the insulating materials under various combined stresses is a major and significant interest in failure studies [27,28]. Under various environmental stresses, the insulator loses its ability to work as required because of premature dielectric changes that take place in the form of chemical reactions and change in physical properties. This section describes all the physico-chemical changes that took place under various combined stresses. Figure 5 shows slices of samples cut from the 150 h aged samples for physico-chemical analysis.

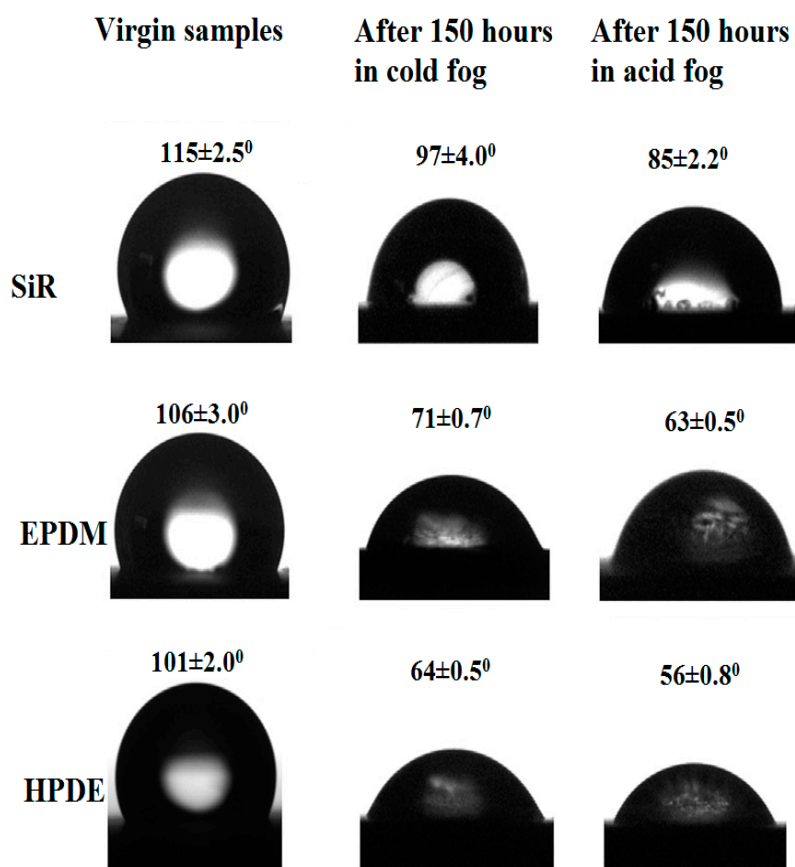
The measured contact angles of all samples before and after aging in acidic and clean cold fog are shown in Figure 6. It is noticeable that the contact angle decreases with increased aging time in

all samples. During measurements, it was observed that the hydrophobicity of the degraded SiR sample is restored in the “ON/OFF” scenario. The contact angle decreases during the “ON” scenario and increases to some extent during the “ON/OFF” scenario as compared to the EPDM and HDPE samples, where the contact angle steadily decreases in both scenarios. Thus, it can be concluded that the hydrophobicity recovery of SiR is more elastic than those of HDPE and EPDM. It should be noted that the surface of HDPE and EPDM undergo stronger erosion than that of SiR because of the chemical compositions of acidic cold fog. In addition, they suffer degradation because of the surface discharge in the presence of saline contamination and acidic cold fog. As a result, the contact angle was reduced by 8.3% for the SiR 150 h aged sample in clean cold fog in relation to the reference sample. For the 150 h aged sample in acidic cold fog the contact angle was decreased by 15.8%, showing that acidic cold fog has a relatively more severe effect on the surface than that of clean cold fog. Moreover, this effect is even more severe for EPDM and HDPE where the contact angle was reduced by 23.2% and 27.2% respectively in acidic cold fog during 150 h of aging and 19.4% and 21.1% in normal cold fog in the same conditions. From Figure 6 it can also be observed that both EPDM and HDPE have contact angles of less than  $90^\circ$  during 150 h in clean cold and acidic cold fog, indicating poor hydrophobicity. By definition, hydrophobic surfaces have contact angles of more than  $90^\circ$  while hydrophilic surfaces have angles of less than  $90^\circ$ . These results are because the surfaces are affected by partial discharge activity and acidic and saline contamination. For the same reason the contact angle reduction in the case of acidic cold fog is greater than that of clean cold fog. It was also found that methyl groups ( $\text{CH}_3$ ) are responsible for the hydrophobic and hydrophilic behaviour of SiR, EPDM and HDPE. As a matter of fact, when the numbers of these groups are decreased on the surface, the hydrophobicity of these materials is reduced.

Figure 6. Contact angles of virgin and aged samples.

It was observed that, in an environment of  $-2^\circ\text{C}$  and at high acidity  $\text{pH}$  (3.6), the contact angles of the samples decreased remarkably. For example, the contact angle of the best hydrophobic material (SiR) was reduced from  $97.40 \pm 20$  to  $850 \pm 2.20$  when the nature of the fog was changed from clean to acidic. The hypothesis for this change was that acidic moisture was condensed at low temperature in the channels between submicron particles, and thus the air beneath the water droplets was to some

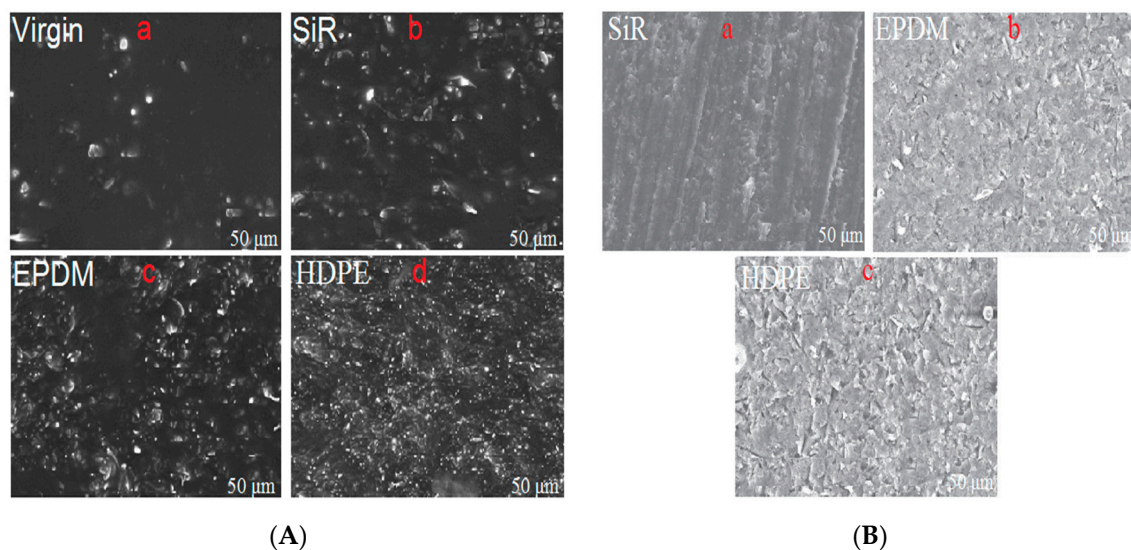
A Scanning Electron Microscope (SEM) analysis was undertaken to obtain information about the specimens' surface structures and composition. Morphological and topological changes in the samples before and after the acidic and clean cold fog tests are shown in Figure 7A,B. Material properties have been observed after 150 h of aging for both acidic and clean cold fog conditions. Figure 7A shows the virgin sample before the treatment at a magnification range of 50  $\mu\text{m}$ , it shows no dents, cracks or surface roughness and degradation. On the other hand, cracks and significant dents can be identified after 150 h of aging for all materials, especially on more exposed parts, such as those where the flow of leakage current was higher during the acidic than the clean cold fog application, as shown in Figure 7B. It was found that the surface morphology changes of the sample treated in acidic cold fog are different from those in clean cold fog. As for Figure 7A, no major cracks and dents were found in the clean cold fog samples except for some parts showing minor cracks and dents. This may be because of smaller discharge intensity in clean cold fog. The material treatment for the acidic fog was more served than that for clean cold fog as a result of high intensity of discharge activities. The experimental results discussed above reveal that acidic cold fog exposure has more severe degradation effects on insulation materials than clean cold fog exposure. After aging in acidic cold fog, the surface becomes rough with a number of dents and cracks and a decrease in the hydrophobicity. Moreover, the surface of EPDM and HDPE is damaged severely when compared to SiR, as the Si-O bond has high bond energy resulting in a high heat resistance against discharge and degradation.

**Figure 7.** SEM picture of insulator surface: (A) Surface aged in acidic cold fog for 150 h, (a) Virgin; (b) SiR; (c) EPDM; (d) HDPE; (B) surface aged in clean cold fog for 150 h, (a) SiR; (b) EPDM; (c) HDPE.

From the SEM and FTIR results, it can be concluded that various oxygenated types such as hydroxyl, carbonyl and ester groups were formed when SiR, EPDM and HDPE were exposed in the application of the combined effect of saline contamination and acidic cold fog. Cracks and dents formed on the insulation samples as a result of surface degradation is found to be different under acidic cold fog than in normal condition.

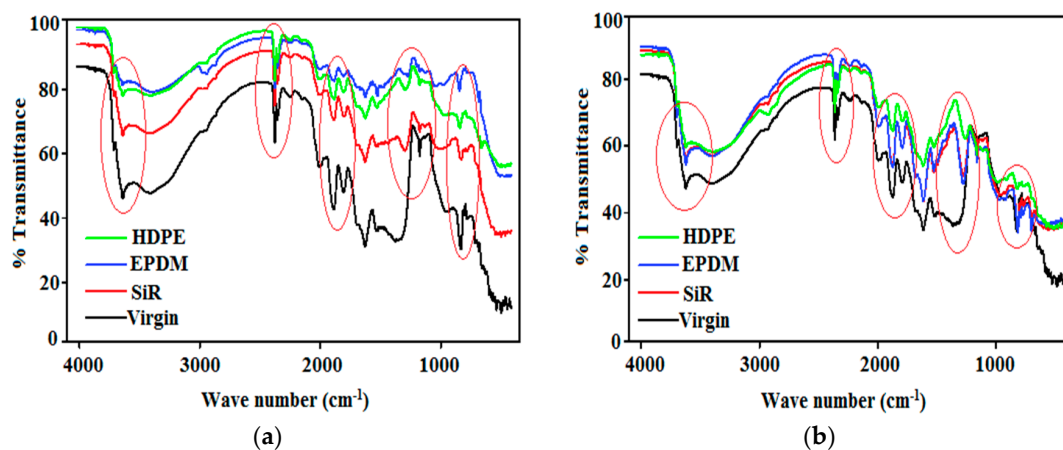
The FTIR technique allows detection of molecular bonds formed on the sample surface [30]. Figure 8a,b shows the FTIR spectra of samples (SiR, EPDM and HDPE), energised at AC voltage in the

combined application of saline contamination and clean or acidic cold fog. Figure 8a,b shows the FTIR spectra for the SiR, EPDM and HDPE samples exposed to saline contamination, combined to clean or acidic cold fog respectively, as per the adopted experimental set up. The spectra show a variation at the same wave number for the dents and cracks on the samples treated in acidic as compared to clean cold fog, with micro cracks on the sample surface. This is because all samples experience different types of chemical reactions and surface degradation because of the non-uniformity of heat generated along the creepage distance. For the silicone rubber sample, absorption at 2435 to 2710  $\text{cm}^{-1}$  in clean cold fog and at 2310 to 2490  $\text{cm}^{-1}$  in acidic cold fog is related to the Si-CH<sub>3</sub> bond. Absorption at 970 to 1180  $\text{cm}^{-1}$  in clean cold fog and at 1240 to 1390  $\text{cm}^{-1}$  in acidic cold fog is caused by the Si-O-Si main bond. It is clear that the absorption the C-H bonds of CH<sub>3</sub> is greater in clean than in acidic cold fog, which means that the number of C-H bonds is relatively less after the sample is tested using the combined action of saline contamination and acidic cold fog. The HDPE sample shows strong bands at 2470  $\text{cm}^{-1}$  and 2590  $\text{cm}^{-1}$  because of the stretching vibration of C=O in the -COOH group with acidic and clean cold fog respectively. The relative area ratios between the characteristics peak of C=O at 810  $\text{cm}^{-1}$  and the characteristics peak of CH<sub>2</sub> at 1120  $\text{cm}^{-1}$  in the FTIR spectra illustrate the fact that the number of C=O increases with increasing absorption rate, which means that roughness has increased on the HDPE surface. In the EPDM spectra, the extensive peaks at 1360  $\text{cm}^{-1}$  and 2490  $\text{cm}^{-1}$  are related to the O-H and C=C stretching vibrations respectively. The peaks at 3760  $\text{cm}^{-1}$  and 2990  $\text{cm}^{-1}$  are assigned to the -CH<sub>2</sub>- and C-H scissoring vibration and the stretching vibration of methyl respectively. Reduction that took place in the methyl and hydroxyl groups was over 67%, and 72% in the case of SiR, whereas it was almost 90% and 93% for EPDM and HDPE. Figure 8a,b clearly shows that, in the case of the combined effects of saline contamination and acidic cold fog, the surface of the EPDM and HDPE samples are more severely damaged during the oxidative degradation of organic compounds in air than that of SiR, because the Si-O bond has high bond energy, meaning that the SiR because the Si-O bond has high bond energy, meaning that the SiR has high heat resistance against degradation.

**Figure 8.** Fourier Transform Infrared (FTIR) spectrum: (a) Aged sample of SiR, EPDM and HDPE in acidic cold fog; (b) aged samples of SiR, EPDM and HDPE in normal cold fog.
