Diagnosis of abnormal temperature rise observed on a 275 kv oil-filled cable surface: a case study

IEEE Transactions on Dielectrics and Electrical Insulation

Diagnosis of Abnormal Temperature Rise Observed on a 275 kV Oil-filled Cable Surface – A Case Study

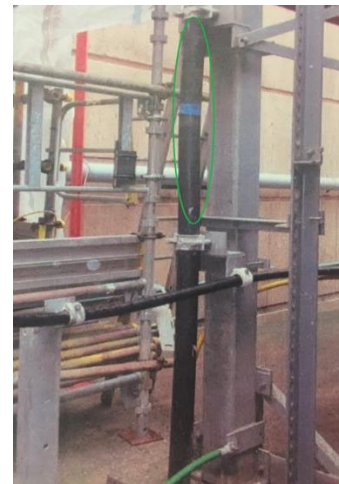
As shown in Figure 3, the Blue phase is apparently bent between two cleats which are used to fix the cable. In Nov. 2017, an inspection via infrared thermal images of the three phase cable, at 6 °C ambient temperature, revealed a local cable surface temperature rise of 5.2 °C above other phases around the bent area of Blue phase (in Figure 4). In details, the temperature of Blue phase was 17 °C which was 11 °C rise above the ambient temperature, while the temperature of the other phases were 11.8 °C which were 5.8 °C higher than the ambient temperature.

Figure 3. 275kV OF cable (Blue Phase) – the area marked in the green ellipse was observed to have a 5.2°C temperature rise.

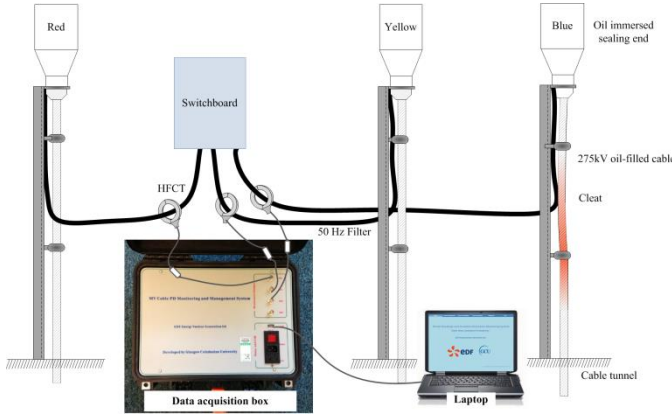
Figure 5. Physical connections of test instruments.

The PD tests were carried out on the Jan 30th 2018. As shown in Figure 5, three HFCTs were clamped at the earthing strap of the cable terminations: these were connected to CH1, CH2 and CH3 of a bespoke DAQ box using BNC cables. The acquired data was then saved to laptop computer and analysed via specialist software. The test results are shown in Figure 6; examples of pulsative signals are highlighted in the ellipses in Figure 6a.

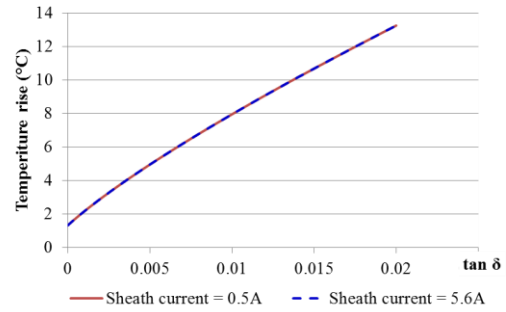
Figure 10. Cable surface temperature in excess of ambient temperature.

Figure 10 indicates that for the OF cable in the case study, the sheath currents has little effect on the cable surface temperature. Therefore the sheath current is not regarded as the reason for different temperature in the three phases.

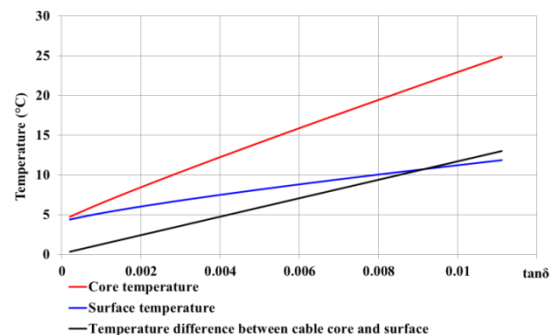
Figure 11. Temperature of cable core and cable surface for 26A load current at an ambient temperature of 6°C.

The rise of cable core and cable surface temperature as the $\tan \delta$ increase is illustrated in Figure 11. It was reported that for oil-impregnated paper cable (see Table 2) in [22], when $\tan \delta$ is greater than 0.01, the cable insulation is assessed as being in bad condition and needing urgent action. Analysis shows that when $\tan \delta$ values are 0.0017 and 0.009, which correspond to good and considerably aged insulation conditions respectively, the corresponding cable surface temperatures are 5.8 and 11°C higher than ambient temperature correspondingly. In addition, if the $\tan \delta$ increases from 0.001 to 0.01, it causes a cable surface temperature rise of 5.97 °C.

Figure 11 also suggested that as $\tan \delta$ increase, the temperature difference between cable core and cable surface becomes greater. When $\tan \delta$ is 0.0031, for which cable insulation can be assessed as in good condition, cable core temperature is 6 °C above ambient temperature. Therefore another reason which explains the thermal problem observed would be an oil leakage from the cable core to under the cable surface without the cable insulation severely deteriorating. As a result, oil with higher temperature leaking from the oil duct through an existing path would infuse higher temperature oil through the insulated paper and result in a cable surface temperature rise.

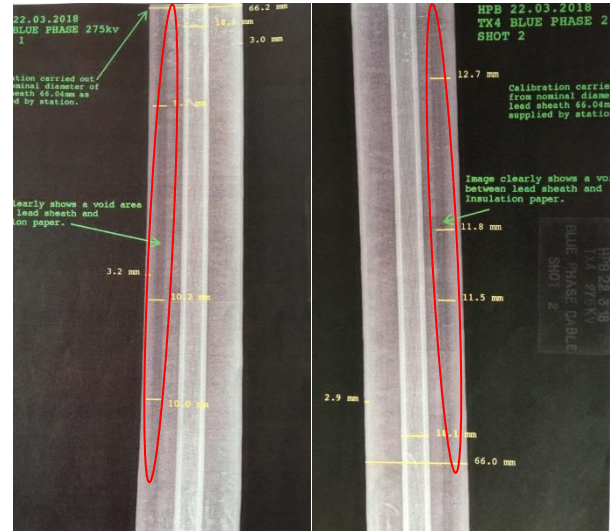
Figure 12. X-ray images of Blue Phase cable acquired on March 22nd 2018.

An X-ray technique was used to help researchers confirm the proposed fault diagnoses. The X-ray images were taken from both front and back side of the Blue Phase, as shown in Figure 12a and Figure 12b, respectively. Cable

construction is clearly displayed in the two X-ray images. Slight distortion of the cable can be demonstrated from inconsistent outer diameters of lead sheath, which are 66.2 and 66.0 mm respectively, and various thickness of the lead sheath which are 2.9, 3.2 and 3.0 mm respectively. The red ellipses in Figure 12a and Figure 12b show the oil region between the cable insulation and lead sheath, this has different widths at various positions.

(a) Front images (b) Rear images
– the red ellipse shows the area of oil leakage

(c) Schematic diagram of the X-ray results, a representation of the front and rear X-ray images

The images show that the thickness of the lead sheath varies, i.e. 3.2, 3.0 and 2.9 mm. The diameter of the conductor is shown to be 18.1 mm and the outer diameter of the lead sheath is shown to vary between 66.2 and 66.0 mm. The X-ray images also indicate a narrow region between cable insulation and lead sheath filled with oil. The lengths of the void at various positions in Figure 12a are measured as 9.7, 10.0 and 10.2 mm and in Figure 12b as 12.7, 11.8 and 11.5 mm. As shown in Figure 12c, an oil filled region between the cable insulation and lead sheath, approximately one meter in length, may have been responsible for the abnormal temperature rise. As shown in Figure 13, channels formed due to distortion and deformation allow the higher
