*Corrosion behavior of carbon steel in presence of sulfate-reducing bacteria in seawater environment.* (2013) *Electrochimica Acta*, 113. 390-406. ISSN 0013-4686.

# Corrosion behavior of carbon steel in presence of sulfate-reducing bacteria in seawater environment

## A B S T R A C T

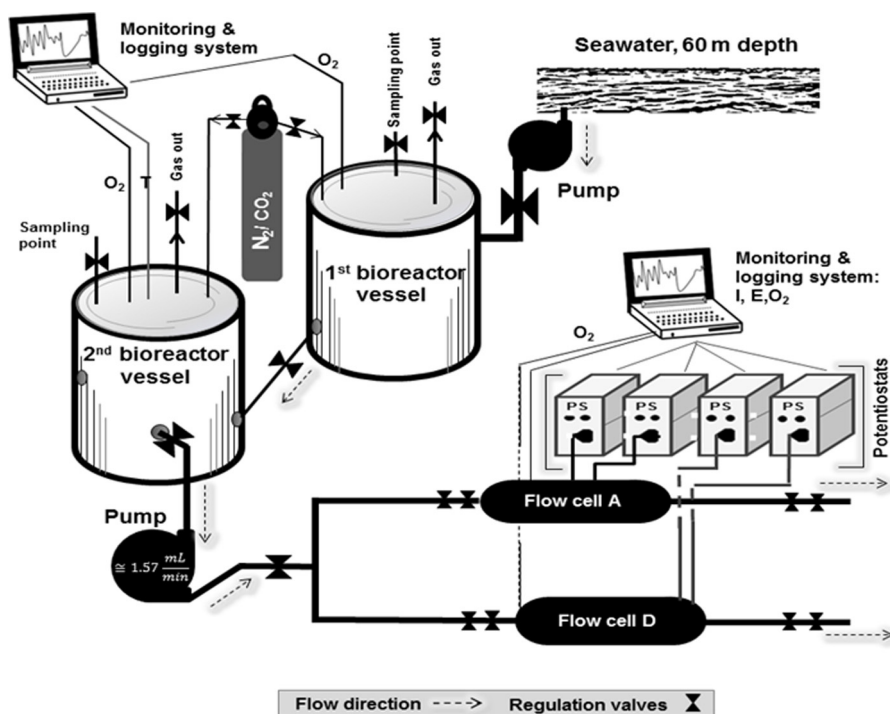
Fig. 1. The continuously fed with fresh media test loop.

A peristaltic pump (W-M 520SN/REL, Watson–Marlow, UK) drew media from the second bioreactor vessel, and the output flow was split between the two flow cells. Perfluoroalkoxy tubing (PFA-T8-062-50, Swagelok, UK) was used. Two regulation needle valves (PFA-4RPS8, Swagelok, UK) were installed before and after each flow cell. Flow cells were made from acrylic tubes (6 cm inner diameter, 1 cm wall thickness and 34 cm length) and acrylic plates (5 cm × 34 cm × 0.5 cm). Twelve pairs of feedthroughs (M20 size fittings, produced by OBO Bettermann, Germany) were installed on the top of each flow cell. A schematic drawing of a flow cell showing its cross section and distribution of feedthroughs is presented in Fig. 2. Electrodes (working–WE, counter–CE and reference–Ref) for electrochemical measurements were installed in the two flow cells, in identical arrangements at 12 o'clock positions. An in-house manufactured liquid sampling port (SP) that accommodated dipping oxygen probe was installed at F10 position in each flow cell. To monitor biofilm formation, ten carbon steel specimens (rectangular plates with dimensions of a 1 cm × 1 cm × 0.2 cm) were installed at 6 o'clock position in each flow cell.

The entire “once-through” flow loop was constructed from polymers to minimize contamination with exogenous metal ions. Furthermore, materials, including perfluoroalkoxy (2 mm thickness), polyolefin (1 mm thickness), polypropylene (2 cm thickness) and acrylic (0.5 cm and 2 cm thickness) polymers with minimal oxygen permeability and minimal deterioration under test conditions were chosen.

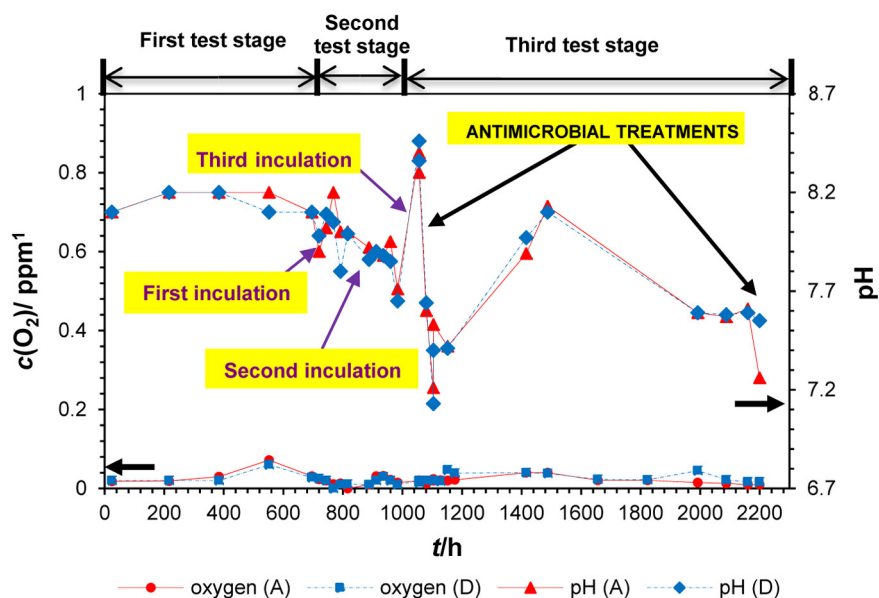
**Fig. 4.** Oxygen concentration in parts per million ( $c(\text{O}_2)/\text{ppm}$ ) and pH evolution of bulk media in flow cell A (inoculation with *Desulfovibrio alaskensis*) and flow cell D (inoculation with *Desulfovibrio desulfuricans*) during the whole test.

During the first test stage, pH around 8.1 (Fig. 4), low cell density (<10<sup>3</sup> cells mL<sup>-1</sup>), corresponding to indigene population naturally present in seawater, high sulfate (≈3.5 × 10<sup>3</sup> ppm, i.e. 2.7 g L<sup>-1</sup>), and low sulfide (not detectable) concentrations were detected in the bulk medium flowing through the both flow cells (Tables 1 and 2). It is then possible to conclude that the bulk medium conditions, exhibited in the two different flow cells, are very similar as expected (identical medium was flowing through both flow cells) proving that the further differences found could be attributed to the nature of the inoculations.

The second inoculation imposed significant perturbation to the systems and resulted in a noticeable alteration of environment and material corrosion behavior. High cells densities were measured in both flow cells (Tables 1 and 2) even when the flux conditions were reestablished: Moreover higher densities were found in flow cell A (inoculated by *D. alaskensis*) than in the D one (inoculated by *D. desulfuricans*) with, respectively, 600 and  $1850 \times 10^3$  cells mL<sup>-1</sup>. A pH decrease down to 7.6 was noticed (Fig. 4) that

Short time after the third inoculation, a sudden pH increase was observed in the both flow cells (up to 8.5, Fig. 4), most probably due to cathodic corrosion reaction of hydrogen evolution and release of hydroxide ions (OH<sup>-</sup>) into bulk medium, as a result of substantial increase in corrosion. This was reflected by the increase of the

income of fresh media. This process was slow and it resulted in pH 8.1 at  $t_e = 1450$  h (Fig. 4). From that point until the test termination, both flow cells exhibited a decrease in pH with final pH of 7.4 in flow cell A and 7.7 in flow cell D (Fig. 4).

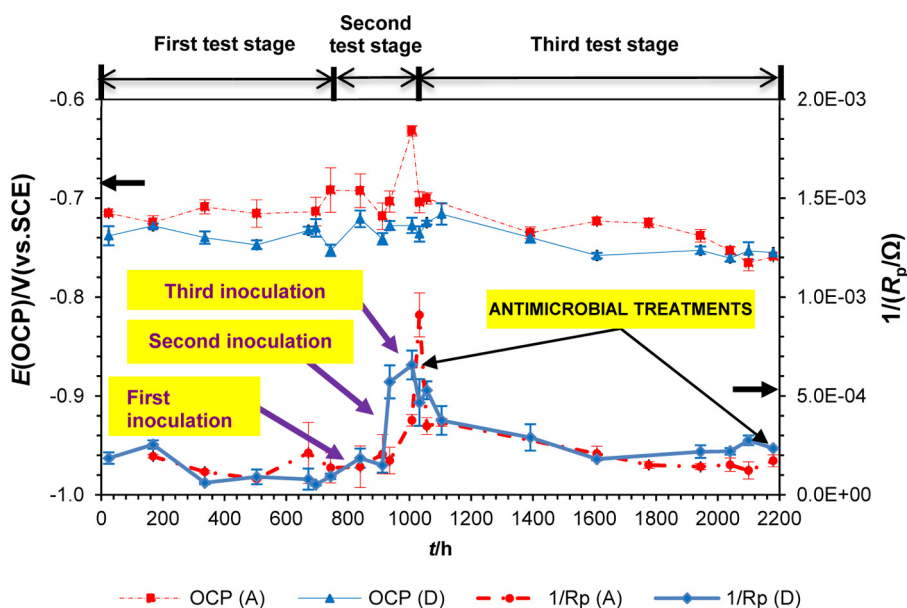
**Fig. 5.** Average instantaneous corrosion rate ( $1/(R_p/\Omega)$ ) and OCP ( $E(OCP)/V$  vs. SCE) values with standard deviation error bars for 12 o'clock positioned steel specimens (WE) exposed in flow cell A (inoculation with *Desulfovibrio alaskensis*) and flow cell D (inoculation with *Desulfovibrio desulfuricans*) during the 2200 h of test.

Measured instantaneous corrosion rates for WEs exposed in flow cells, obtained during the first test stage, are presented in Fig. 5. In both flow cells,  $1/(R_p/\Omega)$  values measured during initial 200 h of tests were low, around  $3 \times 10^{-4}$ . After  $t_e = 200$  h,  $1/(R_p/\Omega)$  values decreased to  $1 \times 10^{-4}$ , where they remained (with some fluctuations) until end of the first test stage. Typical ECN records for WEs exposed in flow cells, obtained during the first test stage, and are presented in Fig. 6. ECN transients are oriented in both directions (up and down), indicating that both WEs are equally subjected to corrosion. This type of signal modulations is characteristic for the carbon steel immersed in chloride solution as seawater [38]. Moreover the magnitude of the ECN first increased with the time, as indicated by comparing the curves obtained for  $t_e = 20$  h and for  $t_e = 200$  h. Since the ECN is produced by independent current sources on steel surfaces [39], higher current reveals greater electrochemical activity and more pronounced anodic reaction being indicative for elevated corrosion rates [21,39]. Consequently in the test conditions, the initial increase of ECN magnitude can be explained by the breakdown of the initial protective ferrous layer, exposing bare steel surface to high amount of aggressive Cl<sup>-</sup> ions present in seawater what may result in metastable pitting attacks. Afterward, since the tendency in corrosion rate showed a lessening ( $1/(R_p/\Omega)$  plateau with lowest value in Fig. 5), ECN amplitudes decreased (Fig. 6, curves obtained at  $t_e = 400$  h), indicating lower corrosion and lower surface activity. Theoretically, a protective layer of corrosion products, e.g. sulfated green rust ( $\text{GR}(\text{SO}_4^{2-}) = \text{Fe}^{\text{II}}_4\text{Fe}^{\text{III}}_2(\text{OH})_{12}\text{SO}_4 \times 8\text{H}_2\text{O}$ ), produced directly or by oxidation of iron hydroxide ( $\text{Fe}(\text{OH})_2$ ), is often found on the carbon steel surface when exposed to environments as described here [40–42]. Moreover, if any oxygen is present, certain portion of  $\text{GR}(\text{SO}_4^{2-})$  will be oxidized into Fe(III)oxyhydroxides such as goethite ( $\alpha\text{-FeOOH}$ ) and lepidocrocite ( $\gamma\text{-FeOOH}$ ) [40] (please note

However, no significant modifications were observed in the electrochemical response after this first inoculation:  $1/(R_p/\Omega)$  remained stable with low values (Fig. 5). This stable trend in corrosion currents could be attributed to the corrosion product layer that remained stable even with the perturbation of the medium. In addition, sulfidogenic bacteria could enhance protective layer properties by promoting formation of protective iron sulfide ( $\text{Fe}_x\text{S}_y$ )

average  $1/(R_p/\Omega)$  values (up to  $9 \times 10^{-4}$  for flow cell A and  $7 \times 10^{-4}$  for flow cell D, Fig. 5), and of the ECN amplitudes (Fig. 7). However, the ECN did not exhibit the geometry characteristic for pitting. Nonetheless, metastable pitting or conjugation of multiple pits in visually detectable general corrosion pattern would not be revealed by EN signals and surface degradation still would have origin in localized corrosion.

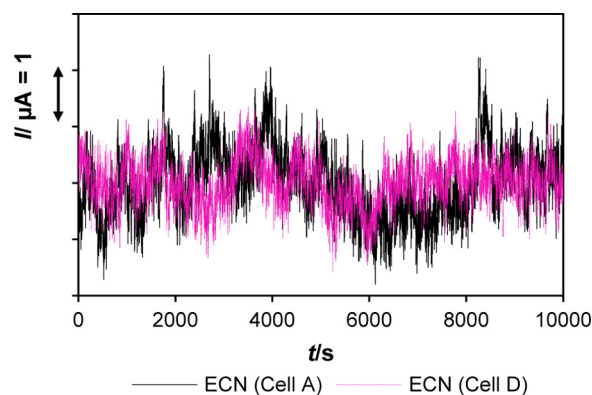
**Fig. 10.** Variations of typical current noise ( $I/nA=f(t)$ ) obtained in flow cell A (inoculation with *Desulfovibrio alaskensis*) and flow cell D (inoculation with *Desulfovibrio desulfuricans*) recorded 12 h after first antimicrobial treatment ( $t_e = 1087$  h). Data linearly detrended.

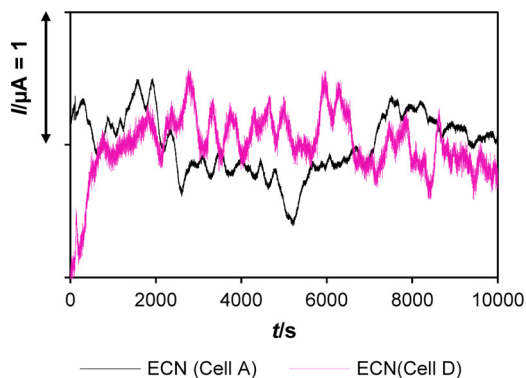
**Fig. 12.** Variations of typical current noise ( $I/nA=f(t)$ ) obtained in flow cell A (inoculation with *Desulfovibrio alaskensis*) and flow cell D (inoculation with *Desulfovibrio desulfuricans*) recorded 12 h after the second antimicrobial treatment ( $t_e = 2192$  h). Data linearly detrended.
