EVALUATION OF GRINDING WHEEL WEAR WHEN GRINDING VACO 180 STEEL UNDER VARIABLE GRINDING CONDITIONS

Jindřich Farský, Tomáš Bakša, Miroslav Zetek, Pavel Adámek

This Publication has to be referred as: Farsky, J[indrich]; Baksa, T[omas]; Zetek, M[iroslav] & Adamek, P[avel] (2018). Evaluation of Grinding Wheel Wear when Grinding VACO 180 Steel under Variable Grinding Conditions, Proceedings of the 29th DAAAM International Symposium, pp.0772-0776, B. Katalinic (Ed.), Published by DAAAM International, ISBN 978-3-902734-20-4, ISSN 1726-9679, Vienna, Austria
DOI: 10.2507/29th.daaam.proceedings.112

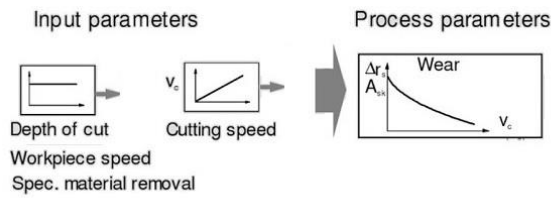
Fig. 1. Influence of grinding speed on wear [2]

The aim of this work is to investigate the influence of grinding conditions, especially grinding speed and depth of cut, on the wear of a grinding wheel when grinding maraging steel VACO 180 with two different grinding wheels with SiC abrasive and ceramic binder. The amount of wear on the grinding wheel under different grinding conditions was evaluated. Wear on the grinding wheel is measured as a change to its diameter after each experiment. The results of these experiments verify the change of wear on the grinding wheels when grinding maraging steel VACO 180 with a low grinding speed. [5], [6], [7]

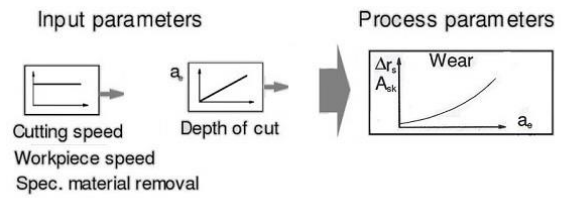
Fig. 2. Influence of depth of cut on wear [2]

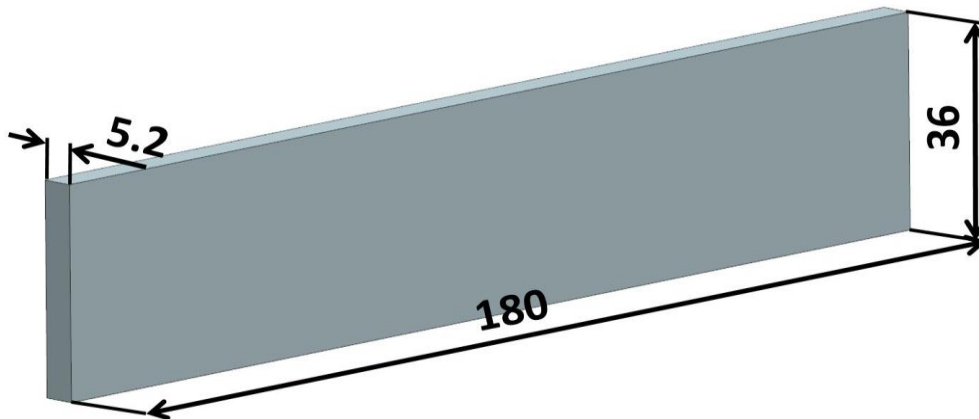
The test bars shown in Fig. 3 were made from VACO 180. The basic dimensions of this bar are 180 x 36 x 5.2 mm (length x height x width). These test bars were clamped in a special clamping mechanism for the ANCA MX7 because this grinder allows clamping of only cylindrical shapes.

Fig. 3. Basic dimension of the test bar

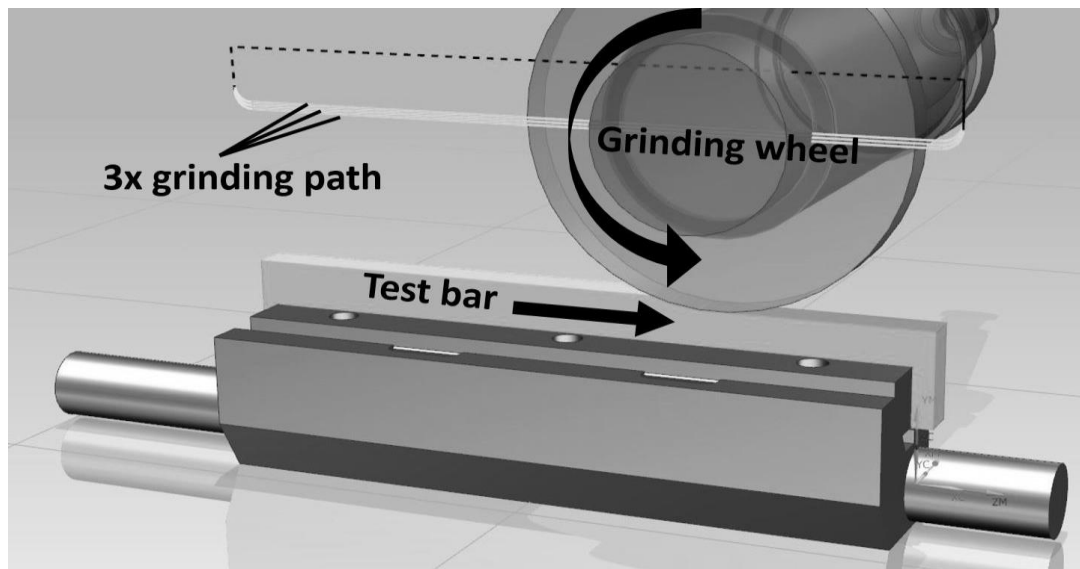
Down grinding was proposed as the grinding strategy. This means that the grinding wheel rotates in the same direction as the movement of the test bar. It was also necessary to select the length of grinding, which was 540 mm. This means that each grinding path must be repeated 3 times. Once the grinding length has been reached, the experiment is finished. The grinding strategy is shown in

Fig. 4. The wear on the grinding wheel was measured after each experiment. Also, it was necessary to recover the grinding wheel with a special grinding stone. This recovering is very important to eliminate errors in the next experiments.

Fig. 4. The strategy used for experiments

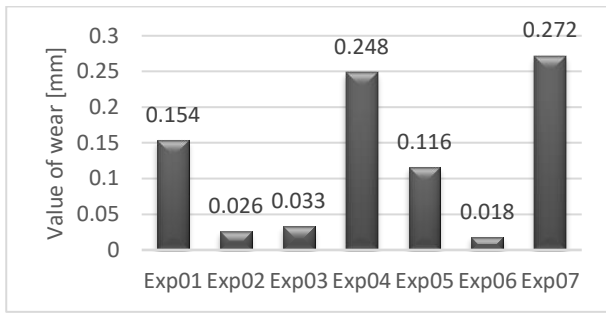
The main idea of this experiment is to verify the influence of the grinding conditions on the size of wear on the grinding wheels. The evaluation was performed by scanning the grinding wheel profile and measuring the differences between each experiment. These measurements were entered into graphs for each grinding wheel. The values of wear on the grinding wheel SiC 01 – VS shown in Graph 1., where you can see the changing values of wear. The maximum value was achieved in experiment 7 with a value of 0.272 mm per diameter of grinding wheel, but this value was with an error because the grinding wheel was damaged, therefore the experiment had to be stopped after the first grinding path. Therefore the maximum value is reached in experiment 4. But for practical purposes, the values which have the minimum value are more important. The minimum value was obtained in experiment 6 which had a grinding speed of $20 \text{ m} \cdot \text{s}^{-1}$ and depth of cut 0.1 mm.

Graph 1. Wear of grinding wheel SiC 01 - VS

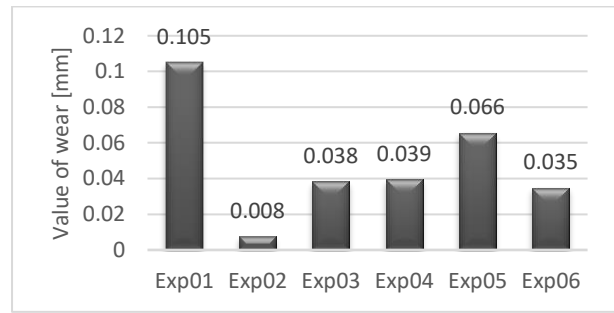
The values of wear measured for the second grinding wheel SiC 02 – S are shown in Graph 2., where the maximum value was obtained in experiment 01, which is 0.105 mm diameter. The minimum value obtained is in experiment 02 which has a value of 0.008 mm diameter with a grinding speed of $15 \text{ m} \cdot \text{s}^{-1}$ and depth of cut 0.05 mm. As you can see on the graph, experiment no. 7 for grinding wheel SiC 02 - S is not marked here. This was because the grinding wheel came loose during the experiment, meaning the experiment had to be abandoned and the measurements were not made.

Graph 2. Wear of grinding wheel SiC 02 - S

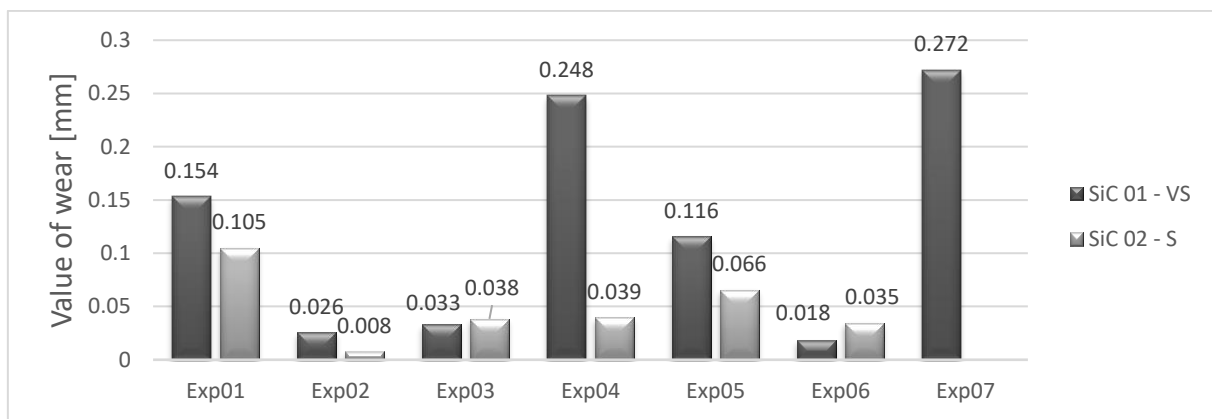
Graph 3. gives a better view of the differences between the grinding wheels. Firstly, it is possible to say the grinding wheel SiC 02 – S has better resistance to wear because in only two experiments the value of wear is bigger than on the first grinding wheel. One of the reasons why the second wheel has less wear is the different structure, which is better for grinding this material when using these grinding conditions.

Graph 3. Comparison of wear on the grinding wheels

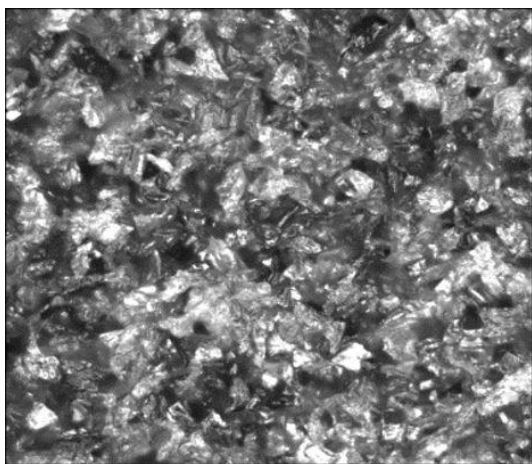
Fig. 5. The structure of new grinding wheel SiC 01 – VS

The values of wear for experiments no. 9 and 8 are not mentioned here, because they were abandoned. The surface of the test bars burned after the first grinding path, and also the material from the test bar clogged the space between the abrasive grains as shown in the photographs below. Here you can see the difference between the new grinding wheels and the clogged wheels.

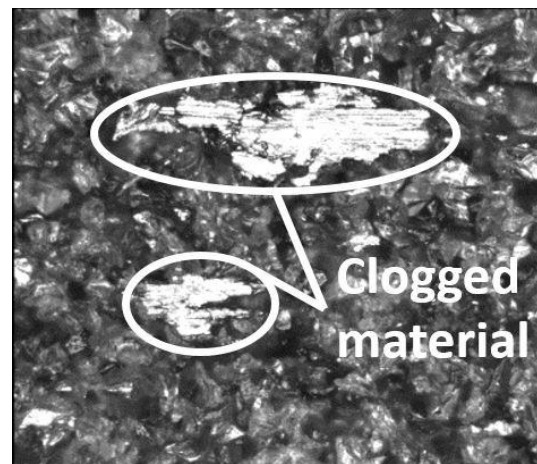
Fig. 6. The clogged structure of grinding wheel SiC 01 – VS

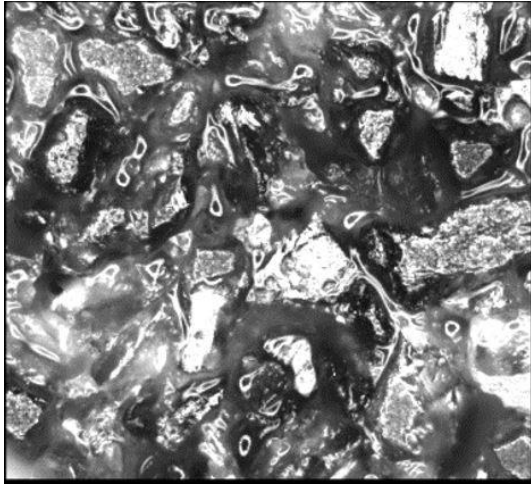
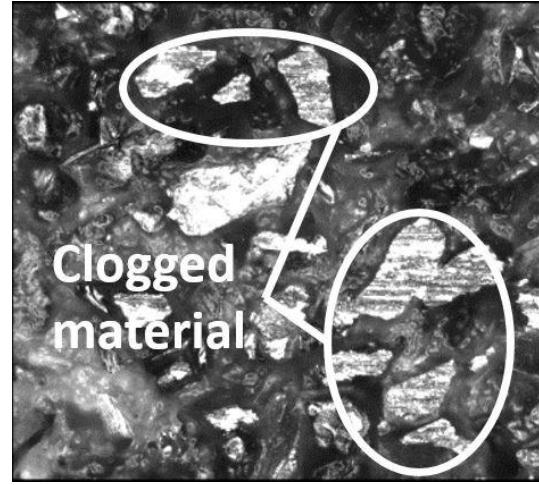
Fig. 7. The structure of new grinding wheel SiC 02 – S Fig. 8. The clogged structure of grinding wheel SiC 02 – S
