Image processing of alos palsar satellite data, small unmanned aerial vehicle (UAV), and field measurement of land deformation

Pekanbaru, Indonesia is connected by four big bridges, Siak Bridge; I, II, III and IV. The quality of the Siak bridges deteriorated seriously at this time. Geological mapping for the land subsidence potency was conducted using small Unmanned Aerial Vehicle (UAV) in the Siak Bridge areas. The study of the Siak bridges are supported by the Differential Interferometric Synthetic Aperture Radar (DInSAR) analysis using ALOS PALSAR satellite data, and the deflection observation that occurs in Siak III Bridge was observed by field measurement. The results of 3D model analysis showed that there is no negative land deformation. DInSAR analysis shows the amount of positive deformation of Siak I is 81 cm, Siak II is 48 cm, Siak III is 89 cm, and Siak IV is 92. Deflection on Siak III Bridge was detected at around 25-26 cm. These models could be used as a new way of measuring the bridge deformation on a big scale.

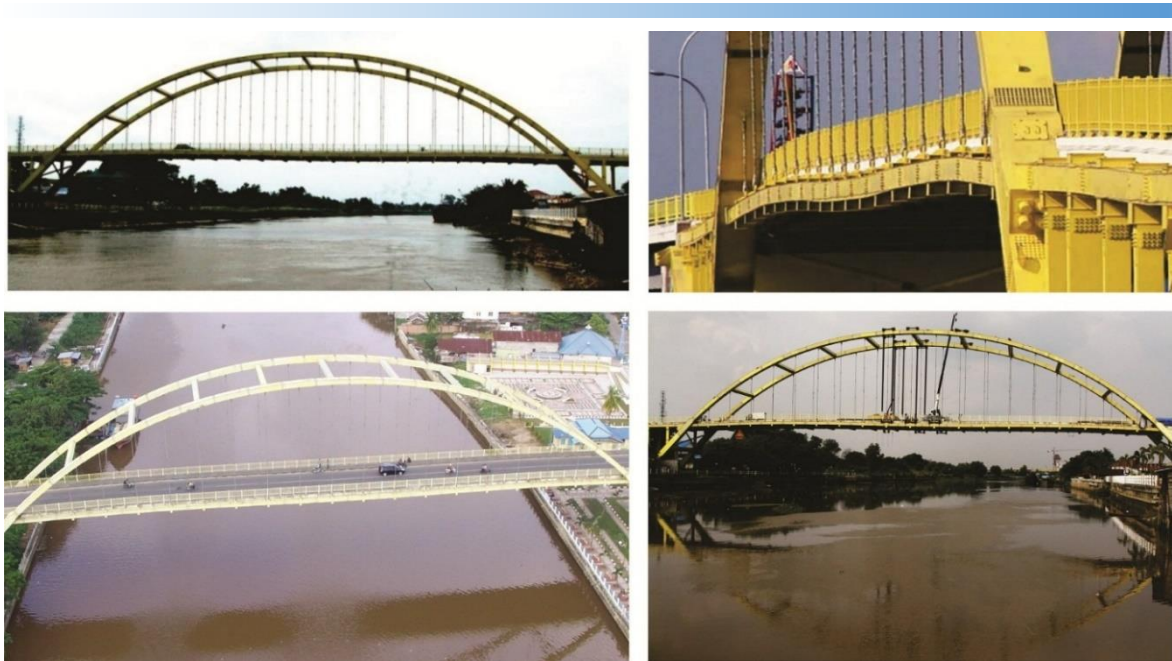
Fig. 7. Clockwise: Siak III bridge after being built completely; the deflection while used; repairing process; after repairing

The deflection measurement of Siak III Bridge (Fig. 7) found that the camber is negative. It curve and bend down as much as 25-26 cm (Fig. 8). This downward curve would certainly affect its durability. It proves that an error occurred in the design/construction, where there is a shift towards a horizontal arc, resulting in stretching, but Siak III Bridge was forced to be constructed in the opposite direction and it caused a curvature in the bridge's floor. Supposedly, this bridge's strength was reported for able to withstand loads of up to 80 tons. This was different from the design of this bridge which had to be able to withstand loads of up to 300 tons.
