IS THE QUALITY OF CEMENT A CONTRIBUTING FACTOR FOR BUILDING COLLAPSE IN GHANA?

Humphrey Danso¹ and Isaac Boateng²

School of Civil Engineering and Surveying, University of Portsmouth, United Kingdom

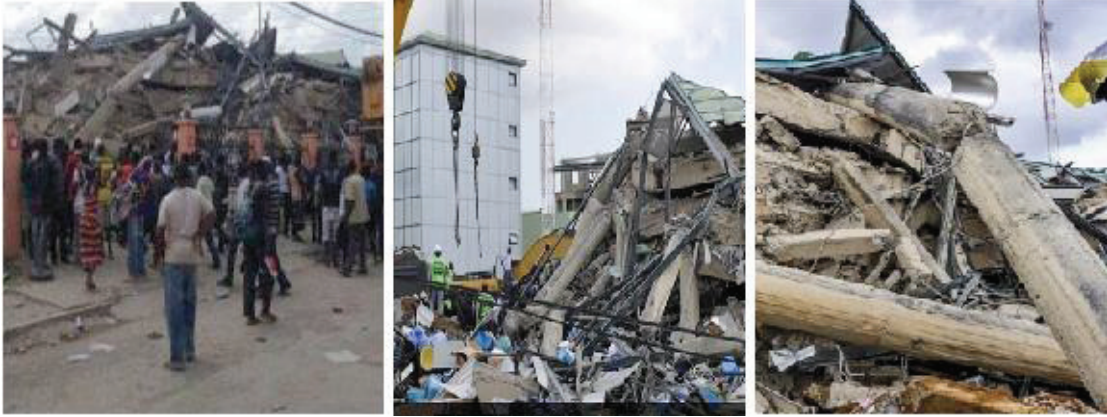
Figure 2: Melcom Shopping Mall Building after Collapse

The appearance of the building before collapse is presented in Figure 1 and after the collapse can also be found in Figure 2. The building experienced a total collapse with all the structural components falling down. This accounted for the high fatality rate.

External View of Building after Collapse

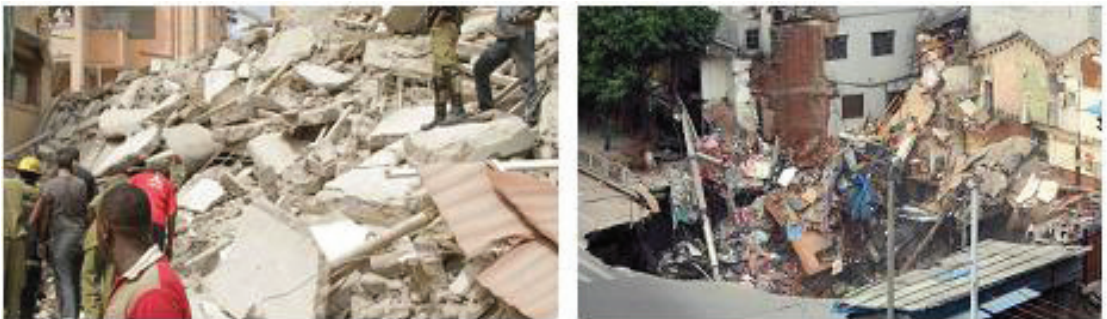
Figure 3: Krofrom Three-Storey Residential Building after Collapse

A very recent incident of building collapse in Ghana was the three-storey residential building situated at Krofrom, a suburb of Kumasi, the Ashanti regional capital, which collapsed on Monday, April 15, due to a heavy downpour of rain trapping many people under the rubble. 3 people were confirmed dead while 5 others sustained various injuries. Figure 3 presents the external view after the collapse of the building.

External View of Building after Collapse

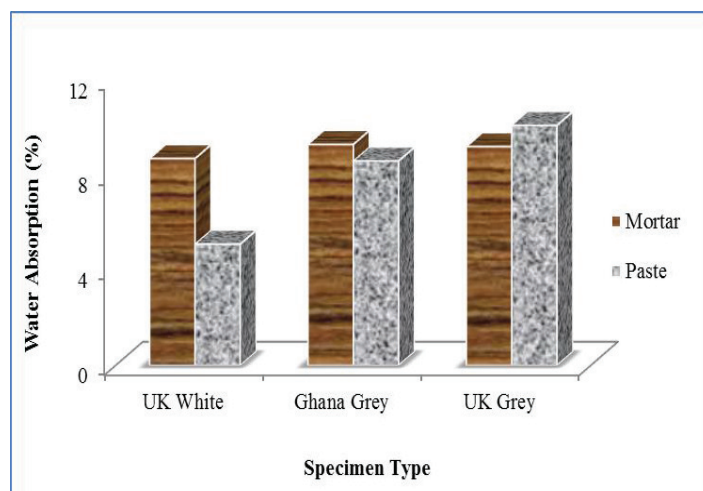
Figure 5: Comparison of Water Absorption Results

Figure 5 presents the results of the water absorption test values for the specimen. The UK Grey recorded about 17% increase in water absorption than the Ghana Grey for cement paste specimen, while the Ghana Grey had an increase of 1% than that of the UK Grey for mortar specimen. On the other hand, the UK White had lower water absorption than both Ghana Grey and UK Grey specimen. This result indicates that the UK Grey cement has higher water absorption properties than that of the Ghana Grey cement, implying that Ghana Grey cement performed better in resistance to water absorption than UK Grey cement. While the UK White performed better in water absorption than both Ghana Grey and UK Grey cements. The practitioners in the construction industry as well as academicians in Ghana should therefore know that the cement produce in Ghana have good resistance the water absorption.

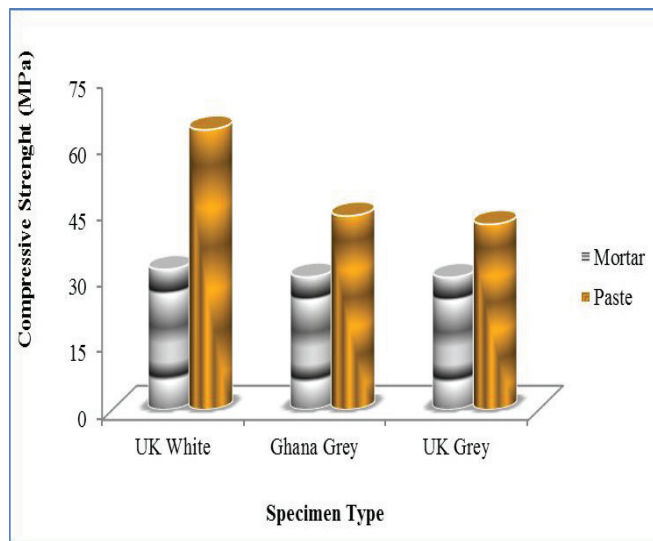
Figure 6: Comparison of Compressive Strength Results

The compressive strength test results comparison is presented in Figure 6. The results show that the Ghana Grey cement had less than 1% and 5% increase in compressive strength for mortar and cement paste respectively than UK Grey cement specimen. The UK White cement on the other hand, recorded higher compressive strength than both Ghana Grey and UK Grey cement specimen. It can be concluded that while UK White cement performed better in compression than Ghana Grey and UK Grey

cements, the Ghana Grey was better than the UK Grey cement. Building contractors and other practitioners in the construction industry as well as academicians in Ghana should therefore know that the cement produce in Ghana have good resistance under the influence of a compression stress.
