Hazard Facts

Landslides in Scotland

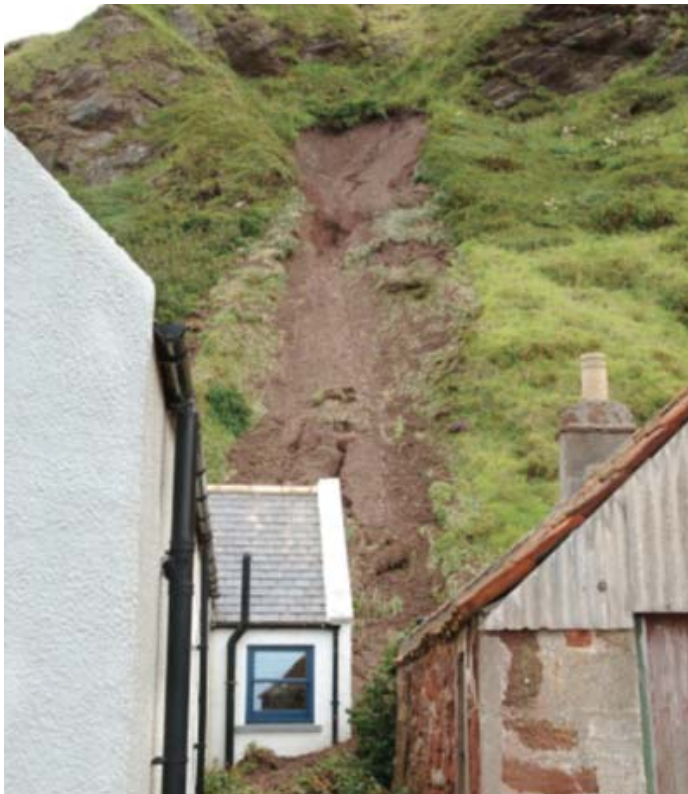
A property is partially buried by a mudslide in Pennan, Aberdeenshire, August 2007. Image ©NERC

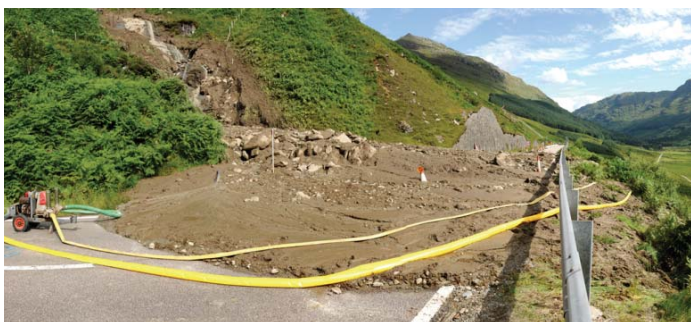
Landslide debris blocking the A83, Rest and Be Thankful, August 2012. Image © NERC

Debris flows occurring along a section of the A83, near the Rest and be Thankful, have resulted in numerous road closures. The recent landslides here have largely been associated with intense rainfall, and unconsolidated (loose) slope deposits. The A83 has been the subject of recent reviews and mitigation surveys. Flashing warning signs (wig-wags) are in place to alert drivers to a higher debris flow during periods of forecasted and heavy rainfall and in December 2015, recently installed mitigation measures proved successful during the high profile Storm Desmond. Debris from several large failures was captured, and held, in engineered netting during the intense storm. www.bgs.ac.uk/landslides/RABTAug2012.html
