# Experimental evaluation of the prevention methods for the interface between masonry infill walls and concrete columns

## *Avaliação experimental dos métodos de prevenção de fissuras na interface alvenaria de vedação e pilar de concreto*

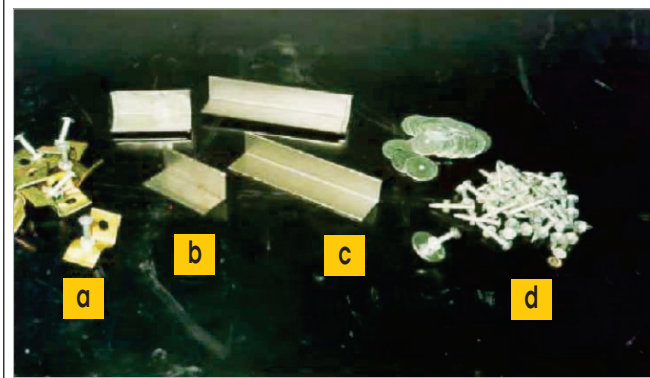
**Figure 2 – Types of Fixation for the Connecting Devices for Masonry-Column: a) Short Steel Brackets, b) 50 mm Steel Angles, c) 100 mm Steel Angles and d) Steel Pins and Washers (7)**

The use of metallic reinforcements to prevent cracking in the joint between the wall and the column, the use of steel bars (bars composed of steel, which are used in reinforced concrete, with thicknesses between 4 and 6 mm) or the use of electrowelded wire mesh composed of small-diameter wires fixed with pins, washers or angles on the concrete column are prevalent in the Brazilian civil construction industry (Figures [1] to [3]).

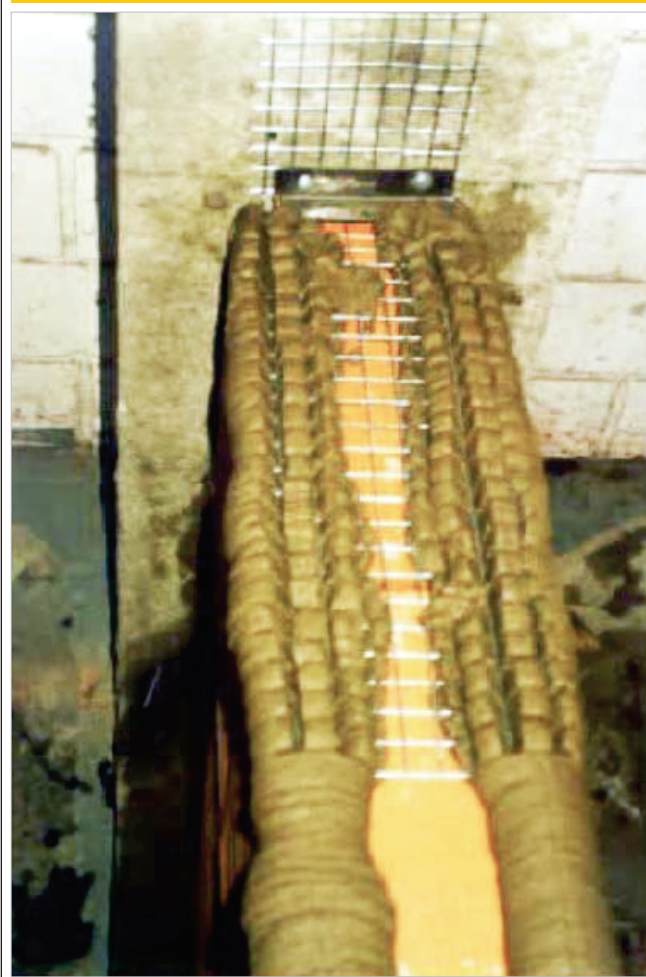
**Figure 3 – Photo of an masonry/column Joint with an electrowelded metallic mesh fixed to the column using angles and metallic pins (7)**

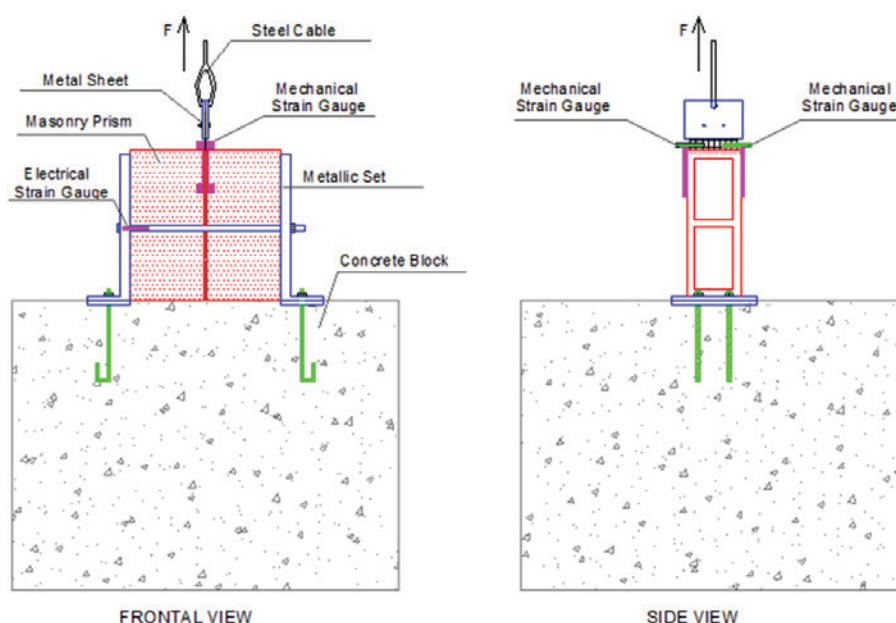
Figure 4 – Detail of the arrangement in the pullout test of the column/wall connecting device of the mortar joint from masonry prisms

Figure [4] illustrates the arrangement of the proposed pullout test and the fixation of the steel plates on large concrete blocks. The horizontal displacement of the system is released on application of the compression force on the blocks. As the nuts are tightened, one set of the plates moves and applies the compression force to the prisms.

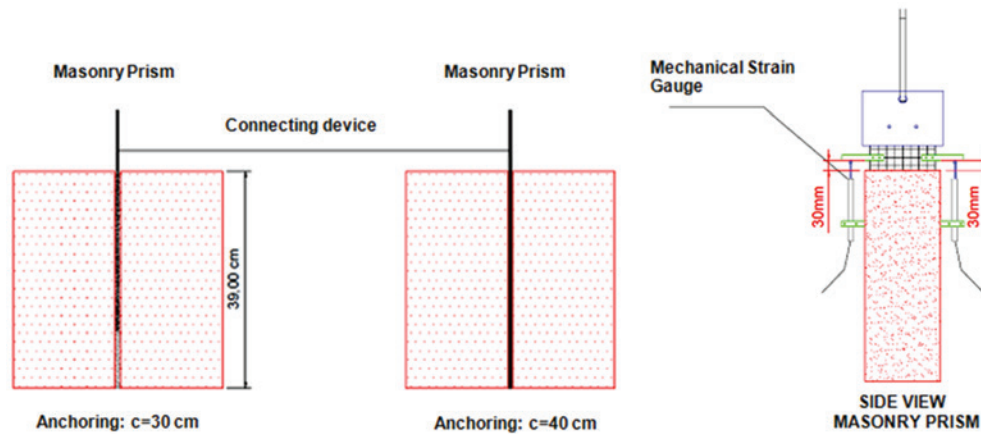
Figure 5 – Detail of the masonry/positioned column connecting device of the evaluated anchoring lengths in the laying joint of the masonry prism

Deflectometers were also installed at various points on the block surface and the connecting device (bar or mesh) to obtain the displacement of the anchoring device in this region (Figure [5]). Note that in a real situation, this displacement can result in crack opening, which the technique seeks to prevent.

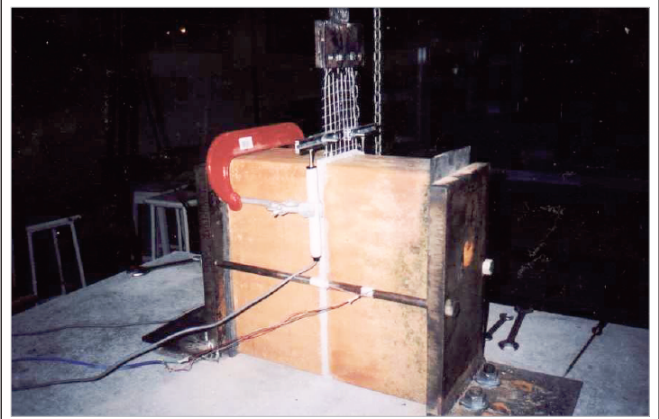
Figure 6 – Photo of the arrangement of the pullout test of the column/masonry connecting device. The pullout test for the electrowelded mesh

device, which was pulled until rupture due to the loss of anchoring (pullout). Figure [6] illustrates the execution of this test for the case of the electrowelded mesh.

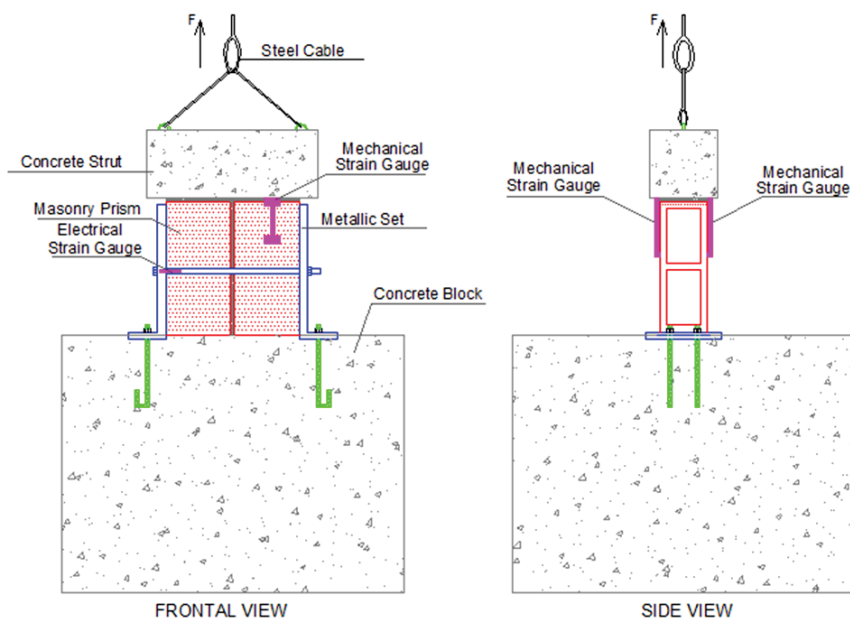
Figure 7 – Arrangement of the tensile test in the models of the treatment for crack prevention in the column/wall joint

After positioned in the equipment, the joints of the models were subjected to a direct traction test as illustrated in Figure [7]. With the prism (wall) fixed to the equipment and the cables connected to the column, the system was pulled until the moment at which an observer 50 cm from the model observed the first crack.

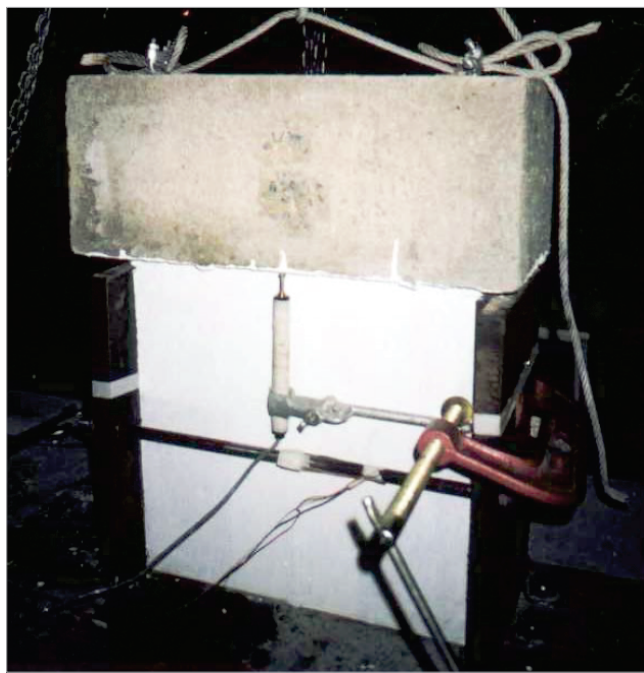
Figure 8 – Photo of the instrumentation of the models with deflectometers for recording the evolution of the crack opening in the column/wall joint. Painting of the masonry blocks with white paint

In this test, the evolution of the crack opening in the joint between the column and wall was also evaluated as a function of the load applied to the model. Figure [8] illustrates the positioning of the de-

flectometers in the region and a scheme used to make the cracks more distinct to the observer: painting of the ceramic blocks with white latex paint.

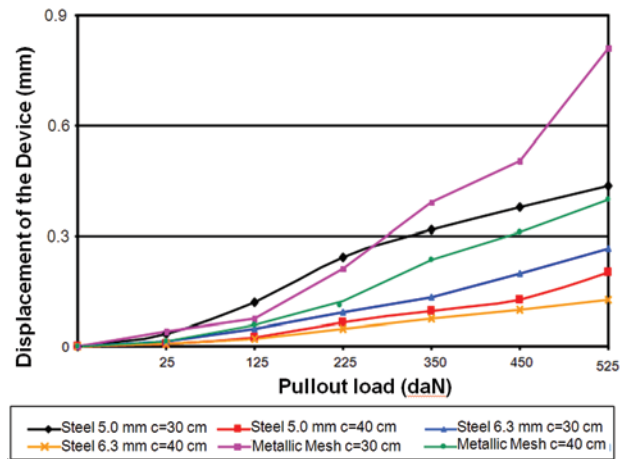
Figure 10 – Results of the pullout test of the connecting devices from the joint of the bedding mortar

Figure [10] shows the results for the displacement of the CA-50 steel bars with diameters of 5.0 mm and 6.3 mm and for the galvanized electrowelded wire mesh, with a square mesh of 15 mm and a wire diameter of 1.65 mm. The evaluated anchoring lengths consisted of 30 cm and 40 cm.

Figure [10] illustrates similar behavior for the three devices. Both of the steel bars and the mesh exhibit significantly higher displacement values for an anchoring length of 30 cm compared with a length of 40 cm. In the case of the 5.0 mm diameter steel bar for a pullout loading equivalent to 450 daN, the displacement value was three times greater than the displacement value obtained for an anchoring length of 40 cm. In an initial analysis that compares the evaluated anchoring lengths, the 40 cm length is determined to be the optimal length, which justifies its use in the execution of the eight proposed models for crack prevention at the interface between the column and wall in this study.

Although the evaluated anchoring lengths (30 cm or 40 cm) are prevalent in the Brazilian construction industry for crack prevention methodologies at the interface between the column and the wall, rupture occurred from pullout of the connecting device (bar or mesh) prior to the yield point of the steel in all evaluated samples. This situation may not be appropriate for the prevention system of cracks in the joints between columns and walls due to the crack openings and the displacements of the connecting device in the mortar joint. These values are significant, as indicated by the results shown in Figure [10].

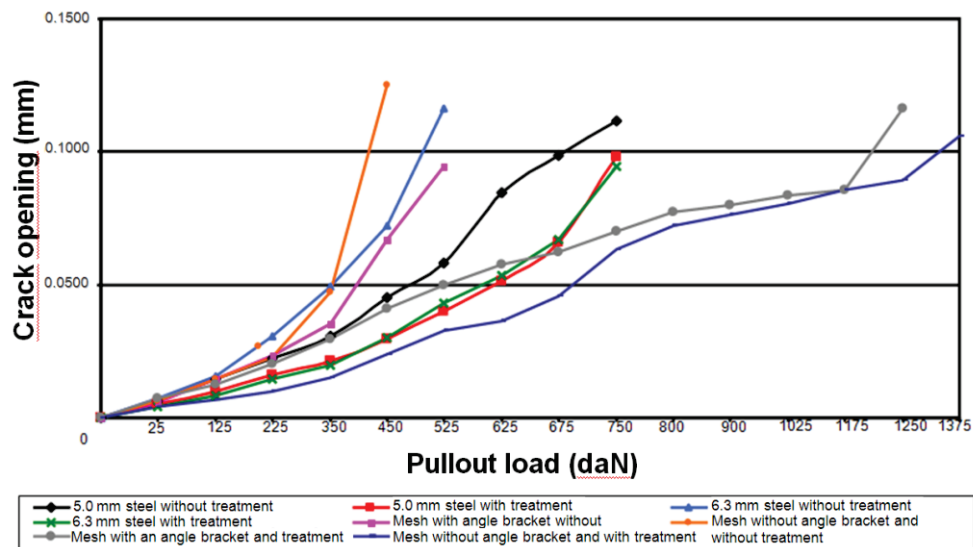
Figure 11 – Results of the evolution of the opening of the crack in the column/wall joint for the evaluated prevention techniques

Figure [11] illustrates the evolution of the values for crack openings in the joint between the column and the wall as a function of the loading in traction applied to the evaluated models, until the occurrence of the first visible crack (opening of approximately 0.1 mm). Figure [11] reveals that the models composed of steel bars with diameters of 5.0 mm and 6.3 mm, with a surface treatment applied to the common face of the column/wall, exhibited identical behavior during the tests. This finding suggests that the use of the 6.3 mm diameter may not produce the smallest crack opening. Regarding the choice of mesh or steel bar as a connecting device, the results shown in Figure [11] suggest a slight advantage for mesh. In general, the evolution of the crack opening in the joint be-

tween the column and the wall was much more controlled with the use of the mesh, particularly for the models in which the column surface was treated with mortar.

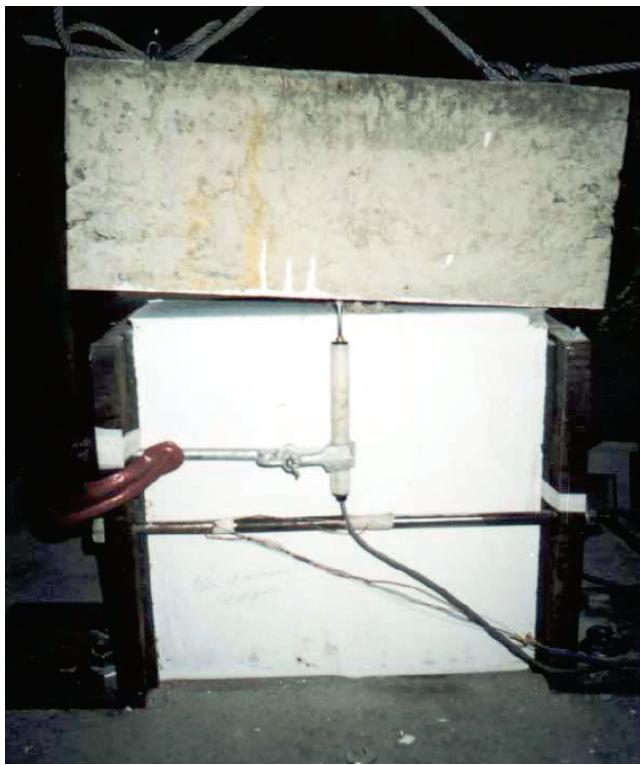
Figure 12 – Photo of typical rupture in the model without treatment of the column face with mortar containing additives

With respect to the efficiency of the treatment of the column face with mortar, a significant improvement in behavior was perceived in relation to the evolution of the crack opening for the models that employed this treatment compared with the same models without the cited treatment of the column face with mortar. The evaluation of the behavior of the models, for any of the evaluated connecting devices (bar or mesh), suggests an efficiency of approximately 40%. The probable increase of the adherence between the column and the wall altered the overall behavior of the joint. Forms of rupture typical to the models both with additive mortar treatment and without additive mortar treatment are illustrated in Figures [12] and [13], respectively.

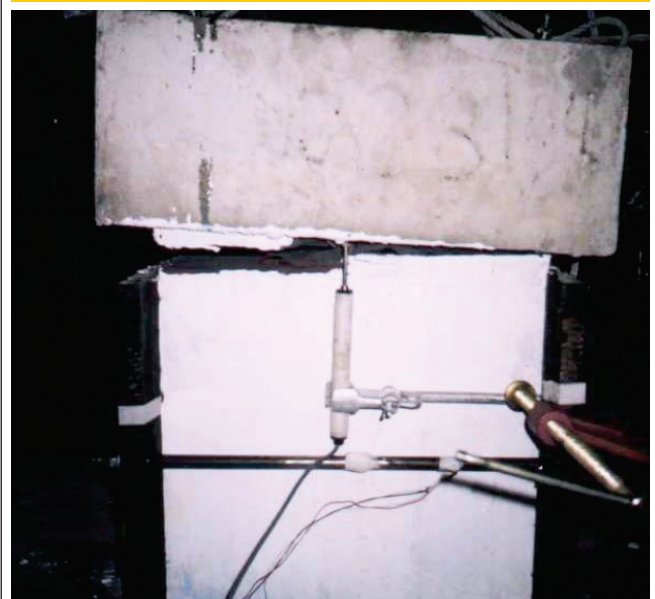
Figure 13 – Photo of typical rupture in the model with treatment of the column face with mortar containing additives
