# Need of Improved Non-Destructive Technique for the Surface Condition Monitoring of High Speed Steel (HSS) Work Rolls

T. Venugopalan<sup>1</sup> and S. Palit Sagar<sup>2</sup>

<sup>1</sup>Tata Steel, Jamshedpur, <sup>2</sup>CSIR-National Metallurgical Laboratory, Jamshedpur

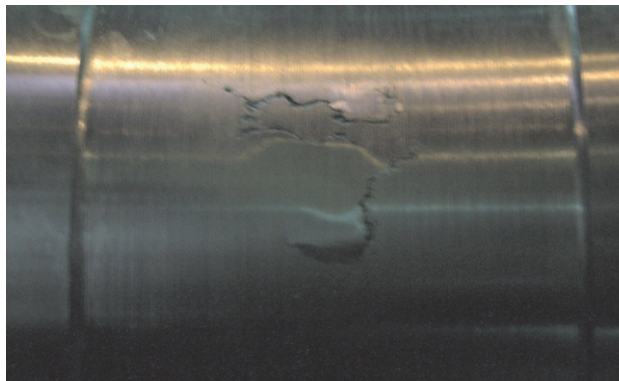
**Fig. 1: Crack networks and spall occurred on the roll surface**

At Tata Steel, though a regular eddy current and ultrasonic testing are performed after each grinding and before placing the rolls back to the stands, still few rolls failure had taken place in the last few months. Figure 1 shows a typical crack network and spall that has occurred in one of the work rolls at Tata Steel.

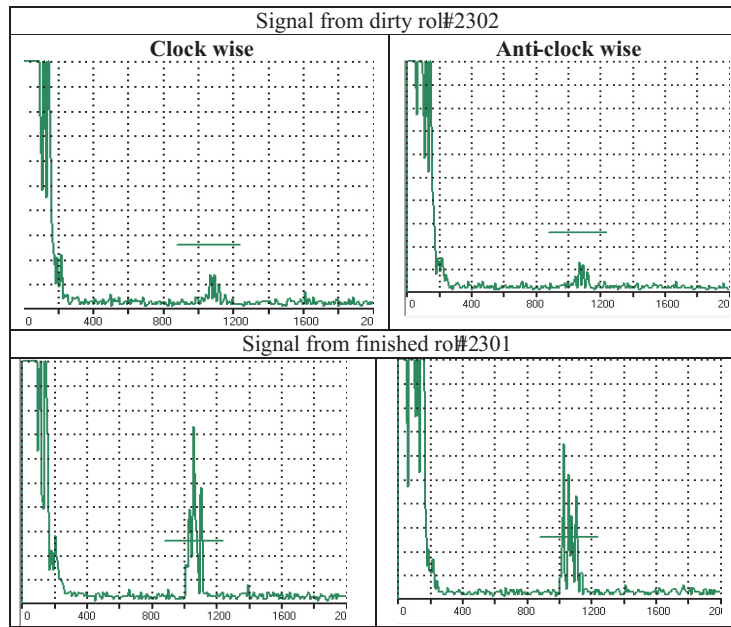
**Fig. 3: Ultrasonic back wall echo from a distance of 1090 mm observed at one location of dirty roll #2302 and finished roll #2301 of finishing mill**

Measurements were carried out on each roll at 12 positions at a distance of 100 mm in both, clock and anti-clock wise directions. The signals observed at one such location in the clockwise and anti-clockwise directions of roll #2302 and #2301 are shown in figure 3 below:

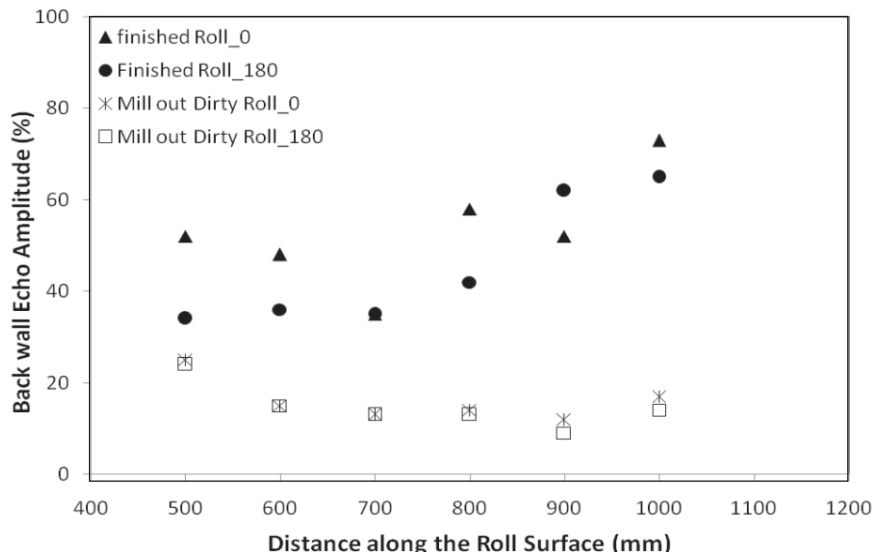
**Fig. 4: Amplitudes of the reflected echo from half the circumference at different measured locations of the rough and finished roll of the finishing mill**

The amplitudes of the reflected echoes from half the circumference at different locations of the two rolls of finishing mill is plotted and is shown in figure 4. The plot shows that the amplitude of the reflected echo from half the circumference in the finished roll is quite high compared to that of the dirty roll. With the reduction in surface roughness, the signal amplitude increases and the signal amplitude is nearly same in all the measured locations. It shows there is no such surface anomaly in the measured roll.

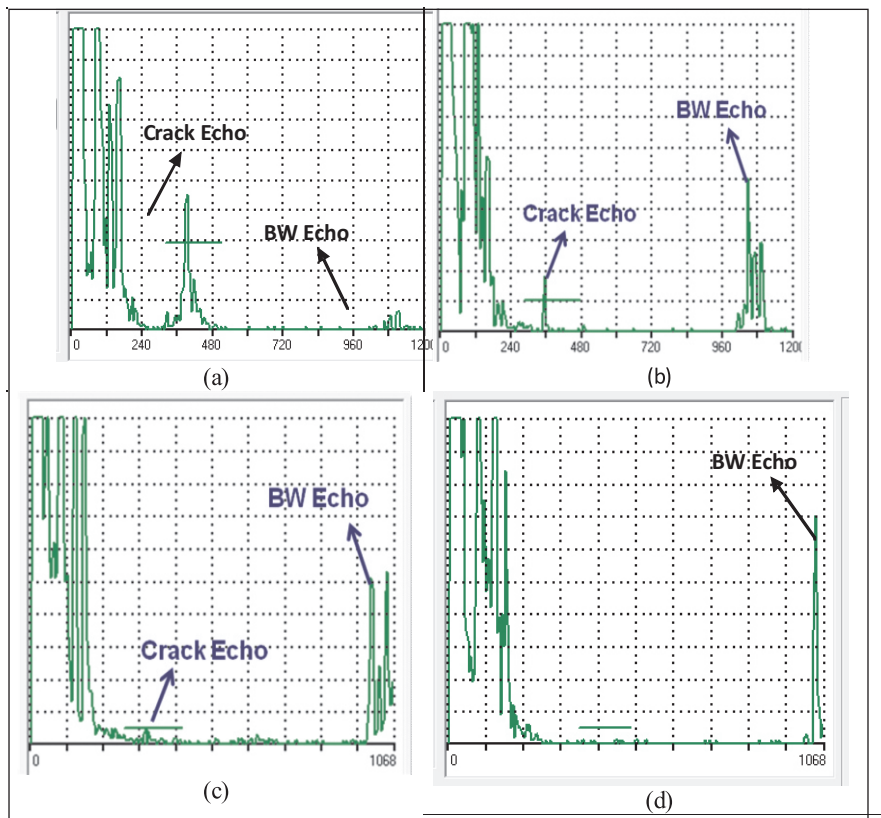
**Fig. 5: Ultrasonic signals at 1280 mm from the work side with crack depths of (a) 5.965 mm, (b) 1.465mm, (c) 0.43 mm and (d) no crack**

Measurements were carried out on HSS roll #2344 of length 2000 mm and diameter 700 mm that has cracked after first campaign and the crack depth was 5.96 mm (approx). Scanning was carried out along the length of the roll in both clock and anti-clockwise directions and total scan time was 5 mins. Crack echo was observed from a position of 1150 mm and ends at 1450 mm along the length from the work side of the Roll. All measurements were carried out by placing the probe at a fixed distance in the radial direction from the crack position. Eddy current testing was also used to detect the crack extension on the surface of the roll and was found 230 mm whereas by surface wave ultrasonic it was 300 mm. The maximum crack echo amplitude was observed at a distance of 1280 mm from the work side of the roll. The roll was then grinded off step wise and after each step ultrasonic measurement was carried out till the crack echo amplitude become zero. Figure 5 shows the signals corresponding to the various crack depths.
