Rapid assessment on mass mortality of fishes in Ennore estuary of Tamil Nadu, India

Mass mortality of fishes and aquatic organisms are reported from Ennore estuary from time to time due to water pollution . Extensive fish mortality was observed in this estuary during 20th August 2014. Dead fishes were found buoyant and spread out for about 3 km distance in the region between Ennore Thermal Power Station to Railway Bridge.

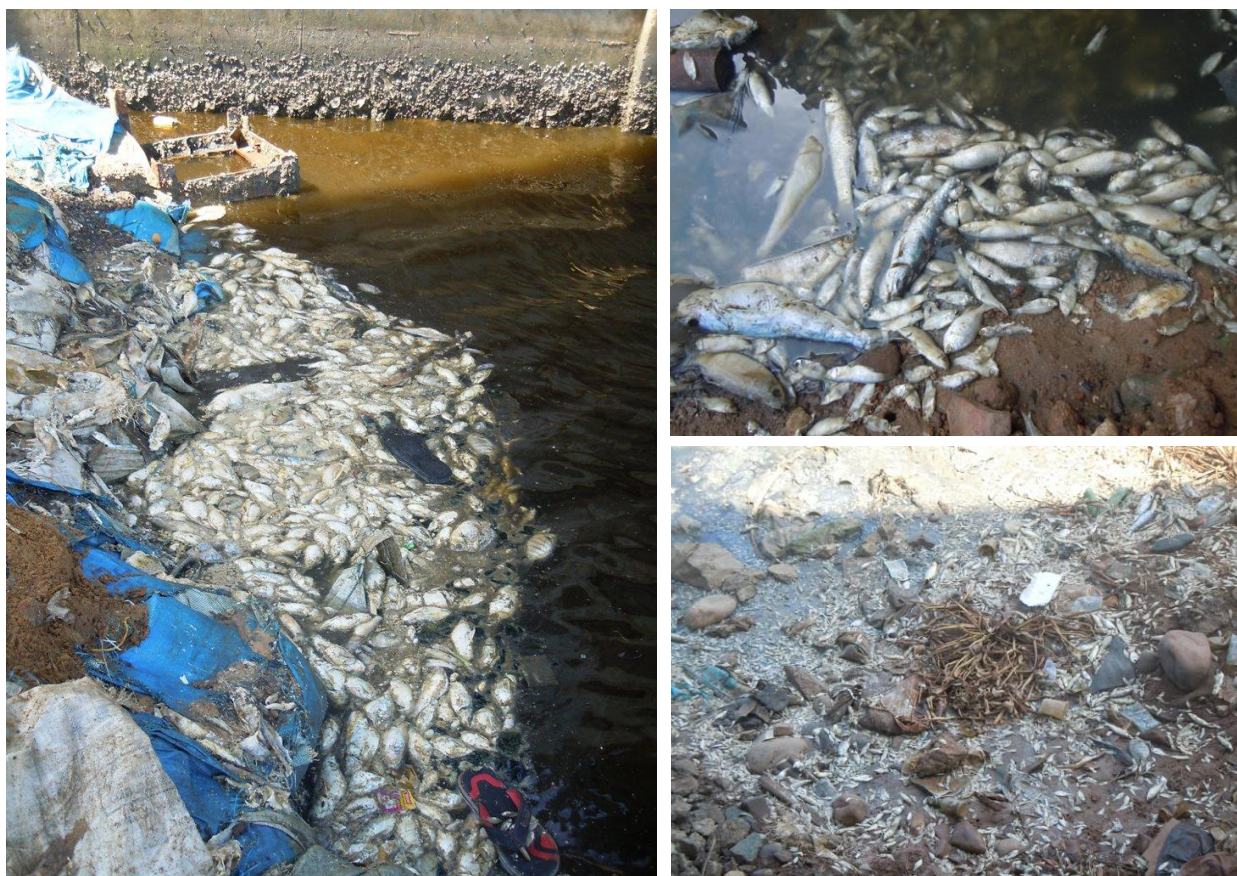
Figure 2: Dead fishes found floating and deposited along the northern side of Ennore estuary.

Heavy metals (Copper, Chromium, Zinc, Lead and Cadmium) concentration in seawater ranges as follows: Zn>Cu>Pb>Cr>Hg>Cd (59,9.64,7.15, 2.75, 2.43 and 0.45), sediment Zn>Cu>Pb>Cr>Cd>Hg (192.50, 118.3, 22.90, 7.56, 3.80 and 0.65) and tissues of *L. macrolepis* and *M. cephalus* were found above the permissible safe levels: Cu>Cr>Zn>Pb>Cd (5.03, 2.93, 1.89, 1.18 and 0.45) ppm respectively (Table 2). Presence of increased levels of heavy metals Cu, Cr, Zn and Pb might be due to many industries adjoining Ennore estuary releasing effluent discharges, which led to mass mortality of fish. This contamination may cause stress in

It is logical to presume that the contamination of Ennore estuary by heavy metals is largely due to anthropogenic inputs. Large number of industries situated nearby use this aquatic system as big sink for all their effluent dumping. Petrochemical industries, thermal power plant, pharmaceuticals, chemicals, fertilizers; rubber factory, paint industry, automotive manufacturing unit and Ennore coal handling port are the primary anthropogenic source of pollution in this estuary.
