CABLE-TO-POST ATTACHMENTS FOR A NON-PROPRIETARY HIGH-TENSION CABLE BARRIER – PHASE II

MIDWEST ROADSIDE SAFETY FACILITY

MwRSF Research Report No. TRP-03-313-15

June 2, 2015

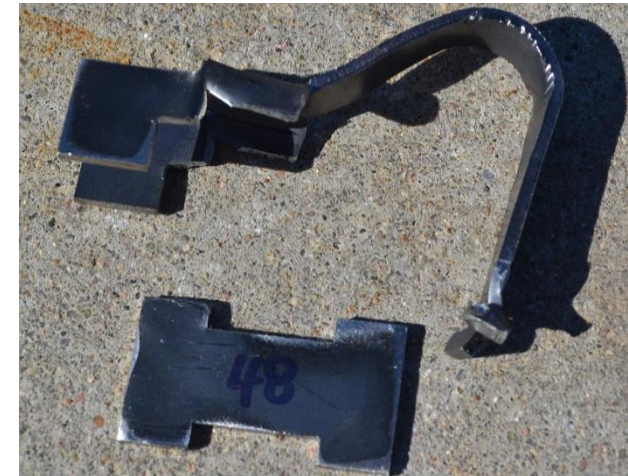
Figure 79. Lateral Test Fracture/Failure Mechanisms for Various Bracket Designs

The location of the bracket fracture/failure during the lateral tests varied between the original bolted bracket and the new shear plate brackets, as shown in Figure 79. This finding may be explained in part by the small bracket rotations allowed by the shear plate attachments. These rotations may have led to tabs contacting the post flange at an angle and causing tab bending and out-of-plane tearing that would not have occurred if the tabs were normal to the flange. Or put more simply, the difference in the constraints at the base of the bracket may have changed the loading and failure of the drop-in shear plate design. However, this variation in fracture/failure locations was not a major concern. The bolted tabbed bracket was designed with the same failure/fracture strength for failures around the bolt hole, through the spine of the bracket, and at the tabbed portion of the bracket. Consequently, the release load between the bolted bracket and the lateral shear plate bracket remained nearly identical. The bending/tearing of the bracket legs in the drop-in shear plate design was not intended and potentially lowered the release loads.

Tearing was also initiated in the lateral shear plate brackets at the junction between the bracket spine and the bottom legs, as shown in Figure 79. This out-of-plane tearing (mode III fracture) was considered a possibility before the tests were conducted. However, the tearing was minor, and this additional failure mechanism did not affect the release loads in the brackets. Thus, it is no longer a concern.

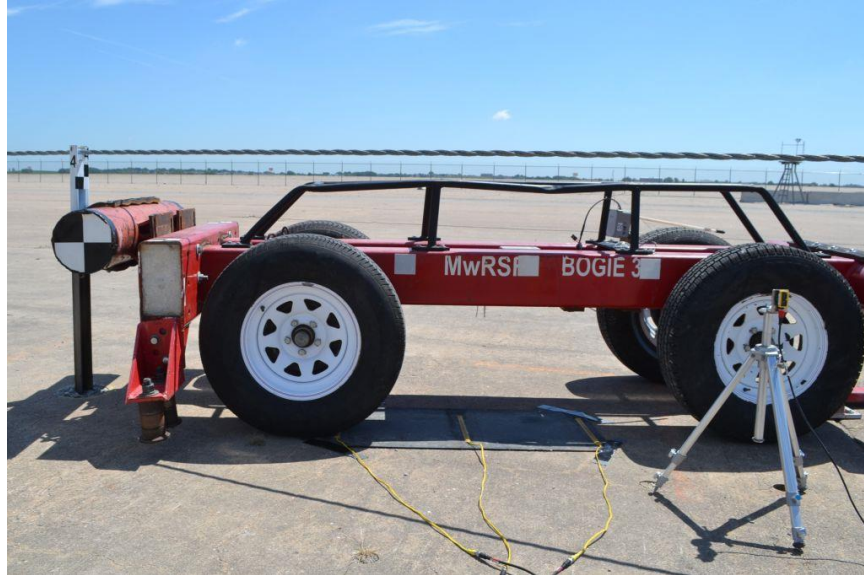
Figure 99. Rigid-Frame Bogie on Guidance Track

A rigid-frame bogie was used to impact the posts. A variable-height detachable impact head was used in the testing. The bogie head was constructed of 8-in. (203-mm) diameter, ½-in. (13-mm) thick standard steel pipe, with ¾-in. (19-mm) neoprene belting wrapped around the pipe to prevent local damage to the post from the impact. The impact head was bolted to the bogie vehicle, creating a rigid frame with an impact height of 24⁷/₈ in. (632 mm). The bogie, with impact head, is shown in Figure 99. The weight of the bogie with the addition of the mountable impact head and accelerometers was 1,861 lb (844 kg).

A pickup truck with a reverse cable tow system was used to propel the bogie to a target impact speed of 45 mph (72.4 km/h). When the bogie approached the end of the guidance system, it was released from the tow cable, allowing it to be free-rolling when it impacted the post. A remote braking system was installed on the bogie, allowing it to be brought safely to rest after the test.
