# DYNAMIC EVALUATION OF A PINNED ANCHORING SYSTEM FOR NEW YORK STATE'S TEMPORARY CONCRETE BARRIERS

## MIDWEST ROADSIDE SAFETY FACILITY

## NEW YORK STATE DEPARTMENT OF TRANSPORTATION

MwRSF Research Report No. TRP-03-216-09

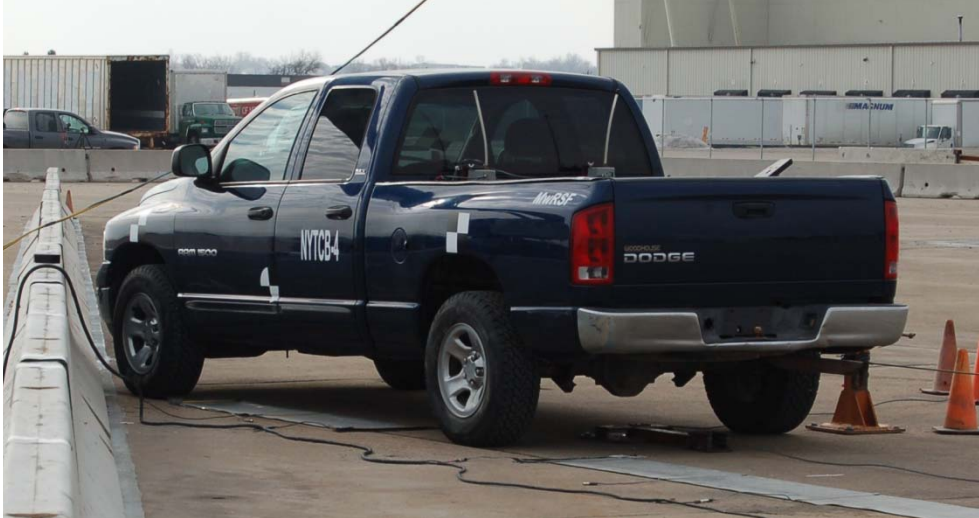
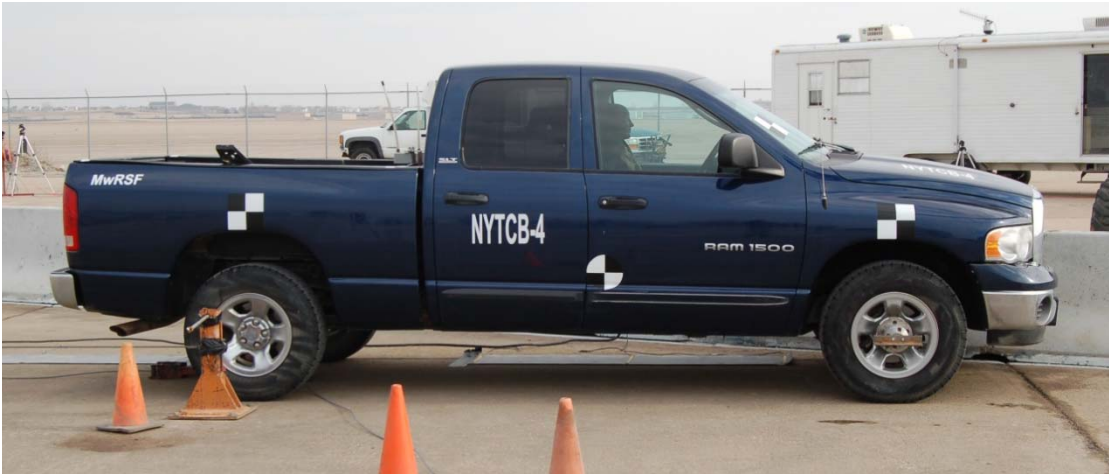
Figure 1. Test Vehicle, Test NYTCB-4

For test no. NYTCB-4, a 2002 Dodge Ram 1500 Quad Cab pickup truck was used as the test vehicle. The test inertial and gross static weights were 5,002 lbs (2,269 kg) and 5,172 lbs (2,346 kg), respectively. The test vehicle is shown in Figure 1, and vehicle dimensions are shown in Figure 2.

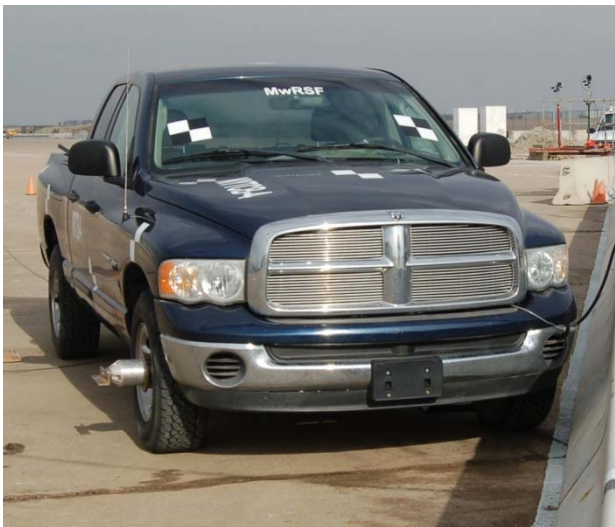
Figure 2. Vehicle Dimensions, Test NYTCB-4

Date: 1/9/2009 Test Number: NYTCB-4 Model: Ram 1500 Q.C.  
Make: Dodge Vehicle I.D.#: 3B7HA18N72G100780  
Tire Size: 265/70 R17 Year: 2002 Odometer: 146121

The Suspension Method (13) was used to determine the vertical component of the center of gravity (c.g.) for the pickup truck. This method is based on the principle that the c.g. of any freely suspended body is in the vertical plane through the point of suspension. The vehicle was suspended successively in three positions, and the respective planes containing the c.g. were established. The intersection of these planes pinpointed the location of the c.g. The longitudinal component of the c.g. was determined using the measured axle weights. The location of the final center of gravity is shown in Figures 2 and 3. The c.g. calculations and ballast information are shown in Appendix A. It should be noted that a non-instrumented dummy was positioned in the left-front seat of vehicle and held in place with the onboard safety restraint system.

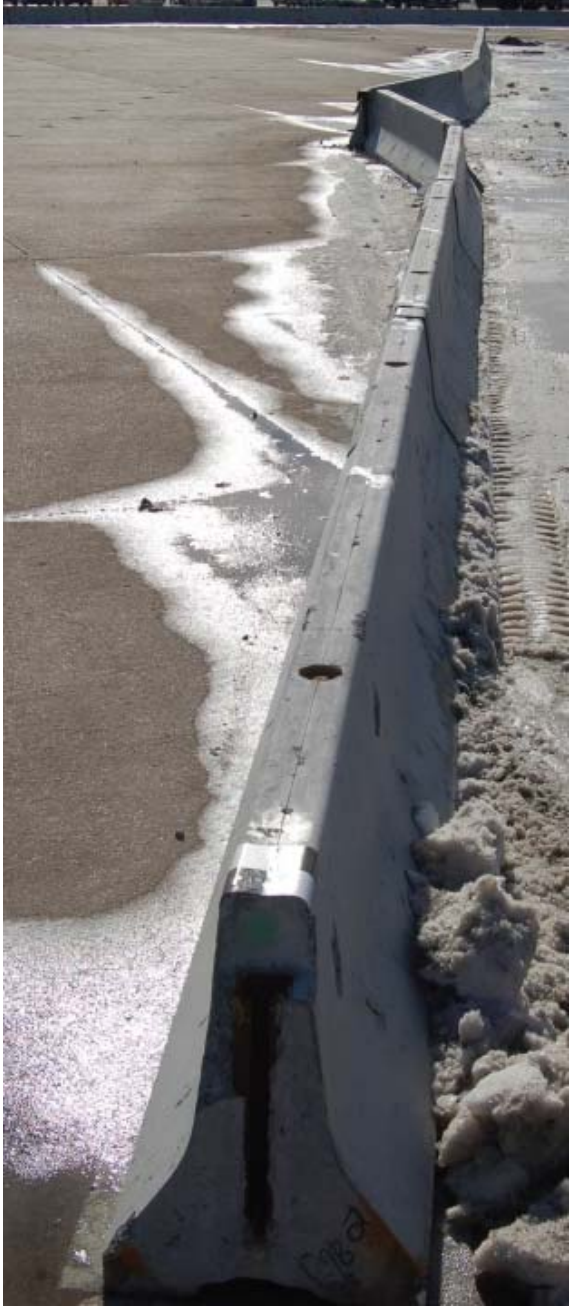
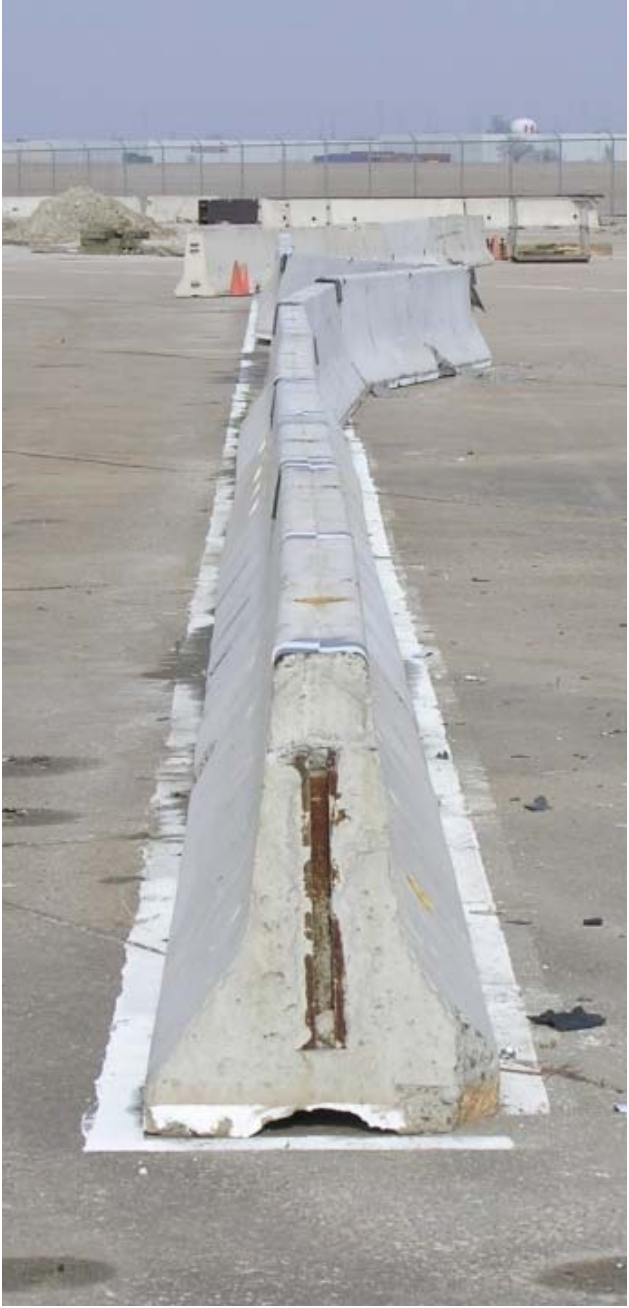
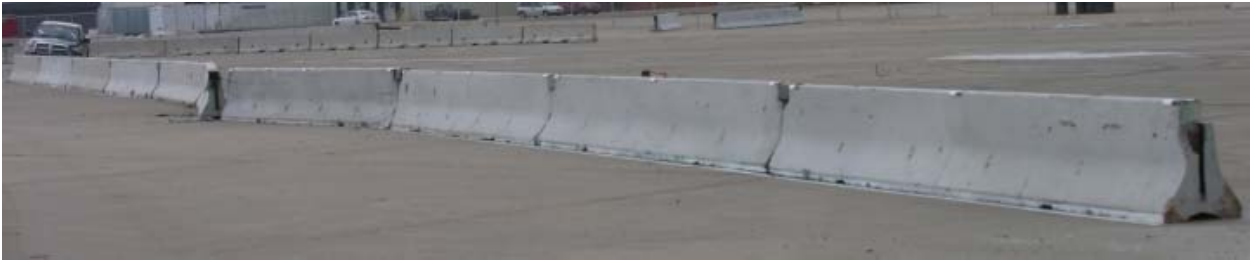
**Figure 25. System Damage, Test NYTCB-4**

The permanent set of the barrier system is shown in Figure 25. The maximum lateral permanent set barrier deflection was 53½ in. (1,359 mm) at the upstream end of barrier no. 5, as measured in the field. The maximum lateral dynamic barrier deflection was 64 13/16 in. (1,646 mm) at the upstream end of barrier no. 5, as determined from high-speed digital video analysis. The working width of the system was found to be 95⅝ in. (2,427 mm).

Damage to the barrier was moderate, as shown in Figures 25 through 33. Barrier damage consisted of contact and gouge marks, concrete barrier cracking, and spalling, and joint failure. The length of the vehicle contact along the system was approximately 26.0 ft (7.93 m), which spanned from 72 3/16 in. (1.83 m) upstream from the downstream end of barrier no. 4 through the joint between barrier nos. 5 and 6.

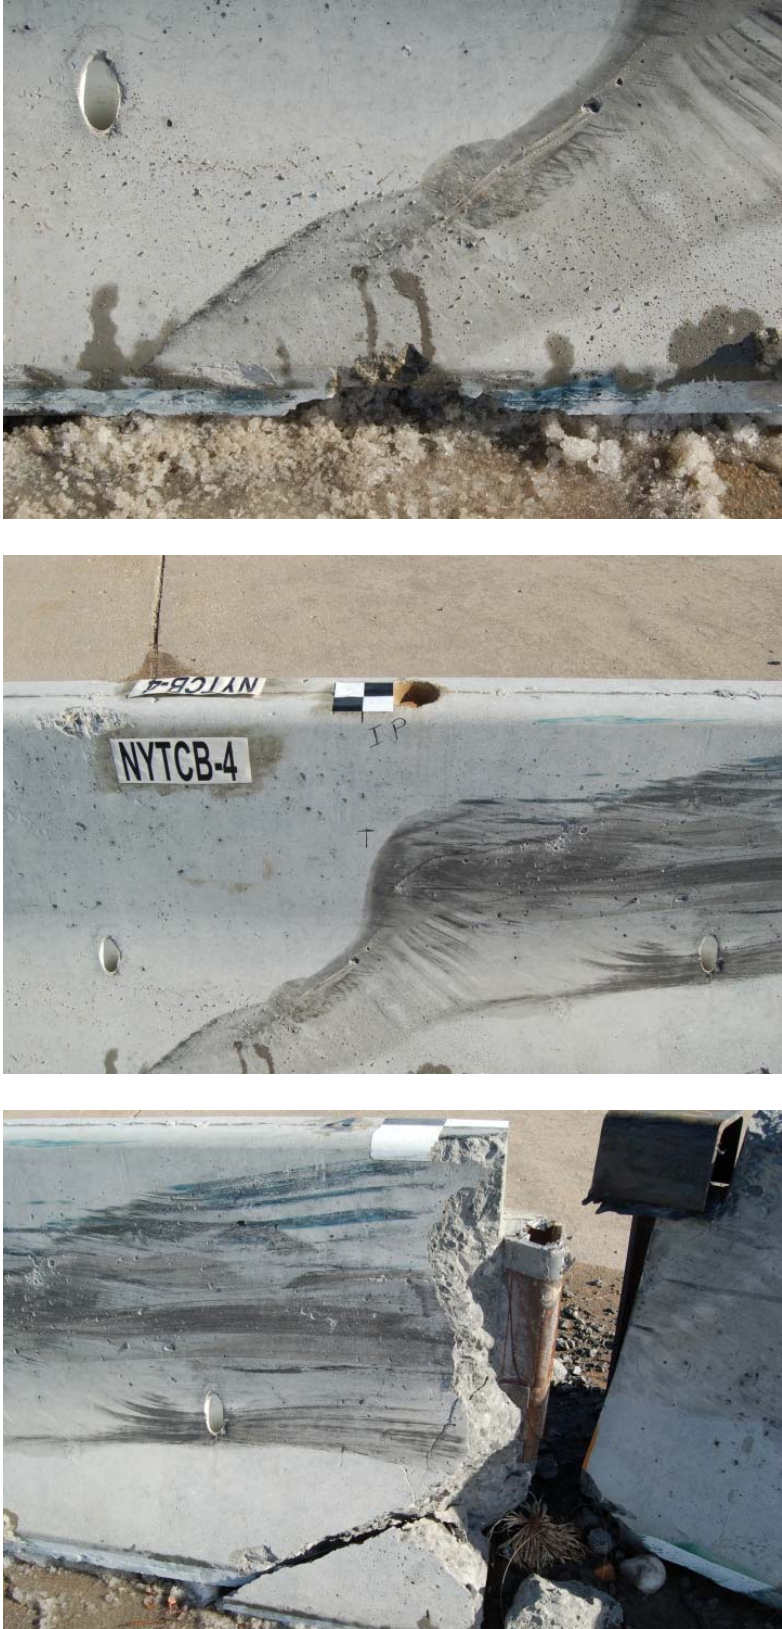
Figure 26. Barrier No. 4 Damage, Test NYTCB-4

The lower-back corner on the downstream end of barrier no. 3 experienced concrete spalling. The lower-back corners on the upstream and downstream ends of barrier no. 4 experienced concrete spalling, as well as the lower-front corner on the downstream end of the barrier. The lower-back corners on the upstream and downstream ends of barrier no. 5 experienced concrete spalling. Concrete spalling also occurred on the upstream end of barrier no. 5 on both the upper- and lower-front corners. A large piece of concrete was removed from the upper-back side of the upstream end of barrier no. 5 near the connection key. The lower-back face of barrier no. 5 experienced major concrete spalling. Concrete spalling occurred on the lower-back corner of the upstream end of barrier no. 6.

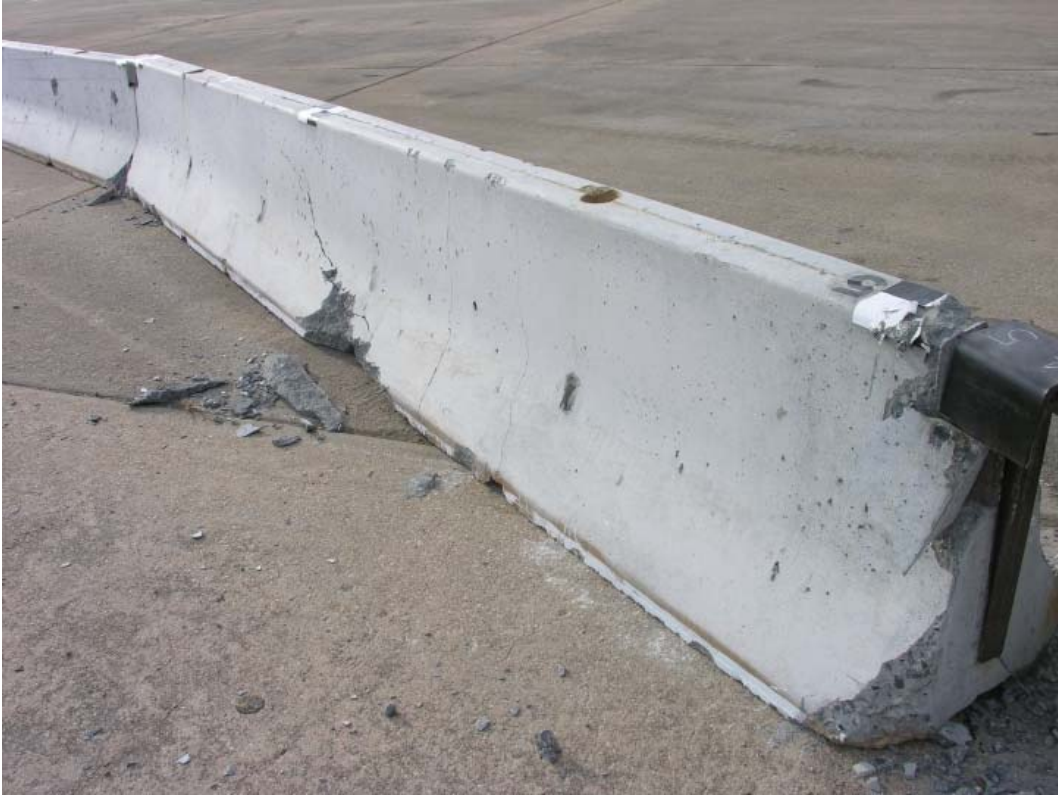
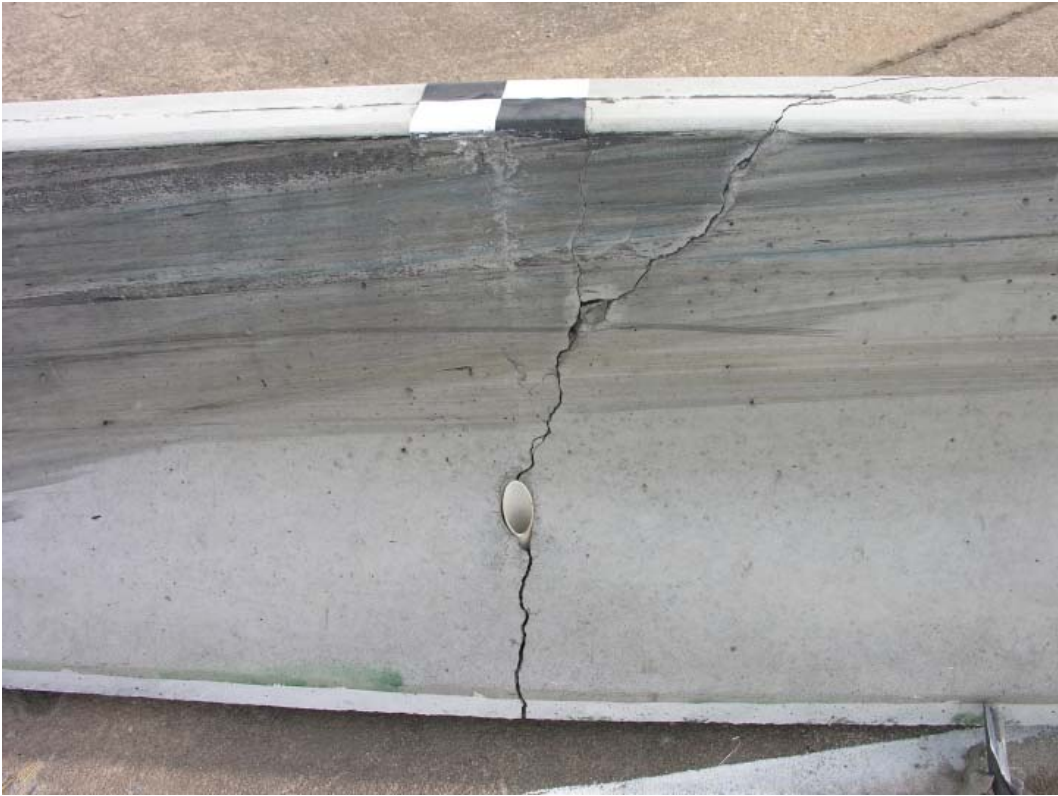
**Figure 27. Barrier No. 5 Damage, Test NYTCB-4**

Vertical cracking was found on the front and back sides of barrier no. 5 near the center of the barrier. Major cracking was also found on the back side of barrier no. 5 at 58 in. (1,473 mm). Major cracking was found on barrier no. 6 at 74 in. (1,880 mm) downstream from the joint between barrier nos. 5 and 6. Minor cracking occurred on the back side of barrier no. 6 at the upper-upstream end.

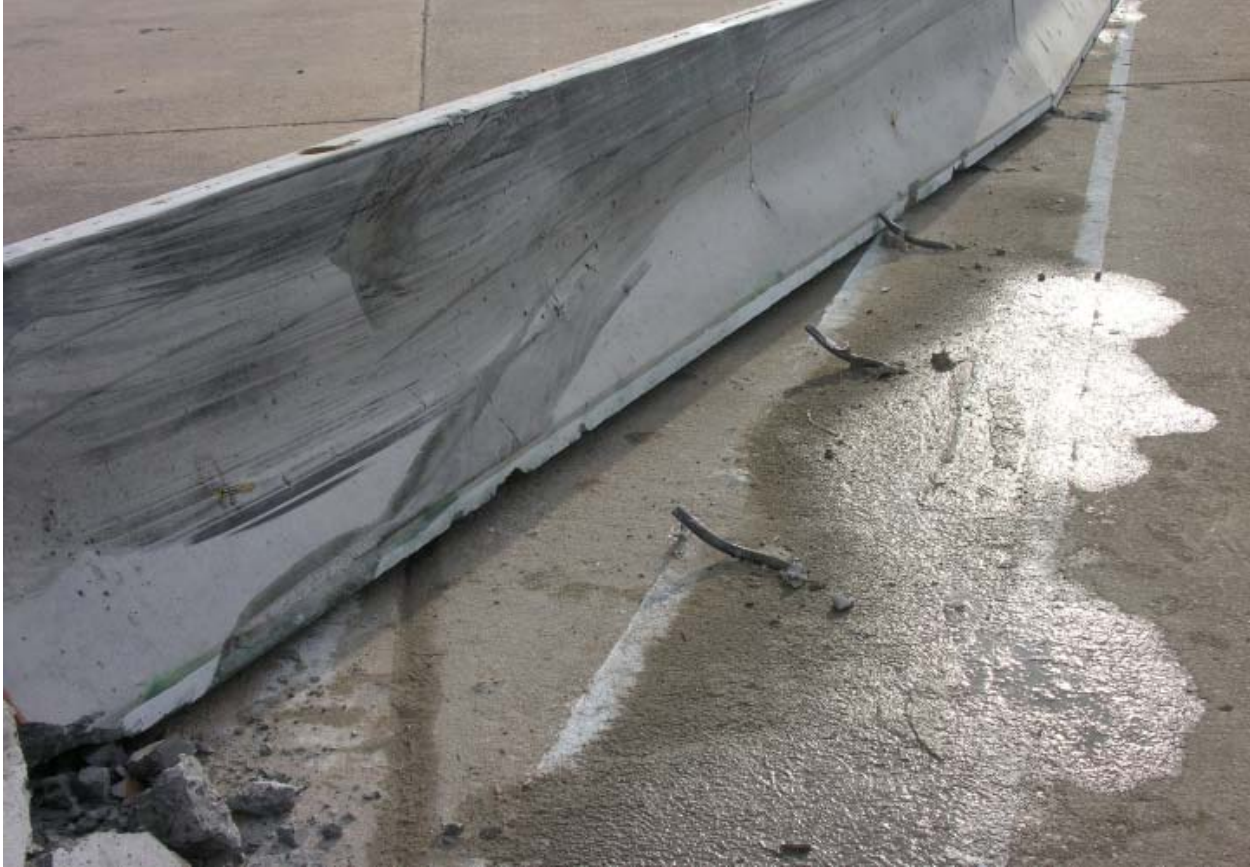
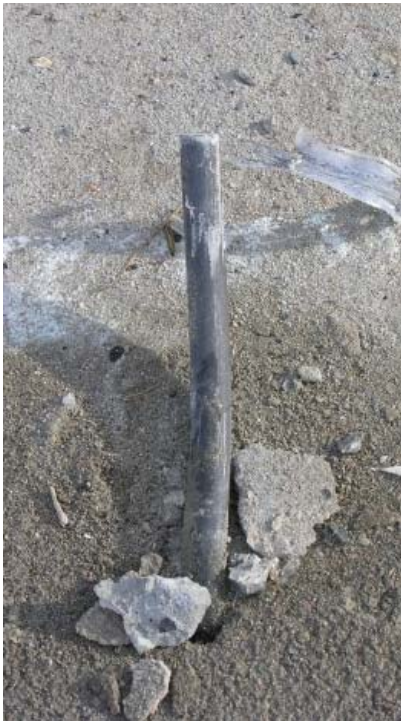
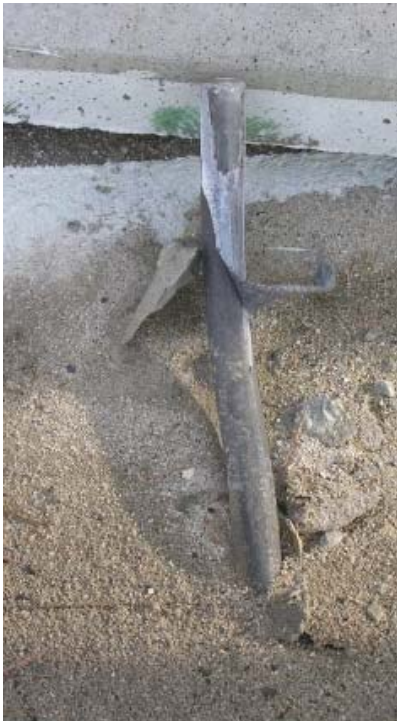
**Figure 28. Barrier No. 5 Anchor Rod Damage, Test NYTCB-4**

The connection key between barrier nos. 4 and 5 fractured and bent toward the traffic side of the barrier. The connection key connecting barrier nos. 4 and 5 disengaged from barrier no. 4 but remained attached to barrier no. 5. Barrier no. 5 disengaged from the anchor rods. The deformed anchor rods remained embedded in the rigid concrete surface.

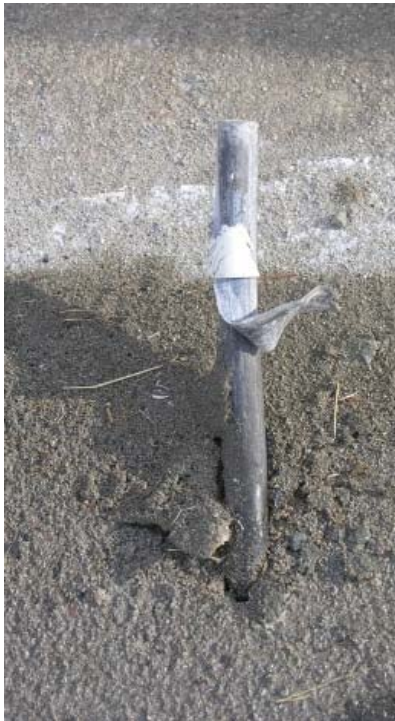
Mid-Upstream

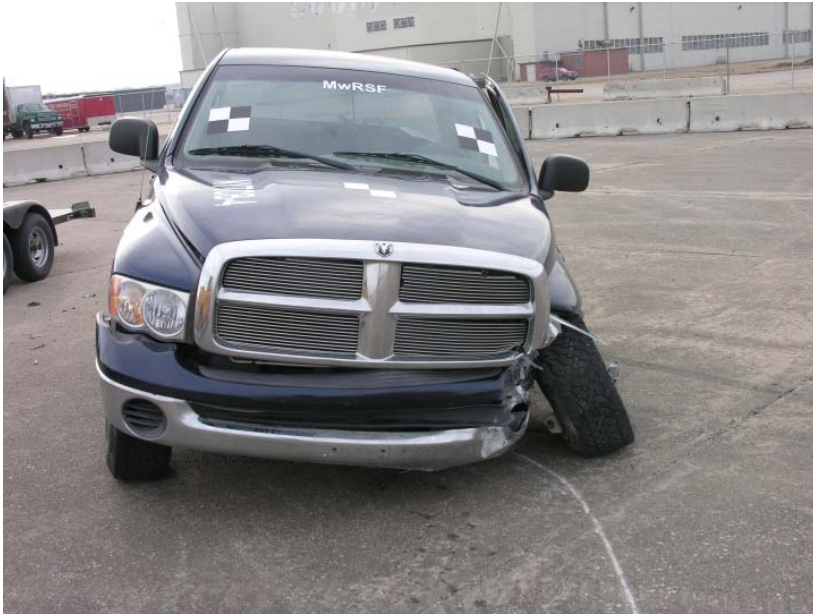
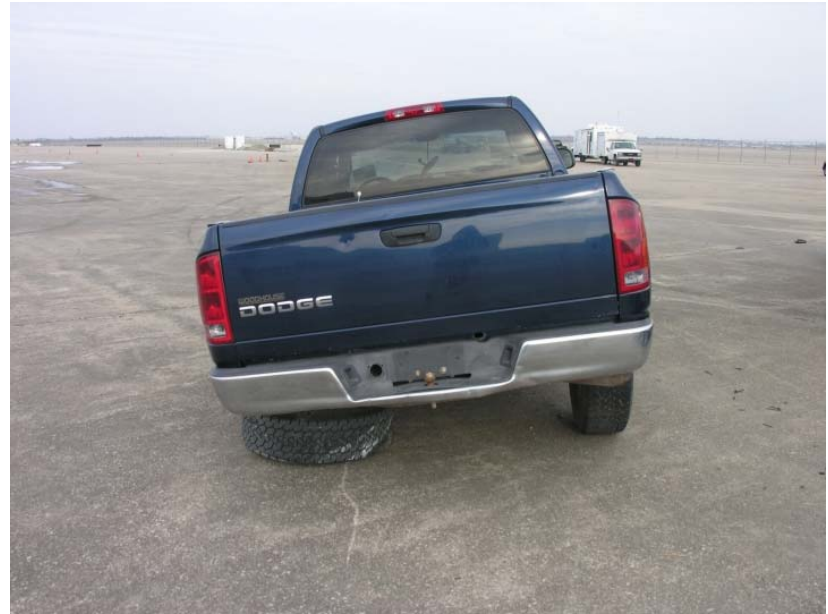
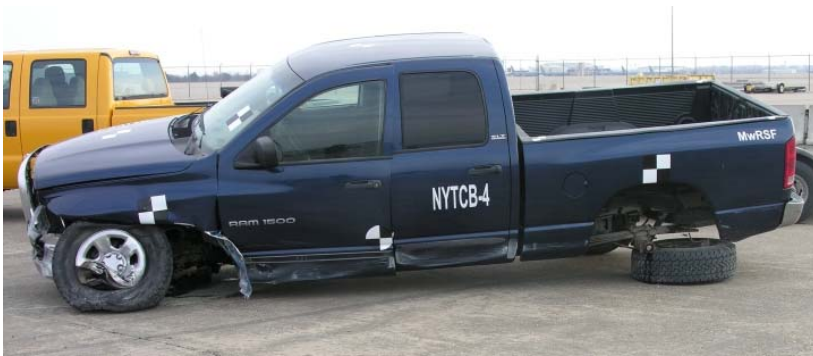
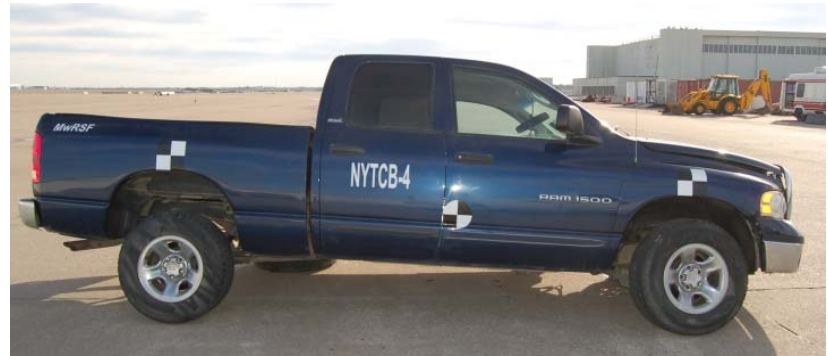
Figure 34. Vehicle Damage, Test NYTCB-4

Damage was concentrated on the left-front corner and left side of the vehicle. The left-front quarter panel deformed inward toward the engine compartment. The left-front wheel and brake line disengaged from the vehicle. The left-rear axle and brake line sheared, and the wheel assembly only remained attached to the vehicle by the emergency brake line. The left-front steel rim was deformed, and the tire bead broke. Scrapes and contact marks were found along the lower portion of the entire left side. The grill was detached and fractured. The hood shifted toward the left. The left headlight assembly and left corner of the front bumper were deformed inward. The left-front corner of the floorboard tore away at the side seam, as shown in Figure 37. The right side of the windshield was cracked. The left-front upper and lower control arm connections were fractured. The left-front vertical stabilizer bar link was bent, and the tie rod end disengaged. The left-rear rotor carrier brackets broke. The rear, roof, and right side of the vehicle as well as all other window glass remained undamaged.

The damage to the vehicle was moderate, as shown in Figures 34 through 37. Occupant compartment deformations to the left side and center of the floorboard were judged insufficient to cause serious injury to the vehicle occupants, as shown in Figure 37. Maximum longitudinal deflections of 5½ in. (140 mm) were located near the left-front region of the driver's-side floor
