EVALUATION OF AN EXISTING STEEL POST ALTERNATIVE FOR THE THRIE BEAM BULLNOSE GUARDRAIL SYSTEM

MwRSF Research Report No. TRP-03-193-07

August 24, 2007

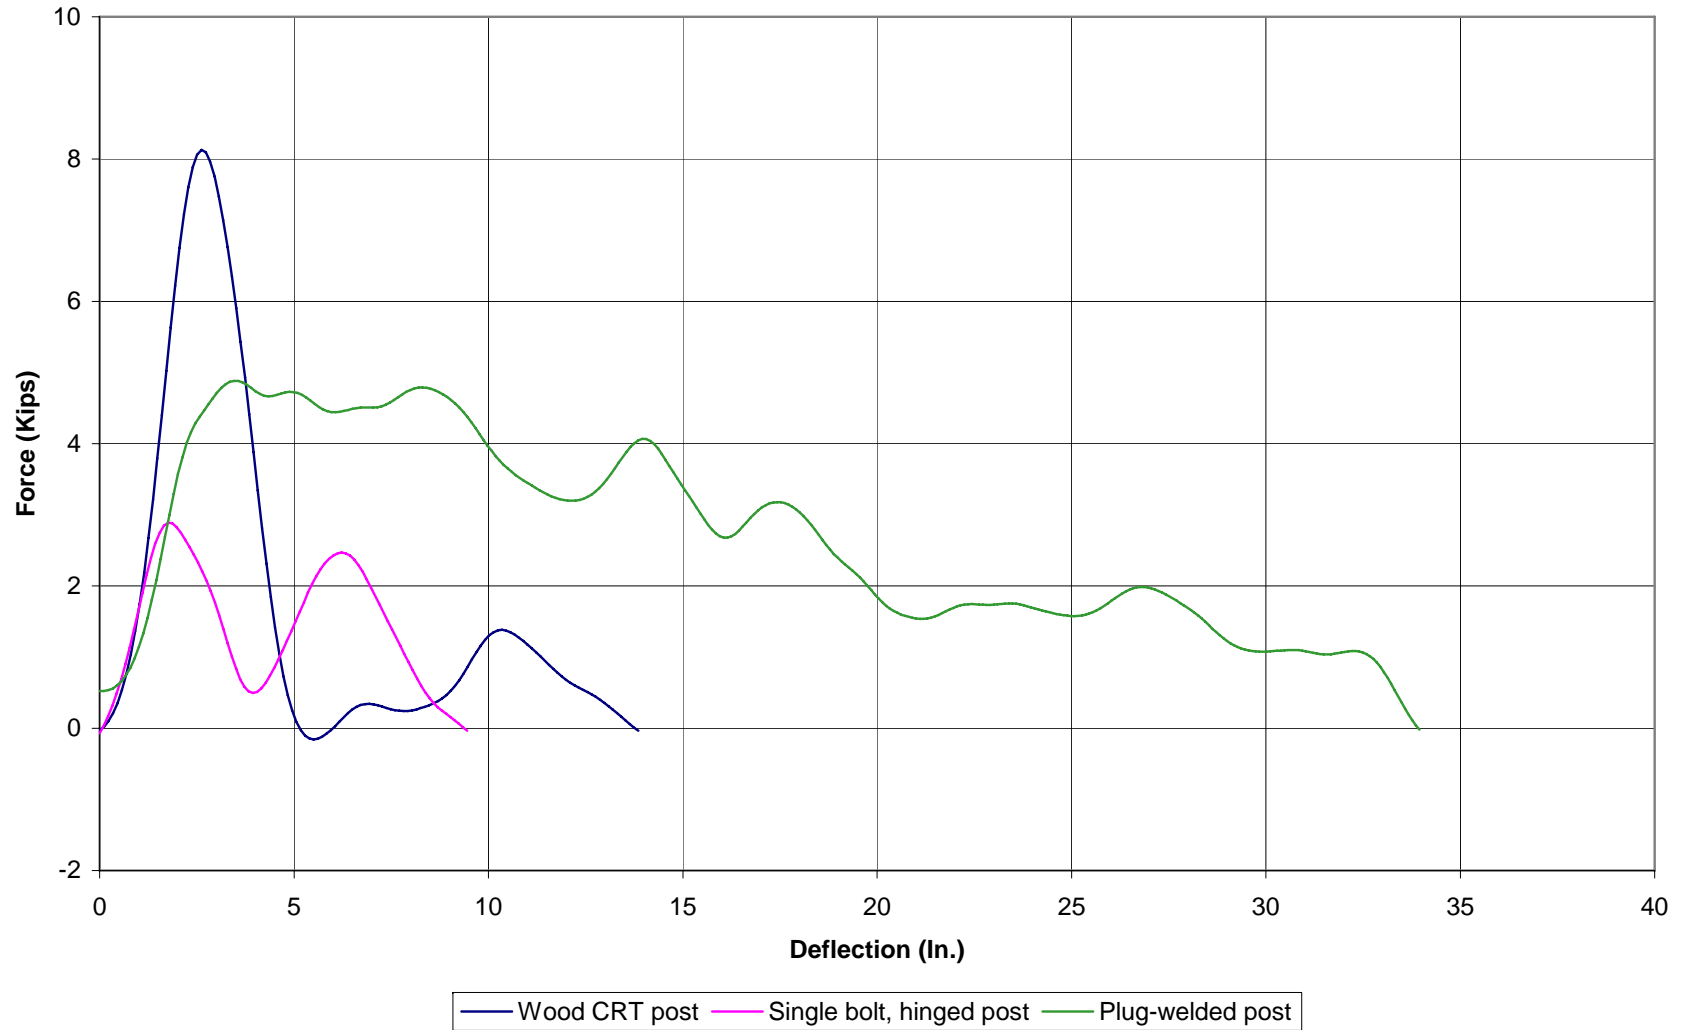
Figure 3. Component Test Results, Force vs. Deflection

The results from the component testing are shown in Figures 3 and 4. Figure 3 displays the force versus deflection properties for the three posts, and Figure 4 displays the energy versus deflection data. Comparison of the data from the three post types yielded valuable insight into selection of an alternative breakaway steel post for the bullnose system. The force deflection data from the testing showed that both the RSI Plug Weld Post and RSI Hinged Steel Post developed lower peak loads than a wooden CRT post. However, investigation of the energy data found that the RSI Plug Weld Post did not release cleanly upon impact and absorbed much more energy than either the RSI Hinged Steel Post or the CRT post. The RSI Hinged Steel Post was observed to absorb the least amount of energy prior to release.

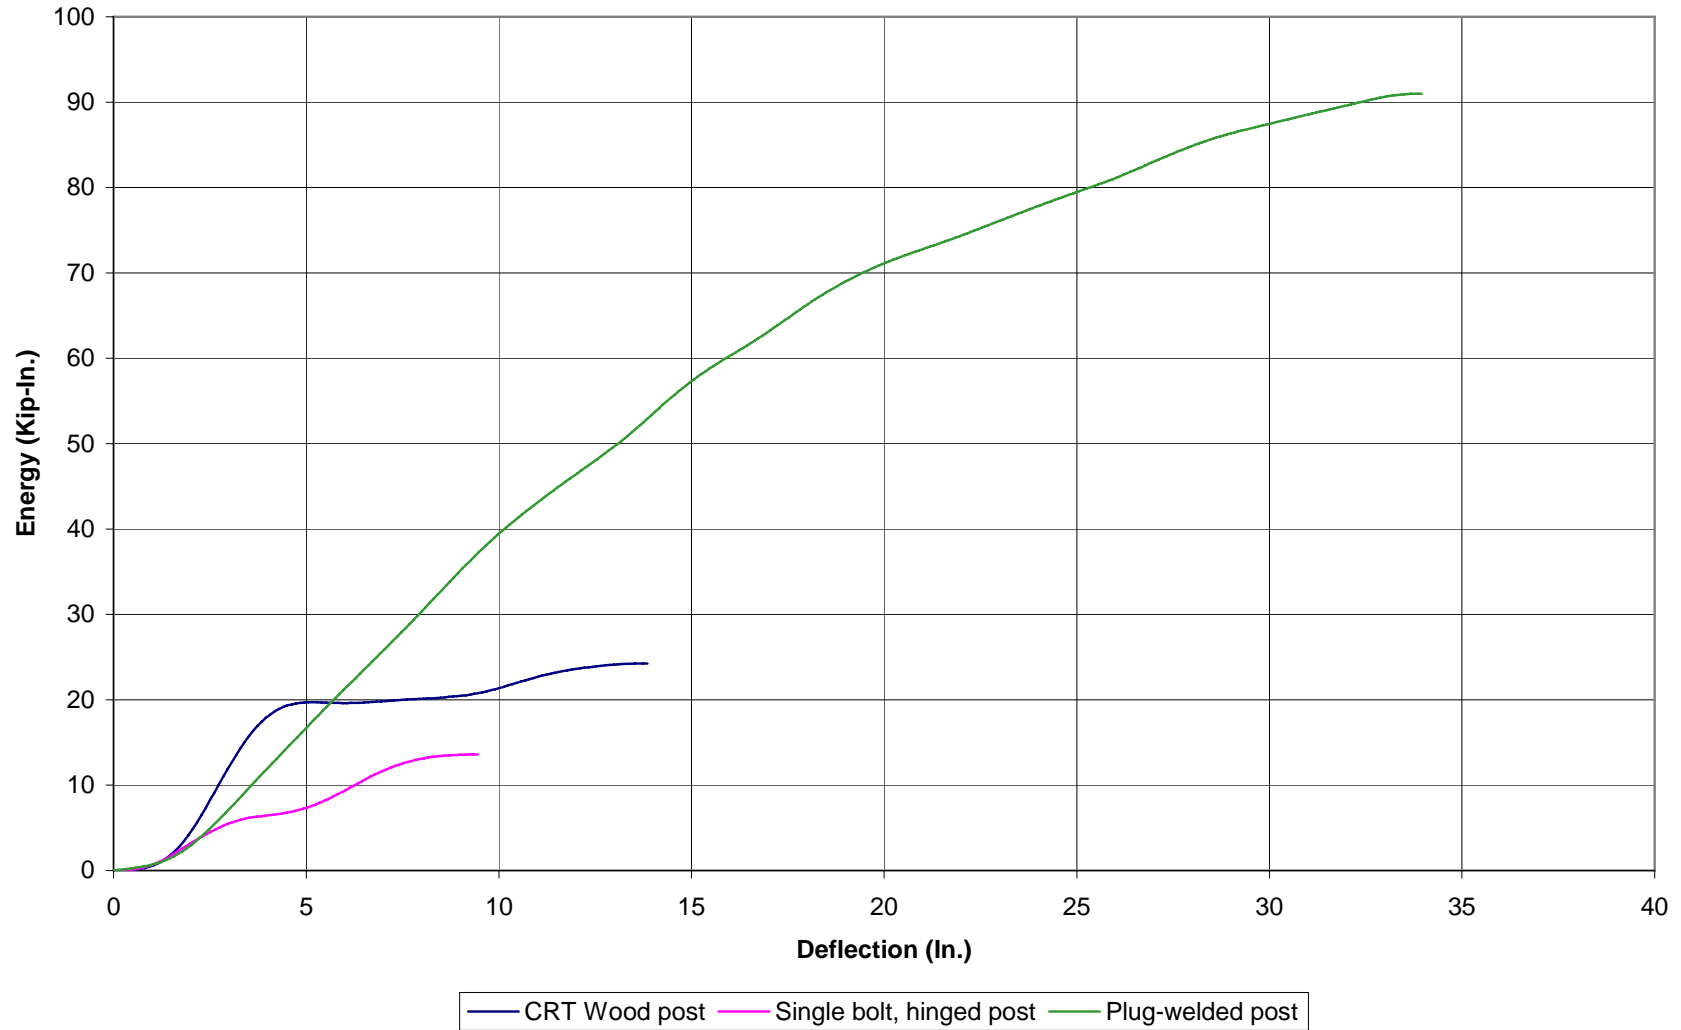
Figure 4. Component Test Results, Energy vs. Deflection

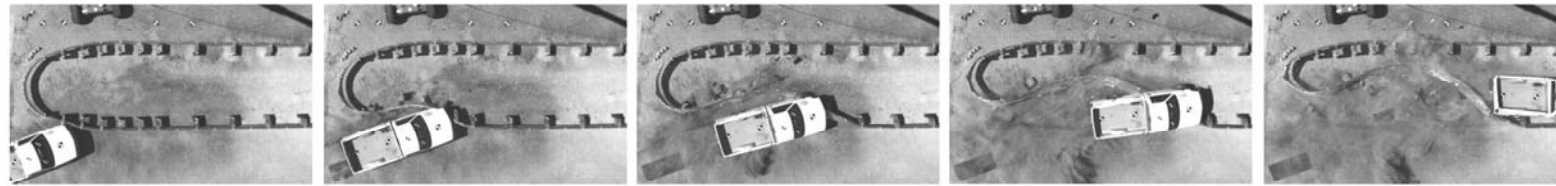
- Test Agency MwRSF
- Test Number SBN-1
- Date 9/14/05
- NCHRP 350 Test Designation 3-11
- Appurtenance Steel Post Bullnose
- Total Length 20.06 m
- Key Elements - Steel Thrie-Beam
 - Thickness 2.67 mm
 - Top Mounting Height 803 mm
- Key Elements - Steel Posts
 - Post No. 1 SDI HP-1 Breakaway
 - Post Nos. 3-8 SDI HP-3 Breakaway Posts
 - Post Nos. 9-12 W152 x 13.4 by 978 mm long
- Key Elements - Post Spacing
 - Post Nos. 1-7 952.5 mm
 - Post Nos. 7-14 1,905 mm
- Key Elements - Wood Spacer Blocks
 - Post Nos. 3-12 152 mm x 203 mm by 362 mm long tapered
 - 152 mm x 203 mm by 362 mm long full-size
- Type of Soil Grading B - AASHTO M 147-65 (1990)
- Test Vehicle
 - Type/Designation 2000P
 - Make and Model 2000 GMC 2500 3/4-ton pickup truck
 - Curb 1,979 kg
 - Test Inertial 2,020 kg
 - Gross Static 2,020 kg

- Impact Conditions
 - Speed 103.1 km/h
 - Angle 20.1 degrees
 - Impact Location Centerline of Post No. 2
- Exit Conditions
 - Speed N/A
 - Angle N/A
 - Exit Box Criterion N/A
- Post-Impact Trajectory
 - Vehicle Stability Unsatisfactory
 - Stopping Distance 36.3 m longitudinal
 - 2.1 m lateral from centerline
- Occupant Impact Velocity
 - Longitudinal -7.03 m/s < 12 m/s
 - Lateral (not required) 2.18 m/s < 12 m/s
- Occupant Ridedown Deceleration
 - Longitudinal -8.18 Gs < 20 Gs
 - Lateral (not required) 11.52 Gs < 20 Gs
- THIV (not required) 7.26 m/s
- PHD (not required) 8.27 Gs
- Test Article Damage Extensive
- Test Article Deflections
 - Permanent Set N/A
 - Dynamic N/A
 - Working Width N/A
- Vehicle Damage Moderate
 - VDS⁵ 11-LFQ-4/11-LFT-4
 - CDC⁶ 11-LYA09
 - Maximum Deformation 44 mm at right-center floorpan

Figure 18. Summary of Test Results and Sequential Photographs, Test No. SBN-1

In test no. SBN-1, a 2,020-kg pickup truck impacted the CIP of the bullnose system at a speed of 103.1 km/h and an angle of 20.1 degrees. The results from test no. SBN-1 are summarized in Figure 18. During test no. SBN-1, the bullnose system with breakaway steel posts failed to capture the impacting vehicle. As the pickup truck penetrated into the system, the vehicle ramped up the guardrail and vaulted the system. Review of the test results and comparison of the behavior of the system with the successful testing of the original bullnose system revealed that the failure of the test was largely due to the upstream anchorage at post no. 1. In test no. SBN-1, post no. 1 was an RSI steel anchorage post. This post developed upstream anchorage far longer during the impact event than the wooden BCT post used in the original design. Film analysis showed that the upstream anchorage at post no.1 remained active until approximately 240 msec in test no. SBN-1, while in the CIP test of the original bullnose, test no. MBN-8, the upstream anchor at post no. 1 remained active for only 154 msec. The retention of the upstream anchorage in test no. SBN-1 led to a reduction in the penetration of the pickup truck into the system and a corresponding reduction in the formation of a pocket in the guardrail to effectively capture the front of the vehicle. This can be observed in the comparison of the overhead sequential photographs from test nos. MBN-8 and SBN-1, as shown in Figures 19 and 20, respectively.

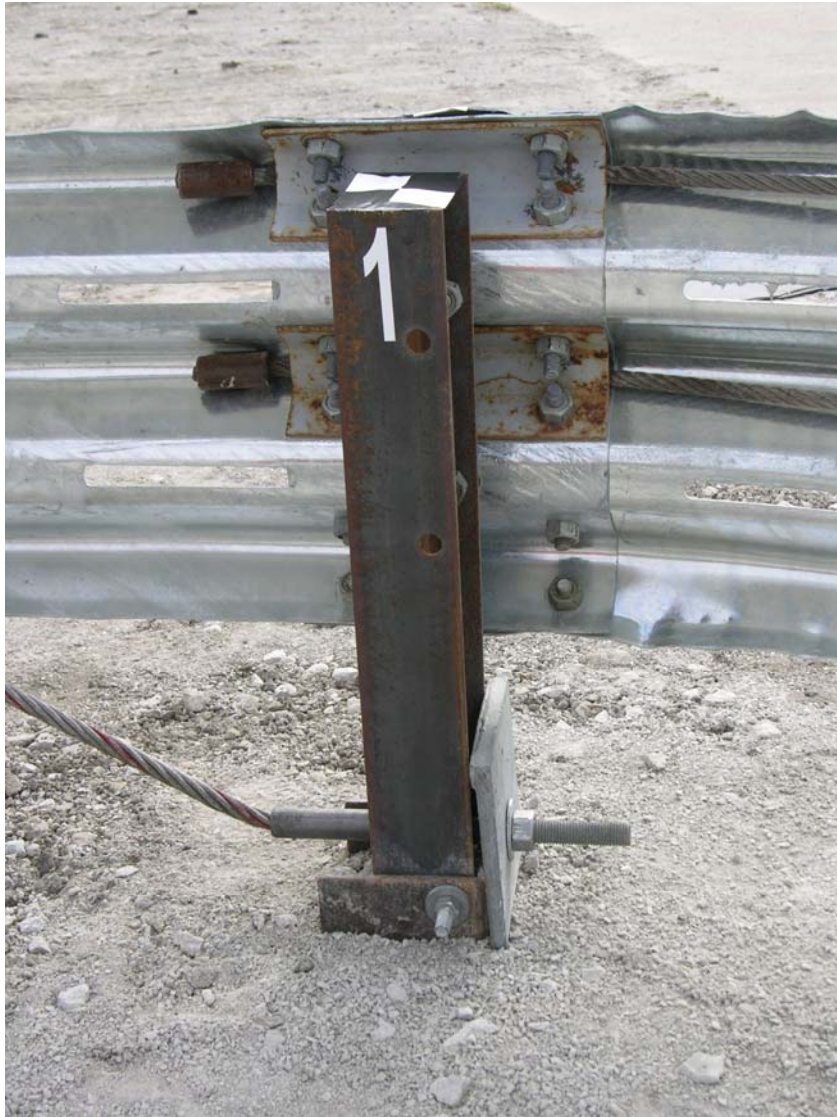
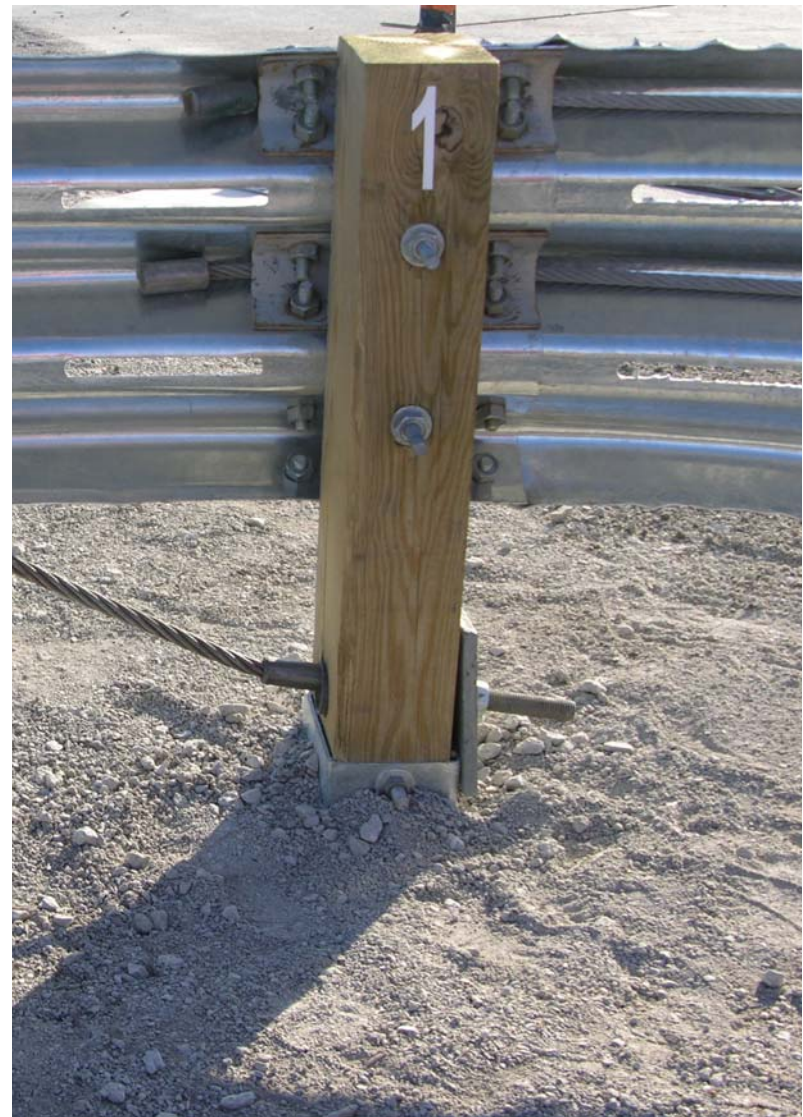
Figure 21. Post No. 1 for Test Nos. SBN-1 and SBN-2

Based on the reduced cost and time required, it was decided that the project would proceed using the second option. Thus, a second full-scale test was conducted on the bullnose system with breakaway steel posts with post no. 1 replaced with a wooden BCT post in a 2,438-mm long foundation tube, as shown in Figure 21.

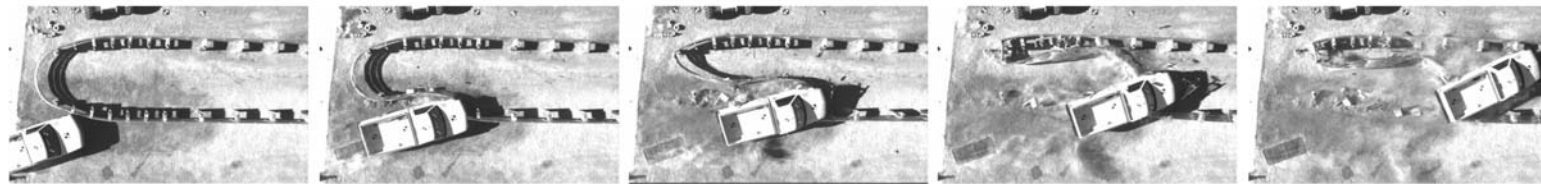
- Key Elements - Steel Thrie-Beam
 - Thickness 2.67 mm
 - Top Mounting Height 803 mm
- Key Elements - Steel Posts
 - Post No. 1 SDI HP-1 Breakaway
 - Post Nos. 3-8 SDI HP-3 Breakaway Posts

- Post Nos. 9-12 W152 x 13.4 by 978 mm long
- Key Elements - Wood Posts
 - Post No. 1 Thrie Beam BCT Post in 2,438-mm foundation tube
- Key Elements - Post Spacing

- Impact Conditions
 - Speed 101.3 km/h
 - Angle 20.7 degrees
 - Impact Location Centerline of Post No. 2
- Exit Conditions
 - Speed N/A
 - Angle N/A
 - Exit Box Criterion N/A
- Post-Impact Trajectory
 - Vehicle Stability Satisfactory
 - Stopping Distance 13.6 m longitudinal
1.5 m lateral from centerline
- Occupant Impact Velocity (350 Update)
 - Longitudinal -8.32 m/s < 12 m/s
 - Lateral 1.40 m/s < 12 m/s
- Occupant Ridedown Deceleration (350 Update)
 - Longitudinal -8.24 Gs < 20 Gs
 - Lateral -9.36 Gs < 20 Gs
- THIV (not required) 8.05 m/s
- PHD (not required) 11.25 Gs
- Test Article Damage Extensive
- Test Article Deflections
 - Permanent Set N/A
 - Dynamic N/A
 - Working Width N/A
- Vehicle Damage Moderate
 - VDS⁵ 11-LFQ-3
 - CDC⁶ 11-LFEN5
 - Maximum Deformation 13 mm at left-center floorpan

Figure 22. Summary of Test Results and Sequential Photographs, Test No. SBN-2

In test no. SBN-2, a 2,002-kg pickup truck impacted the CIP of the bullnose system at a speed of 101.3 km/h and an angle of 20.7 degrees. The bullnose system design for this test was unchanged from test no. SBN-1 other than the replacement of post no. 1 with a standard BCT post. The results from test no. SBN-2 are summarized in Figure 22. During test no. SBN-2, the bullnose system with breakaway steel posts failed to capture the impacting vehicle. As the pickup truck penetrated into the system, the vehicle ramped up the guardrail and vaulted the system. Review of the test results and comparison of the behavior of the system with the previous test nos. MBN-8 and SBN-1 yielded information regarding the failure of the test. The initial performance of the system in test no. SBN-2 was improved over that of the previous test. The upstream anchor released earlier in the event and the vehicle penetrated farther into the system and was more effectively captured. However, as the vehicle was being captured, it appeared that the vehicle rode up the debris from the failed steel posts and attached wood blockouts, thus causing the vehicle to vault the guardrail and resulting in the subsequent failure of the test due to loss of vehicle containment. Because the RSI Hinged Steel Posts were hinged about the base as their failure mechanism, the tops of the posts and the blockouts did not disengage and clear away from underneath the guardrail and provided collected materials for the impacting vehicle to climb up.
