PERFORMANCE ANALYSIS OF WELCH PRODUCTS RECYCLED RUBBER SPACER BLOCK

MwRSF Research Report No. TRP-03-132-03

Bogie Test WB-1 (Wood Spacer Block Baseline Test)

Bogie Test WB-2 (Recycled Rubber Spacer Block Test)

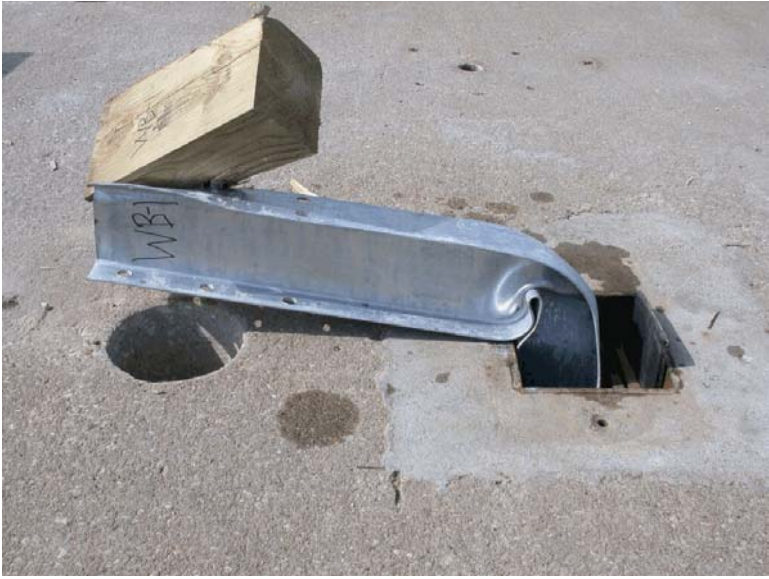
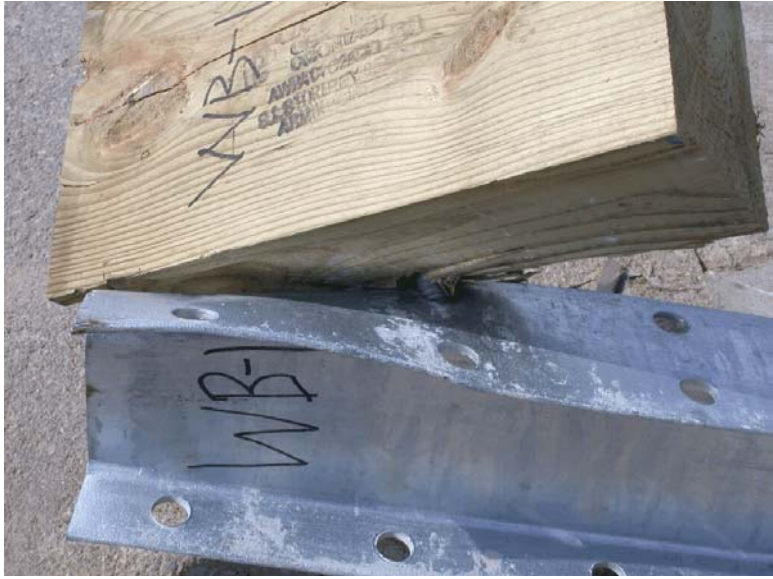
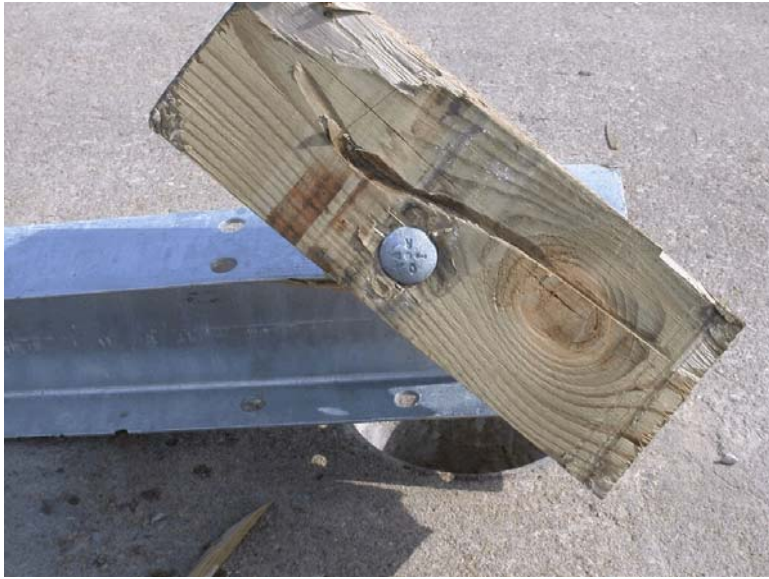
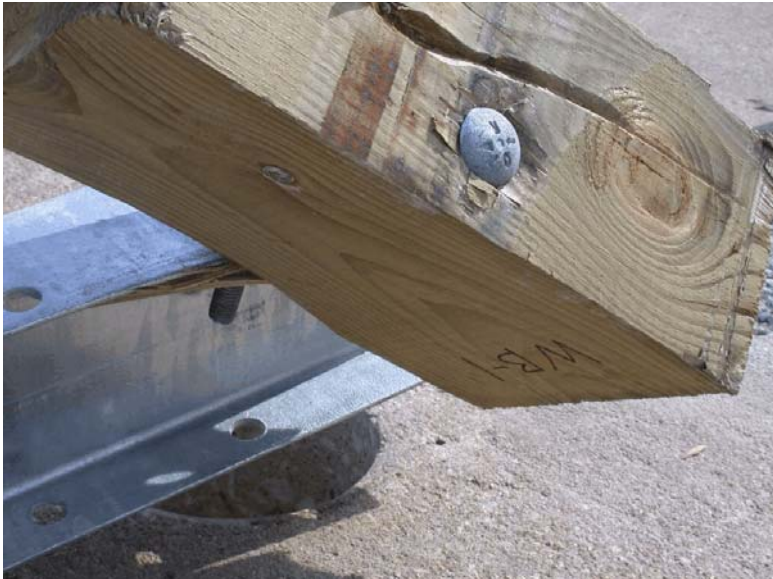
Figure 4. System Damage, Bogie Test WB-1

4. System performance – The wood spacer block displayed minor damage due to the impact of the bogie vehicle. Some cracking and chipping of the wood on the front face of the block was observed. A portion of the routed edge on the rear of the block was disengaged as to bogie rolled over the post. No crushing or change in the depth of the spacer block was observed during the impact. The spacer block remained attached to the post.

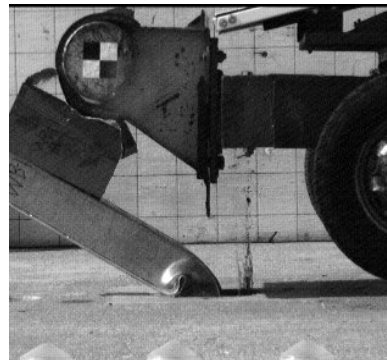
Figure 5. Sequential Photographs, Test WB-1

3. Impact speed: 32.2 km/hr
Impact orientation: 0 degrees
Bogie Impact Height: 550 mm

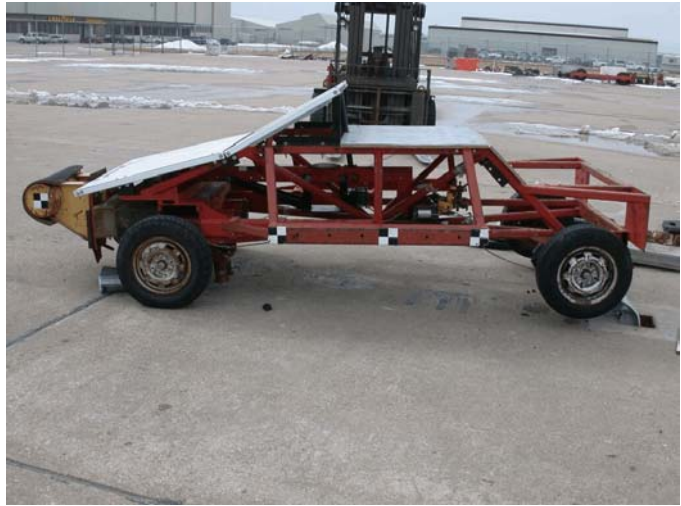
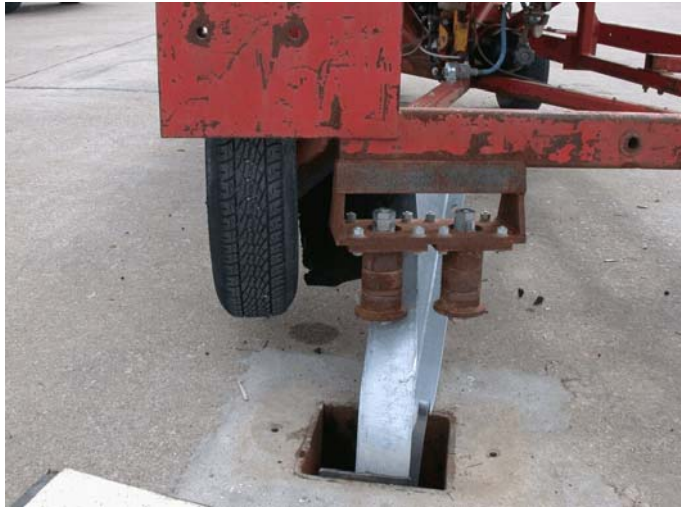
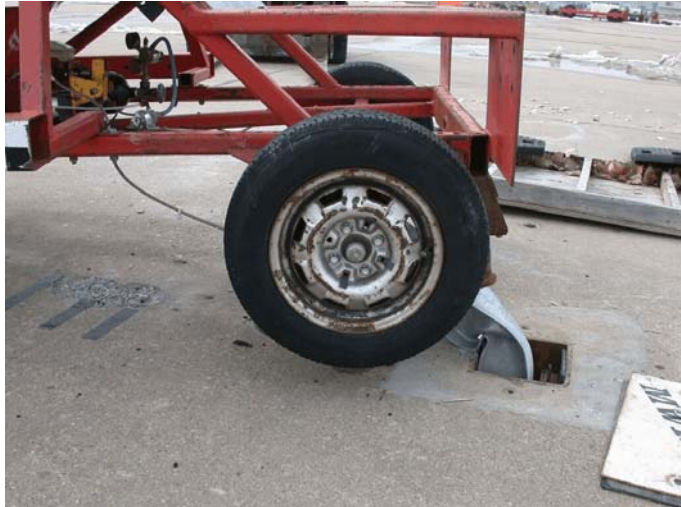
Figure 18. System Damage, Bogie Test WB-2

4. System performance – The recycled rubber spacer block displayed minor damage due to the impact of the bogie vehicle. The front face displayed slices near the top and bottom of the block where the W-beam guardrail penetrated into the rubber during impact. An approximately 76 mm x 76 mm section of the block near the top-left corner on the rear of the block was disengaged as the bogie vehicle rolled over the post. Significant crushing of the spacer block was observed during the impact. The depth of the spacer block was reduced a maximum of approximately 76 mm. The spacer block remained attached to the post.

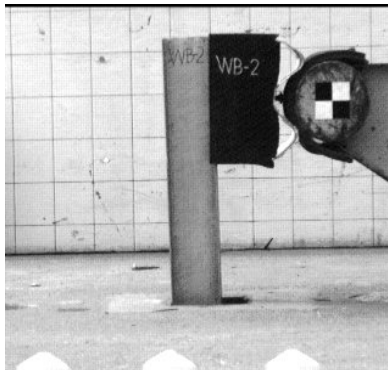
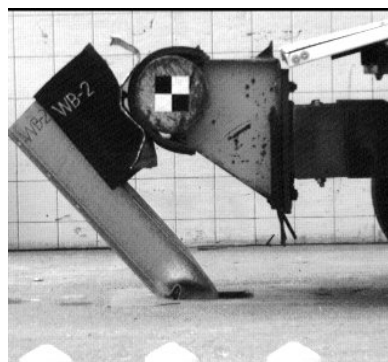
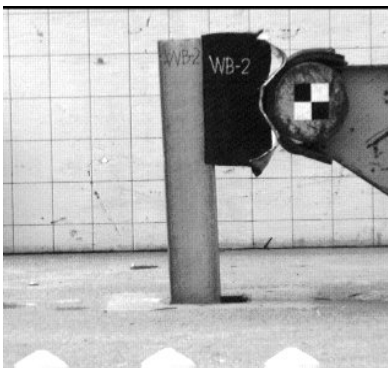
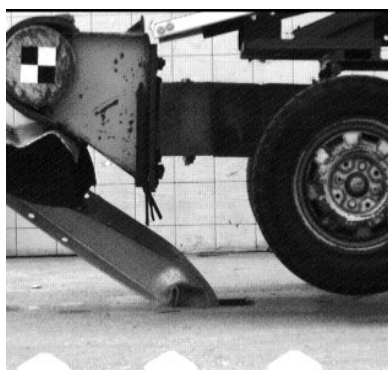
Figure 22. Sequential Photographs, Test WB-2

3. Impact speed: 31.9 km/hr
Impact orientation: 0 degrees
Bogie Impact Height: 550 mm

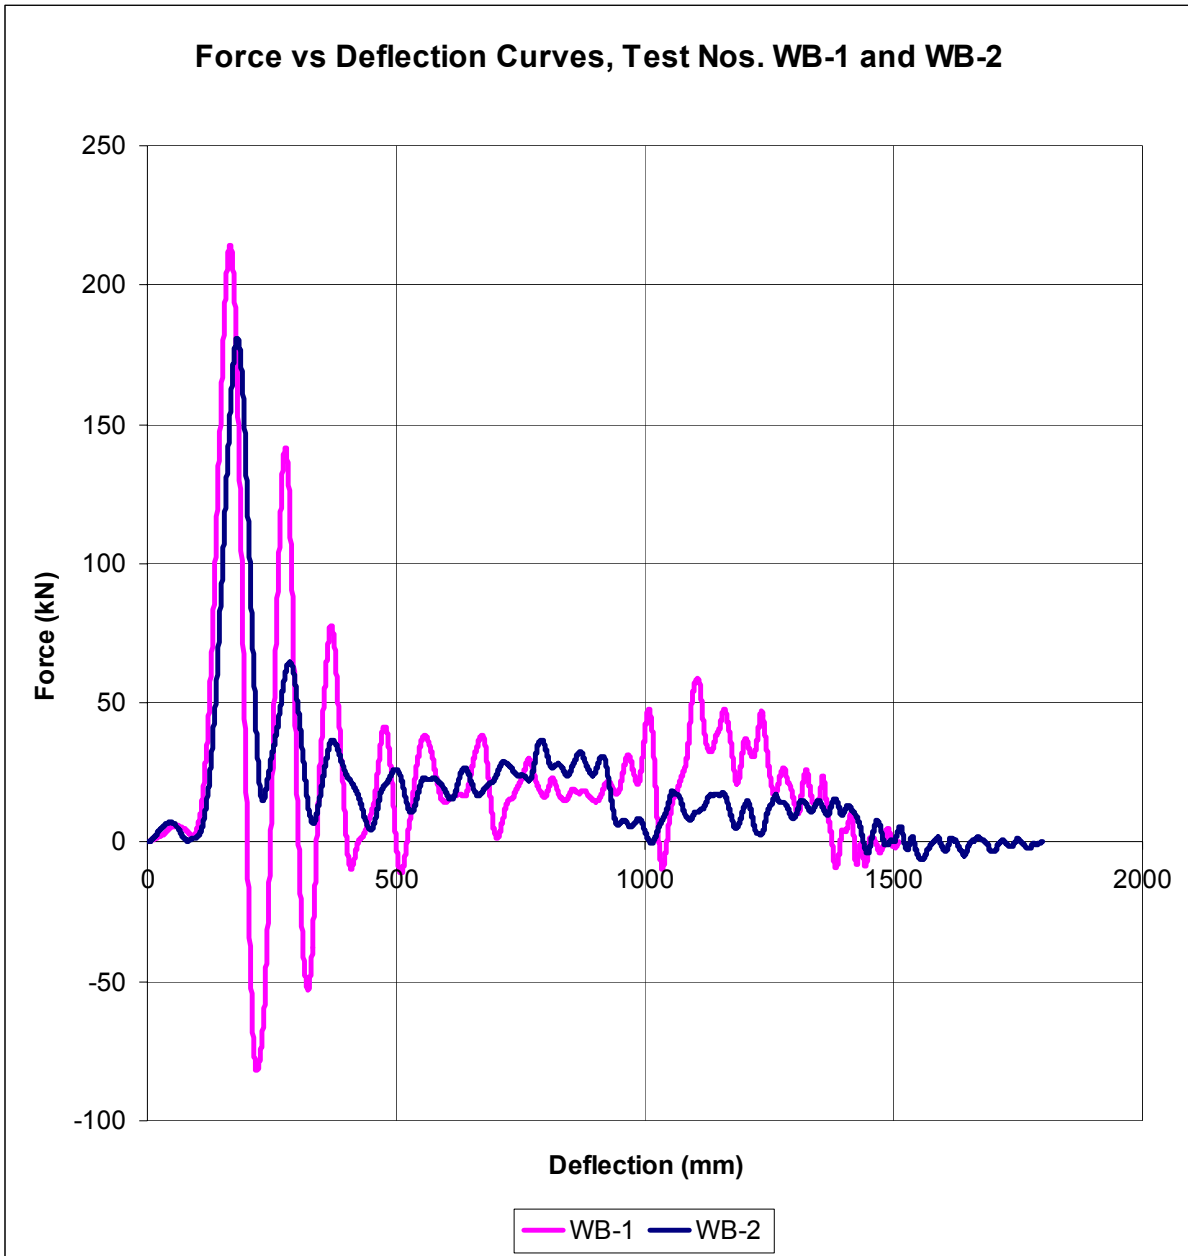
Figure 24. Force vs Deflection, Test Nos. WB-1 and WB-2

Based on the results of the crash tests, obvious differences were observed in the performance of the wood and recycled rubber blockouts. While both blockouts displayed similar levels of permanent damage after impact, the recycled rubber blockout was observed to be much less stiff than the wood blockout during the impact. Analysis of the high speed film showed that the recycled rubber blockout crushed approximately 76 mm during the impact, thereby reducing the effective depth of the spacer block to 127 mm. The reduced depth of the spacer block causes an increased potential for wheel snag because the guardrail would no longer be spaced 203 mm in front of the post as in standard W-beam guardrail systems. It is believed that the increased potential for wheel snag may pose a hazard if the recycled rubber blockout were installed on a standard W-beam guardrail.

In light of the comparison of the crash test results, the researchers recommend that the Welch Products recycled rubber blockout be subjected to full-scale crash testing on a standard W-beam system to alleviate the previously mentioned concerns with stiffness and construction. The bogie tests detailed herein demonstrated that the performance of the recycled rubber blockout was substantially different under load than the standard wooden blockout. As such, it is not possible to accurately predict the performance of the blockout when installed in a full-scale system without further testing.
