DEVELOPMENT OF A LOW-PROFILE BRIDGE RAIL FOR TEST LEVEL 2 APPLICATIONS

MIDWEST ROADSIDE SAFETY FACILITY

MwRSF Research Report No. TRP-03-109-02

August 20, 2002

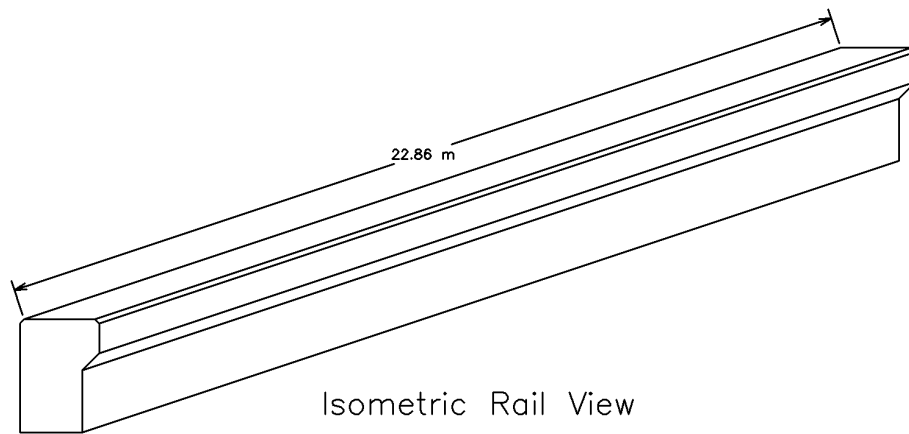
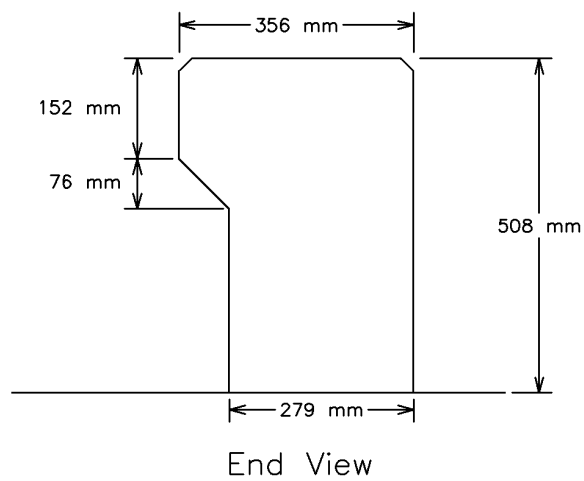
Figure 2. Low-Profile Bridge Rail Details

- (1) Use Grade 60 reinforcement.
- (2) Use minimum concrete strength of $f'c = 31.03$ MPa.
- (3) Use 38 mm minimum cover.
- (4) Use 19 mm chamfer on top corners.
- (5) Extra No. 3 bar place along sloped stirrup used for continuity near front face.
(Position may be altered.)
- (6) Minimum lap length for longitudinal bars is 229 mm.
- (7) Special reinforcement spacing at free ends or joints to be determined.

consisted of a Nebraska 47-BD Mix Type 3, with a minimum compressive strength of 31.03 MPa. A minimum concrete cover of 38 mm was used for all of the rebar placed within the concrete bridge rail. All of the steel reinforcement in the bridge rail was Grade 60 epoxy-coated rebar.

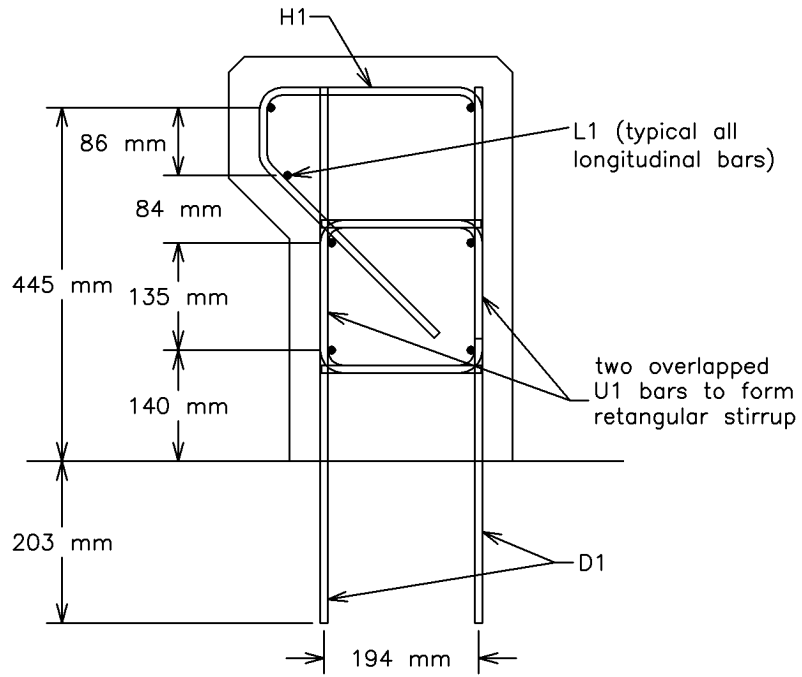
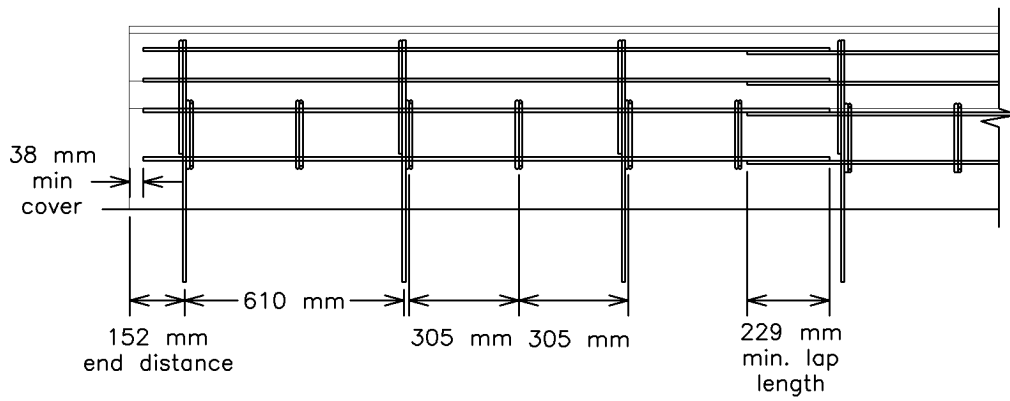
Figure 3. Low-Profile Bridge Rail Design Details

Rebar Details

Rebar Longitudinal Details

The steel reinforcement utilized No. 3 bars for the longitudinal, vertical dowel, vertical hoop, and vertical U stirrup bars, as shown in Figures 3 and 4. Each of the seven runs of longitudinal rebar was 22.78-m long. The length of the longitudinal bar can be varied as long as the minimum lap length of 229 mm is maintained. The vertical dowel bars were 673-mm long and spaced 610 mm on center. The vertical hoop bars were 956-mm long and spaced 610 mm on center, as shown in Figure 3. The vertical rectangular stirrups, formed with two overlapped 556-mm long U stirrup bars, were spaced 305 mm on center, as shown in Figure 3. The vertical dowel bars were attached to the existing concrete apron using an epoxy resin, as shown in Figure 3. For actual attachment to a reinforced concrete deck, the vertical bars would be bent into a L-shape and tied to the appropriate transverse deck bars in order to develop their structural capacity.

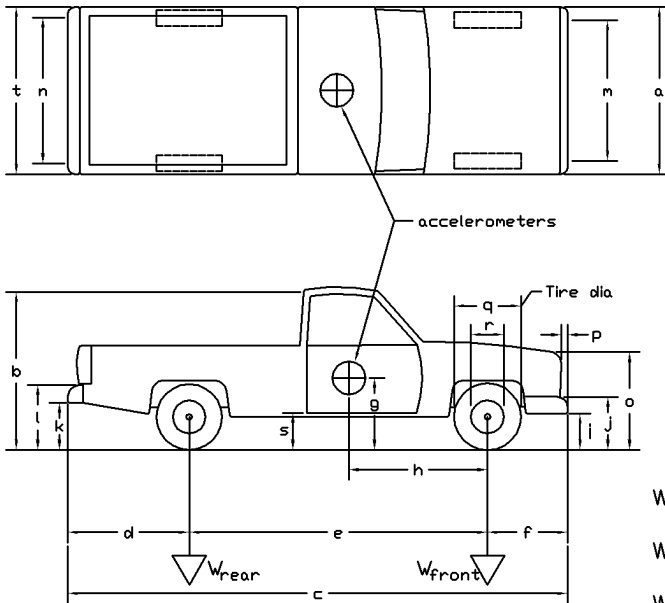
Vehicle Geometry – mm

a 1861 b 1842
 c 5537 d 1295
 e 3327 f 914
 g 667 h 1384
 i 445 j 673
 k 578 l 781
 m 1613 n 1625
 o 1041 p 108
 q 765 r 445
 s 476 t 1842

For test LPBR-1, a 1995 GMC 2500 SL $\frac{3}{4}$ -ton pickup truck was used as the test vehicle. The test inertial and gross static weights were 2,018 kg. The test vehicle is shown in Figure 7, and vehicle dimensions are shown in Figure 8.
