## DEVELOPMENT OF A TL-3 F-SHAPE TEMPORARY CONCRETE MEDIAN BARRIER

# **DEVELOPMENT OF A TL-3 F-SHAPE TEMPORARY CONCRETE MEDIAN BARRIER**

*MwRSF Research Report No. TRP-03-64-96*  
December 1996

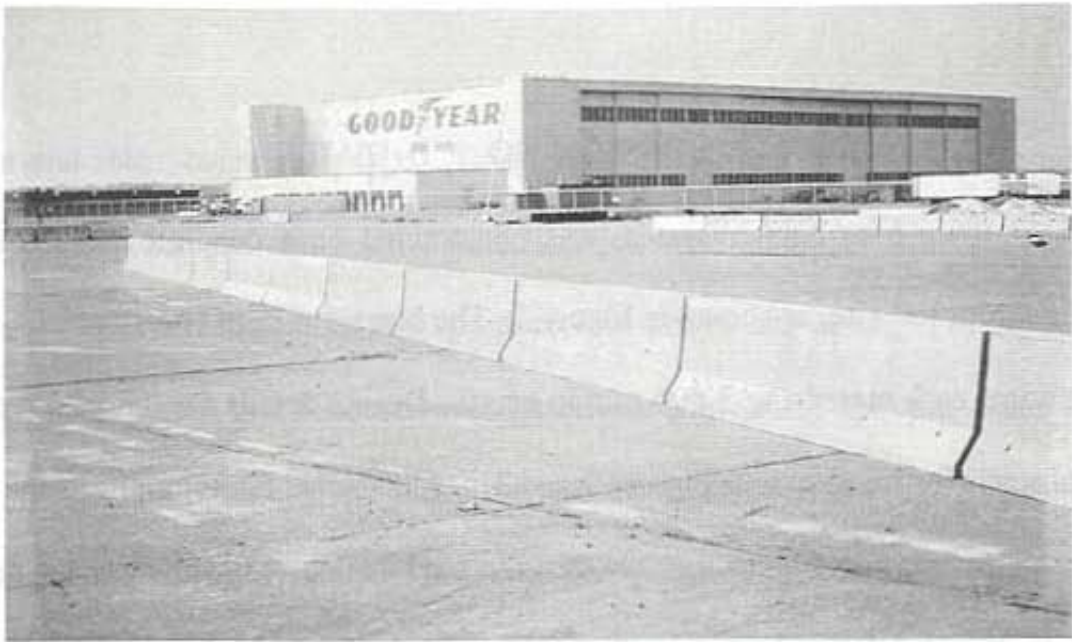
Figure 1. Temporary F-Shape CMB System, Design No. 1

A 61.97-m long barrier system was constructed on a concrete surface located at the MwRSF outdoor test site, as shown in Figure 1. The barrier system consisted of sixteen F-shape CMB sections, each measuring 3,800-mm in length. Design details for the joint connections and steel reinforcement are shown in Figures 2 and 3, respectively. Photographs of the pin and rebar connection are shown in Figure 4. Note that the cavities located at the barrier ends in Design No. 1 were intended for making a rigid connection between barrier segments when the barrier was installed in permanent applications.

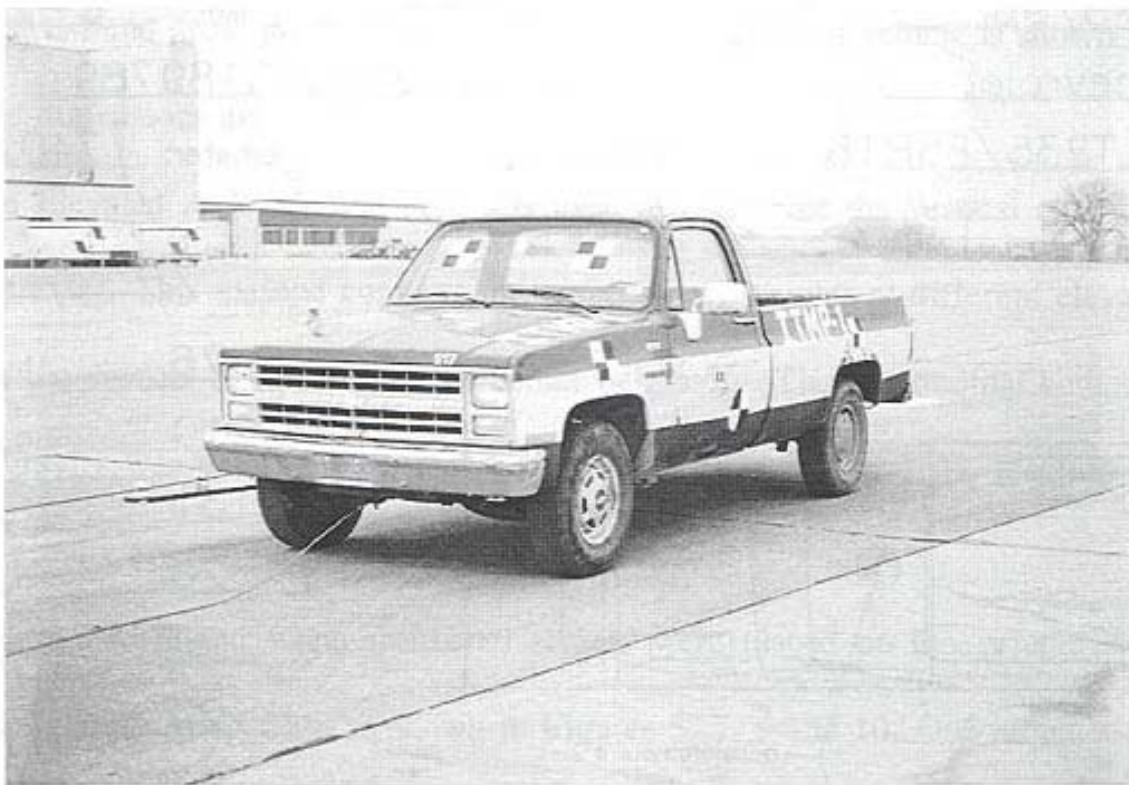
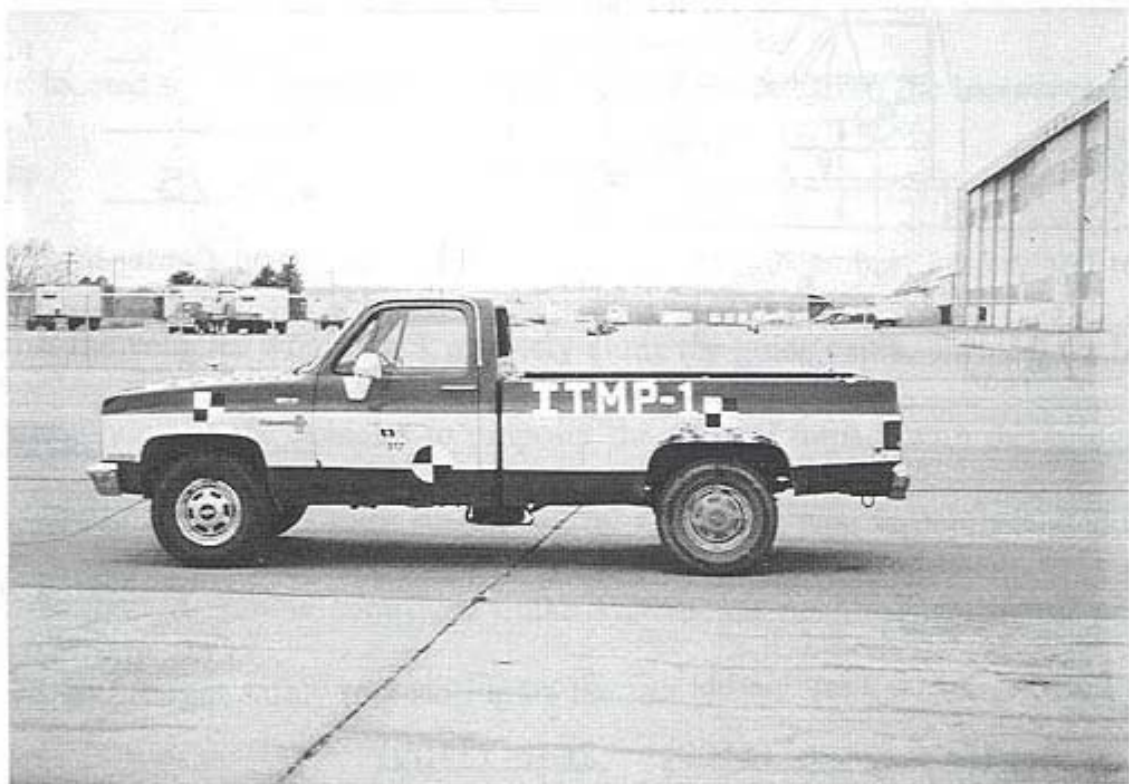
Figure 5. Test Vehicle, Test ITMP-1

For test ITMP-1, a 1985 Chevrolet C-20 ¾-ton pickup truck was used as the test vehicle. The test inertial and gross static weights were 2,000 kg. The test vehicle is shown in Figure 5, and vehicle dimensions are shown in Figure 6.

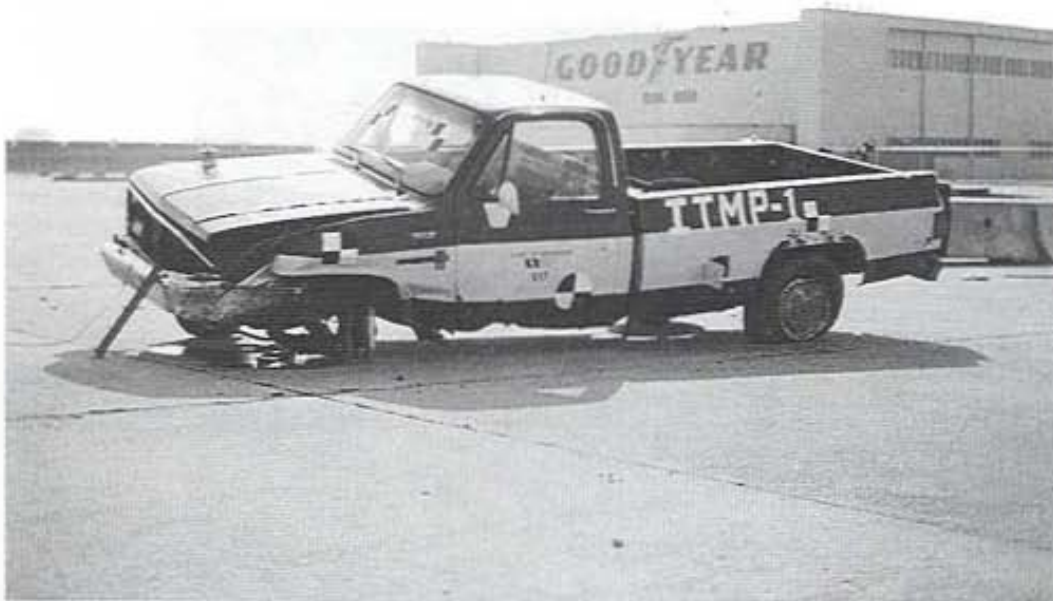
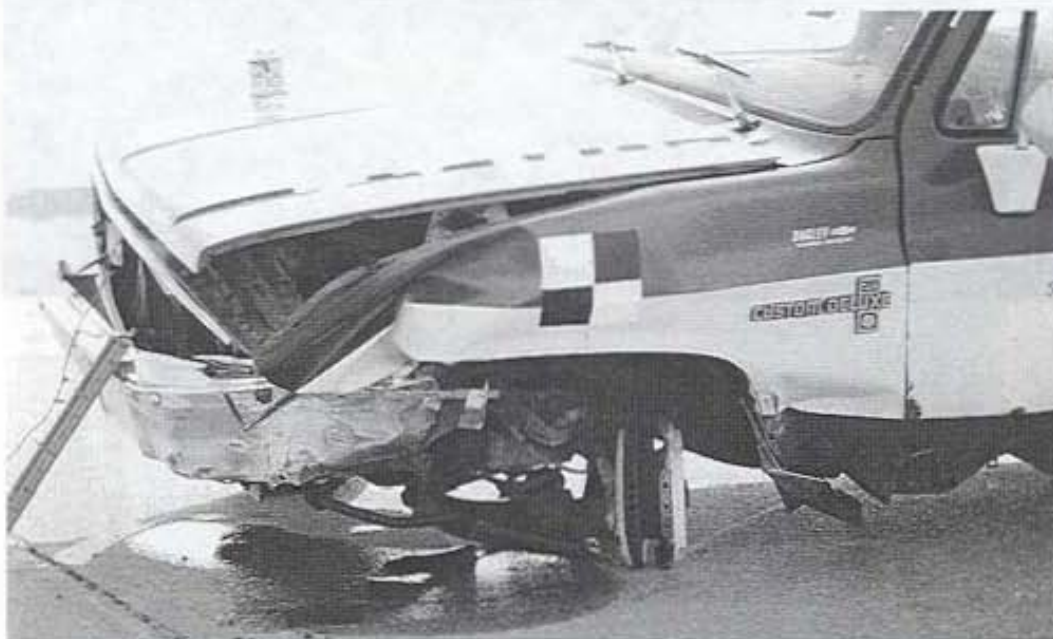
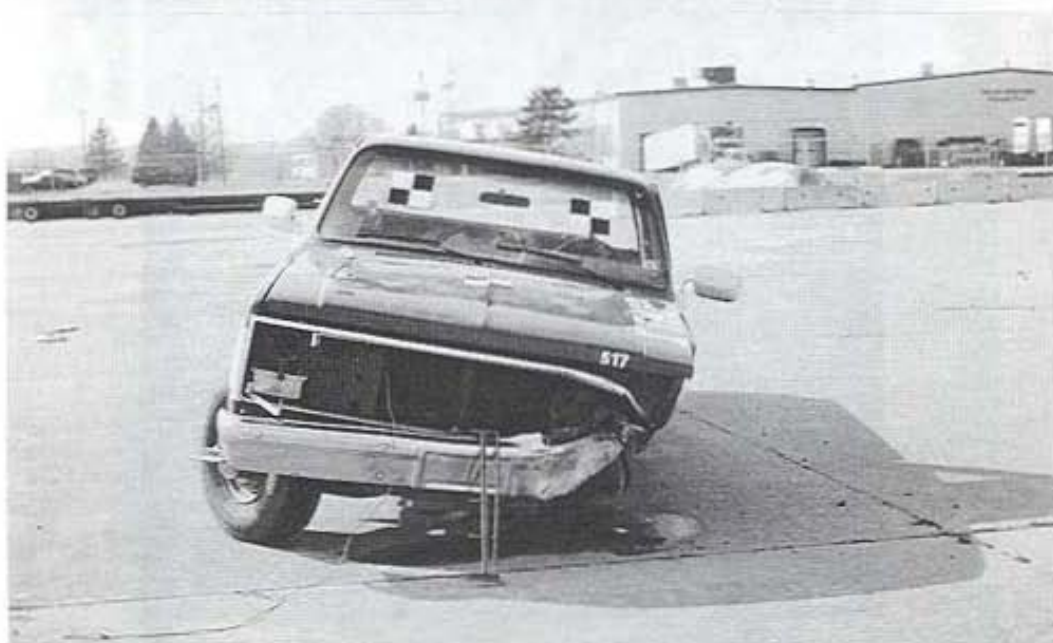
Figure 18. Vehicle Damage, Test ITMP-1

Vehicle damage was moderate, as shown in Figure 18. The front bumper and left-front quarter panel were crushed inward. The left-front wheel assembly was dislodged during the impact as the outer steel rim fractured from the inner region attached to the wheel hub. The steel frame was slightly bent inward near the front with a slight twist along its length from front to rear. Maximum occupant compartment deformations to the floorboard were 127 mm of longitudinal displacement near the center firewall region and a vertical displacement of 32 mm and 51 mm near left-side floorpan and center hump, respectively. The deformations to the floorboard were judged insufficient to cause serious injury to the vehicle occupants.

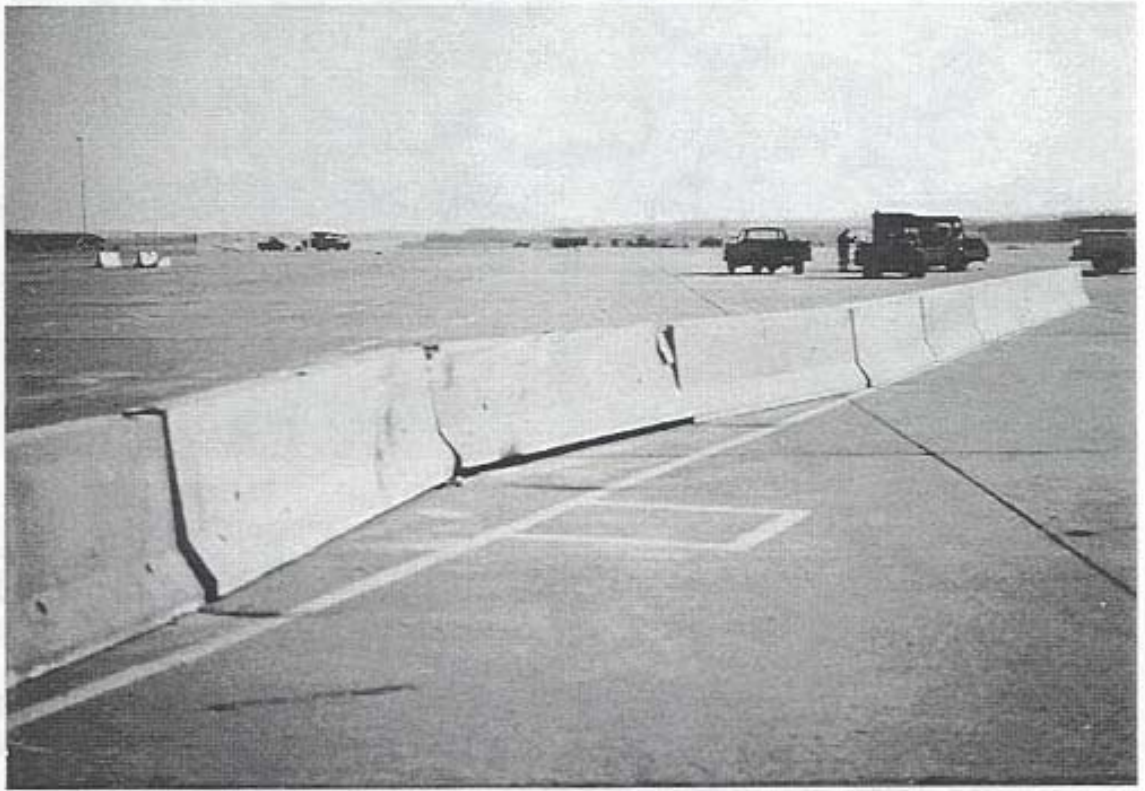
Figure 19. Barrier Damage, Test ITMP-1

Barrier damage was extensive, as shown in Figures 19 through 22. Concrete damage consisted of tire marks, scrapes, gouges, spalling, and fractured concrete pieces. The ends of barriers nos. 7 through 10 were cracked and fractured at various locations, and two cracks were also observed to extend through barrier no. 9. Ten of the steel connector pins were also deformed, ranging from slight to extensive. The maximum permanent set deflection of the barrier was 0.99 m.

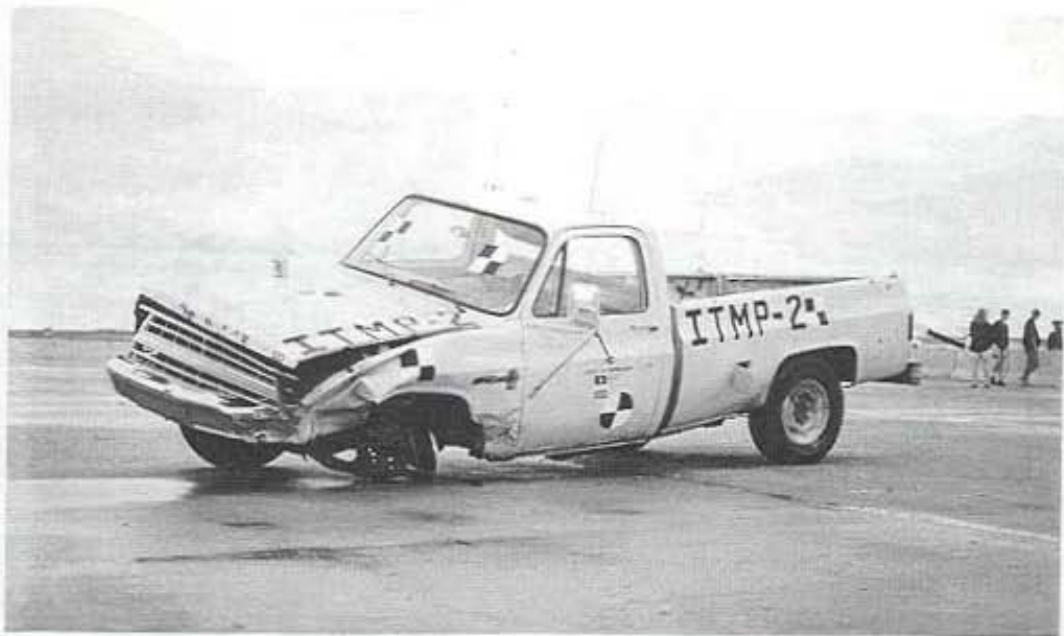
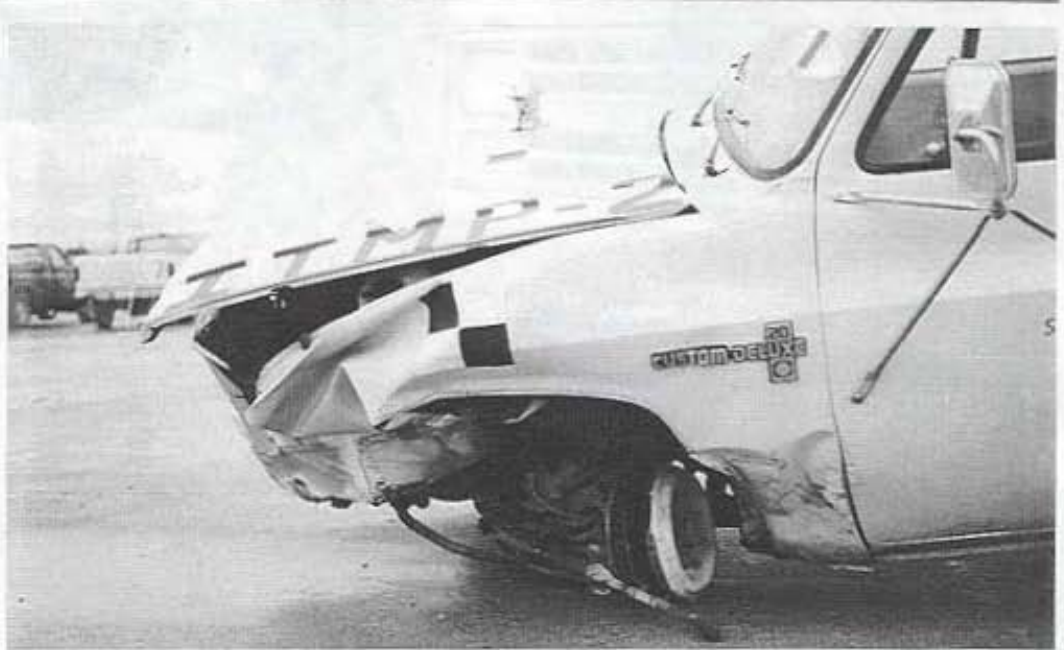
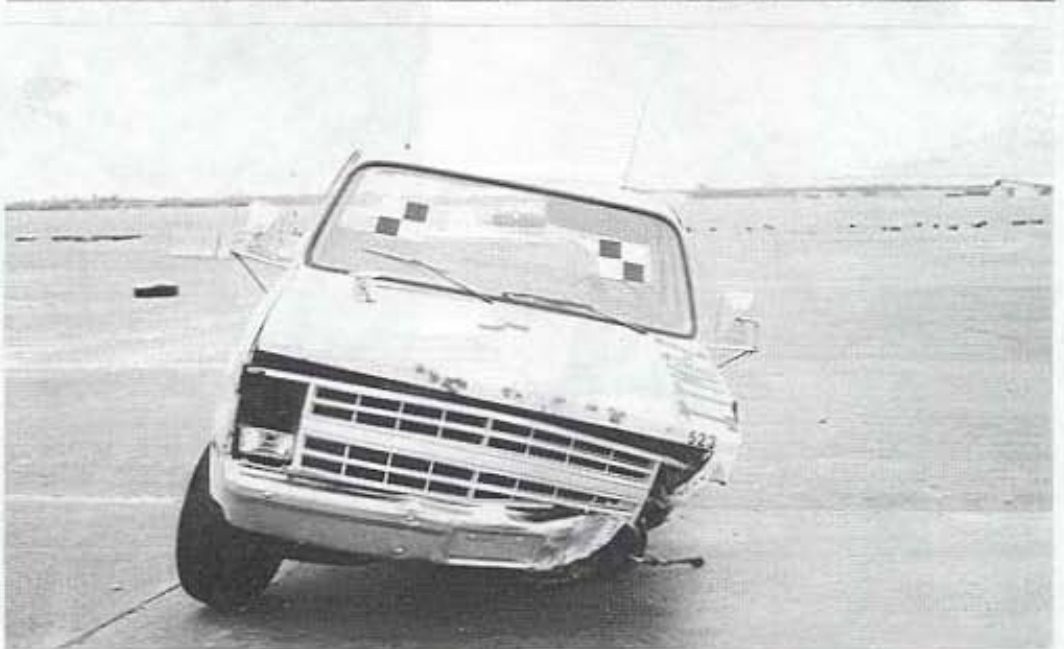
Figure 31. Vehicle Damage, Test ITMP-2

Vehicle damage was moderate, as shown in Figure 31. The front bumper and left-front quarter panel were crushed inward. The left-front wheel assembly was dislodged during the impact as the outer steel rim fractured from the inner region attached to the wheel hub. The steel frame was bent inward near the front with a significant twist along its length from front to rear. Maximum occupant compartment deformations to the floorboard were 55 mm of lateral displacement near the firewall and both a vertical and longitudinal displacement of 38 mm near the center hump behind the gear shift. The deformations to the floorboard were judged to be insufficient to cause serious injury to the vehicle occupants.

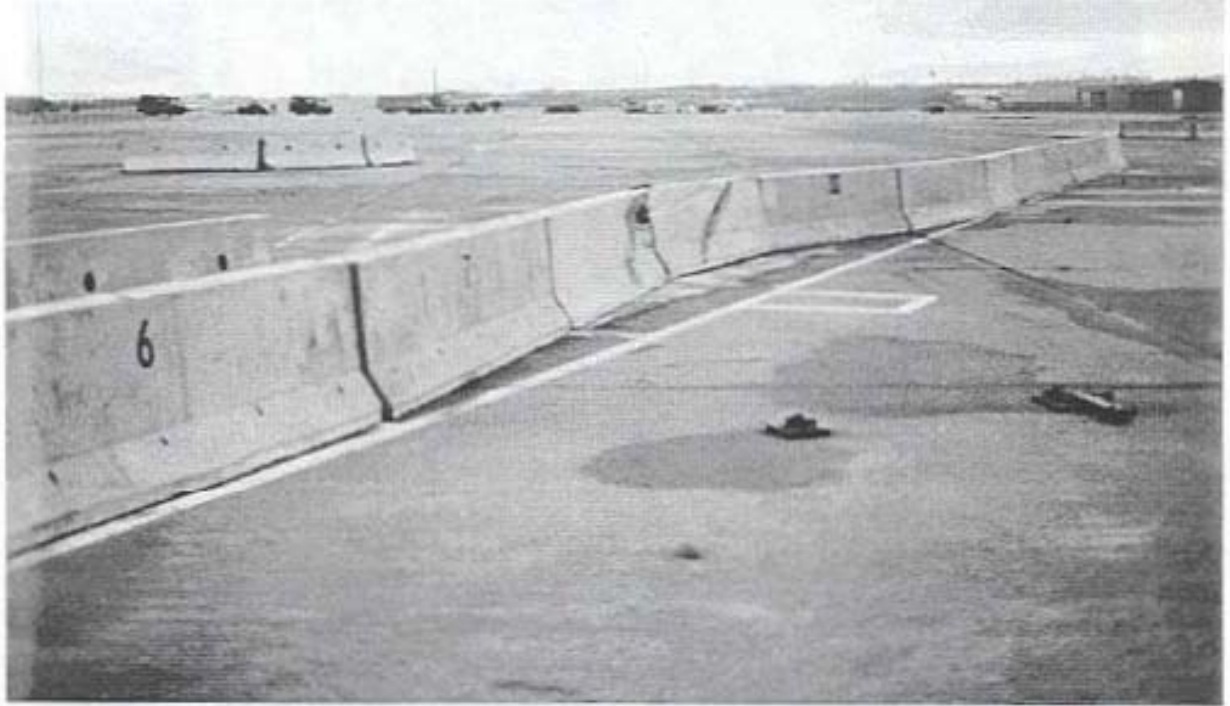
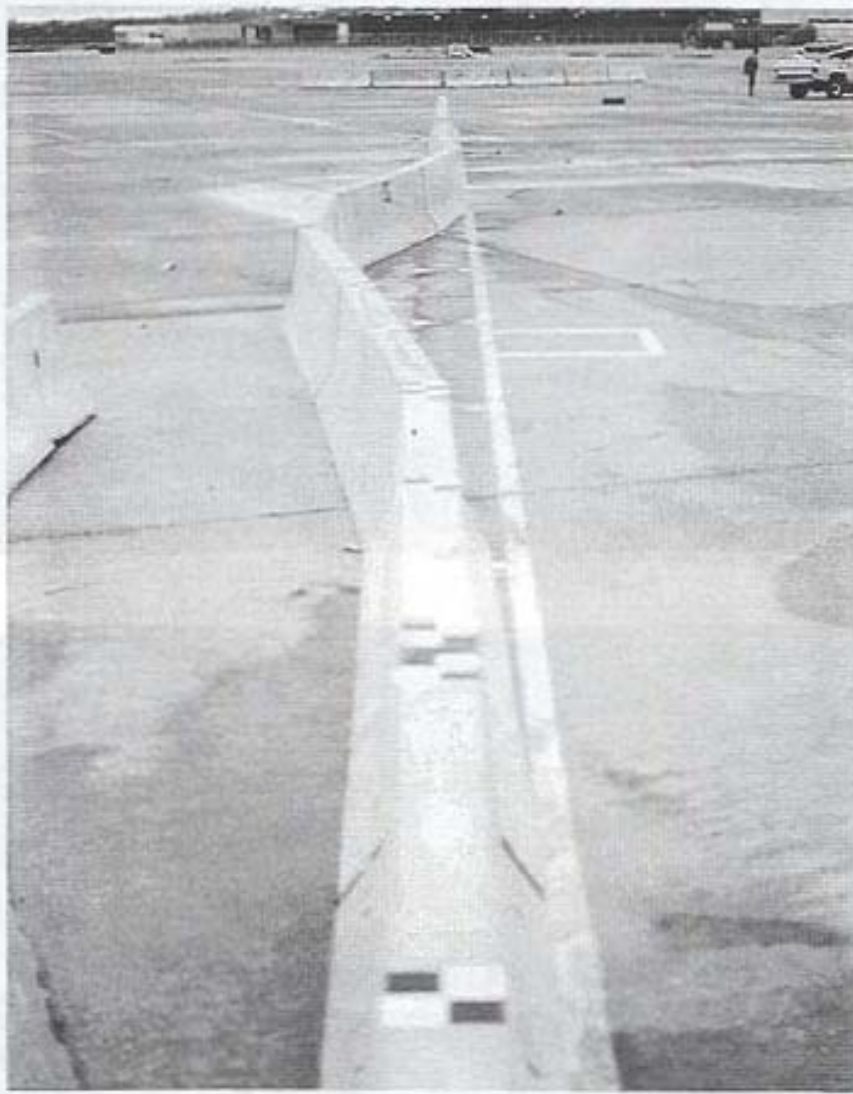
Figure 32. Barrier Damage, Test ITMP-2

Barrier damage was minor, as shown in Figures 32 through 34. Concrete damage was mostly cosmetic, consisting of tire marks, scrapes, gouges, and minor spalling. Nine steel pins were also deformed, ranging from slight to extensive. The maximum permanent set deflection of the barrier was 1.14 m.
